**Goodman Property Stream Mitigation Plan**  
**4,325 Linear Feet of Stream Restoration**  
**3,205 Linear Feet of Stream Preservation**  
**Full Delivery Project • Contract No. 000616**  
Lenoir County, North Carolina  
Tar-Pamlico River Basin: 8-digit CU 03020105

**GOODMAN PROPERTY STREAM MITIGATION PLAN**

**Lenoir County  
USGS Catalog Unit 03020202  
EEP Project No 000616  
Design Firm: Albemarle Restorations, LLC**

## 2.0 AS-BUILT REPORT

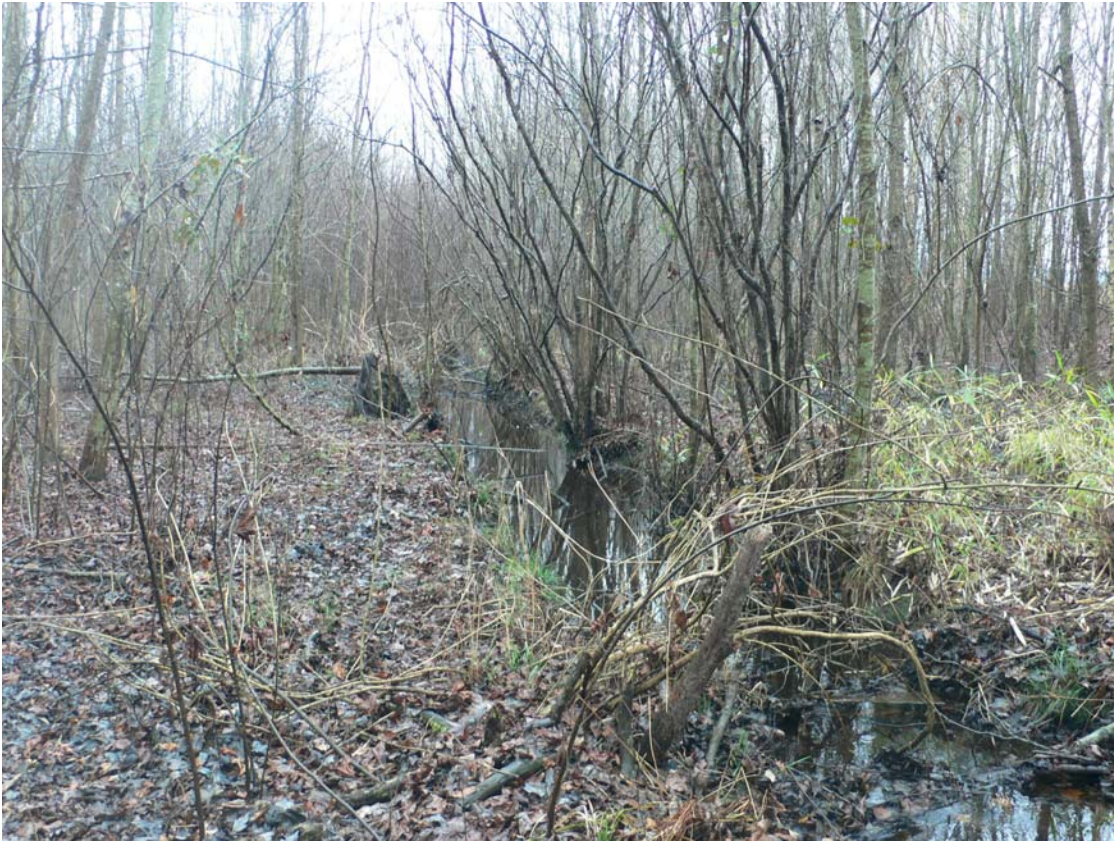
Photo 1: Stream preservation area.

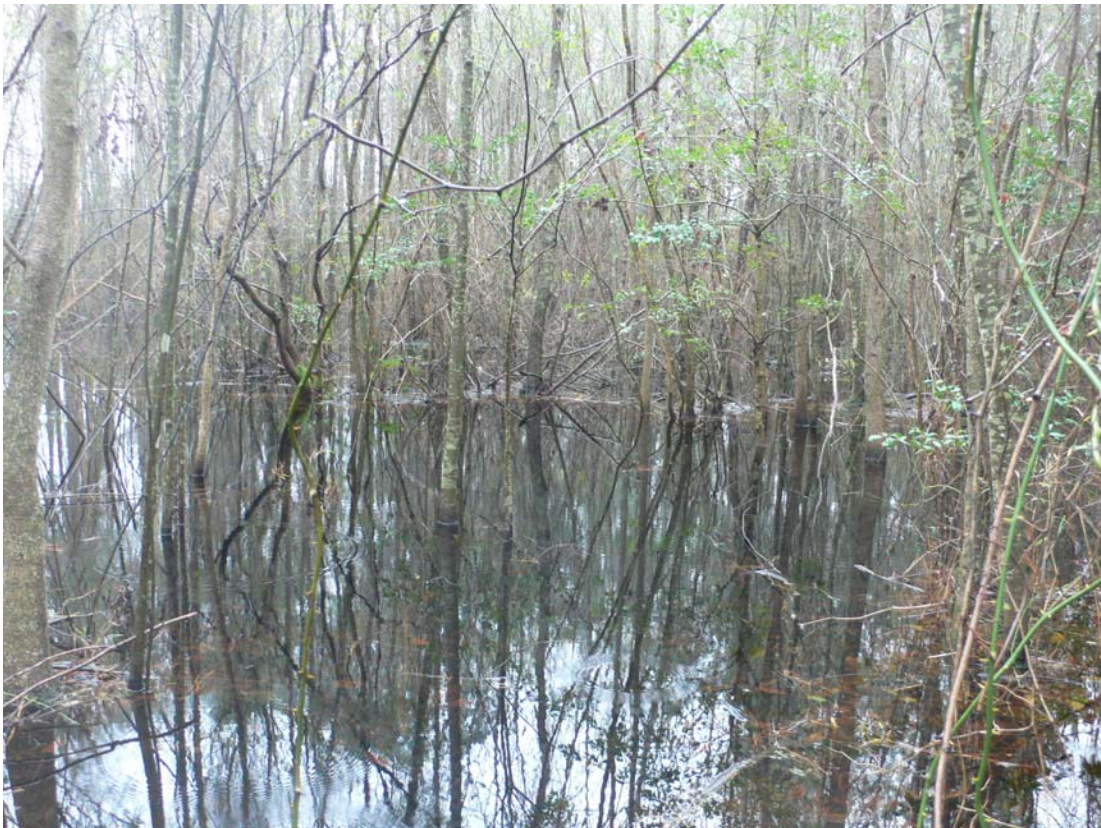
Photo 2: Stream preservation area.

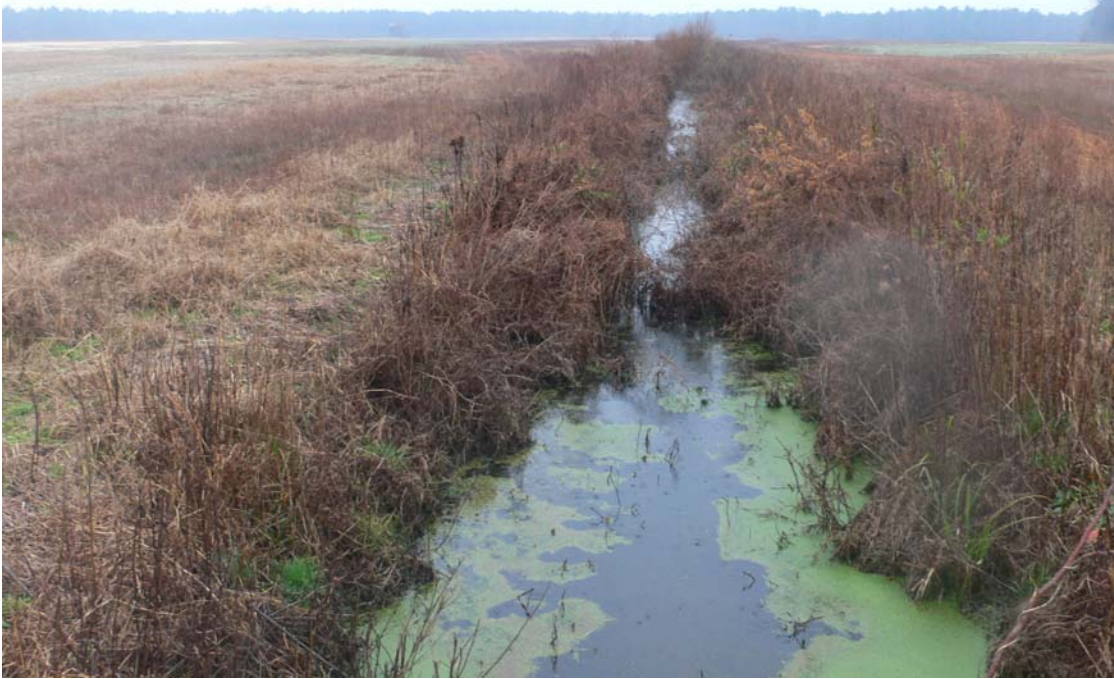
Photo 3: Ditched stream draining the cropland prior to swamp run restoration.

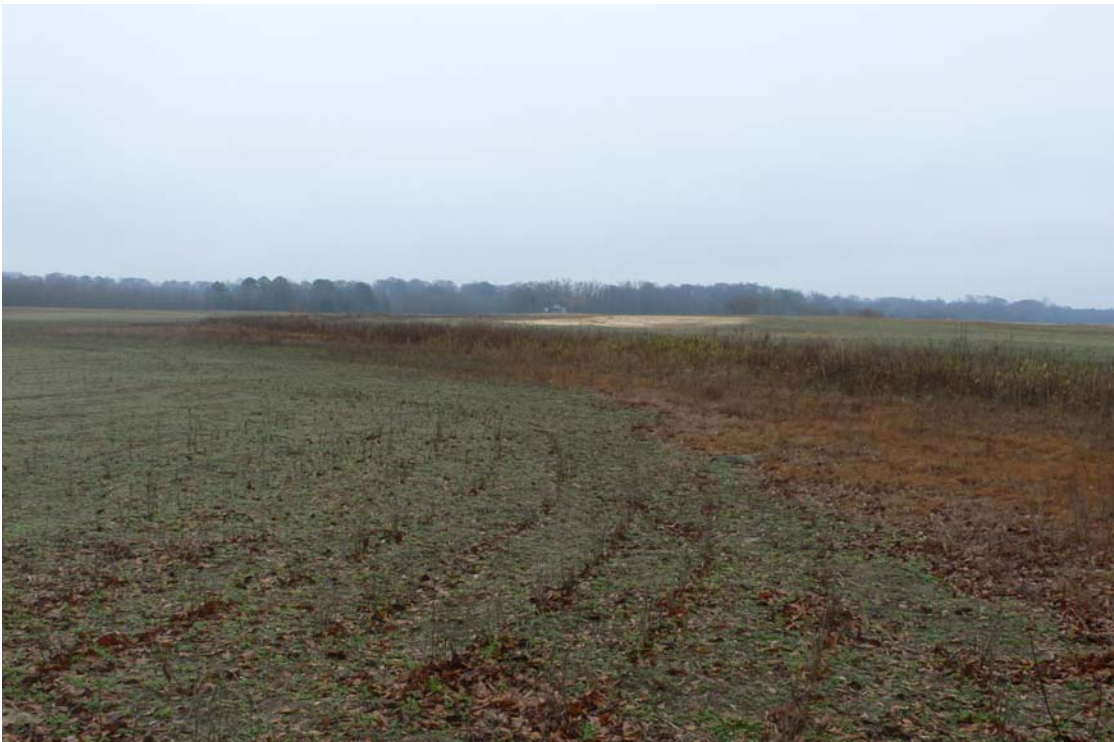
Photo 4: View of the valley showing “hook” tributary or the center tributary prior to swamp run restoration.

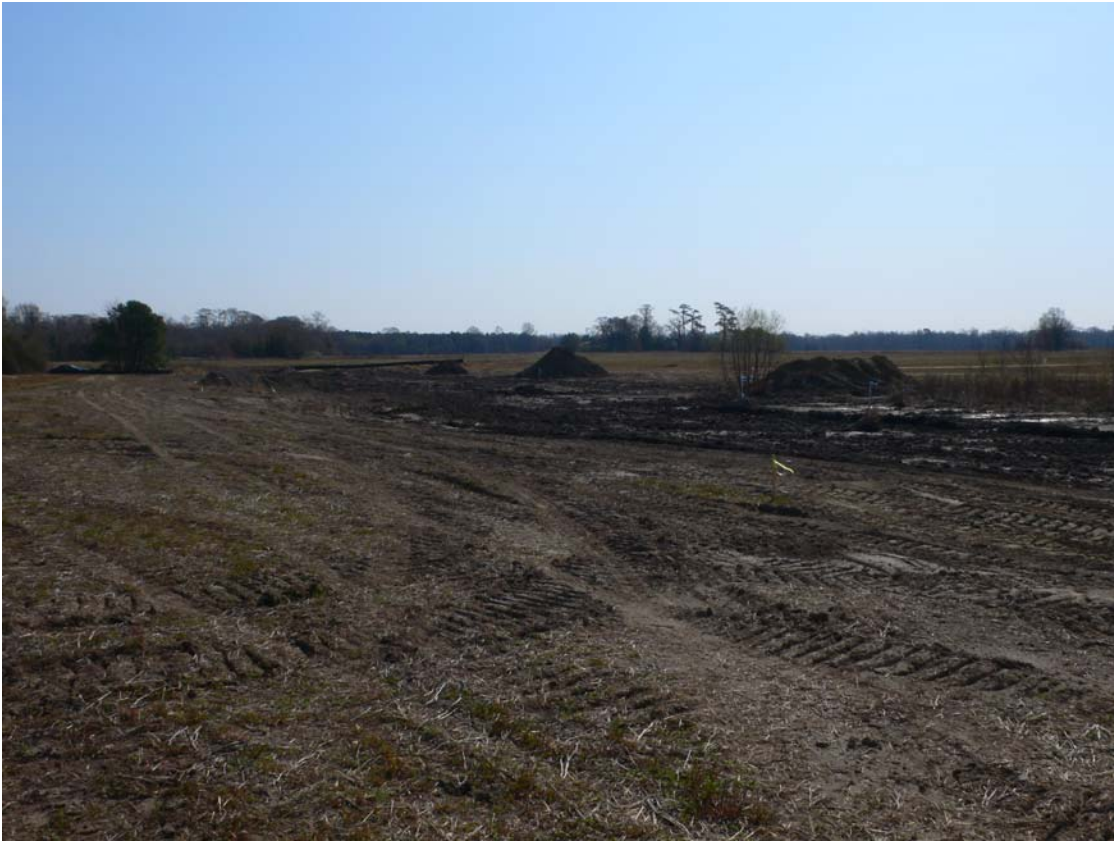
Photo 5: Swamp run grading and stockpiling of topsoil.

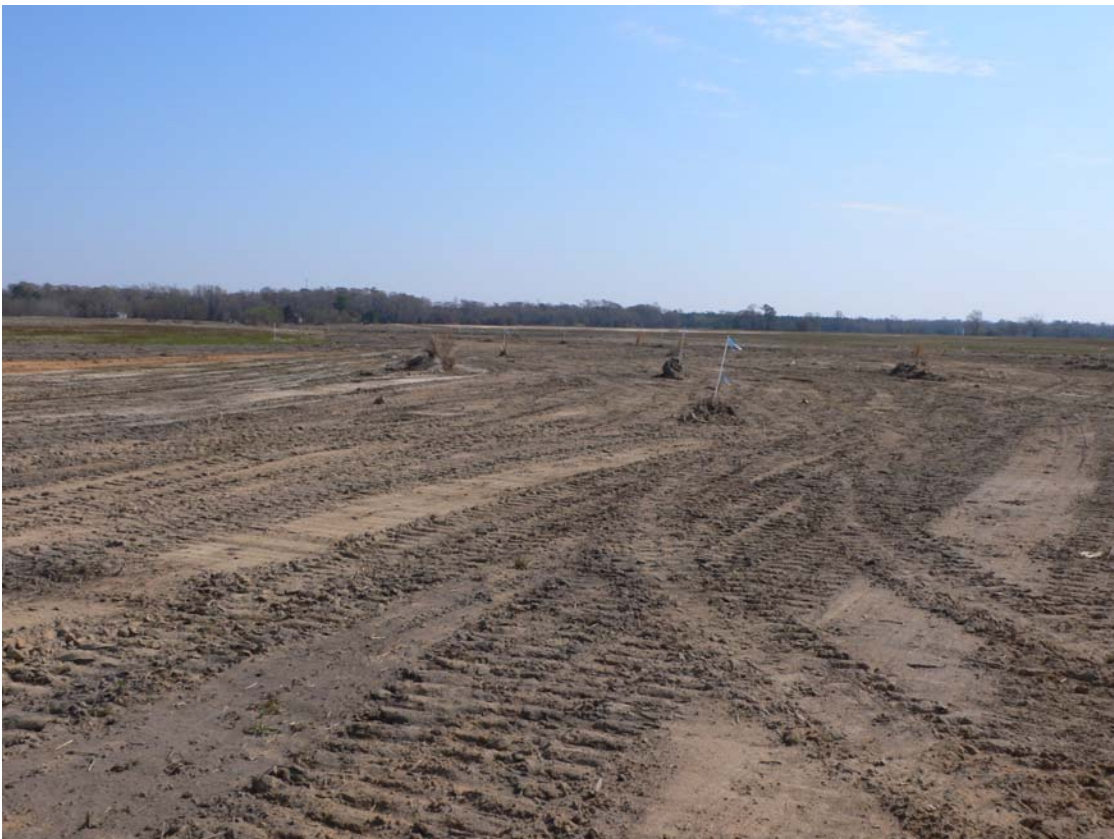
Photo 6: Swamp run grading.

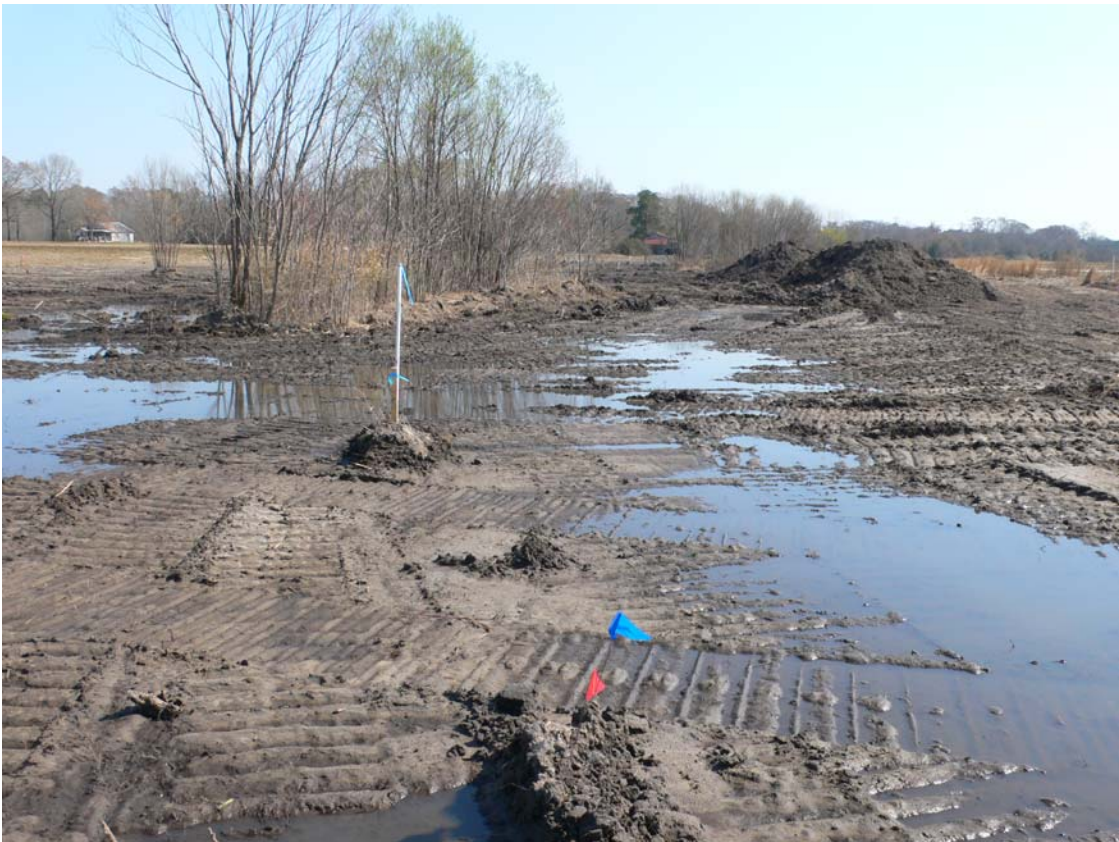
Photo 7: Initial cutting and stockpiling of topsoil.

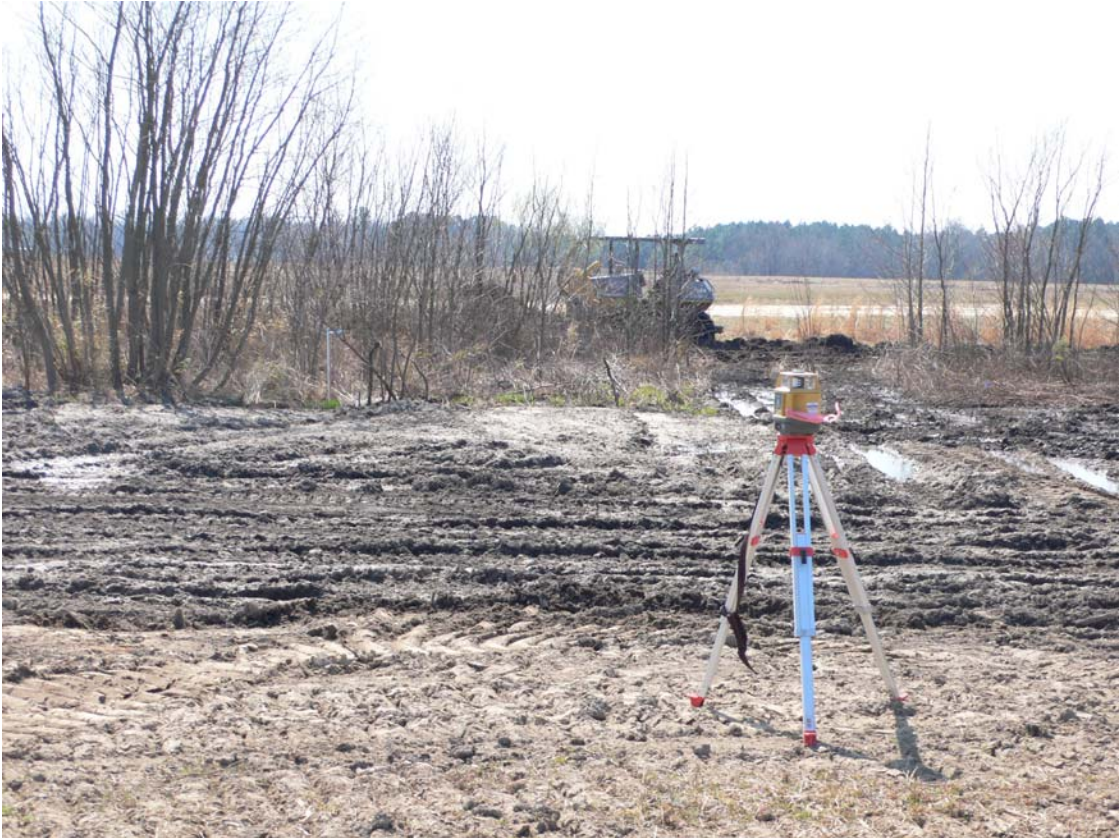
Photo 8: Swamp run grading.

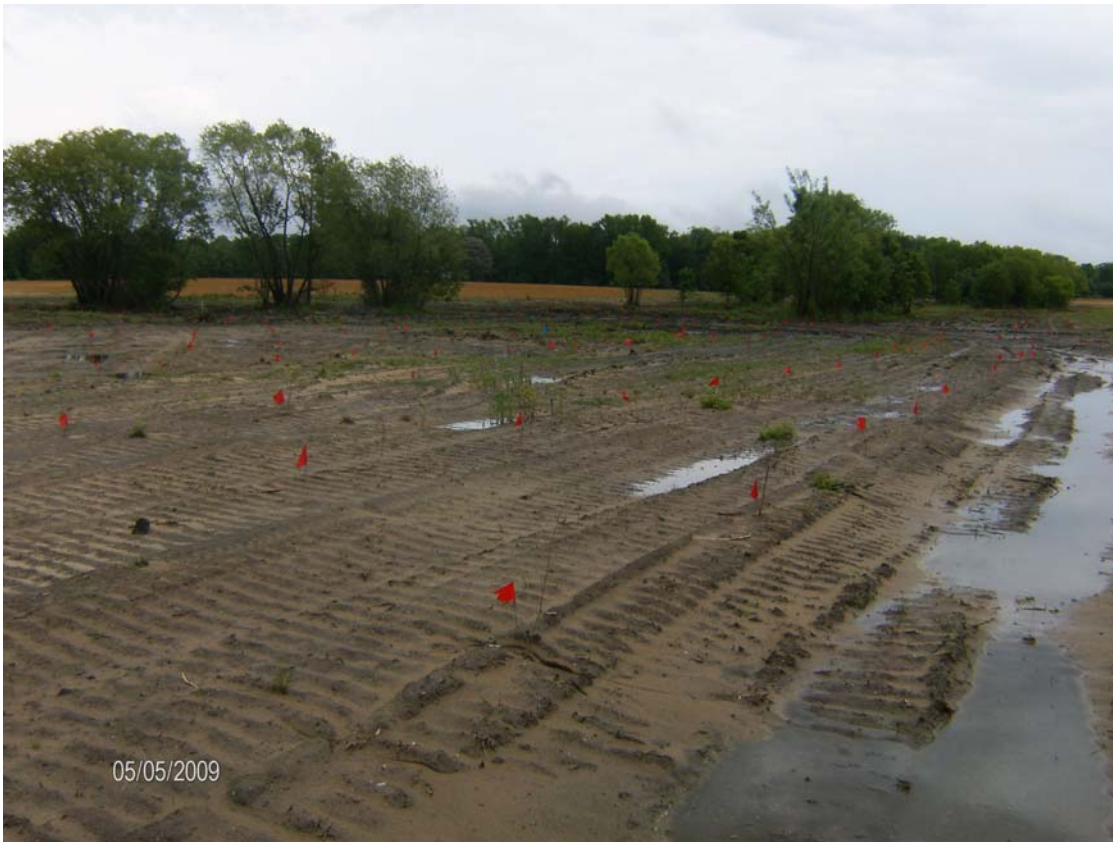
Photo 9: Confluence of the swamp runs.

Immediately following construction and during the planting phase, the swamp run was inundated through out the entire project area. Current site conditions have pockets of water below the confluence of the two swamp runs with standing water at the down stream end of the project. Above the confluence the north and south swamp runs are showing drier then expected conditions due to below average rainfall amounts in April. Photographs of the site taken in April 2009 are found in **Appendix A**.

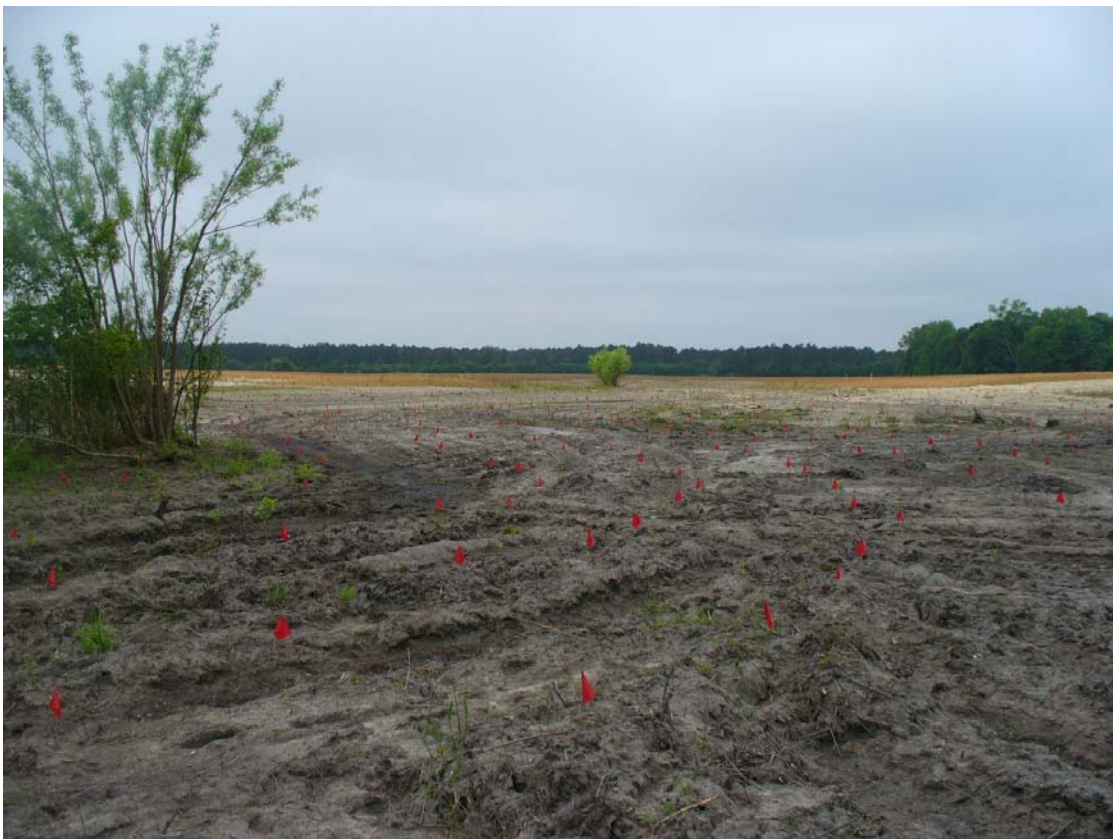
Photo 10: Facing upstream on the restored northern swamp run.

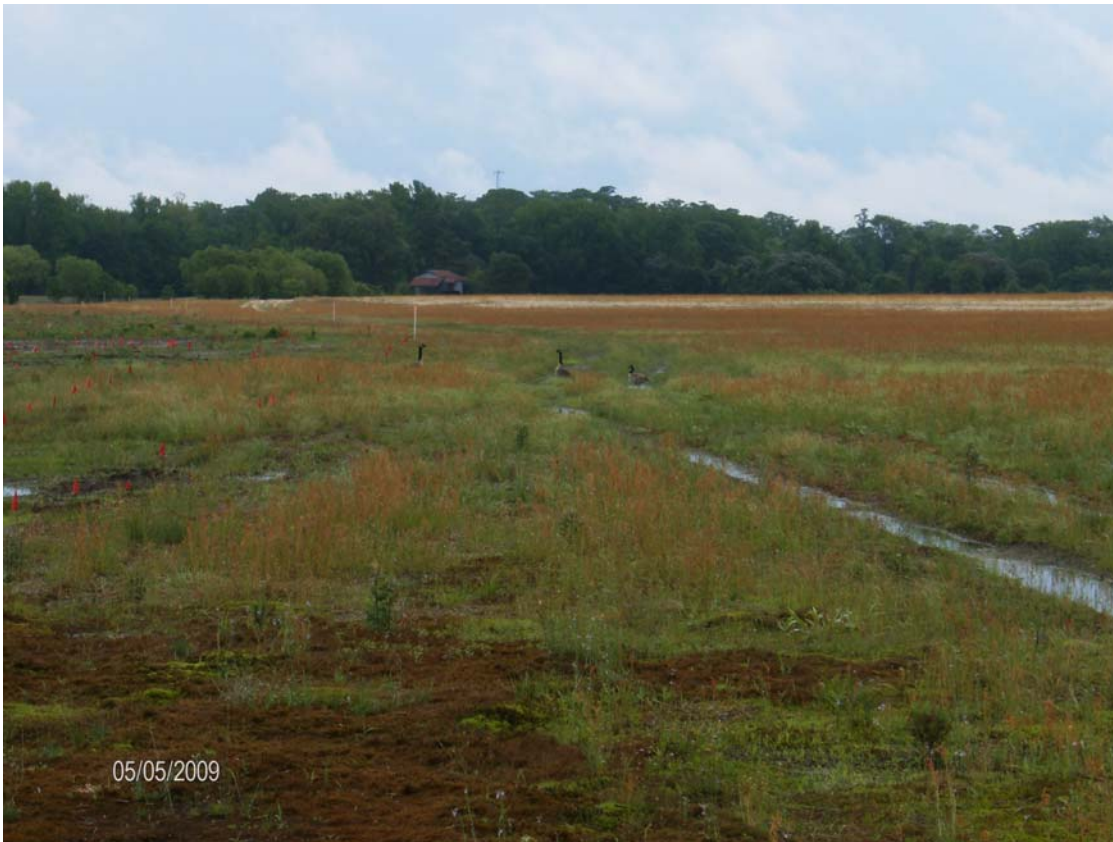
Photo 11: One month post construction.

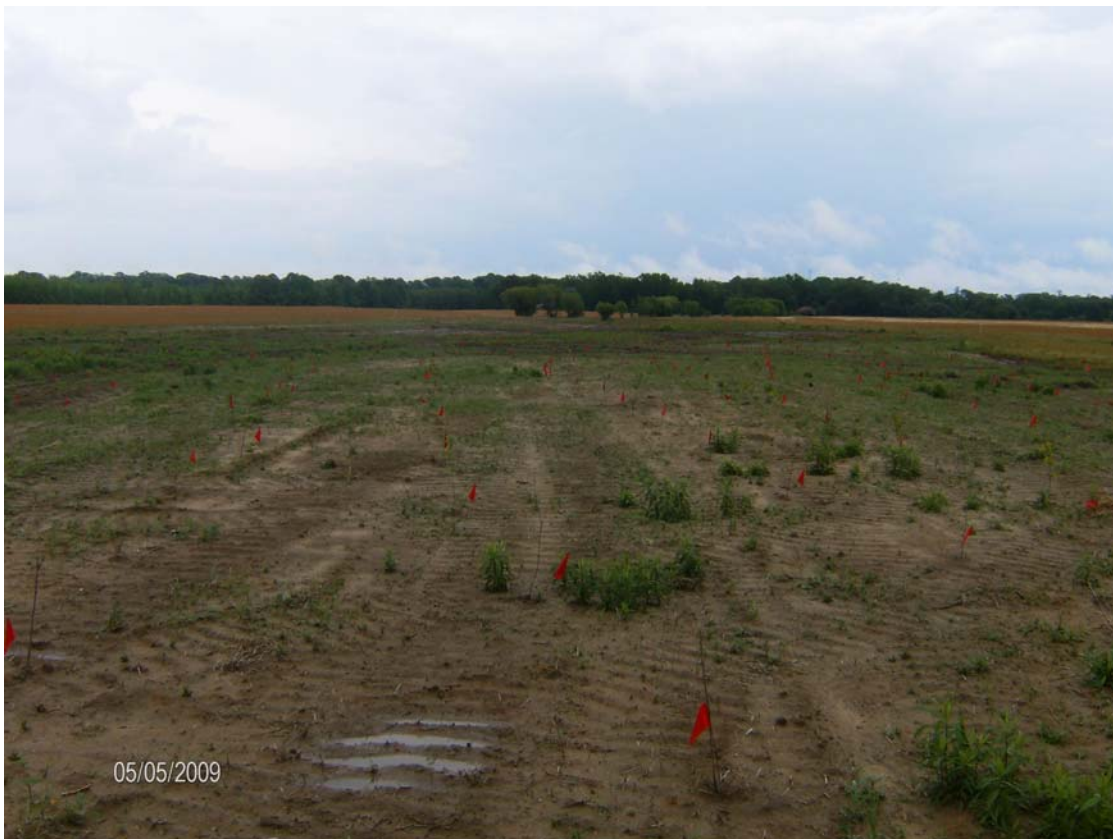
Photo 12: One month post construction.

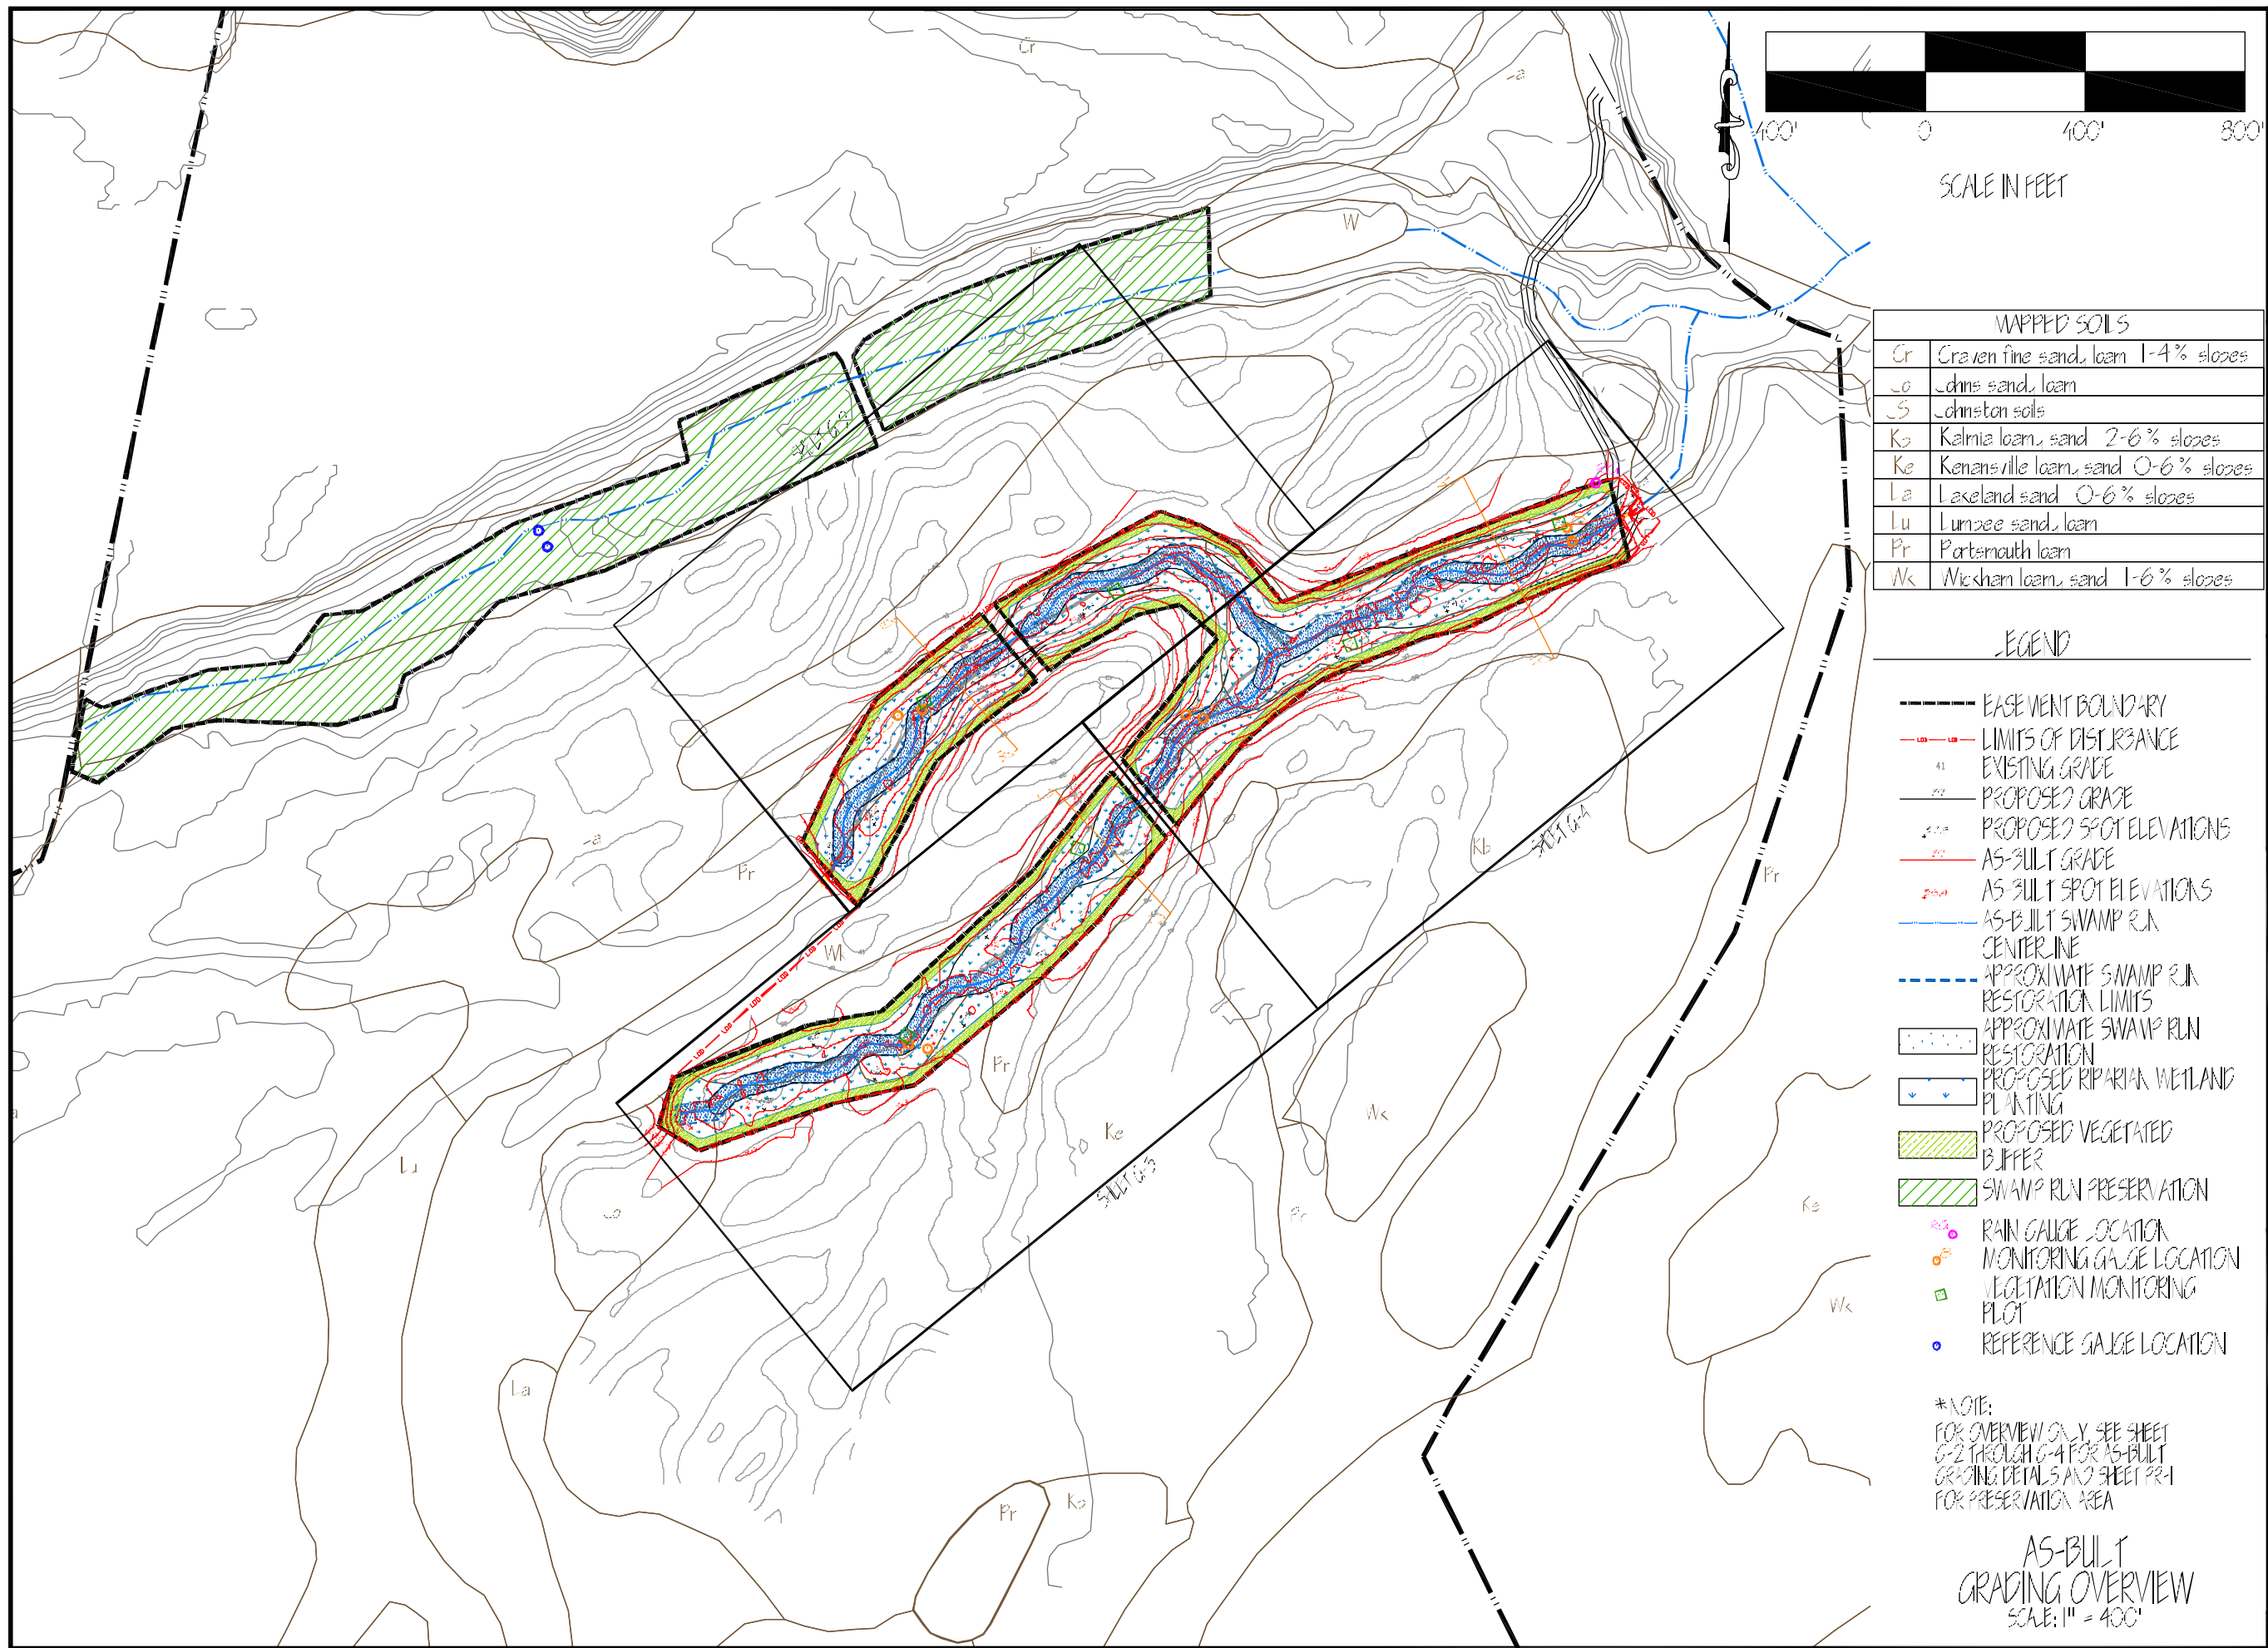
AS-BUILT  
 GRADING OVERVIEW  
 SCALE: 1" = 400'

\*NOTE:  
 FOR OVERVIEW ONLY, SEE SHEET  
 G-2 THROUGH G-4 FOR AS-BUILT  
 GRADING DETAILS AND SHEET PR-1  
 FOR PRESERVATION AREA

Restoration activities, in accordance with the approved Restoration Plan, began on February 11, 2009 with the installation of recommended erosion control practices and grading of the headwater swamp run system. After the swamp run (stream) portion of the project was completed, the adjacent riparian wetland and vegetated buffer were graded. Topsoil, which had been stockpiled during initial construction, was redistributed during final grading. On March 26, 2009 all grading operations were completed. The As- Built survey for the grading is included in **Appendix B**, sheets G-1 thru G-4.

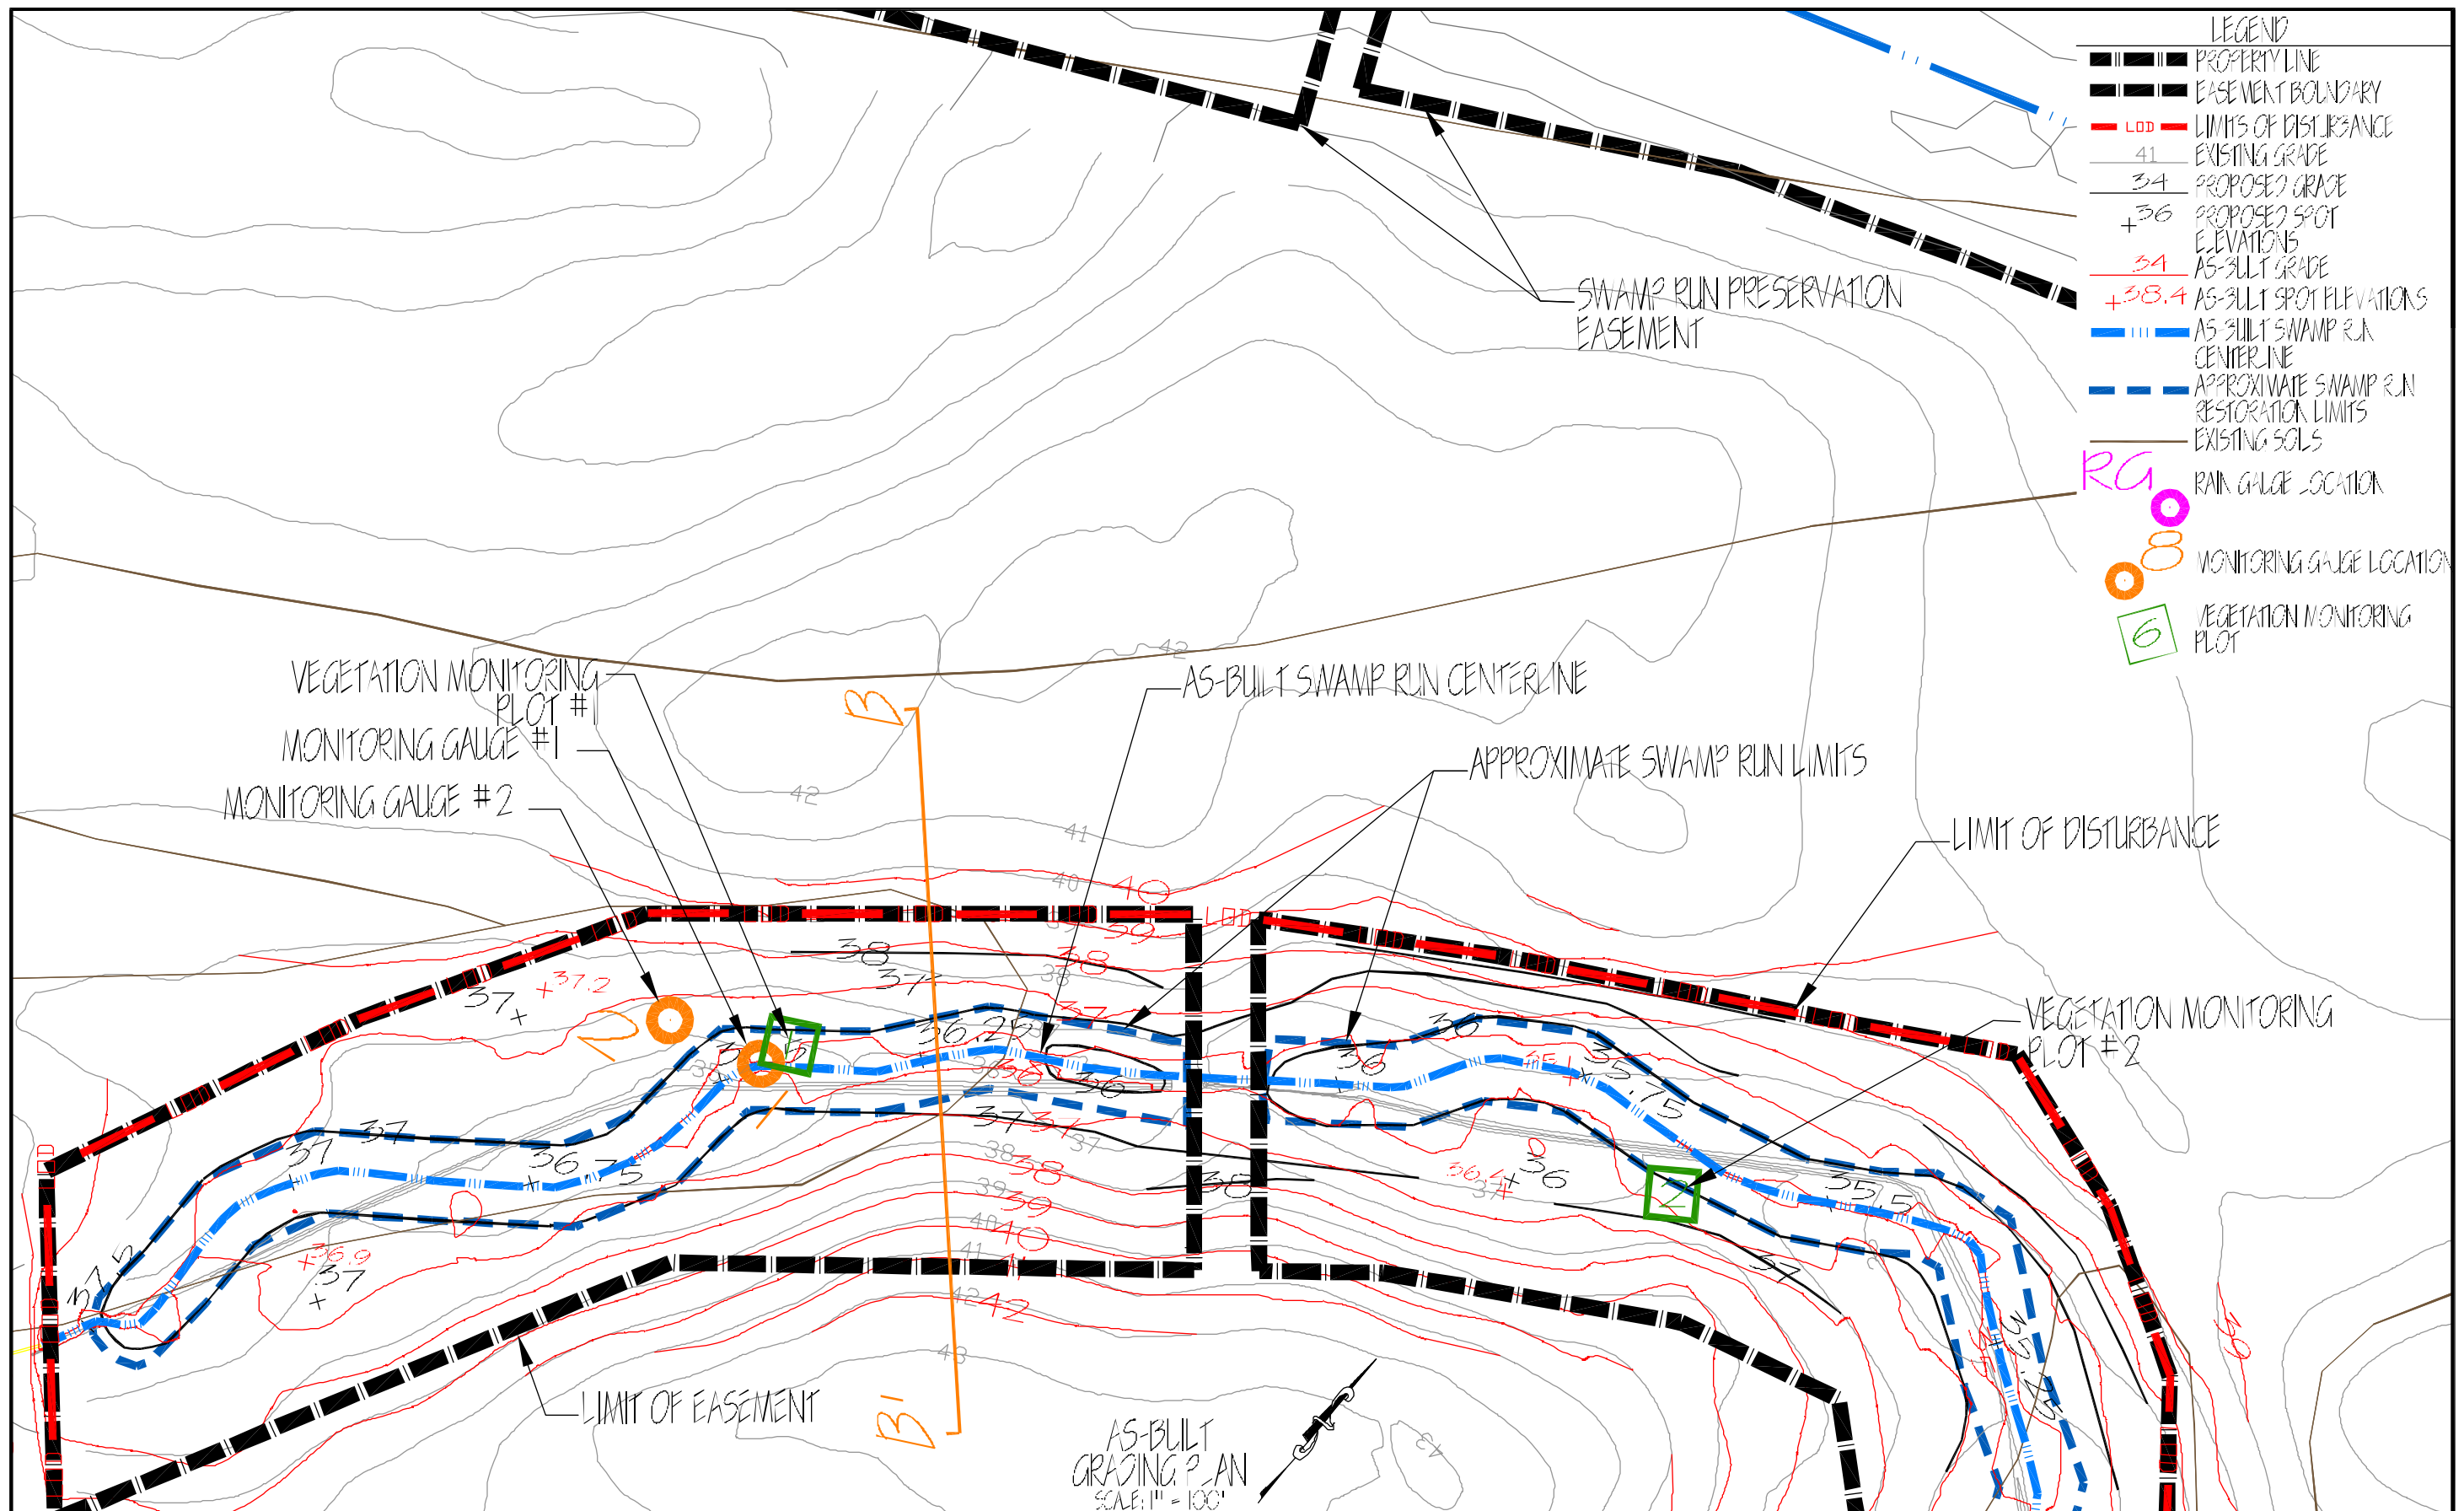
AS-BUILT GRADING PLAN  
 SCALE: 1" = 100'

VEGETATION MONITORING PLOT #1  
 MONITORING GAUGE #1  
 MONITORING GAUGE #2

VEGETATION MONITORING PLOT #2

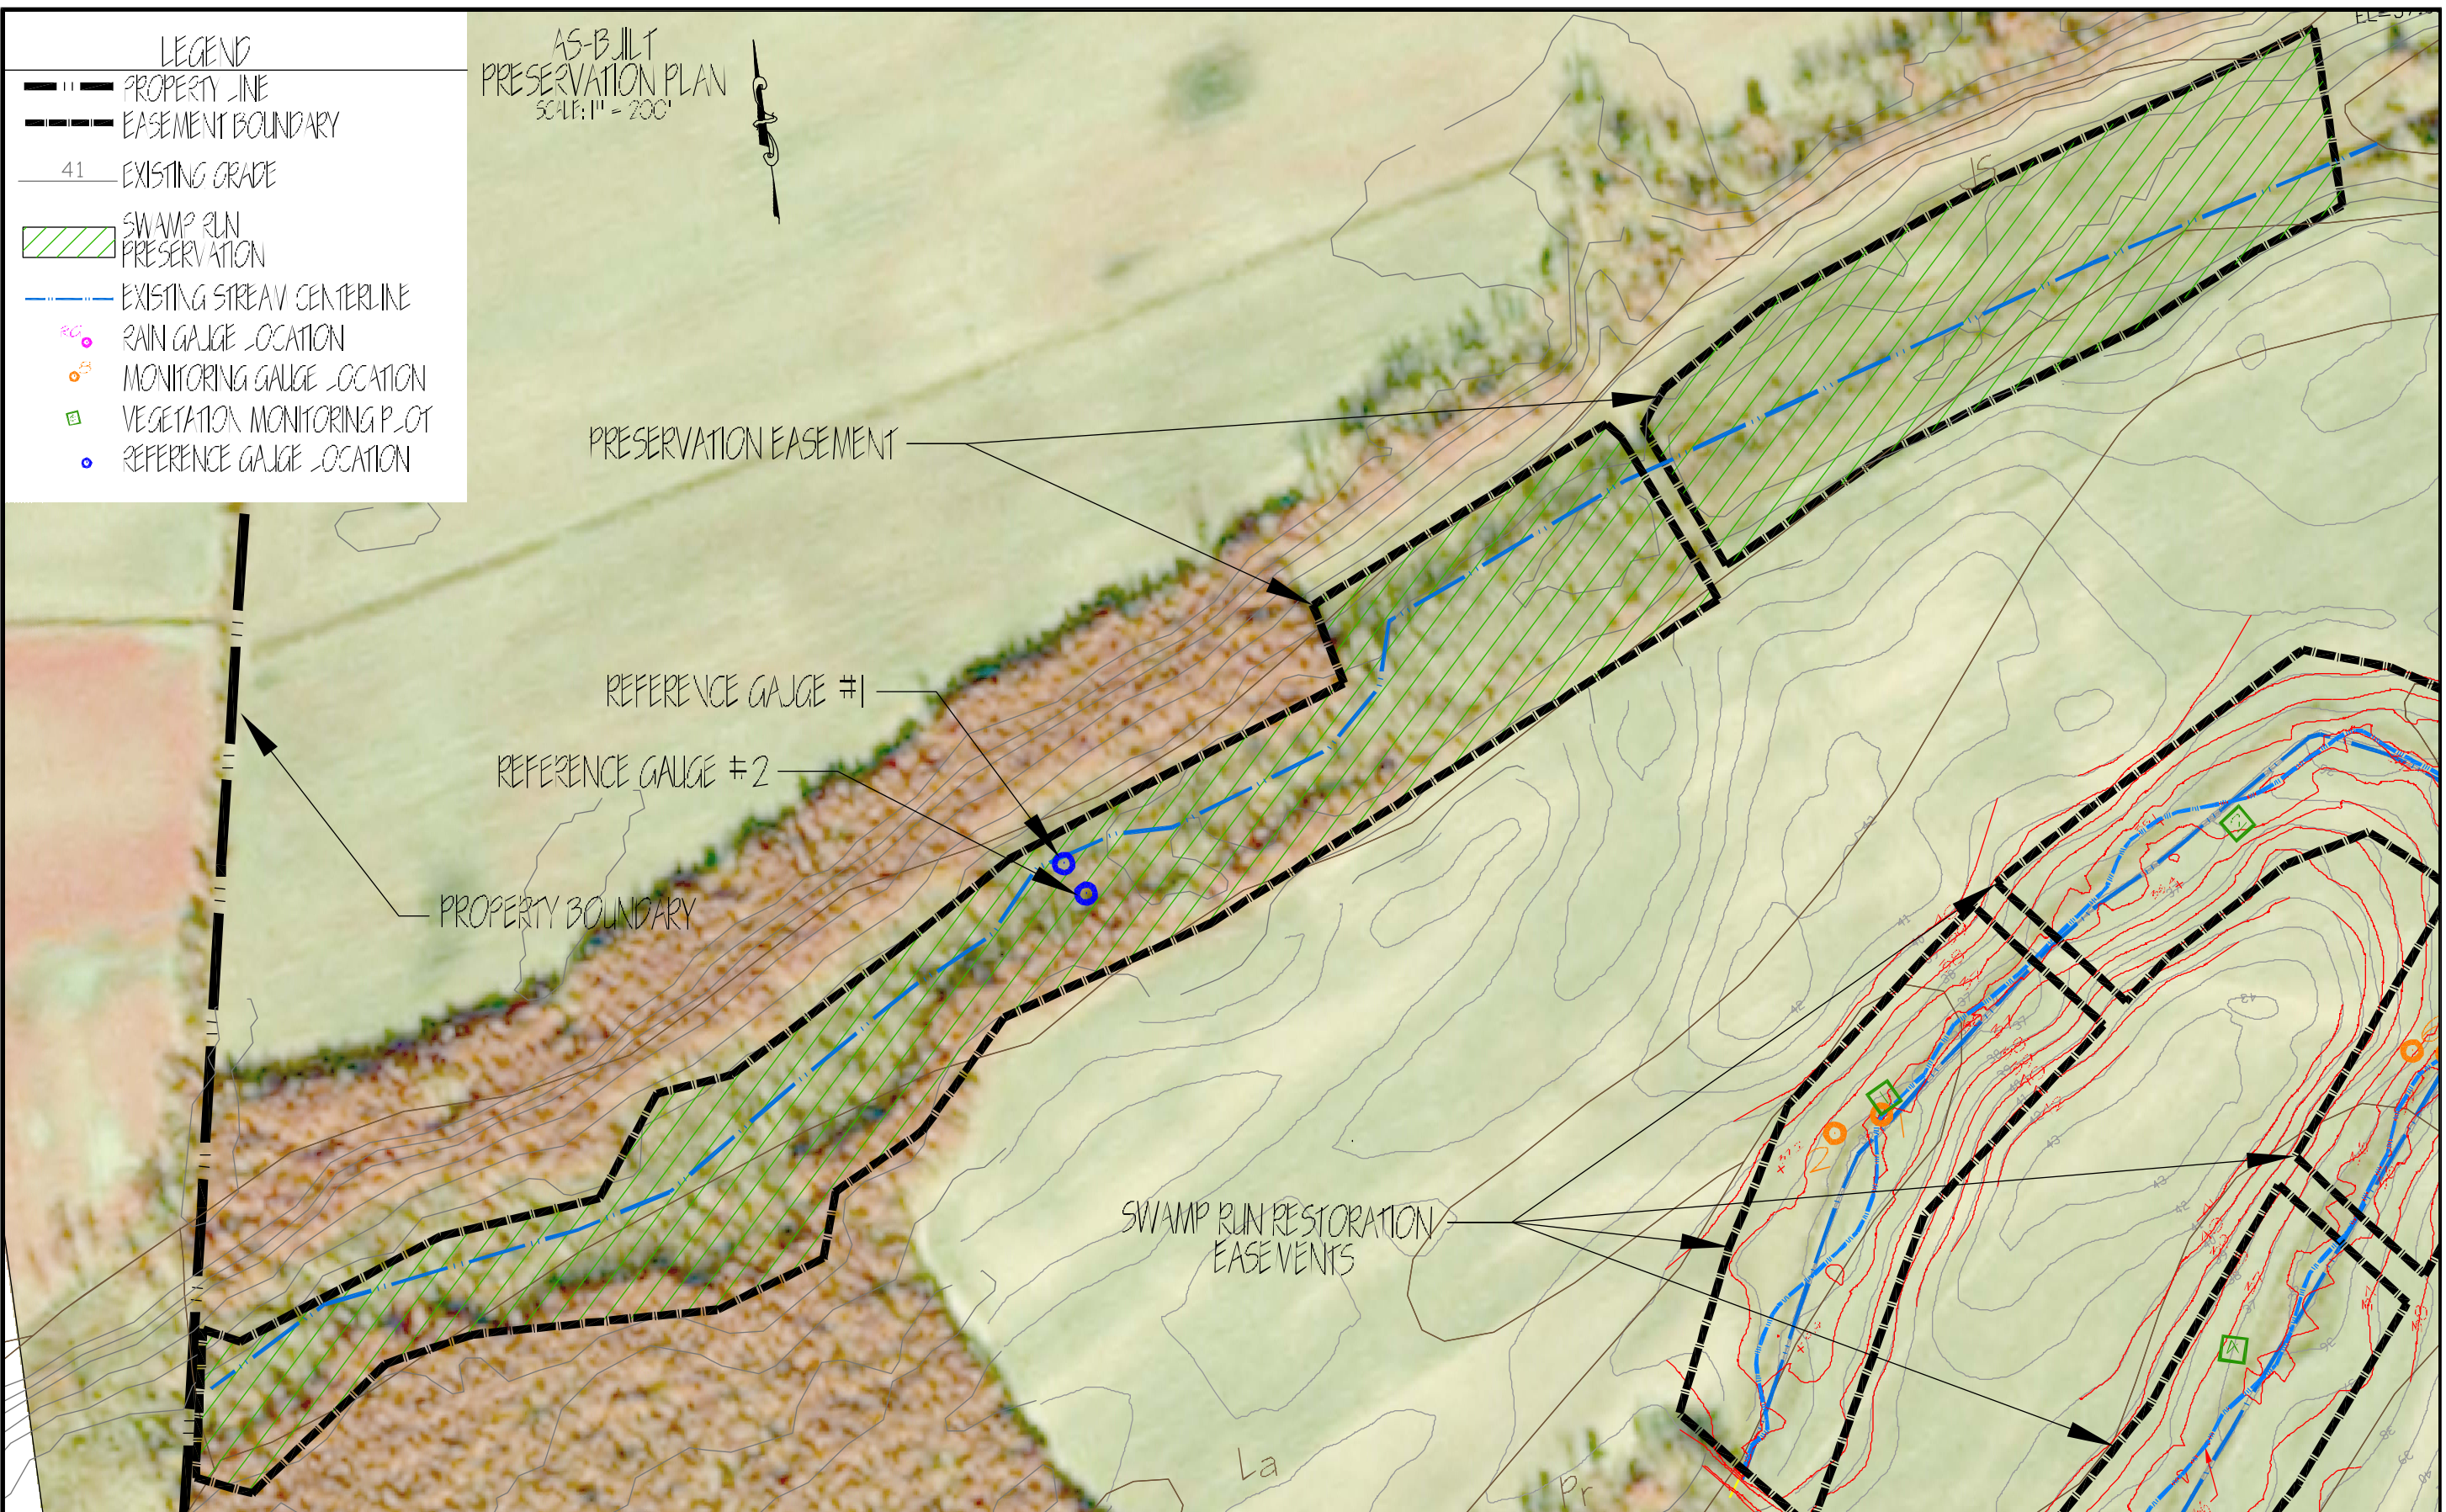
AS-BUILT  
PRESERVATION PLAN  
SCALE: 1" = 200'

REFERENCE GAUGE #1

REFERENCE GAUGE #2
