NCECOSYSTEM
ENHANCEMENT PROGRAM

Goose Creek Stream Restoration Plan

September 2005

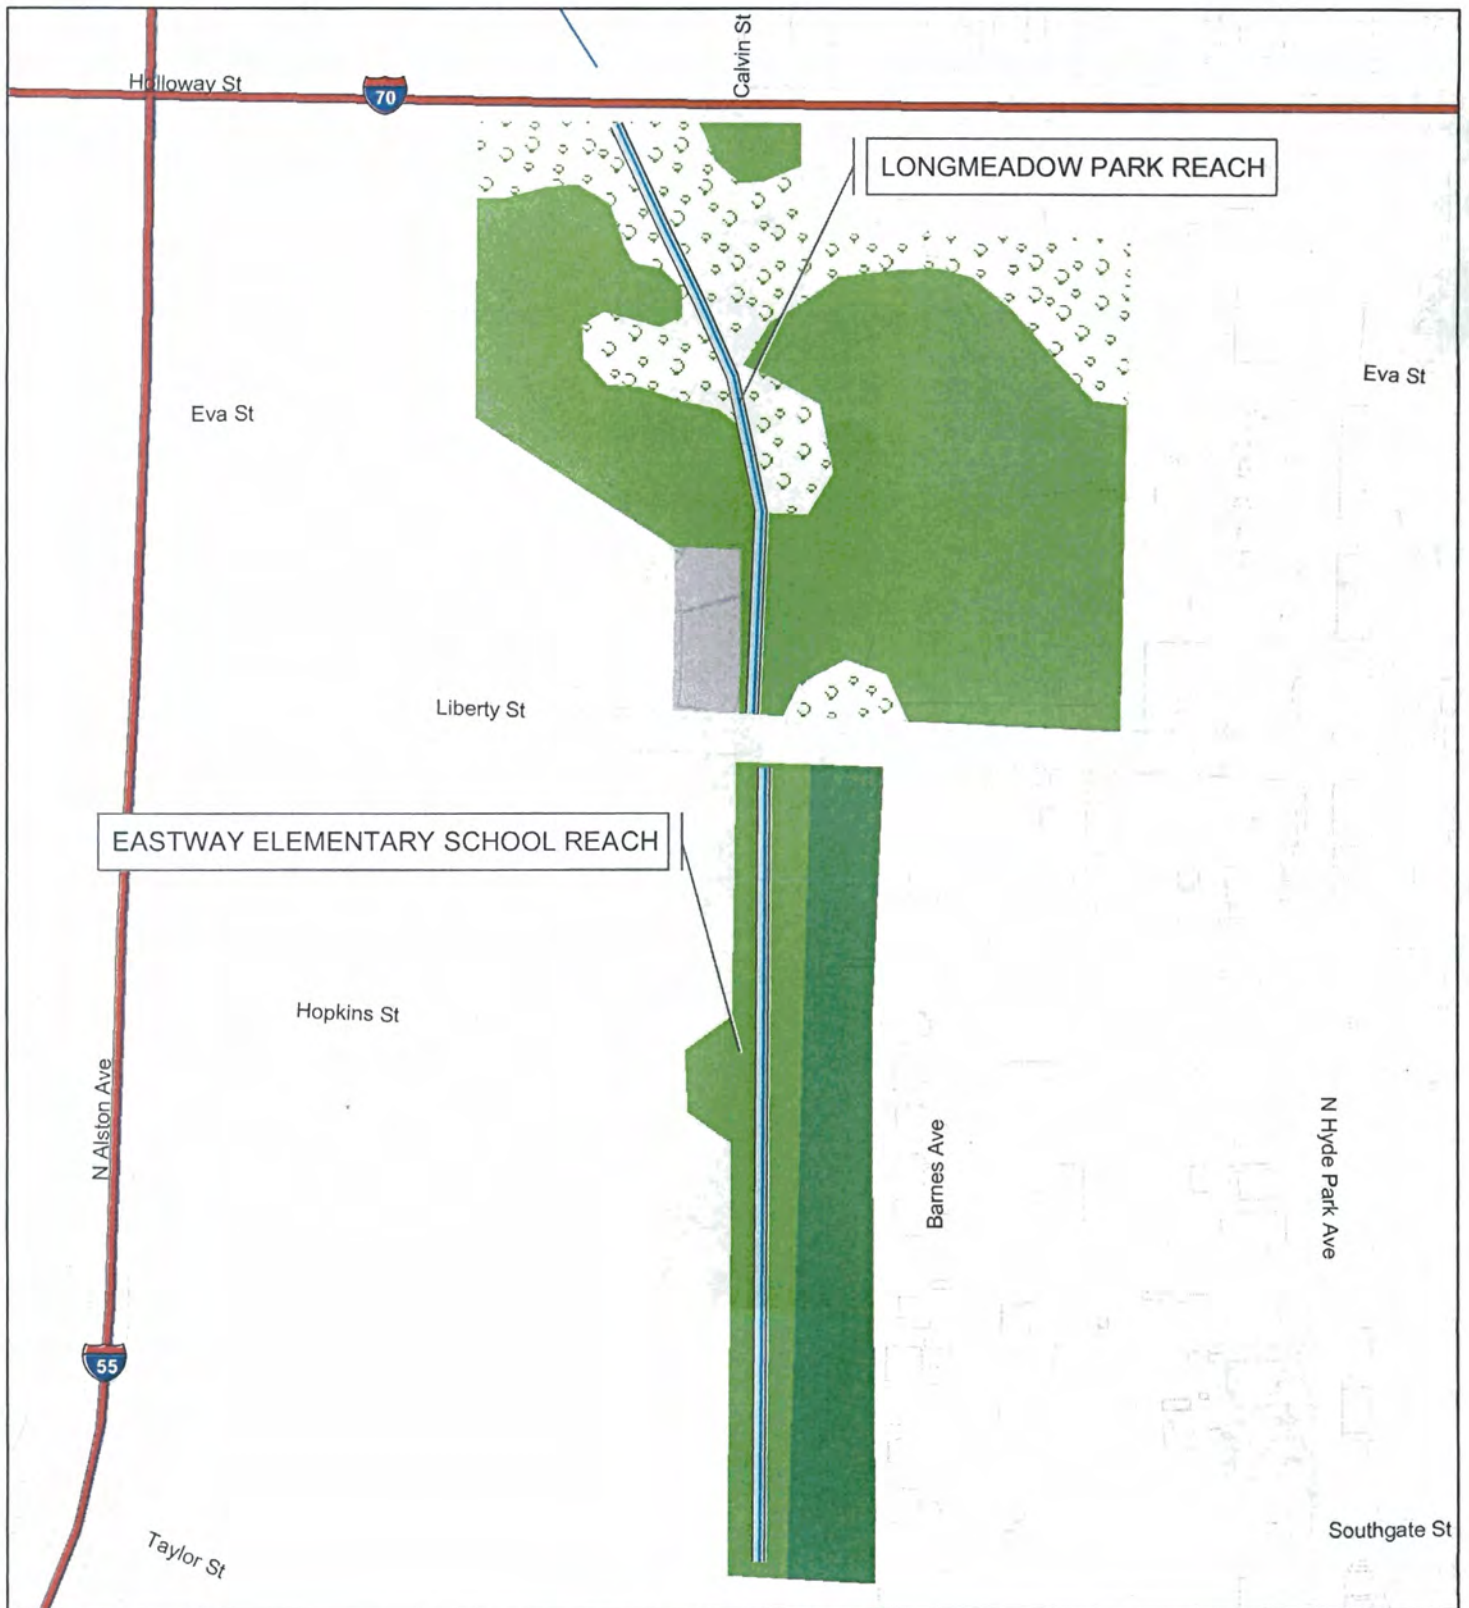
Land/Vegetation Cover

-   Gravel Parking
-   Mowed Grass
-   Natural Forest
-   Park Trees

Vegetation of the upper floodplain is primarily composed of mowed fescue grass (*Festuca* sp.) and common lawn weeds. Log vanes were installed in this reach in 1998, and point bars formed behind them. A mix of native and invasive woody and herbaceous floodplain species became established on these bars. The dominant hardwood species are black willow (*Salix nigra*) and princess tree (*Paulownia tomentosa*), which is an invasive species. A **mix** of native herbaceous species are present including *Rumex* sp. and

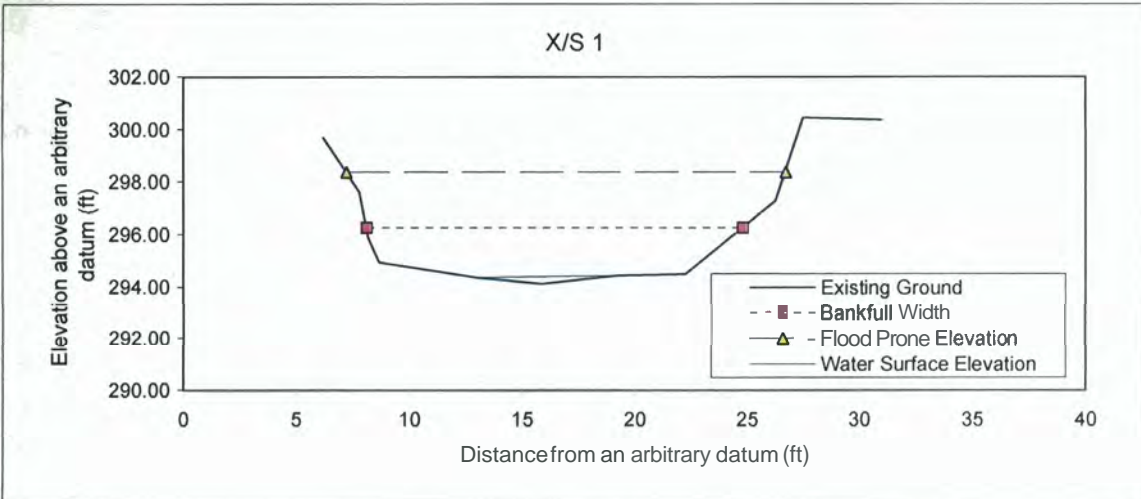
Rosgen Stream Type Classification	
Bankfull Width	16.69 (ft)
Entrenchment	1.17 (ft/ft)
Width:Depth	10.23 (ft/ft)
Sinosity	1.05 (ft/ft)
Slope	0.0160 (ft/ft)
D ₅₀	<2 (mm)
Stream Type	F

Flow Calculations	
Max BF Depth	2.13 (ft)
Mean BF Depth	1.63 (ft)
X/S Area	27.21 (ft ²)
Manning's n	0.0450
BF Ave. Velocity	5.49 (ft/s)
Discharge	149.29 (cfs)
Shear Stress	1.50 (lb/ft ²)

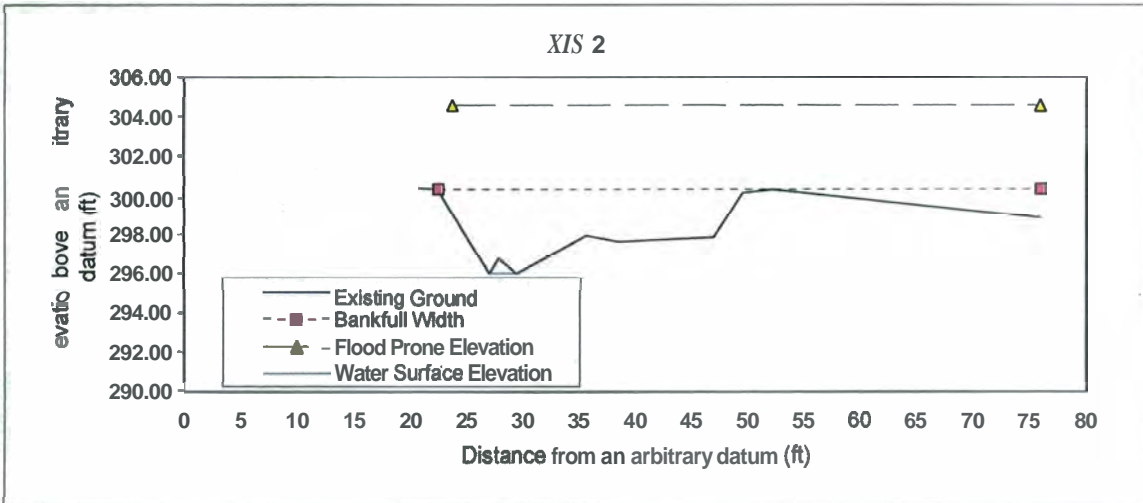
Rosgen Stream Type Classification	
Bankfull Width	53.46 (ft)
Entrenchment	>2.2 (ft/ft)
Width:Depth	16.68 (ft/ft)
Sinosity	1.00 (ft/ft)
Slope	0.0019 (ft/ft)
D ₅₀	<2 (mm)
Stream Type	n/a

Flow Calculations	
Max BF Depth	4.27 (ft)
Mean BF Depth	2.14 (ft)
X/S Area	76.12 (ft ²)
Manning's n	0.0350
BF Ave. Velocity	1.88 (ft/s)
Discharge	143.03 (cfs)
Shear Stress	0.12 (lb/ft ²)

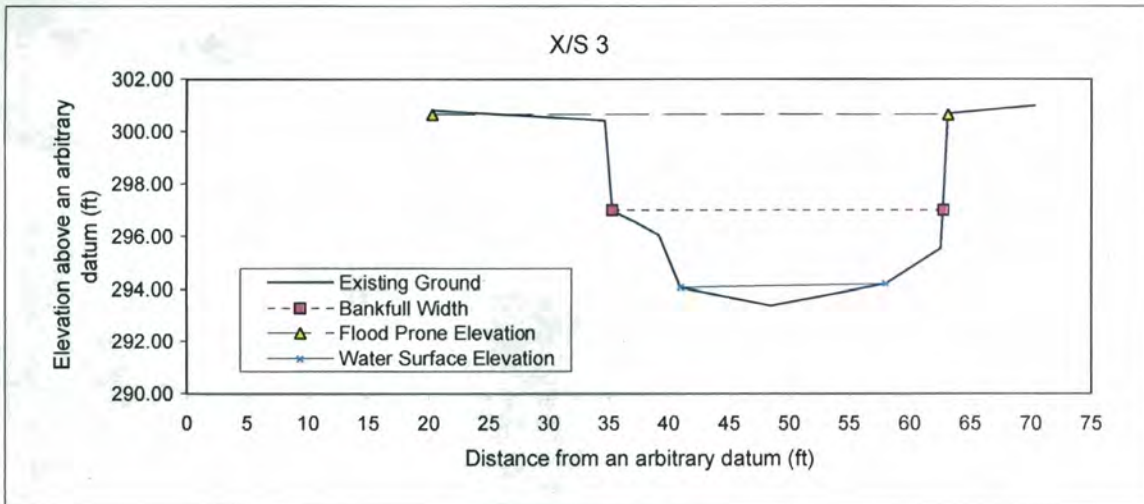
Rosgen Stream Type Classification	
Bankfull Width	27.48 (ft)
Entrenchment	1.35 (ft/ft)
Width:Depth	10.71 (ft/ft)
Sinosity	1.00 (ft/ft)
Slope	0.0042 (ft/ft)
D ₅₀	<2 (mm)
Stream Type	n/a

Flow Calculations	
Max BF Depth	3.64 (ft)
Mean BF Depth	2.57 (ft)
X/S Area	70.48 (ft ²)
Manning's n	0.0350
BF Ave. Velocity	4.87 (ft/s)
Discharge	343.38 (cfs)
Shear Stress	0.61 (lb/ft ²)

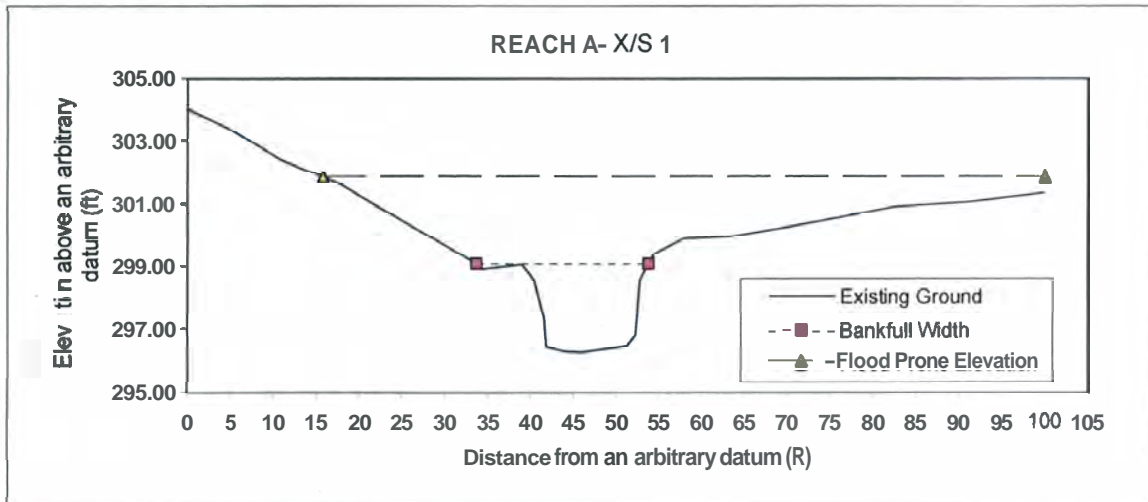
Rosnen Stream Type Classification	
Bankfull Width	20.09 (A)
Entrenchment	3.50 (ft/ft)
Width:Depth	12.86 (ft/ft)
Sinuousity	(ft/ft)
Slope	0.0138 (ft/ft)
D ₅₀	27 (mm)
Stream Type	B4c

Flow Calculations	
Max BF Depth	2.78 (ft)
Mean BF Depth	1.56 (ft)
X/S Area	31.40 (ft ²)
Manning's n	0.0450
BF Ave. Velocity	4.80 (ft/s)
Discharge	150.76 (cfs)
Shear Stress	1.18 (lb/ft ²)

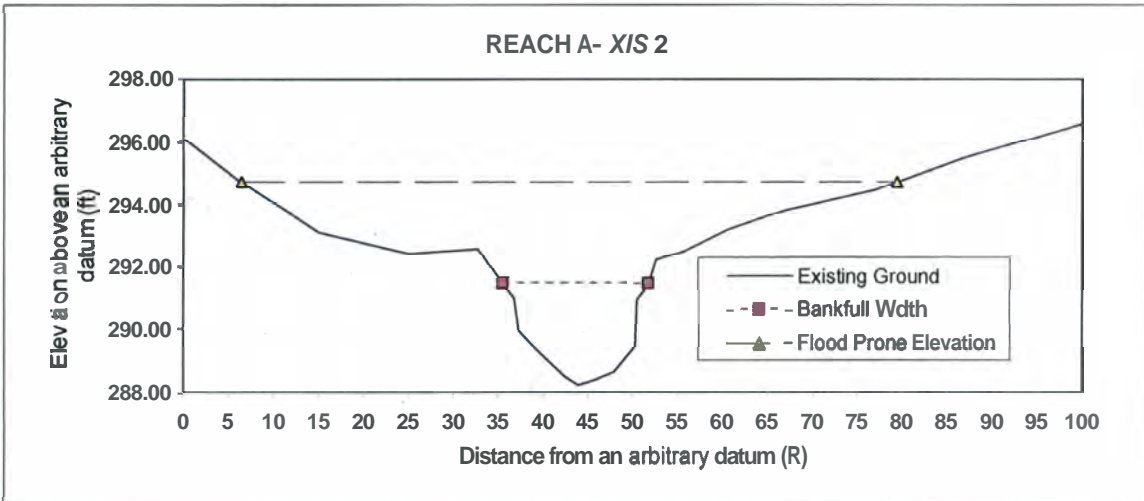
Rosnen Stream Type Classification	
Bankfull Width	16.28 (ft)
Entrenchment	4.48 (ft/ft)
Width:Depth	7.43 (ft/ft)
Sinosity	(ft/ft)
Slope	0.0138 (ft/ft)
D ₅₀	27 (mm)
Stream Type	B4c

Flow Calculations	
Max BF Depth	3.23 (ft)
Mean BF Depth	2.19 (ft)
X/S Area	35.67 (ft ²)
Manning's n	0.0450
BF Ave. Velocity	5.95 (ft/s)
Discharge	212.31 (cfs)
Shear Stress	1.63 (lb/ft ²)

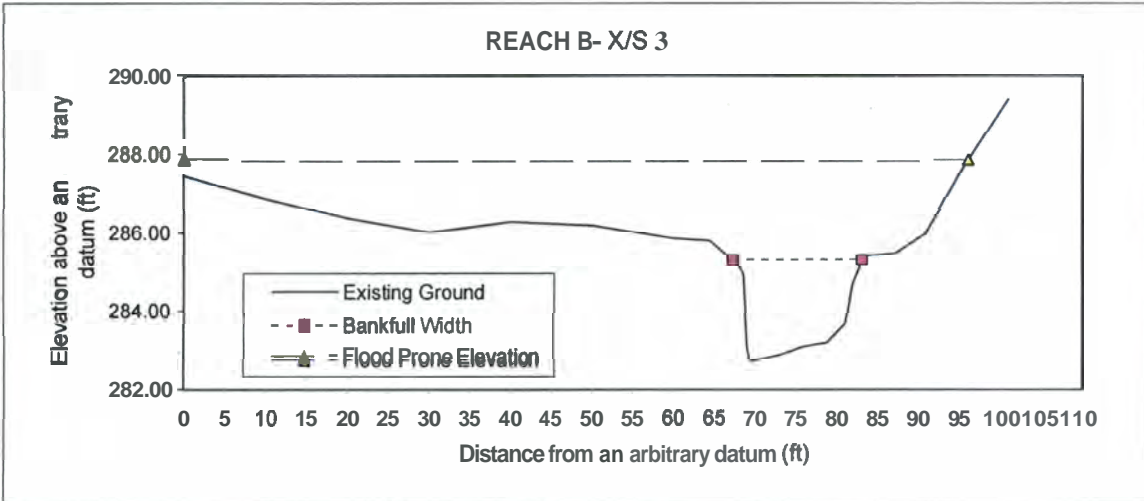
<u>Rosnen Stream Type Classification</u>	
Bankfull Width	15.85 (ft)
Entrenchment	5.43 (ft/ft)
Width:Depth	8.67 (ft/ft)
Sinosity	(ft/ft)
Slope	0.0199 (ft/ft)
D ₅₀	27 (mm)
Stream Type	B4c

<u>Flow Calculations</u>	
Max BF Depth	2.58 (ft)
Mean BF Depth	1.83 (ft)
X/S Area	28.98 (ft ²)
Manning's n	0.0450
BF Ave. Velocity	6.38 (ft/s)
Discharge	184.99 (cfs)
Shear Stress	1.98 (lb/ft ²)

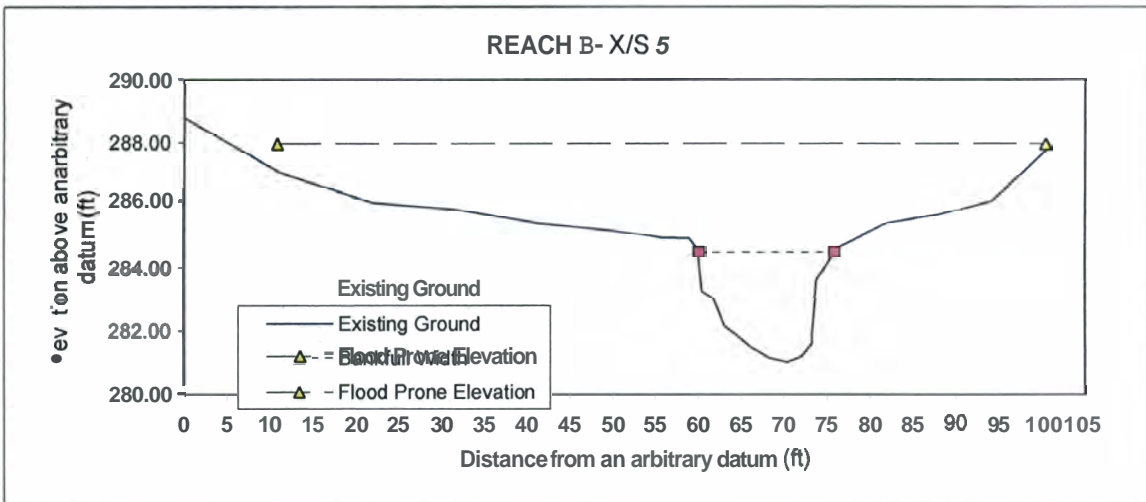
Rosgen Stream Type Classification	
Bankfull Width	15.82 (ft)
Entrenchment	5.27 (ft/ft)
Width:Depth	6.66 (ft/ft)
Sinuousity	(ft/ft)
Slope	0.0199 (ft/ft)
D ₅₀	27 (mm)
Stream Type	B4c

Flow Calculations	
Max BF Depth	3.45 (ft)
Mean BF Depth	2.38 (ft)
X/S Area	37.58 (ft ²)
Manning's n	0.0450
BF Ave. Velocity	7.41 (ft/s)
Discharge	278.38 (cfs)
Shear Stress	2.48 (lb/ft ²)
