**Earl Haigler Mitigation Site
Goose Creek, Union County**

Streambank Enhancement Plan

North Carolina Department of Transportation Stream Mitigation
Program

Transportation Improvement Project R-2420 B

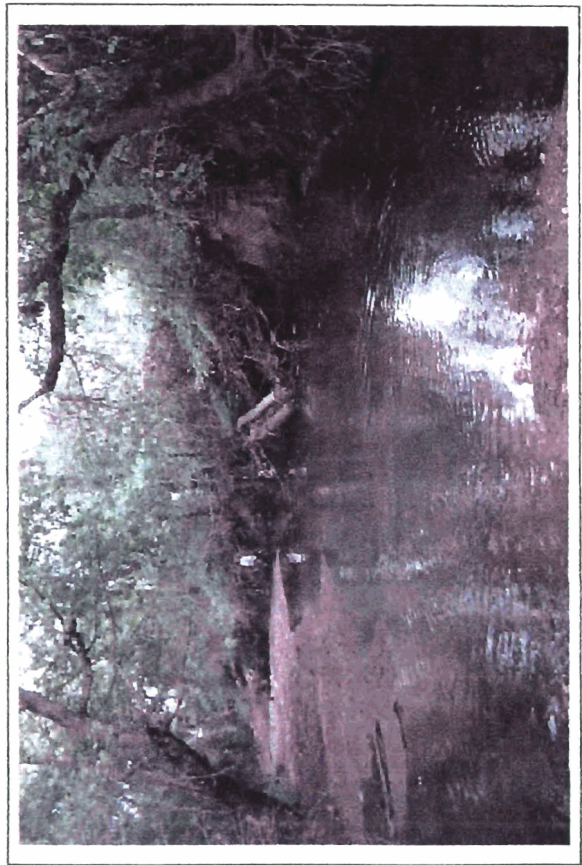
Looking upstream.

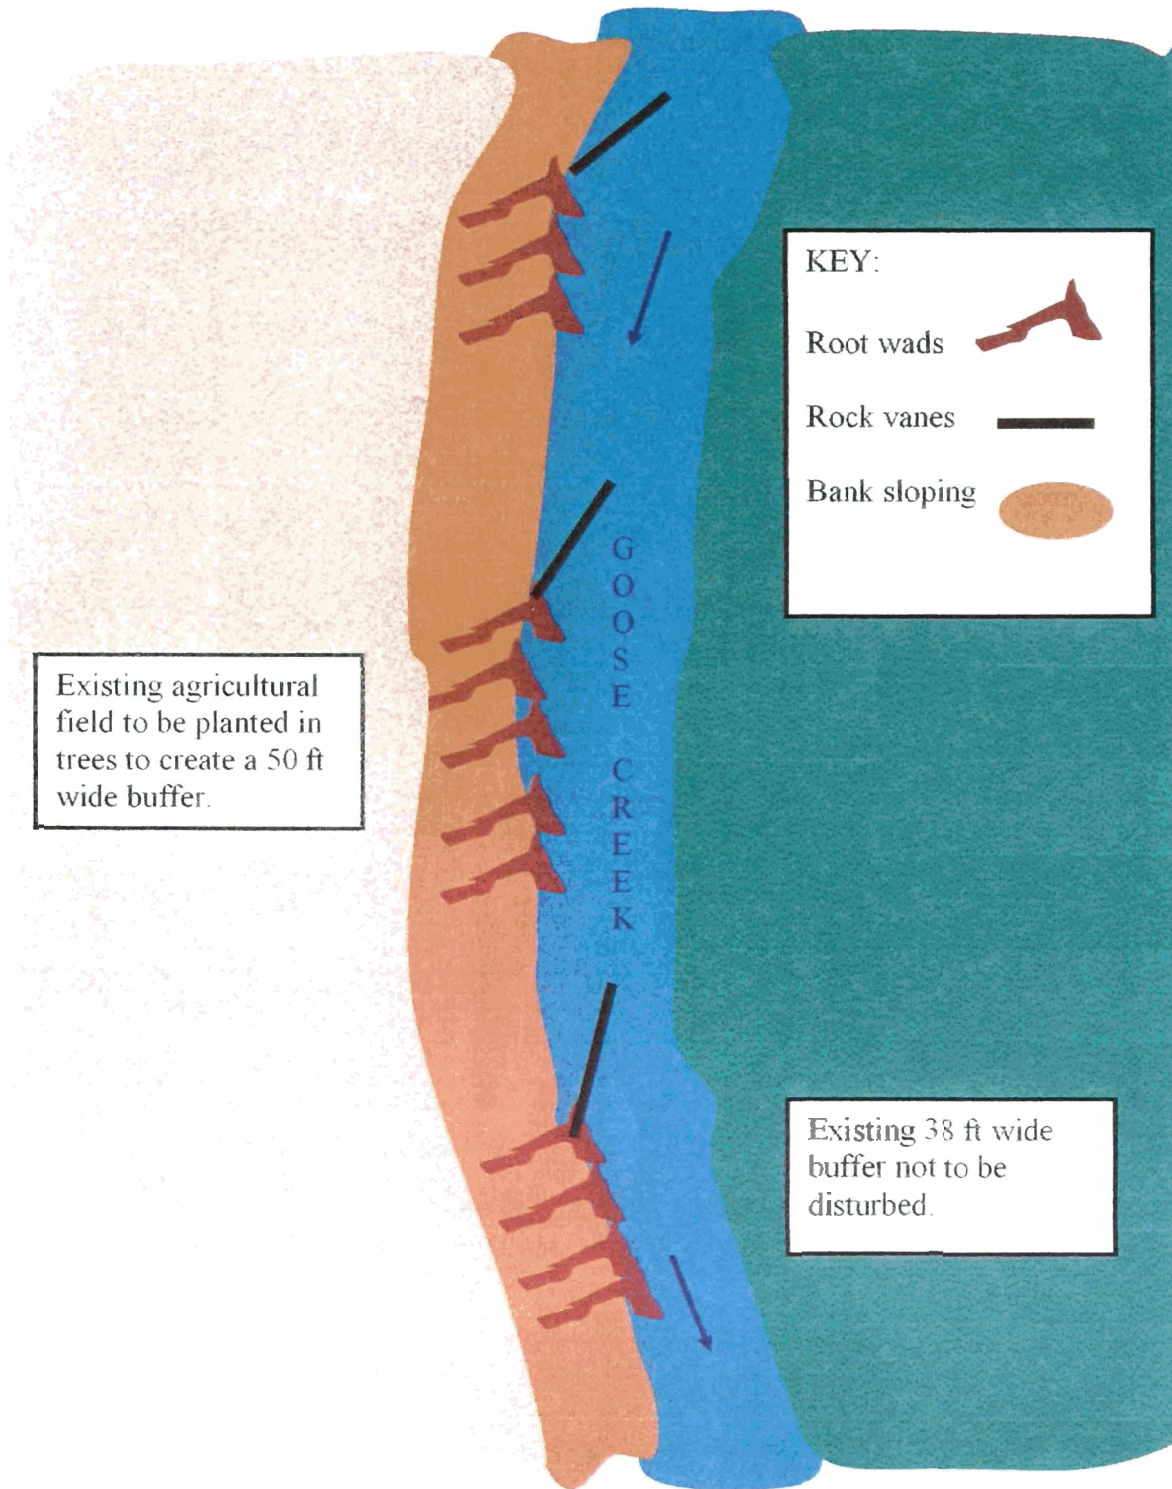
FIGURE 4. Plan view of streambank improvements planned 250 linear feet of Goose Creek at the Earl Haigler site, Union County, November 2003

In-stream structures, bank reshaping, and revegetation are the proposed improvements for this stream channel (Figure 4). The channel will be improved to represent a stable C4 channel type (Table 1). No change in pattern is planned. Design considerations are based on reference reach data and on professional judgement and characteristics of a stable C4 channel.

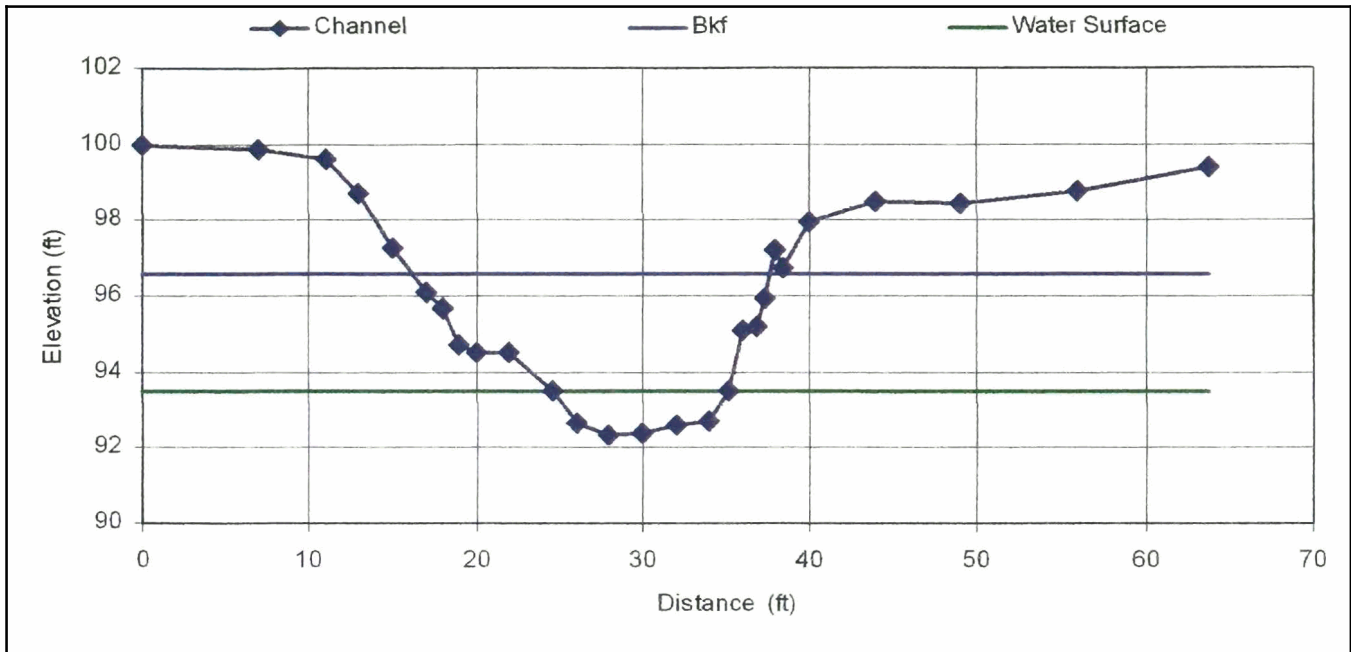
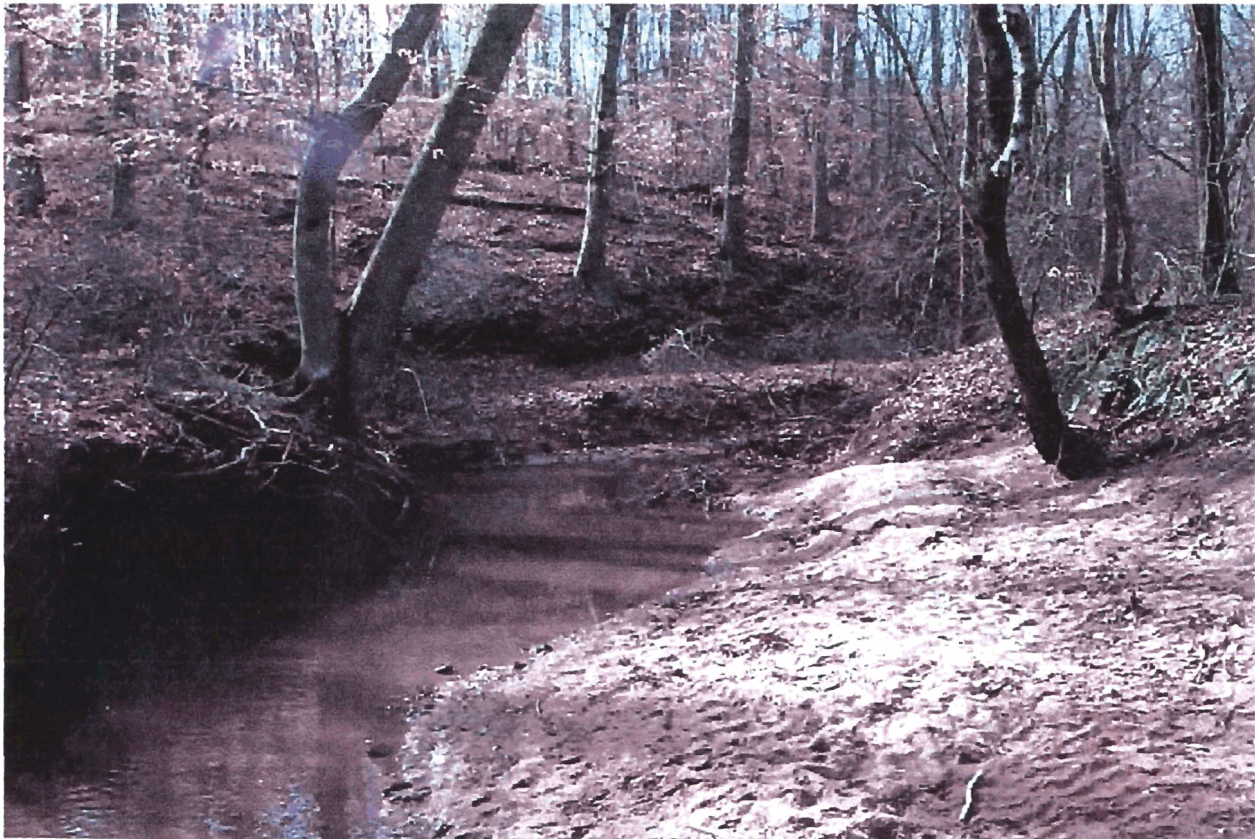
A.1.2. Pool cross-section at station 2+18, looking upstream at reference reach.

Stable reference reach streams were difficult to find in the Goose Creek watershed. However, a stable reference reach cross-section was obtained from Stevens Creek, Mecklenburg County (Mickey and Hining 2003) (Appendix 1). This stream has a drainage area of 3.83 mi². Dimensionless ratios of measurements taken from the reference reach cross-section were used in the design of this streambank stabilization project.

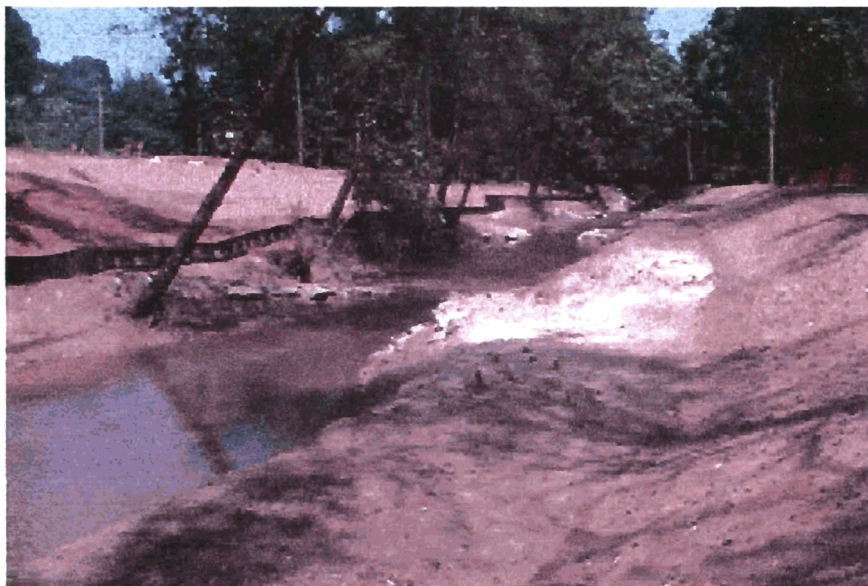
A.2.1. Typical bank grading and revegetation.

Bank grading is the typical channel cross-section design change planned for this site (Figure 2, Appendix 2.1). The eroding right bank will be graded on a 1.5:1 or 2:1 slope to create a bankfull bench. The purpose of this activity is to reduce streambank erosion and create an area suitable to establish bank vegetation.

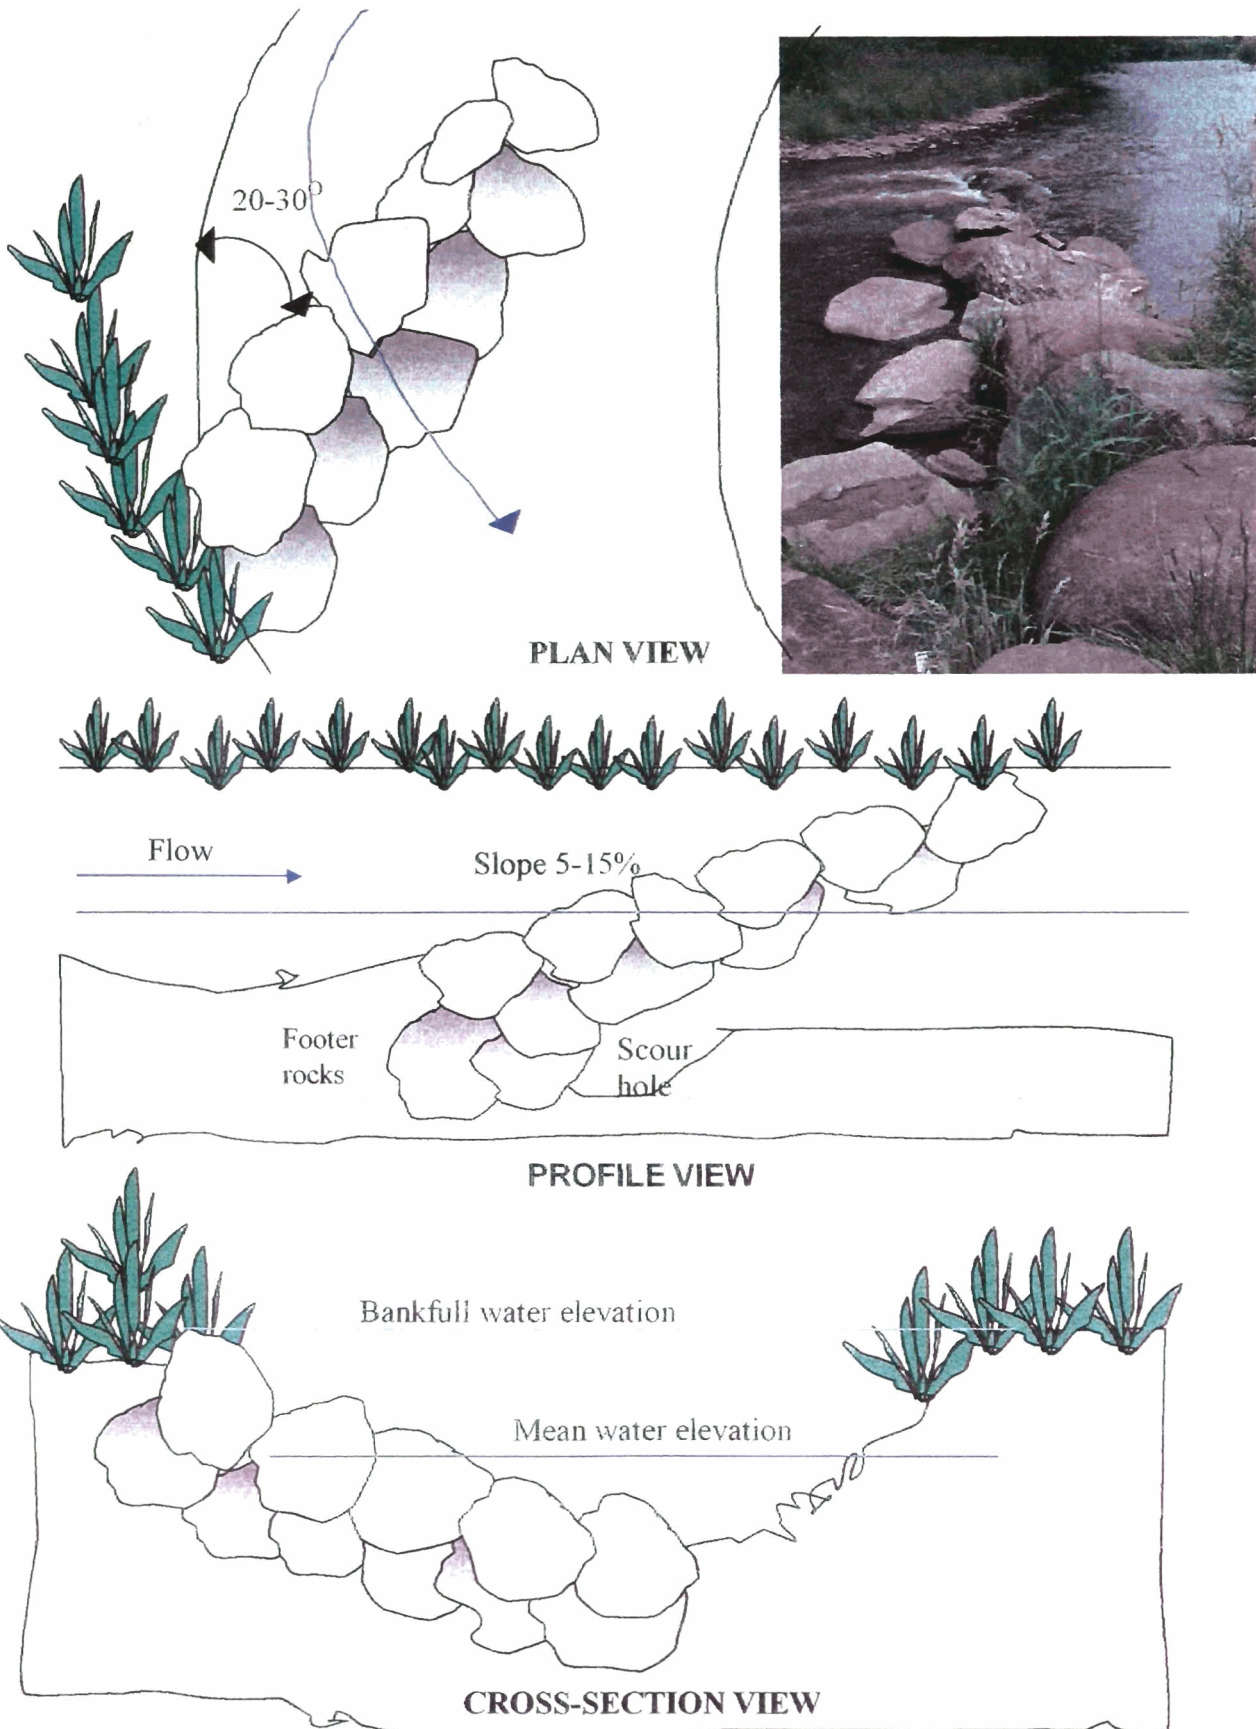
A.2.2. Typical rock vane structure showing plan, profile, and cross-section views

Rock vanes and root wad structures will be constructed according to standard guidelines (Appendix 2.2, 2.3). Rock vanes and root wad structures will be used to reduce the near bank stress and direct flows towards the center of the stream. These structures will also improve in-stream aquatic habitat and provide long-term bank stability. Root wads will be collected on site. Eleven trees along the eroding bank that are being undercut and have potential to fall into the stream will be used for the root wad structures.

Root wads will be used to protect the outside of the meander and provide in-stream cover. Rock for vanes will be hauled from a local quarry. Footer rocks will be placed approximately 2 ft below the normal stream bottom where bedrock is not encountered. Rocks average approximately 500 lbs (4 ft³) to 1000 lbs (8 ft³) in size. Structures will be built using a track-hoe with a thumb working from the top of the bank.

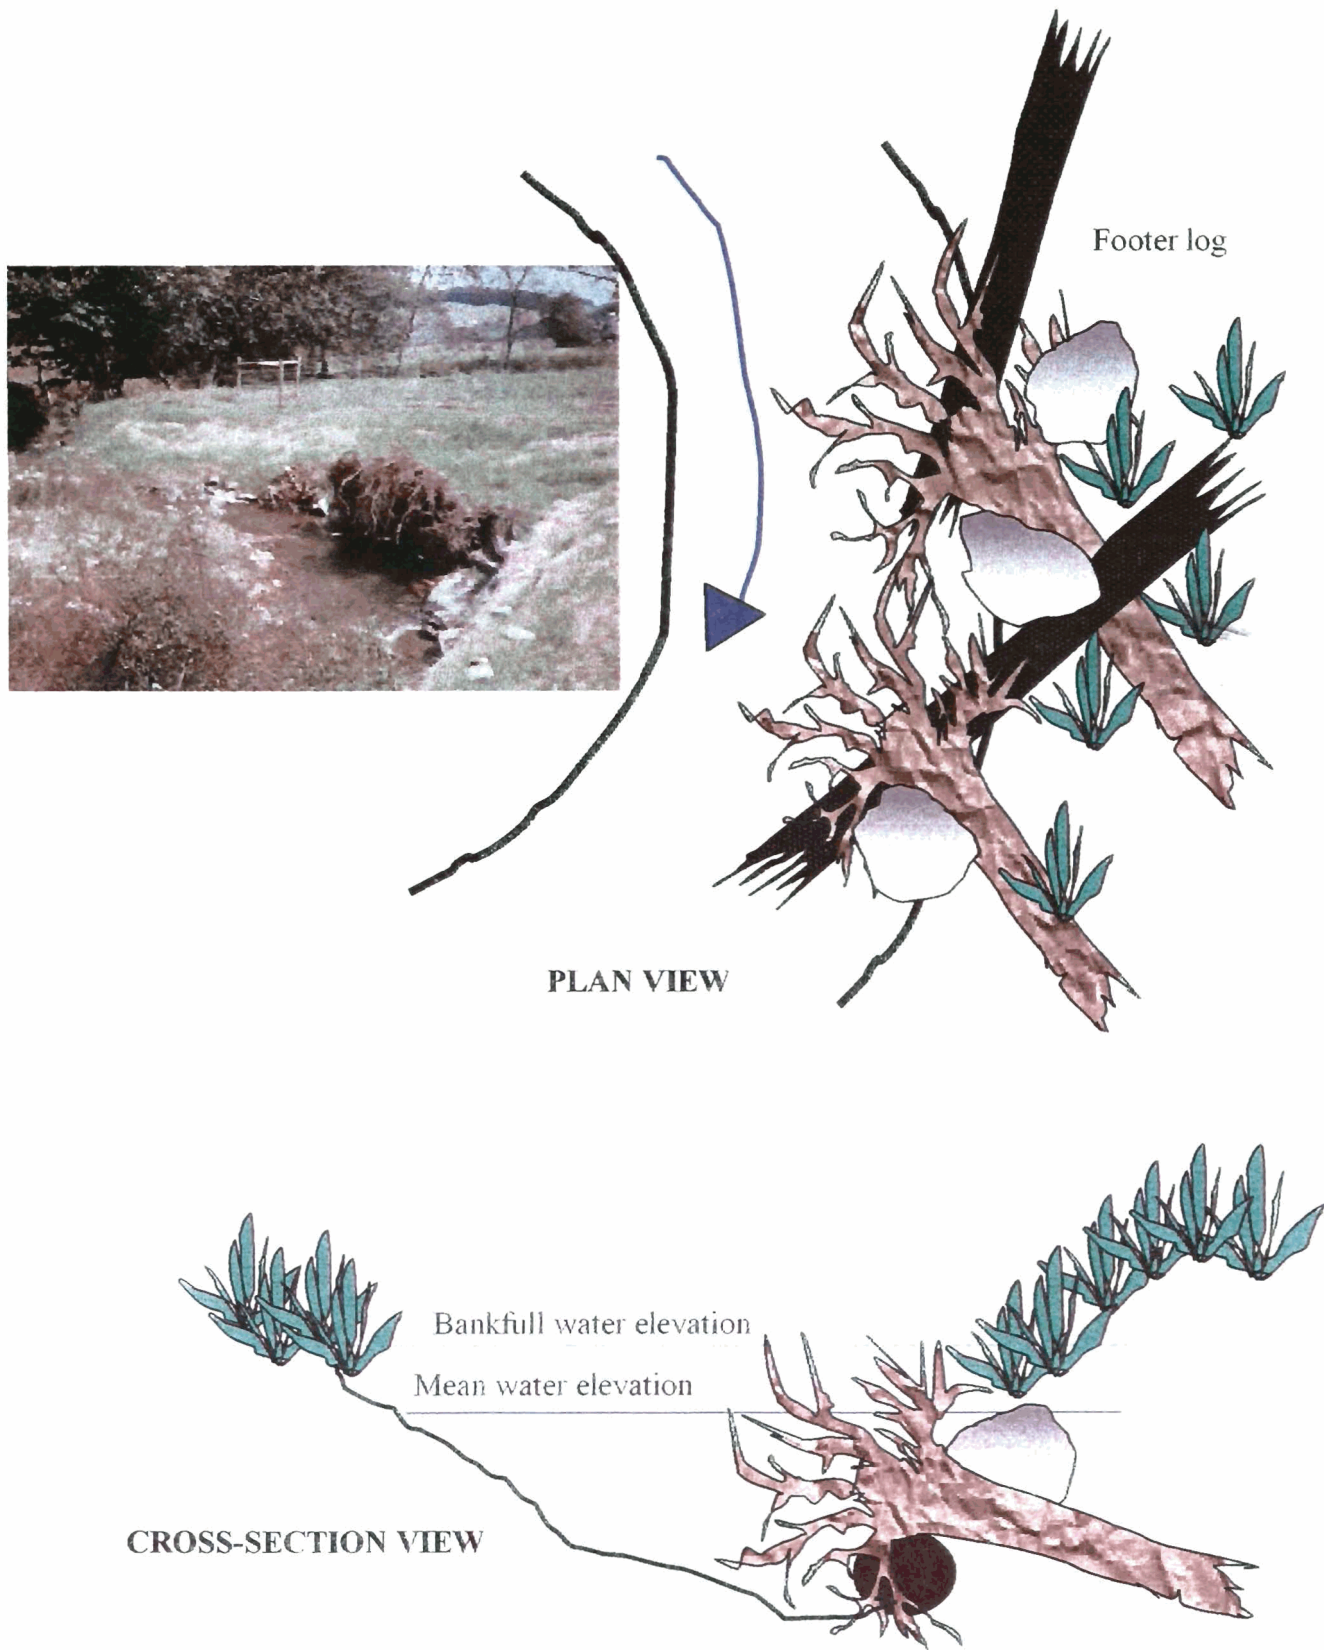
A.2.3. Typical root wad structure showing plan and cross section views.
