**As-Built Report for the Greene Mitigation Site on Goose
Creek, Mecklenburg County**

North Carolina Department of Transportation Stream Mitigation
Program

Transportation Improvement Project R-2420B

2005

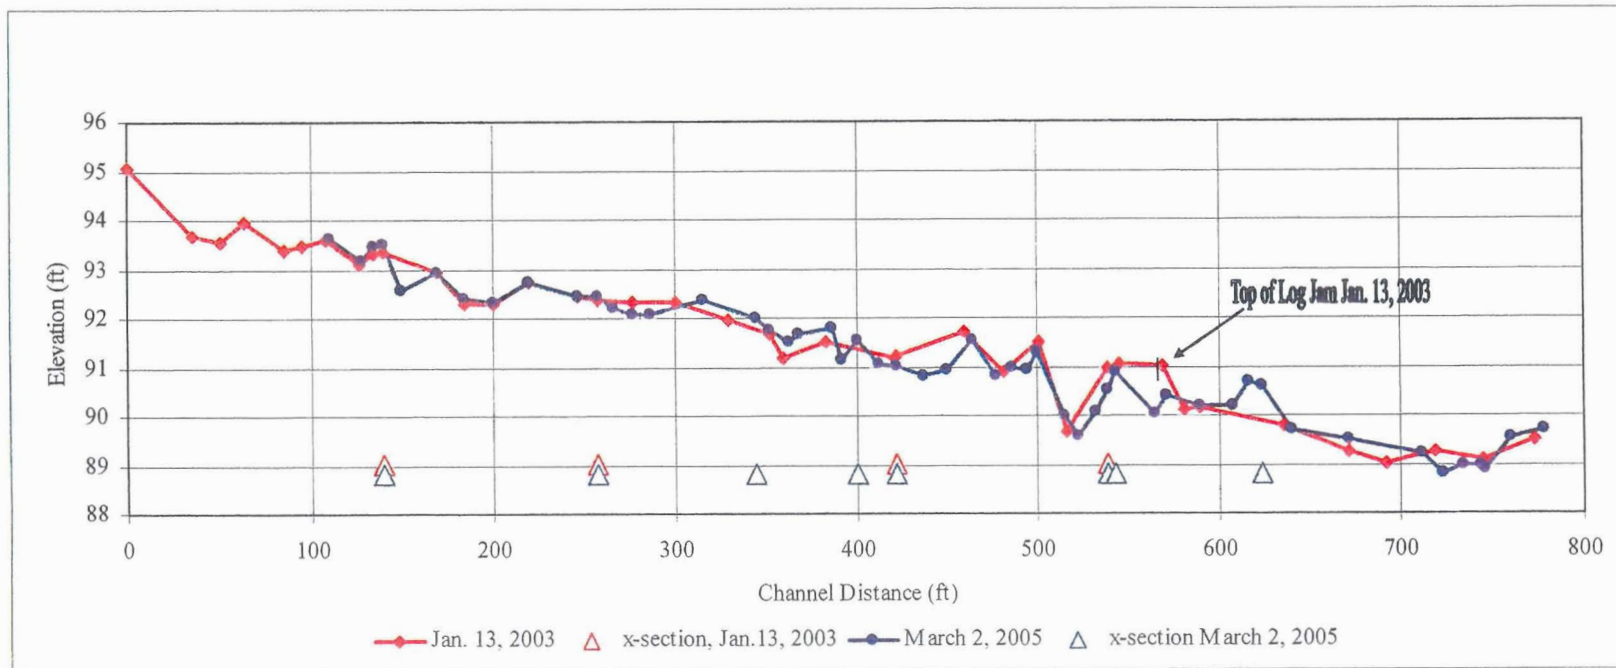
FIGURE 3. Longitudinal profile, Greene mitigation site, Goose Creek, Yadkin River drainage, Mecklenburg County, pre-construction and as-built surveys, March 2005.

The pre-construction longitudinal survey was 773 ft in length whereas the as-built survey began at station 1+10 and ended at station 7+78, a total of 668 ft (Figure 3). The as-built survey did not include the first 109 ft of the project site since no stream work occurred in this section. The pre-construction survey found 49% of the stream was pool habitat whereas the as-built survey contained 37% pool habitat. The reason for the decrease in pool habitat between the two surveys is directly related to two factors. First, the pre-construction survey identified a long shallow pool from stations 3+52 – 4+60 whereas the as-built survey found a pool – riffle – run – pool complex at the same stations. Second, the pre-construction survey contained a long pool that had developed behind a large log/debris jam (Figure 3) from stations 4+82 – 5+68. This log/debris jam is no longer present and the as built survey identified a pool – riffle – pool – riffle – pool – run complex at these same stations. There is a rapid rise in the thalweg at the head of a riffle at station 6+24 (Figure 3). This 0.5 ft rise is attributed to the presence of bedrock located in the pool above this station.

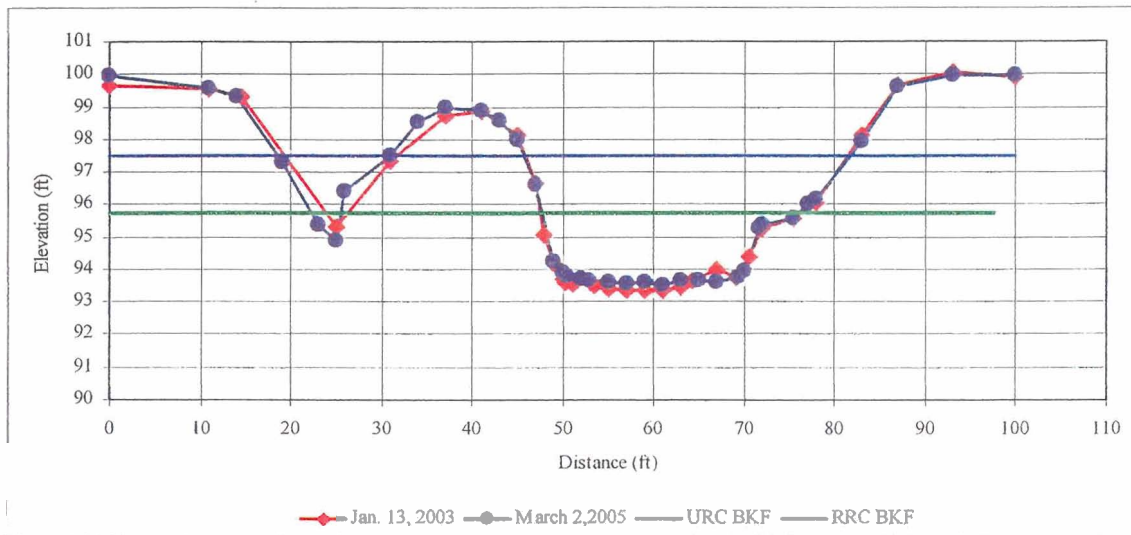
FIGURE 4. Details of pre-construction and as-built cross-sections established at the Green mitigation site, Goose Creek, Yadkin River drainage, Mecklenburg County, March 2005.

Eight cross-sections were established for the as-built survey (Figure 4). Two cross-sections were located at pools (Figures 4.5, 4.6) and six at riffles (Figures 4.1, 4.2, 4.3, 4.4, 4.7, and 4.8). Data from the six riffle cross-sections was used to determine the stream type following

construction (Table 2). The pre-construction survey (Mickey and Scott 2003) classified the stream at the Greene site as an unstable F4 and G4 stream type (Rosgen 1996). Using the North Carolina rural regional curve data (RRC) (Harman 1999), the as-built survey classified the constructed stream reach as a stable F4 at two locations and a B4c at the other four locations (Table 2). The project goal to construct a stable F4 and C4 channel through this reach was achieved. However, when comparing the same six riffle cross-sections to the North Carolina urban regional curve data (URC) (Doll et al. 2002), four of the six cross-sections are C4 and two are slightly entrenched E4 stream types (Table 3). The reason for using the RRC and URC is that the present condition of the stream channel alludes to the stream's stable F4 and B4c conditions evolving in an urban setting to stable C4 and E4 channels. The Goose Creek watershed contains approximately 10% impervious area (M. Fowlkes, personal communication). With the completion of the I-485 project, the area is rapidly transforming from a rural to urban landscape. The C4 and E4 channels are more representative of the newly constructed channel cross-sections (Figure 4).

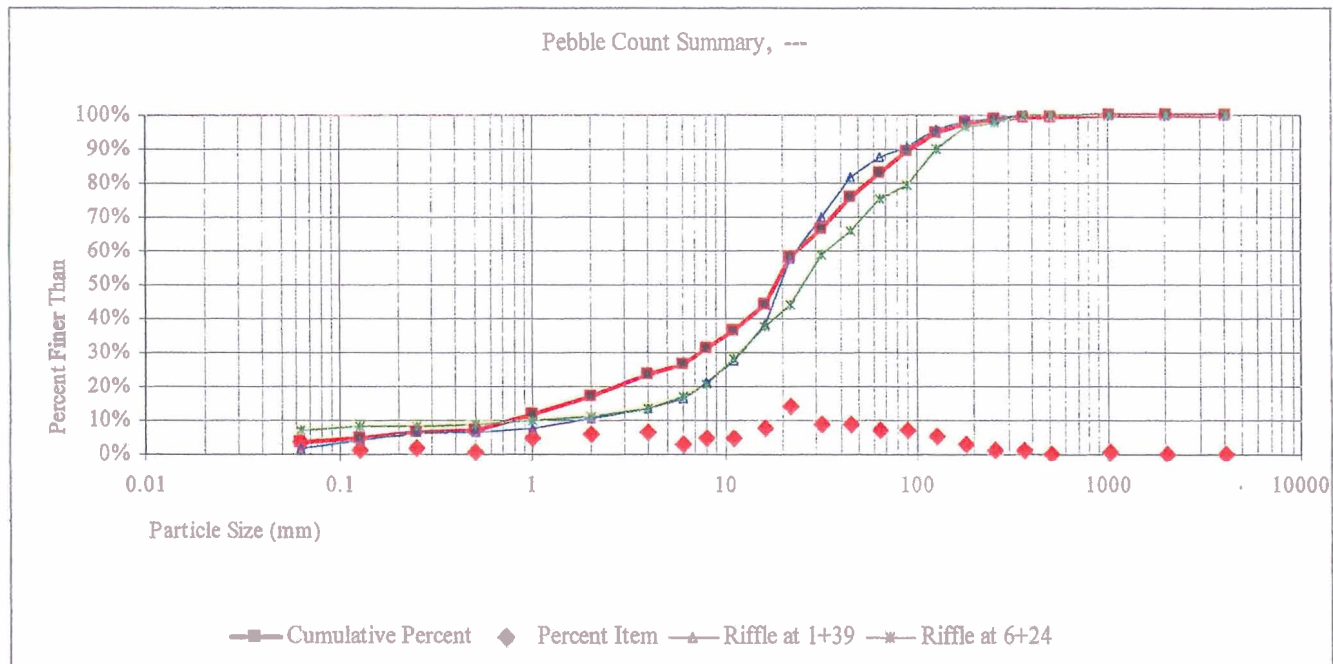
FIGURE 5. Pebble count summary for the Greene mitigation site on Goose Creek, Yadkin River drainage, Mecklenburg County, March, 2005.

Channel bed material was analyzed using the reachwide pebble count and cross-section survey methods (NCSRI 2003). Riffle pebble counts were conducted in the vicinity of cross-section stations 1+39 and 6+24. The D_{50s} observed in the two riffles and reach ranged from 11.7 mm to 25.4 mm with a weighted d_{50} of 18.4 mm (Figure 5). Sixty-four percent of the bed material in this reach of Goose Creek is considered gravel, 17 % silt and sand, and 16 % cobble (Figure 5).

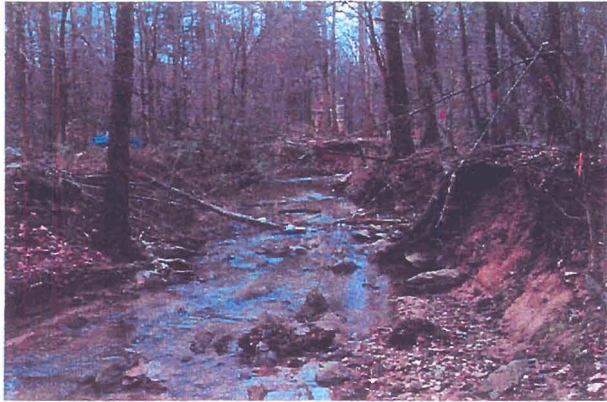
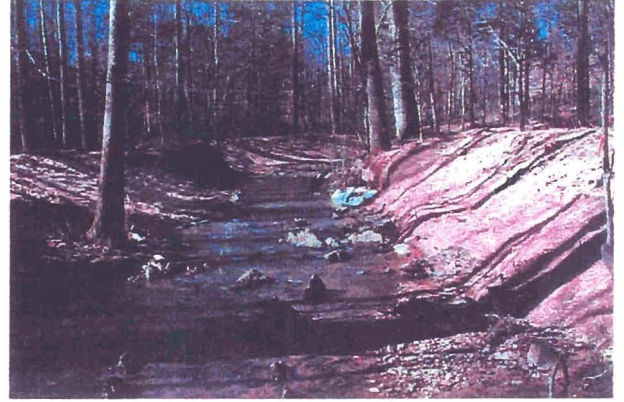
LDS before and after construction from stn. 2+19 – 2+75 RB and stn. 2+38 – 3+00.

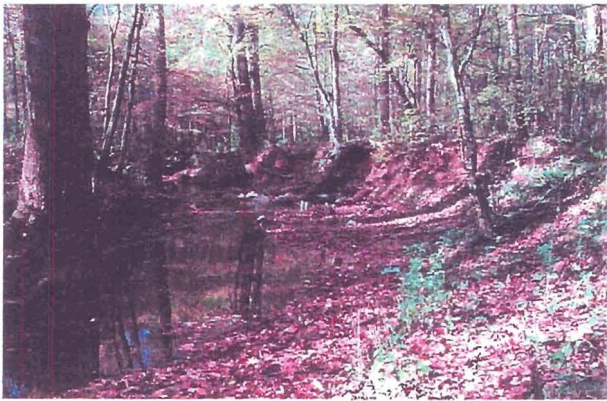
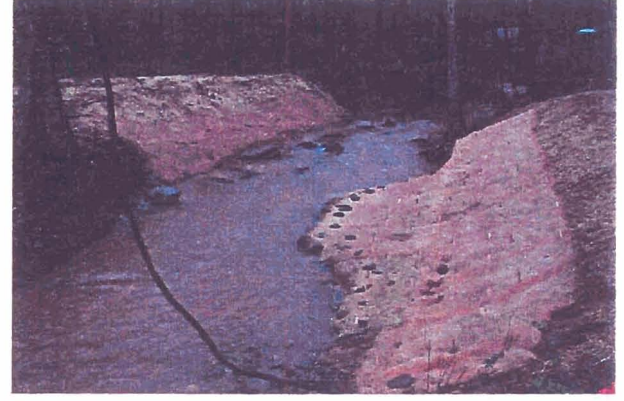
LUS before and after construction from stn. 2+75 – 2+19 RB and stn. 3+00 – 2+38 LB. Notice rock toe bench on right of picture (LB).

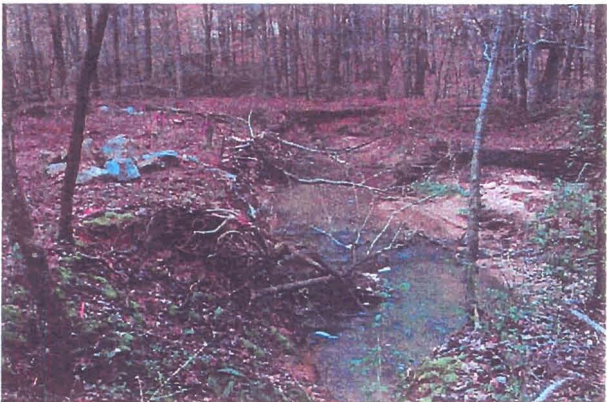
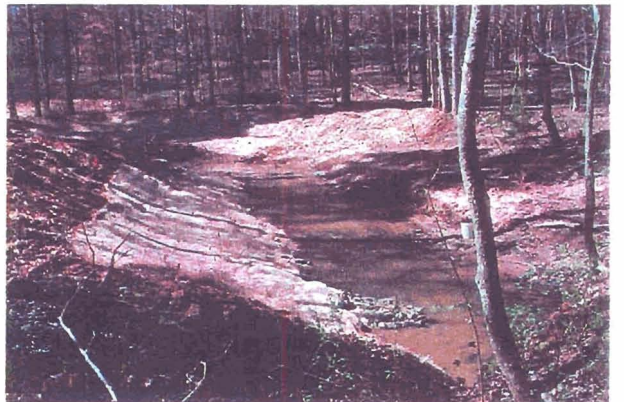
LDS before and after construction from stn. 3+35 – 4+41 LB and RB.

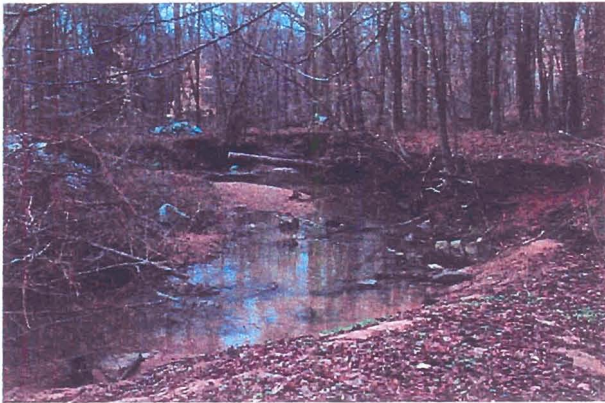
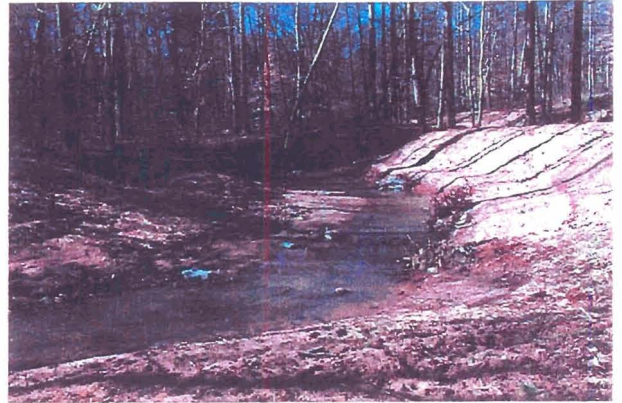
LDS before and after construction from stn. 3+81-4+84 RB.

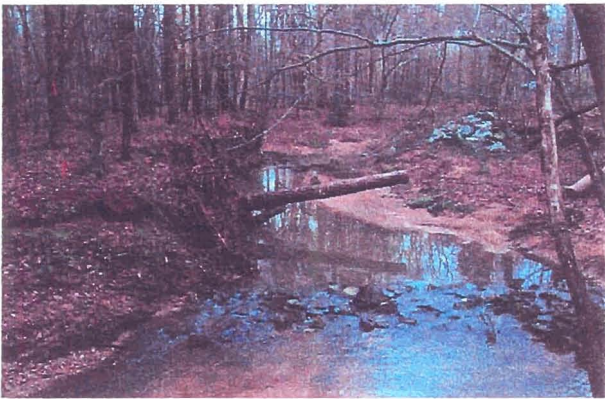
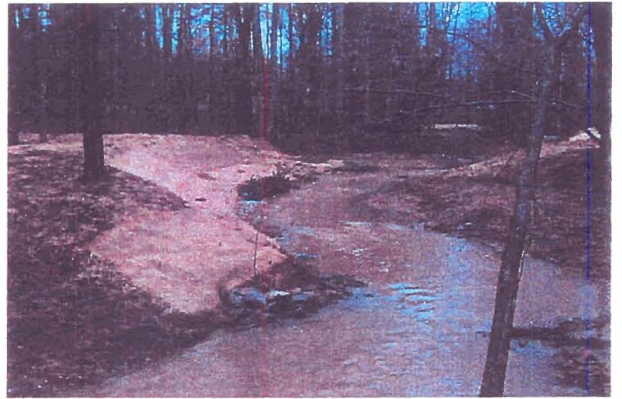
LUS before and after construction from stn. 4+84 – 3+81 RB.

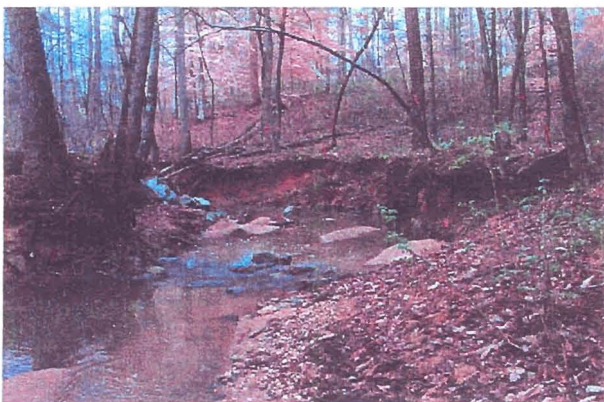
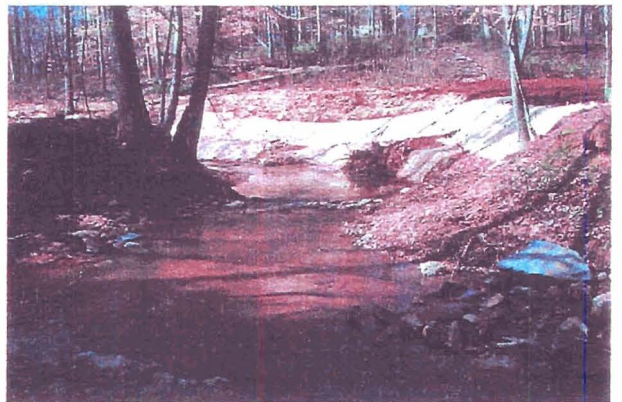
LDS before and after construction from stn. 4+64 – 5+55 RB.

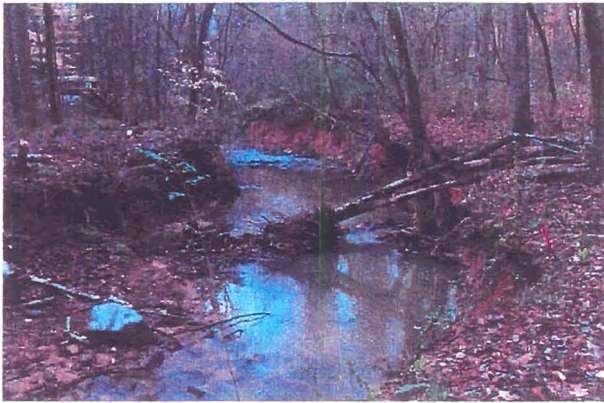
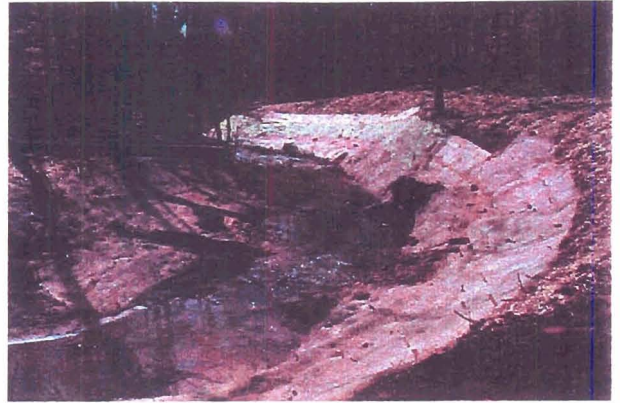
LDS before and after construction from stn. 5+41 – 6+00 LB and stn. 5+35 – 6+96 RB.

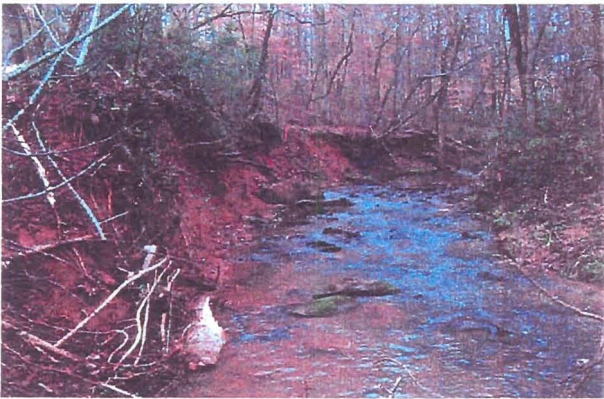
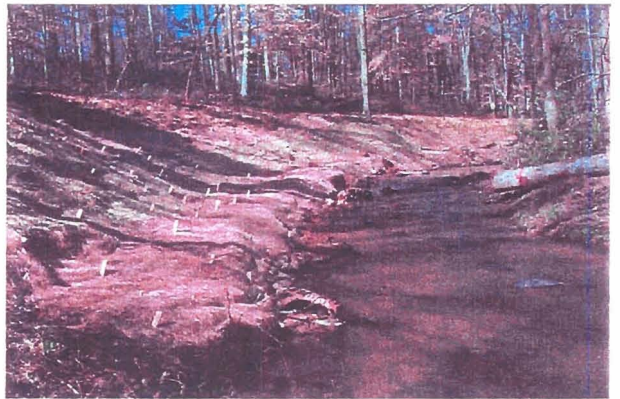
LUS before and after construction from stn. 6+96 – 5+50 RB.

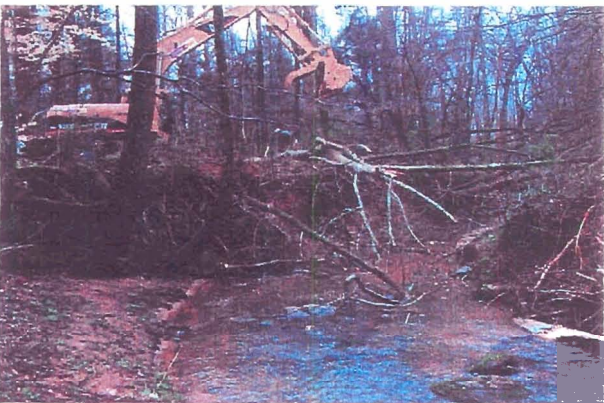
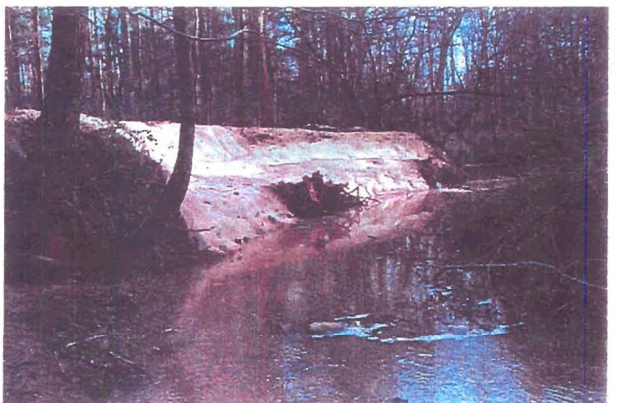
LDS before and after construction from stn. 6+72 – to 7+55 LB.

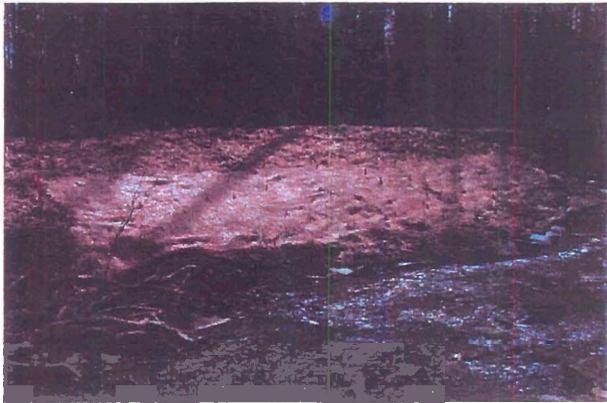
Vegetation plot 1, 0.028 acre, 79 stems, at stn 2+38 – 2+75, LB

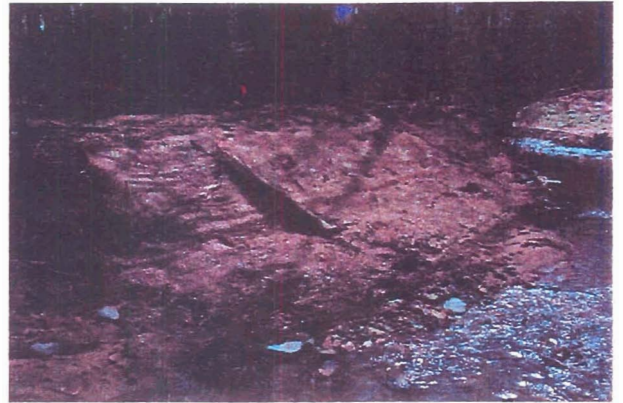
Vegetation plot 2, 0.017 acre, 37 stems, at stn 5+41 – 6+00, RB

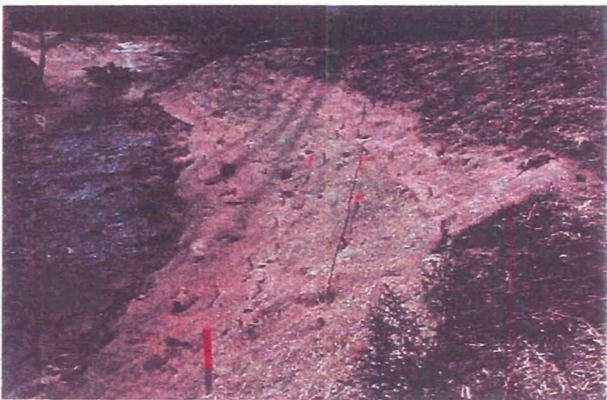
Vegetation plot 3, 0.040 acre, 79 stems, at stn 6+50 – 6+96, RB
