Restoration Plan

Greenbrier Creek Stream Restoration Alamance and Chatham Counties, North Carolina SCO Project Number 04-06210-02

October 2008

Prepared by:
Biohabitats, Inc.
Southeast Bioregion
8218 Creedmoor Road, Suite 200
Raleigh, NC 27613

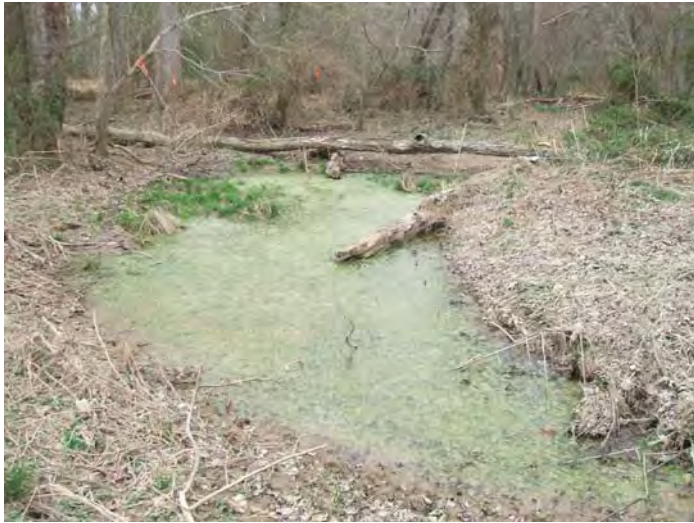
MU-1 wetland on Murchison Easement.

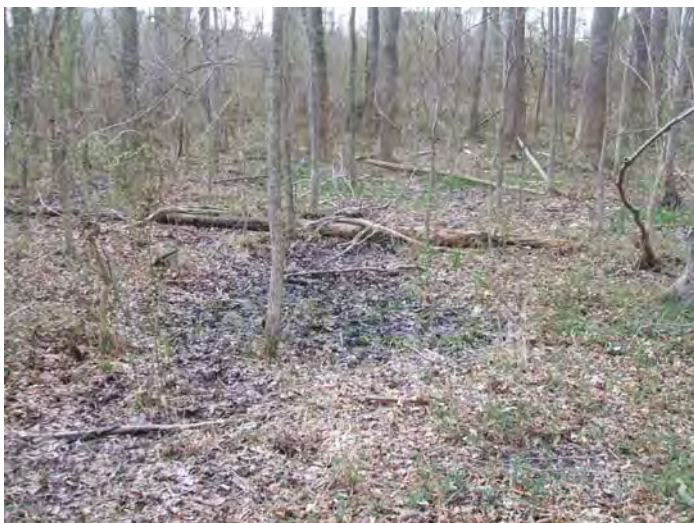
MU-4 wetland on the Murchison Easement.

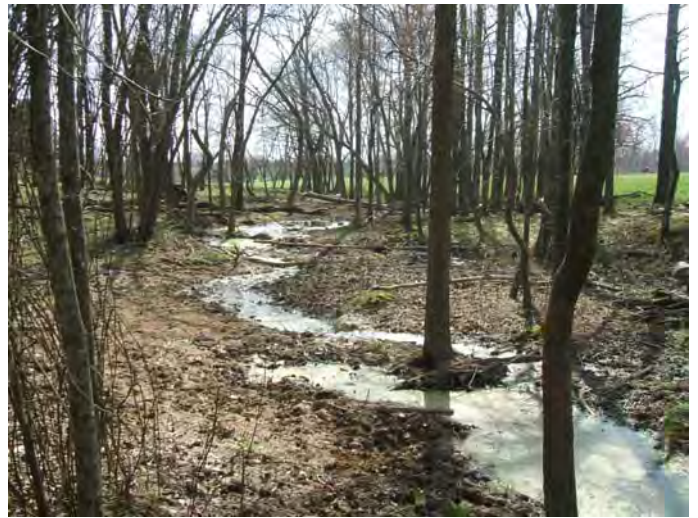
M-1 wetland beside MS-1 on Matthews Easement.

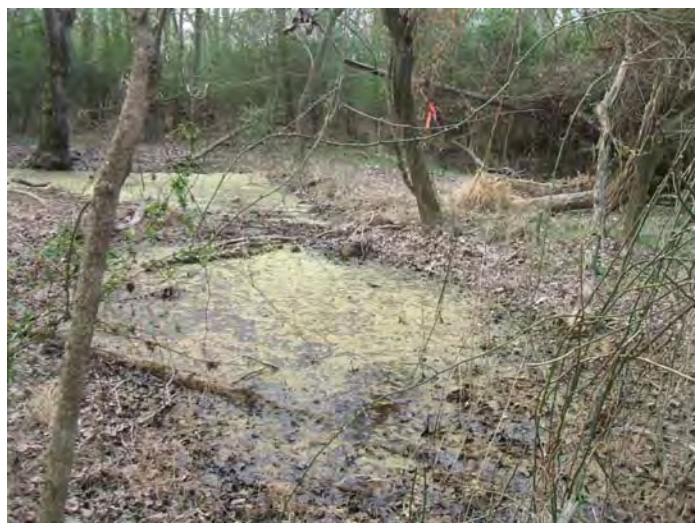
M-2 wetland on Matthews Easement.

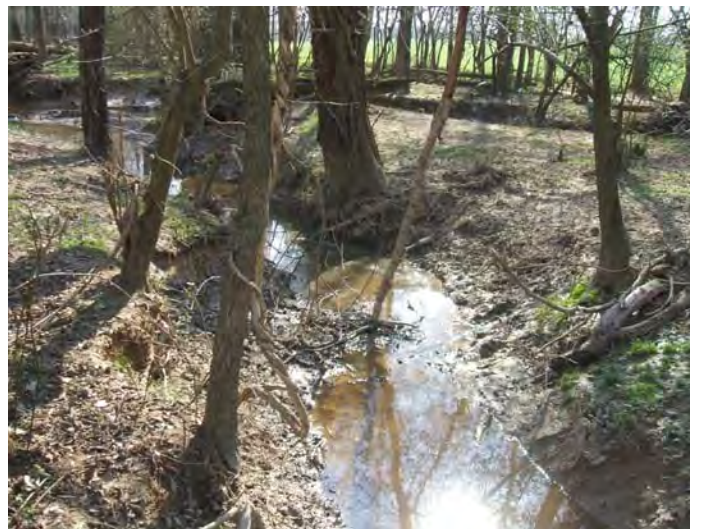
MS-3, northern-most tributary downstream from bridge.
