**FINAL MONITORING REPORT
YEAR 3 of 5**

**Green Valley Farm Site
Riparian Buffer Restoration
DMS Project ID Number 003994-DMS Site 95012**

**Randolph County, North Carolina
Cape Fear River Basin
HUC 03030003010070**

**Construction Completed: June 2012
Data Collection Period: January 2016
Submission Date: February 2016**

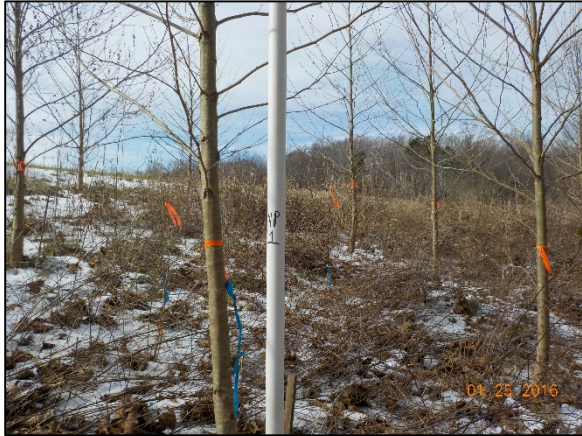
Vegetation Plot 1

Table 6. Riparian Buffer Vegetation Totals Green Valley, Randolph County DMS Project ID Number 003994-DMS Site 95012		
Plot #	Riparian Buffer Stems¹	Success Criteria Met?
01	445	Yes
2	526	Yes
3	1093	Yes
4	890	Yes
5	405	Yes
6	647	Yes
7	364	Yes
8	283	No
9	769	Yes
10	283	No
11	607	Yes
Project Avg	574	Yes
