**FINAL MONITORING REPORT  
YEAR 4 of 5**

**Green Valley Farm Site  
Riparian Buffer Restoration  
DMS Project ID Number 003994-DMS Site 95012**

**Randolph County, North Carolina  
Cape Fear River Basin  
HUC 03030003010070**

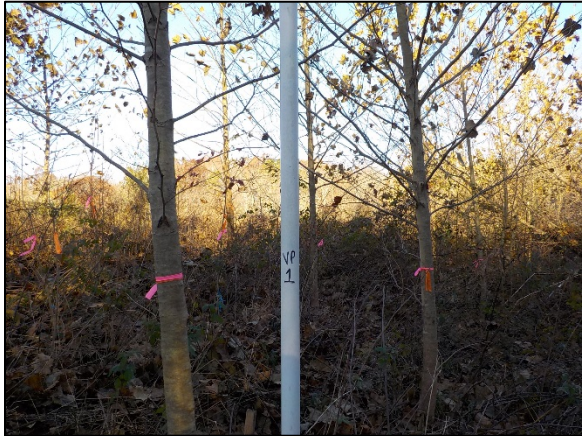
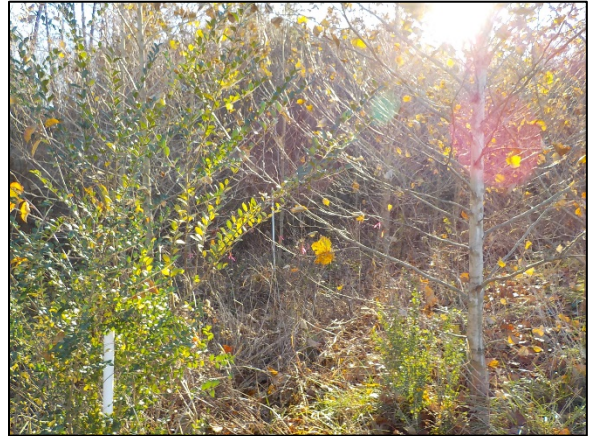
**Vegetation Plot 1**

<b>Plot #</b>	<b>Riparian Buffer Stems<sup>1</sup></b>	<b>Success Criteria Met?</b>
<b>01</b>	445	Yes
<b>2</b>	526	Yes
<b>3</b>	1093	Yes
<b>4</b>	850	Yes
<b>5</b>	445	Yes
<b>6</b>	728	Yes
<b>7</b>	364	Yes
<b>8</b>	445	Yes
<b>9</b>	769	Yes
<b>10</b>	364	Yes
<b>11</b>	567	Yes
<b>Project Avg</b>	<b>600</b>	<b>Yes</b>
