**FINAL MONITORING REPORT
YEAR 5 of 5**

**Green Valley Farm Site
Riparian Buffer Restoration
DMS Contract Number 003994-DMS Site 95012
DWR Project Number 2014-0073**

**Randolph County, North Carolina
Cape Fear River Basin
HUC 03030003010070**

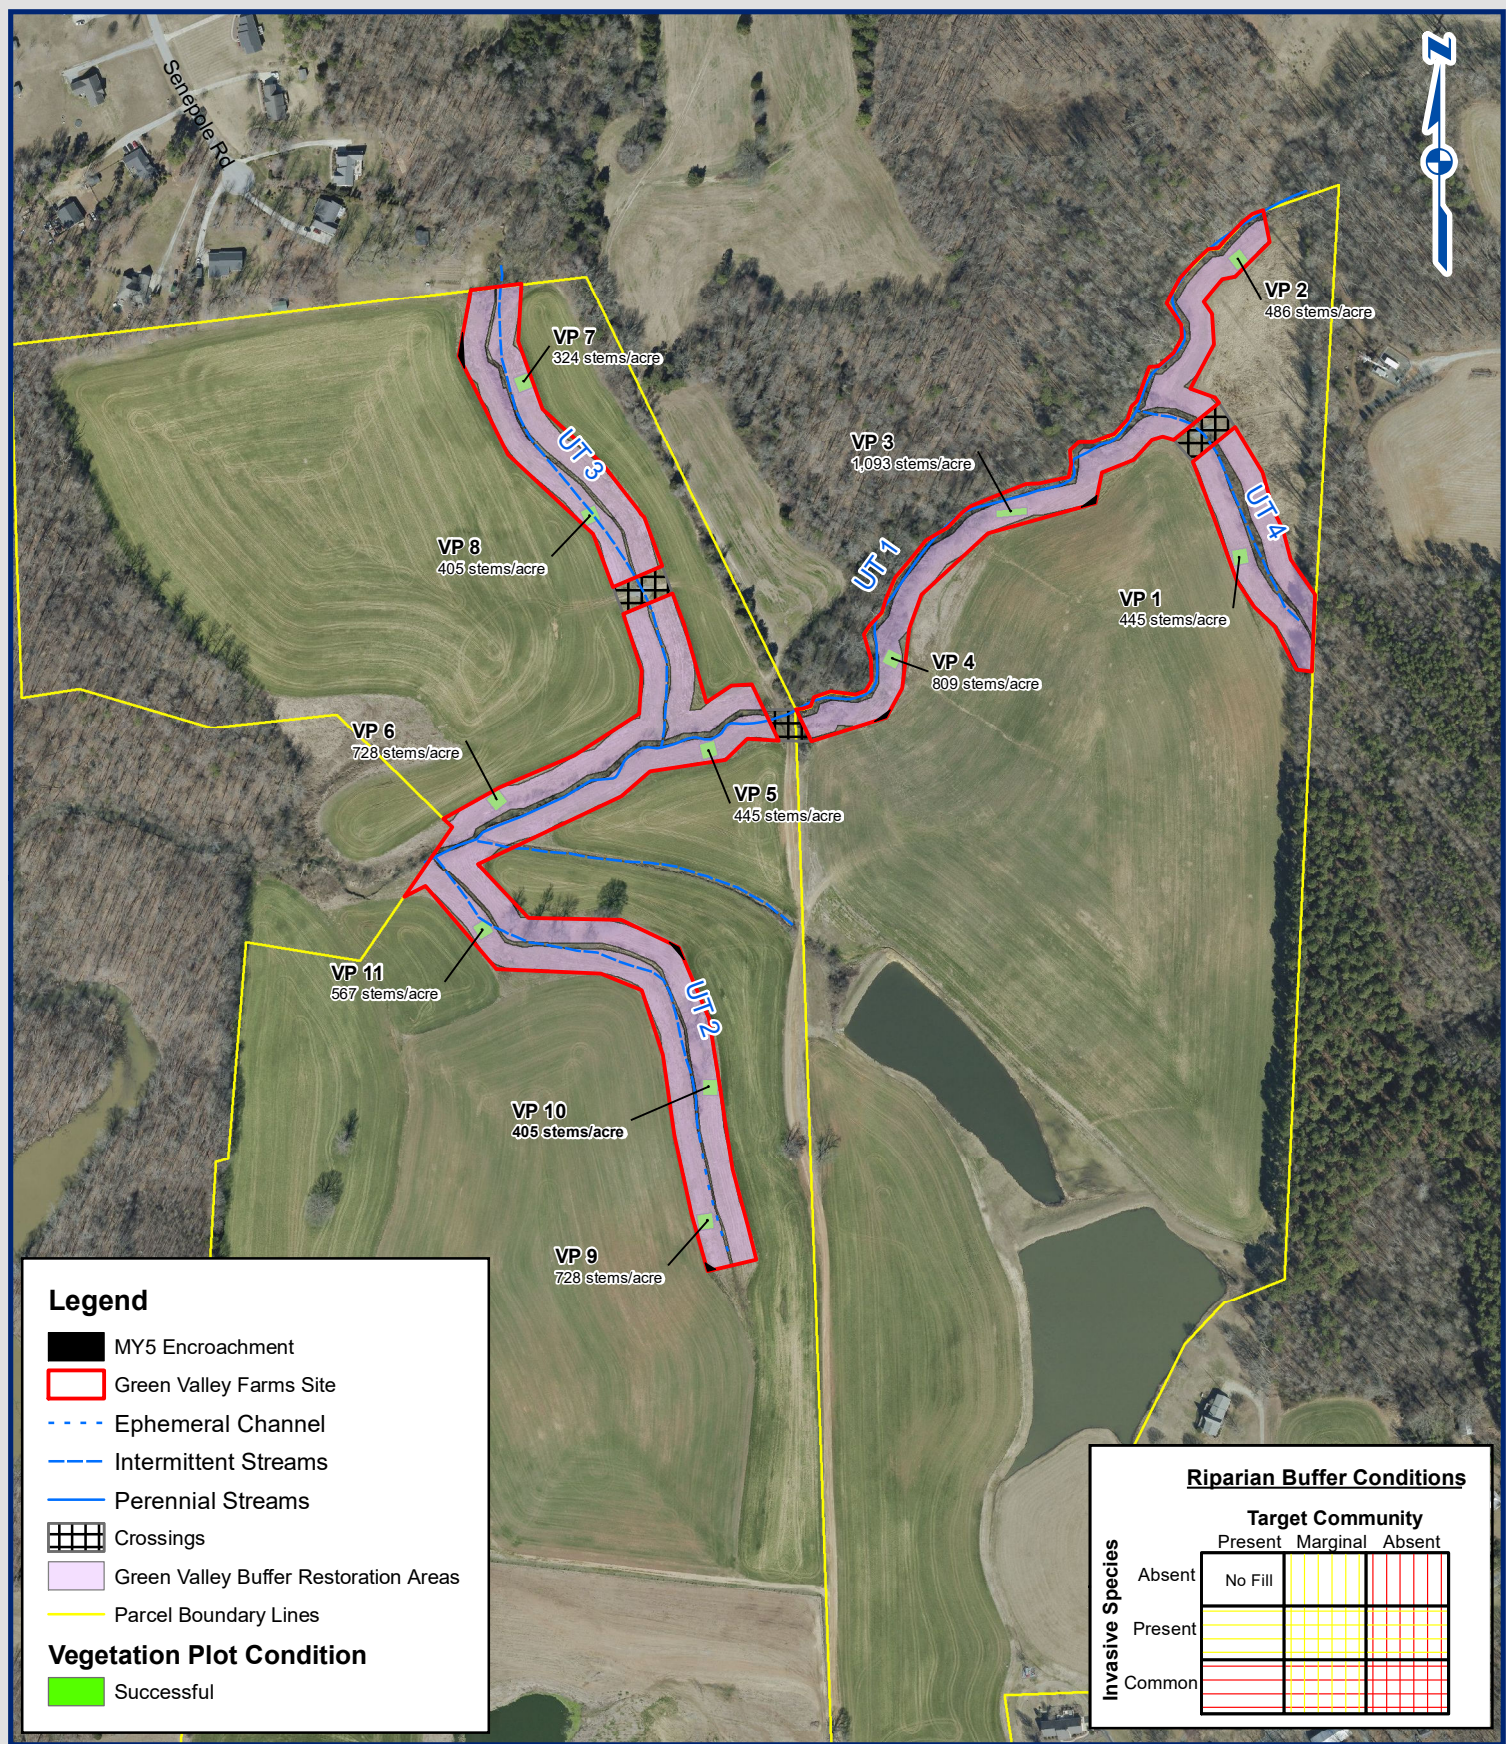
Figure 2. Current Condition Plan View
 Green Valley Farms Riparian Buffer Restoration Site

The invasive Johnsongrass (*Sorghum halepense*) was present across the site during Year 5; however, it is sparse and not problematic. The trees on-site have begun canopy closure and shading it out. There were five small areas of encroachment (about 0.03 acres) where the landowner run over easement markers. Easement markers in these locations were replaced in the fall of 2017. In February 2017, NCDWR staff conducted an on-site determination of the upper portion of UT 4 and found it to be intermittent (**Appendix D**). MY5 conditions are shown on the Current Condition Plan View which is provided in **Appendix B, Figure 2**.

4. Invasive Areas of Concern	Areas or points (if too small to render as polygons at map scale)	1000 SF	horizontal red line fill	0	0.00	0%
5. Easement Encroachment Areas	Areas or points (if too small to render as polygons at map scale)	none	black fill	5	0.03	0%
