Year 3 Monitoring Report

Green Valley Farm II Mitigation Project

DMS Project #: 100111 | Contract #: 7862 | DWR # 20140073v2 | RFP: 16-007703

Randolph County, North Carolina
Cape Fear River Basin
Randleman Lake Watershed
HUC 03030003

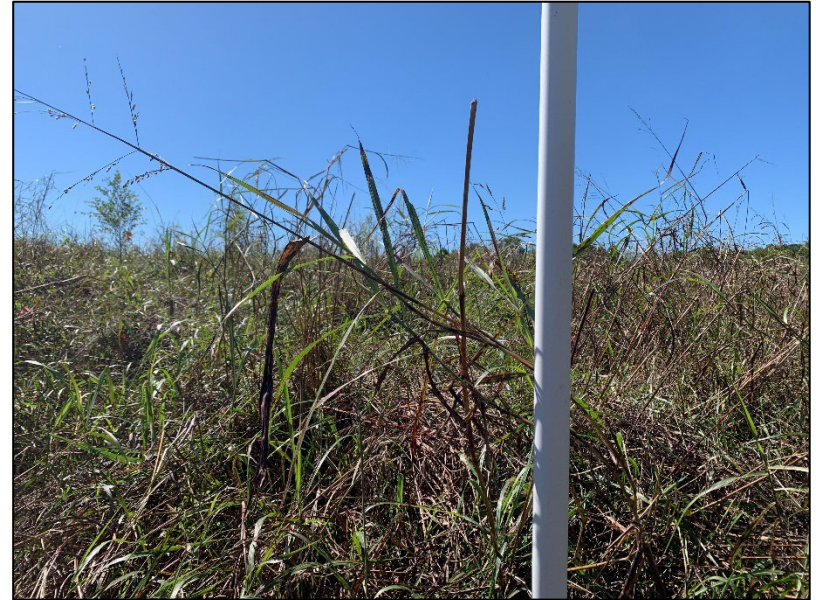
Vegetation Plot 6
10/06/2022

In response to Vegetation Plot 6 not meeting success and visual monitoring in MY2, the southern areas of the easement, about 5.33 acres, were supplemental planted with 1,500 container trees on April 6, 2022. RES attributes the low stem density areas to Johnson grass competition. A mix of 1, 2, 3, and 5-gallon containers were used. Species and container sizes are in **Appendix B**. RES mowed strips and treated the Johnson grass before planting the new container trees. RES also sprayed rings around the newly planted trees in May to keep the competition down. There were signs of minor easement encroachment in MY3 that will be addressed in MY4. Encroachment repairs include adding additional posts between corners along the farm field and blocking a driving path with posts and woody debris on the eastern portion of the easement.
