**Year 1 Monitoring Report**

**Green Valley Farm II Mitigation Project**

**DMS Project #: 100111 | Contract #: 7862 | DWR # 20140073v2 | RFP: 16-007703**

**January 2021**

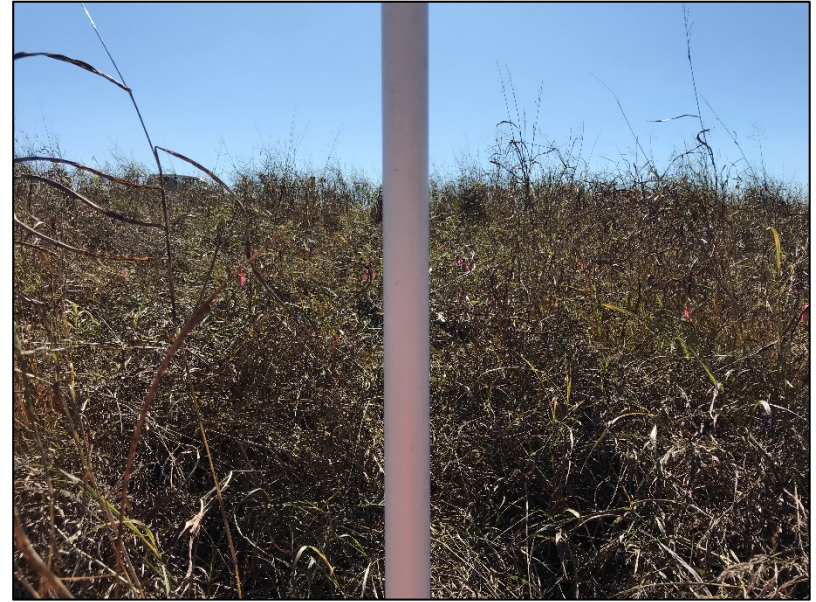
Vegetation Plot 6  
11/04/2020

2. Section 1.6 – Does RES have a theory as to why vegetation in and around veg plot 6 had such high mortality (herbaceous competition, poor soil, late planting date, etc.)? If so, please briefly discuss this and what actions may be considered to ensure the supplemental planting's success.

RES believes the high mortality can be attributed to the growing season (May) planting. RES experienced similar mortality across all four Randleman Group B sites. RES will ensure that supplemental planting is completed during this dormant season.

Monitoring of the six permanent vegetation plots was completed on November 4, 2020. Vegetation tables are in **Appendix B** and associated photos are in **Appendix C**. Year 1 monitoring data indicates that five out of six plots are exceeding the success criteria of 260 planted stems per acre. Planted stem densities ranged from 243 to 890 planted stems per acre with a mean of 600 planted stems per acre across all plots. A total of 16 species were documented within the plots. Volunteer species were noted at Year 1 monitoring and are expected to increase in upcoming years. The average tree height observed was 1.6 feet. The area in and around Vegetation Plot 6 (1.74 acres) will be supplemental planted with bareroot trees this dormant season.
