Gregory Site Stream and Wetland Mitigation Plan Halifax County, NC

June 2004

Gregory Site Stream and Wetland Restoration Plan Halifax County, NC

Report Prepared By Buck Engineering PC

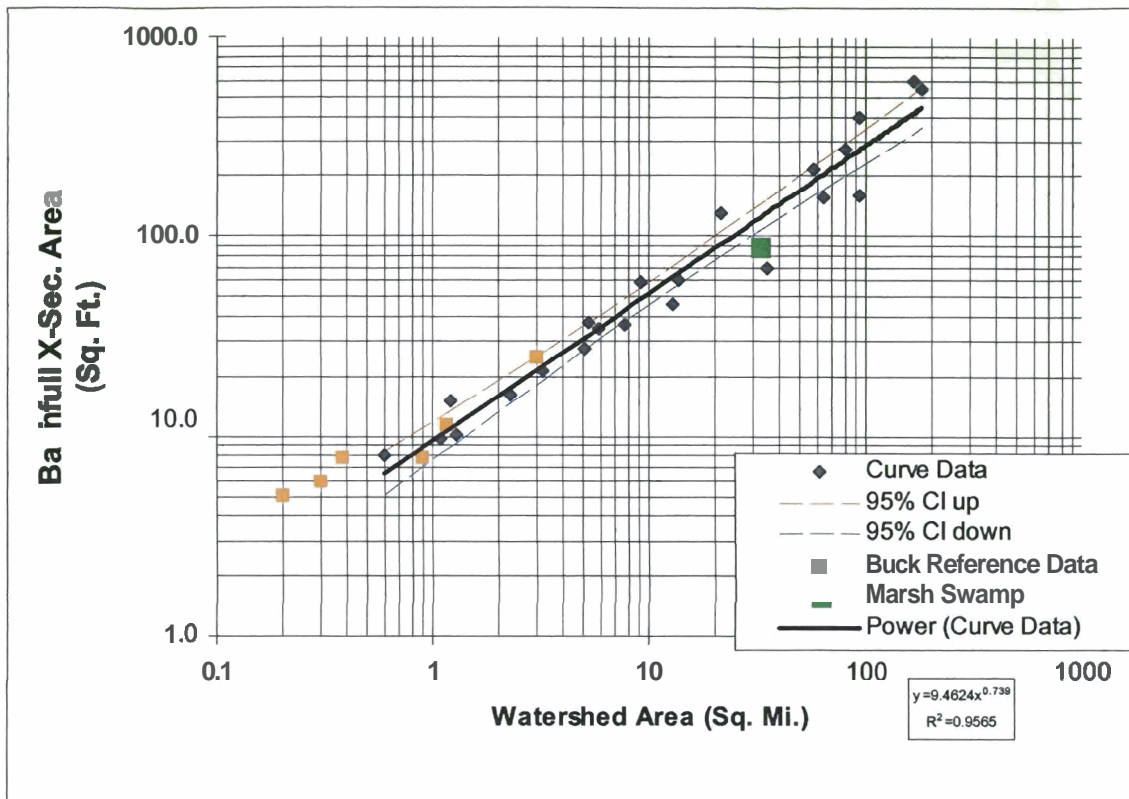
Figure 2-4 NC Coastal Plain Regional Curve (Sweet and Geratz, 2003) with Buck Reference Data Points and Surveyed Bankfull Cross-Sectional Area for Marsh Swamp.

Since Marsh Swamp is unincised, bankfull elevation is represented by the top of the stream bank. This was verified during the July 14 site visit by taking measurements of the channel and estimating channel cross-sectional area for comparison against regional curve information. At the top of the stream bank, Marsh Swamp has a cross-sectional area of approximately 80 to 100 square feet, and the watershed size at the project area is approximately 32 square miles. These data plot well within the scatter of data points collected for the Coastal Plain regional curve (Figure 2-4), and provides strong evidence that Marsh Swamp is an unincised stream channel along the perimeter of the Gregory Site. Therefore, flows larger than the bankfull flow can spread out onto the floodplain.

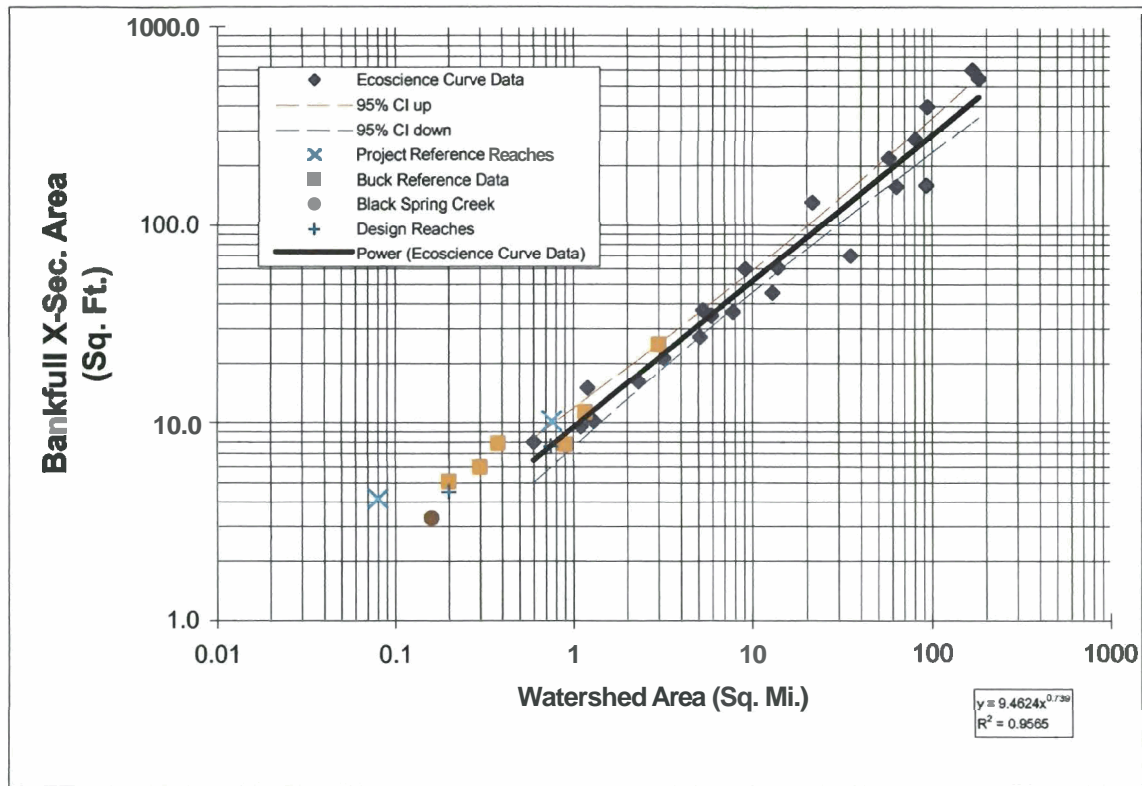
Figure 5-2 NC Coastal Plain Regional Curve with Suveyed Bankfull Cross-Sectional Areas for Project Reference Reaches, Existing Condition, and Design Conditions. (Project data points were not used in determining the regression line.)

upstream **bankfull** data, and comparison with local reference reaches. Bankfull data for the project existing and design conditions and the reference reaches are compared with the NC Coastal Plain regional curves in Figure 5-2.

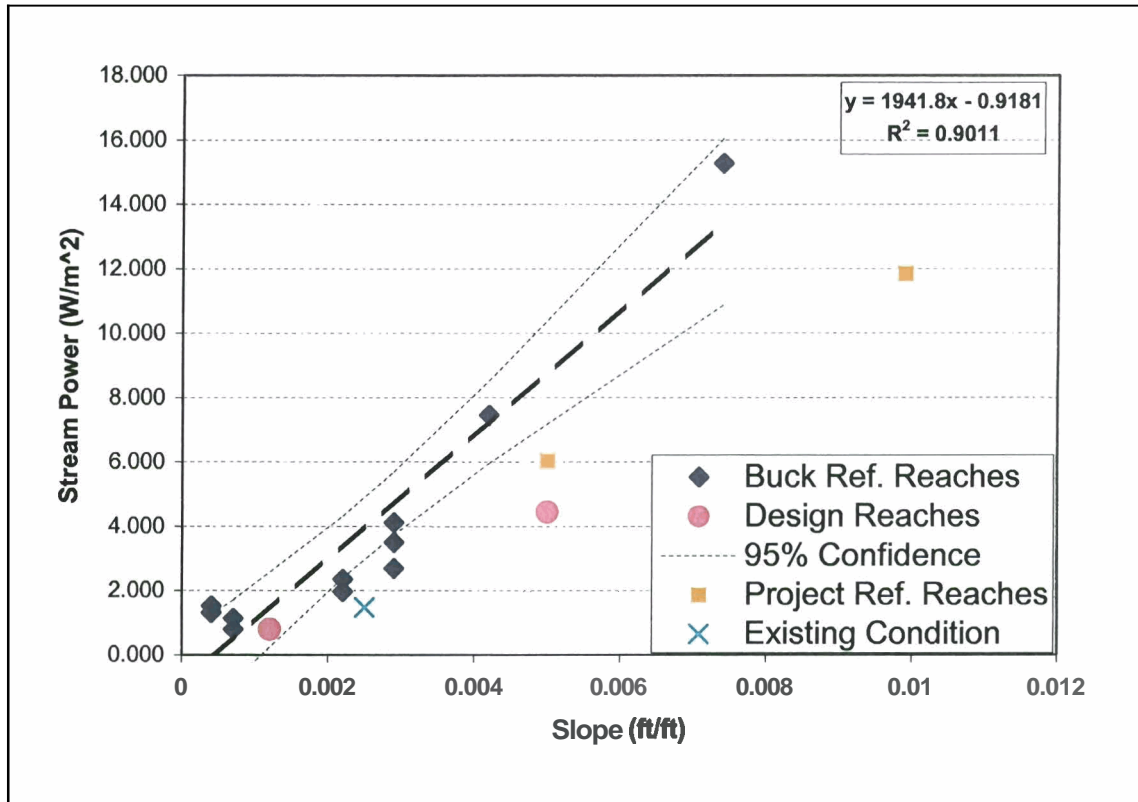
Figure 9-1 Comparison Between Stream Power and Channel Slope for the Gregory Site Existing and Design Reaches, Project Reference Reach Data, and Buck Coastal Reference Reaches.

Equation 2 does not provide a sediment transport rating curve; however, it does describe the stream's ability to accomplish work, e.g. move sediment. For this analysis, stream power values were calculated for the Black Spring Creek existing condition as 1.47 W/m², the tributary to Jacket Swamp reference reach as 11.84 W/m², and the tributary to Beaverdam Swamp reference reach as 6.03 W/m². Stream power was calculated for the design Reaches 1 and 2 as 4.44 W/m² and 0.80 W/m². These data points were then overlaid onto Figure 9-1, which shows the relationship of stream power versus slope for reference reach sand bed streams located within the Coastal Plain of North Carolina. These data are presented for comparison only. Reach 2 plots below the 95% confidence interval for the curve developed for Coastal Plain reference reaches but within the range of data used to develop the curve. The project reference reaches also plot slightly below the curve, which indicates that the design stream powers fall within the range of data expected for stable sandbed systems in this region of the NC Coastal Plain. This provides good evidence that the project design reaches will neither aggrade nor degrade.
