ANNUAL REPORT FOR 2002

Grimesland Sand Pit Site
Pitt County
Project No. 8.T221801
TIP No. R-2510 WM

Office of Natural Environment & Roadside Environmental Unit
North Carolina Department of Transportation
January 2003/ Revised March 2003

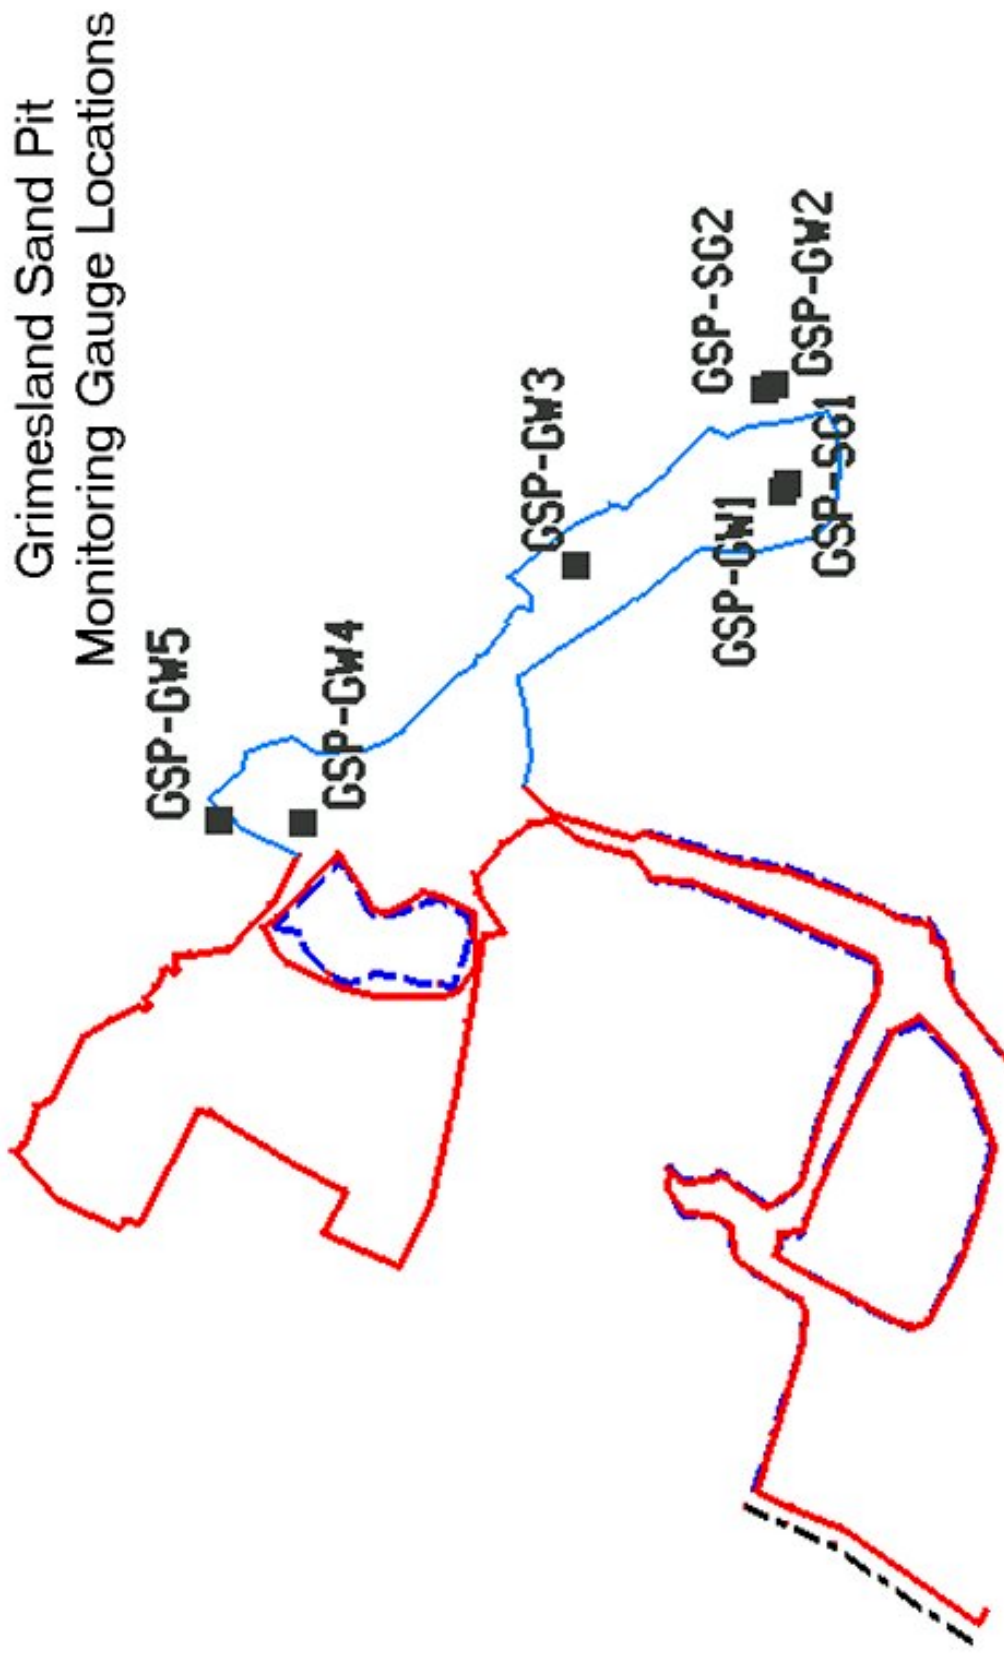
Figure 2. Grimesland Sand Pit Gauge Location Map

Five groundwater and two surface water gauges were installed on site in March of 2000 (Figure 2). The automatic monitoring gauges record daily readings of the groundwater depth, while the surface water gauges record water depth every three hours. The 2002 data represents the first full growing season during which the water table was monitored. A rain gauge installed onsite records daily rainfall totals; these rain events are incorporated into the monitoring results to examine how the site's groundwater level responds to rainfall.

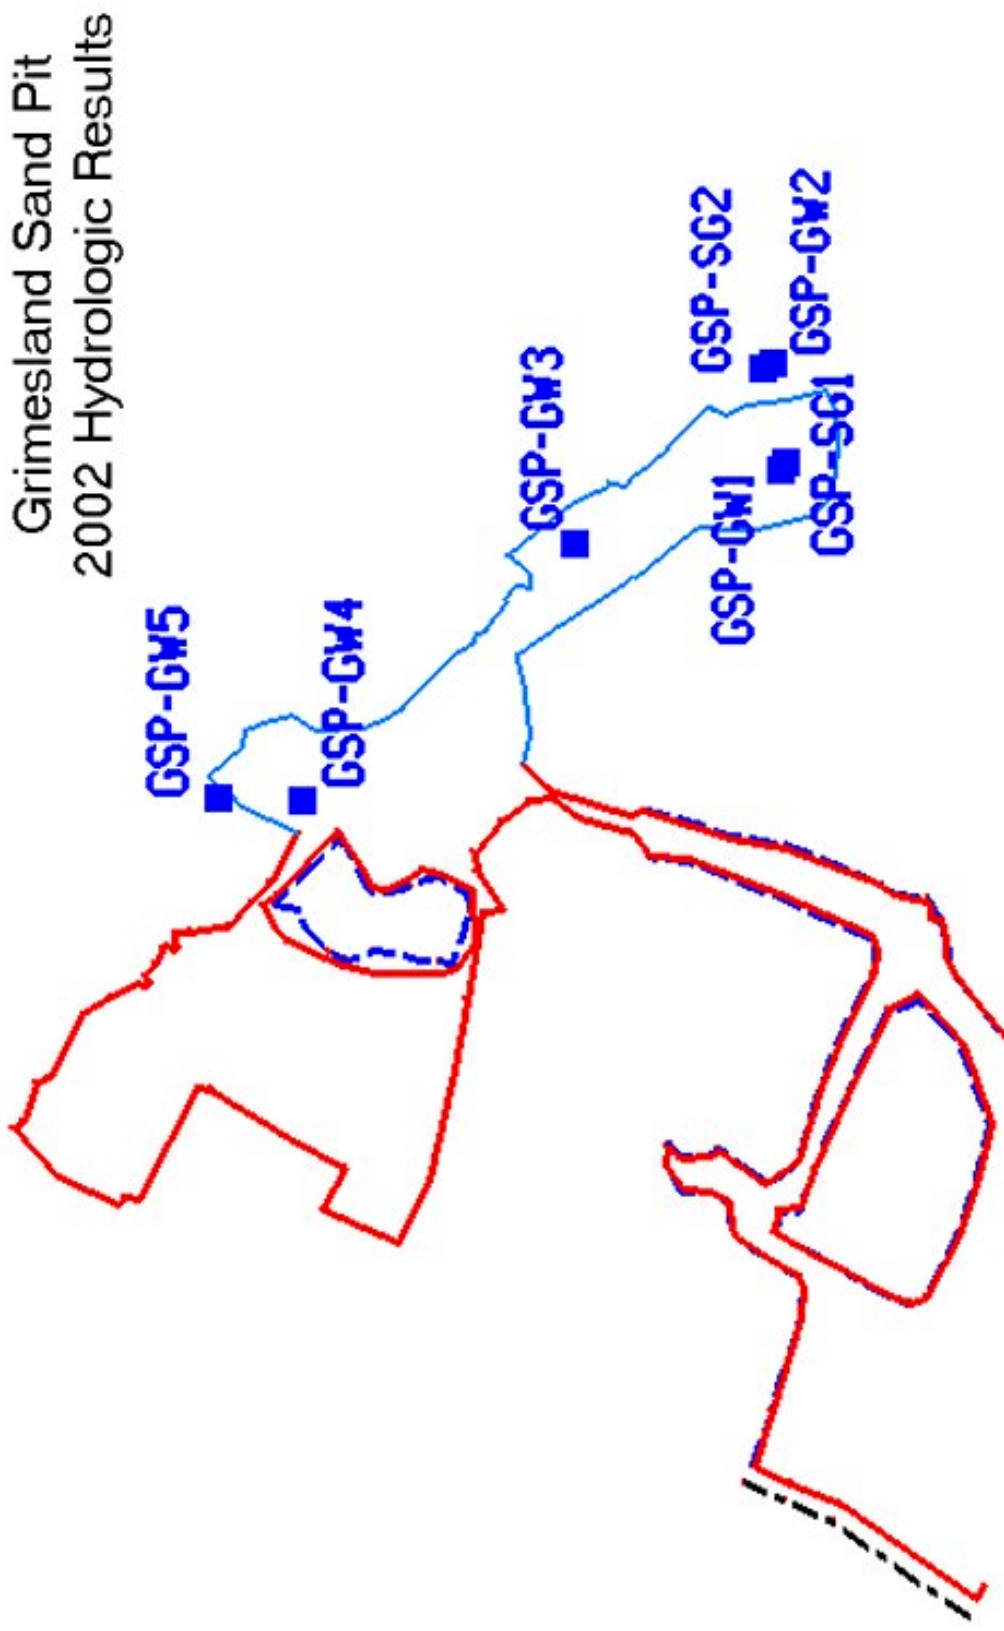
Figure 3. Grimesland Sand Pit 2002 Hydrologic Monitoring Results

Table 1 shows the hydrologic results for 2002; Figure 3 is a graphical representation of these results. In Figure 3, a blue dot indicates the gauge showed success for more than 12.5% of the growing season; a red dot, between 8 and 12.5%; a green dot, between 5 and 8%, and a black dot, less than 5%. All five groundwater gauges met or exceeded the 12.5% time duration during the growing season. The two surface water gauges showed the consistent presence of surface water throughout the growing season.

Monitoring Gauge	< 5%	5 – 8%	8 – 12%	> 12.5%	Actual %	Success Dates
GSP-GW1				✓	58.7	June 25- Nov. 16
GSP-GW2				✓	100.0	March 15- Nov. 16
GSP-GW3				✓	100.0	March 15- Nov. 16
GSP-GW4				✓	58.7	June 25- Nov. 16
GSP-GW5				✓	100.0	March 15- Nov. 16

Five groundwater and two surface water gauges were installed onsite in 2001. 2002 represents the first full year of hydrologic monitoring for the Grimesland site. All five groundwater monitoring gauges indicated jurisdictional success for the year, as each showed saturation within 12 inches of the surface for more than 12.5% of the growing season. The two gauges that did not show success for the entire growing season experienced malfunctions. The two surface gauges showed the consistent presence of surface water throughout the growing season. A comparison of 2002 rainfall versus historical precipitation shows that 2002 experienced below average rainfall conditions.

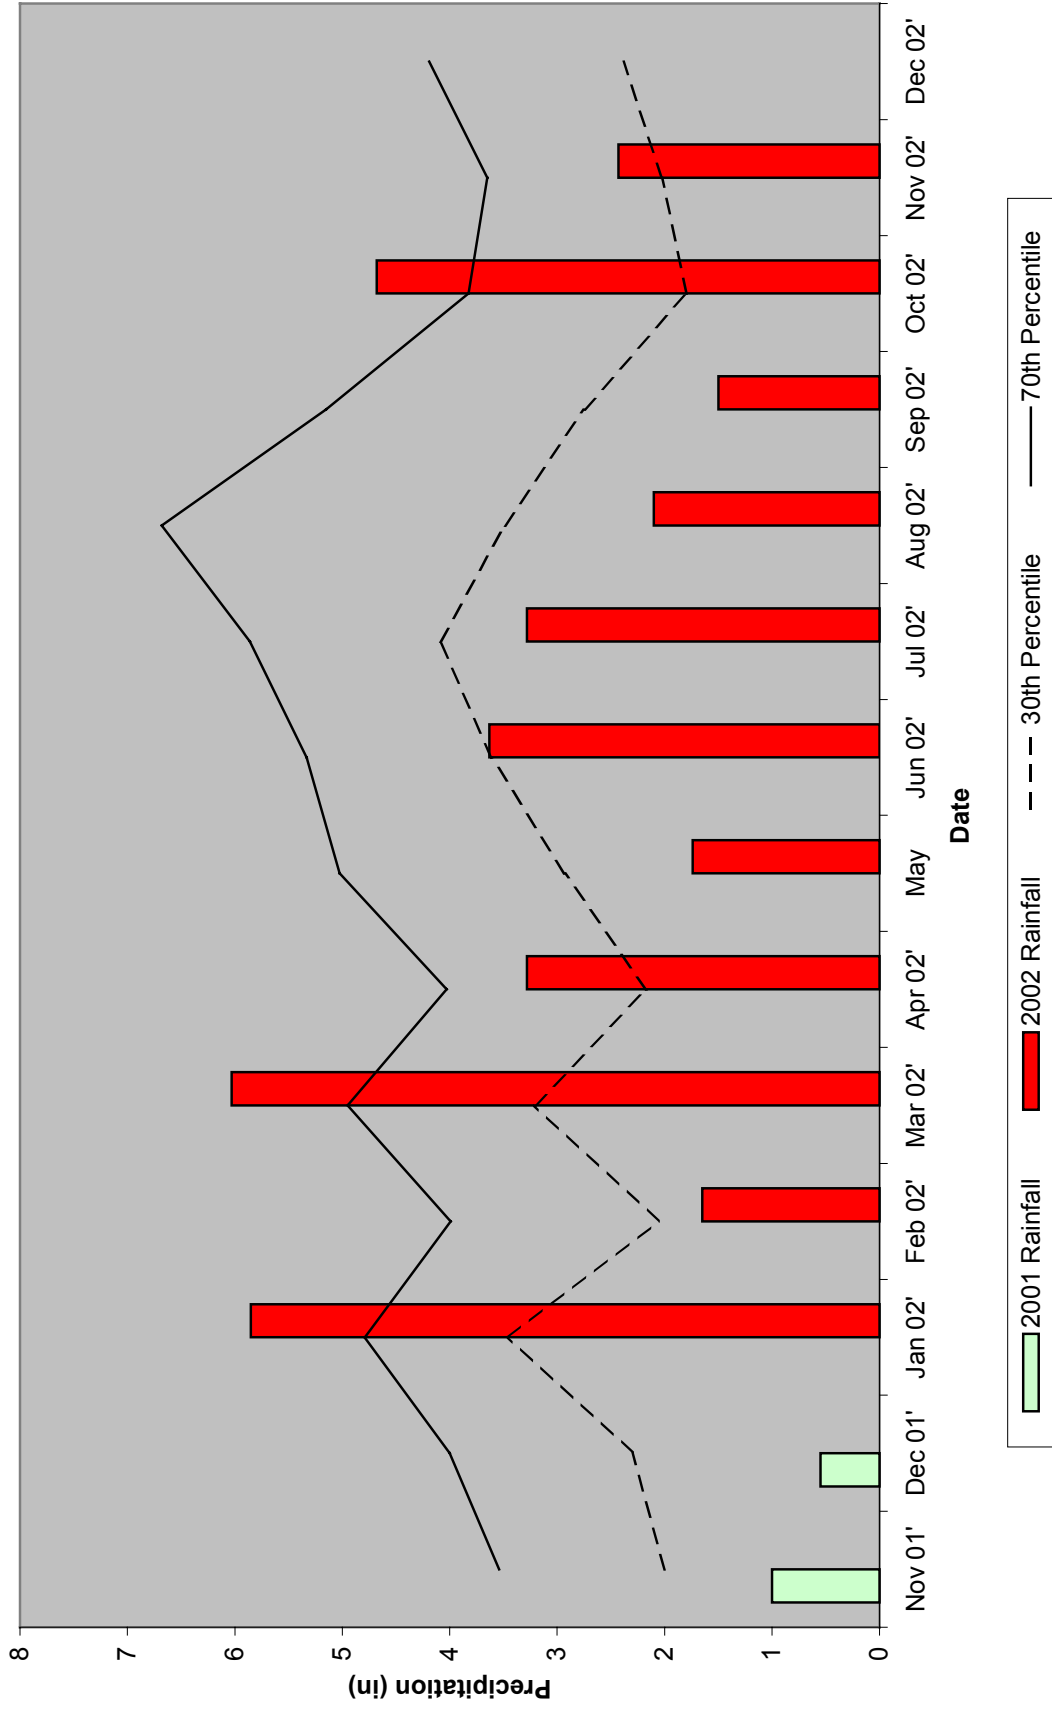
Figure 4. 30-70 Percentile Graph, Washington, NC

Figure 4 is a graph of monthly rainfall for the period of November 2001 through August 2002 compared to historical precipitation data (collected between 1931 and 2001) for Washington, North Carolina. The NC State Climate Office provided the rainfall data. The comparison of 2002 rainfall versus historical values gives an indication of how 2002 compares to historical climate conditions.

Monthly rainfall for the site fluctuated around the average rainfall for 2002. November and December (2001), February, April, May, and July experienced below average rainfall. The month of June recorded average rainfall for the site. January and March experienced above average rainfall. Overall, the site experienced below average rainfall for 2002. All five gauges met the success criteria during months of normal or below normal rainfall.

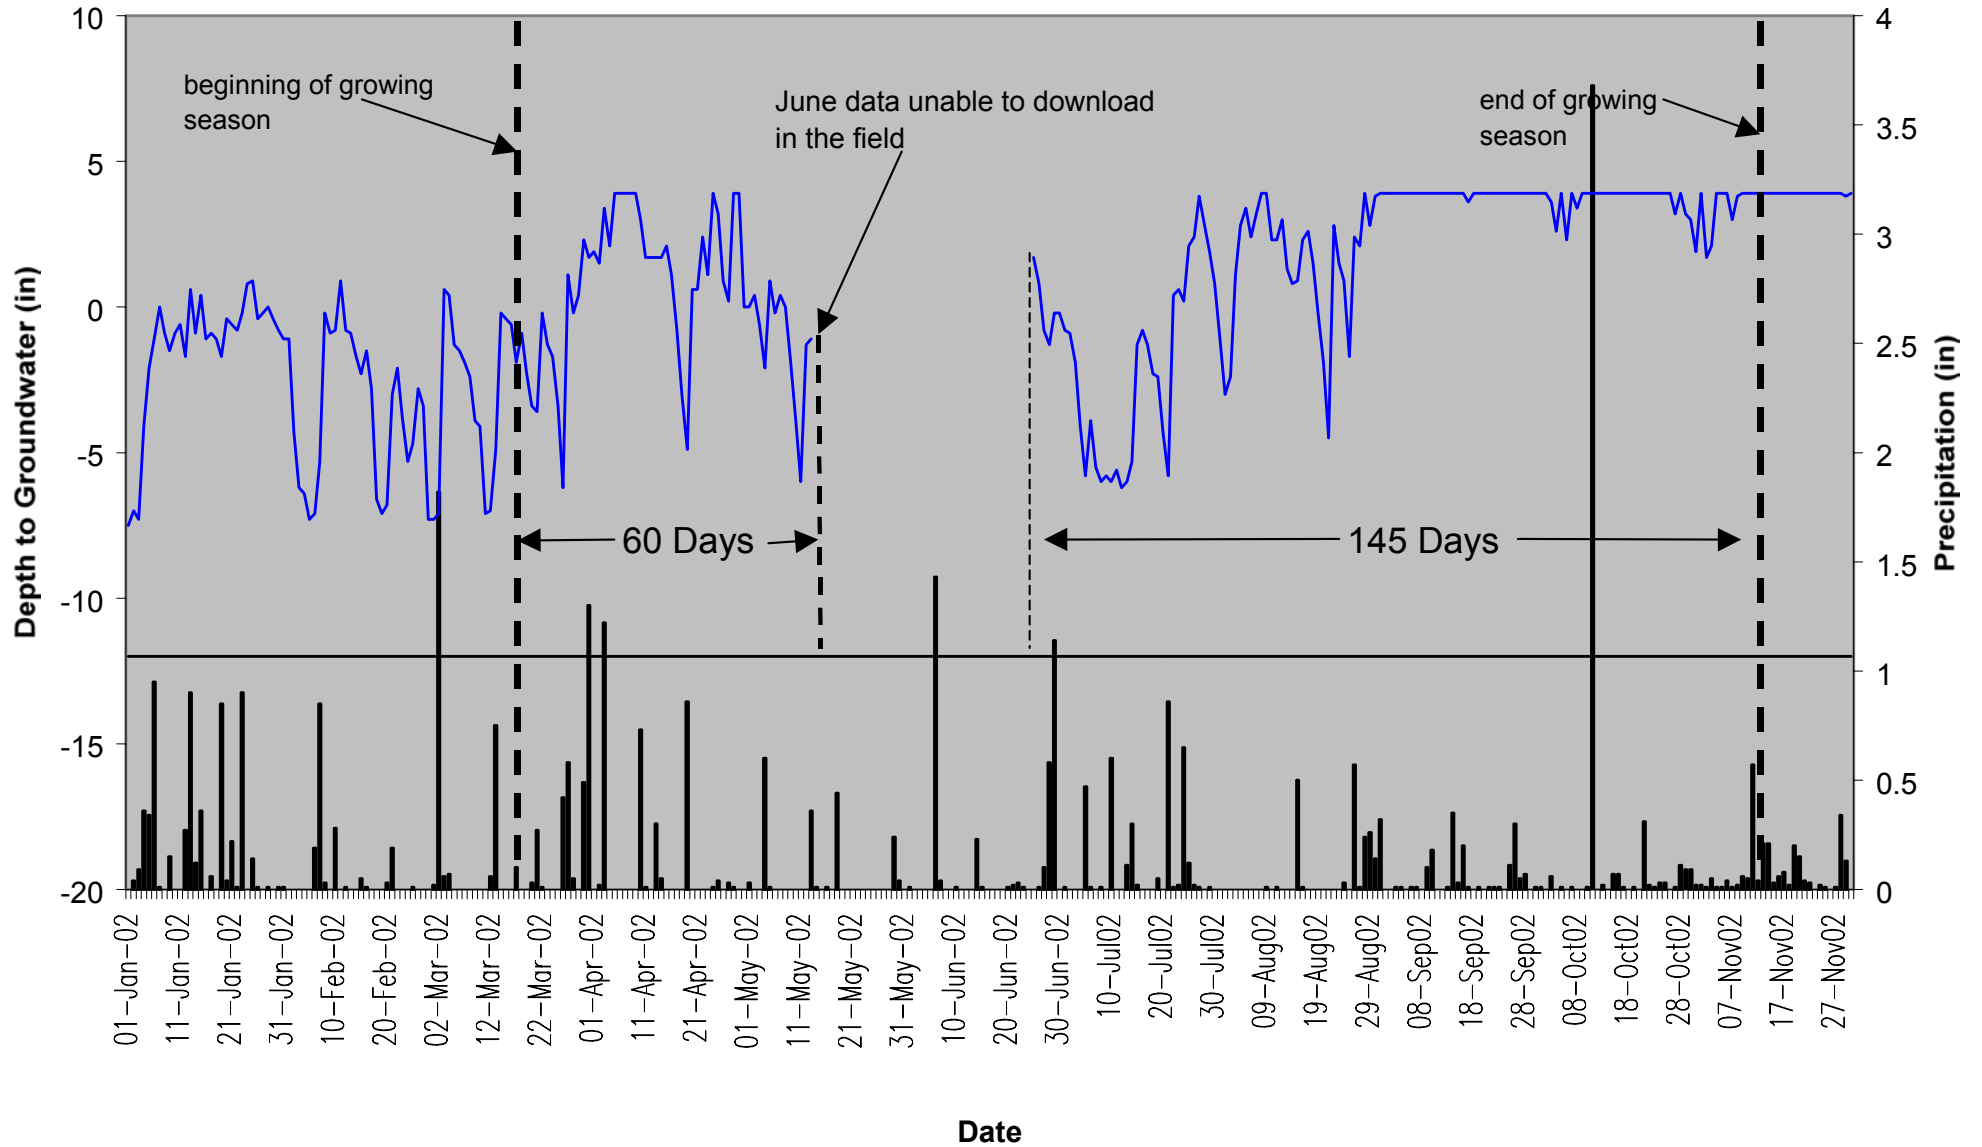
Grimesland - Groundwater Gauge 1

GW1: Data was unable to be downloaded in June; thus there is no data available between May 14 and June 24.

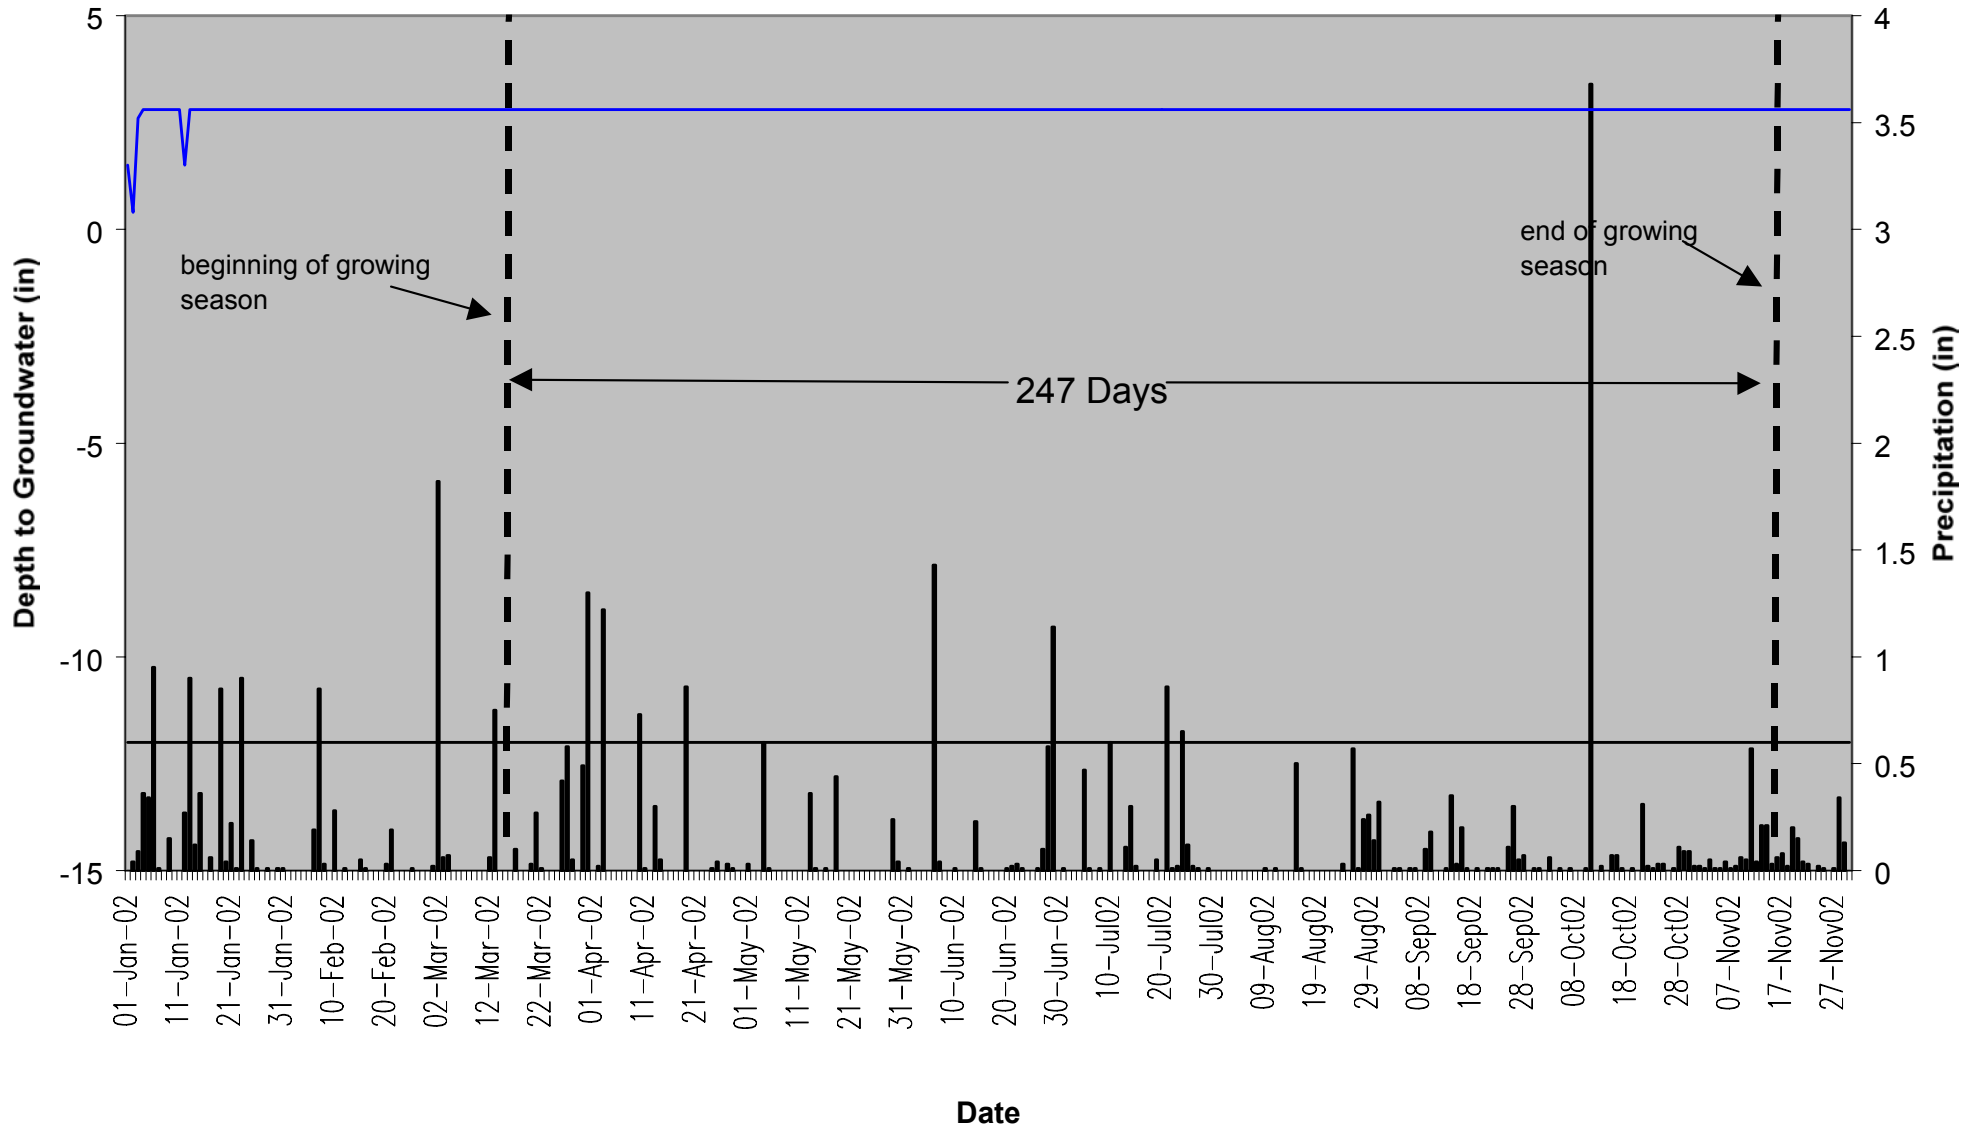
Grimesland - Groundwater Gauge 5

GW 5: The gauge malfunctioned on March 30, and was not able to be downloaded until June 24.

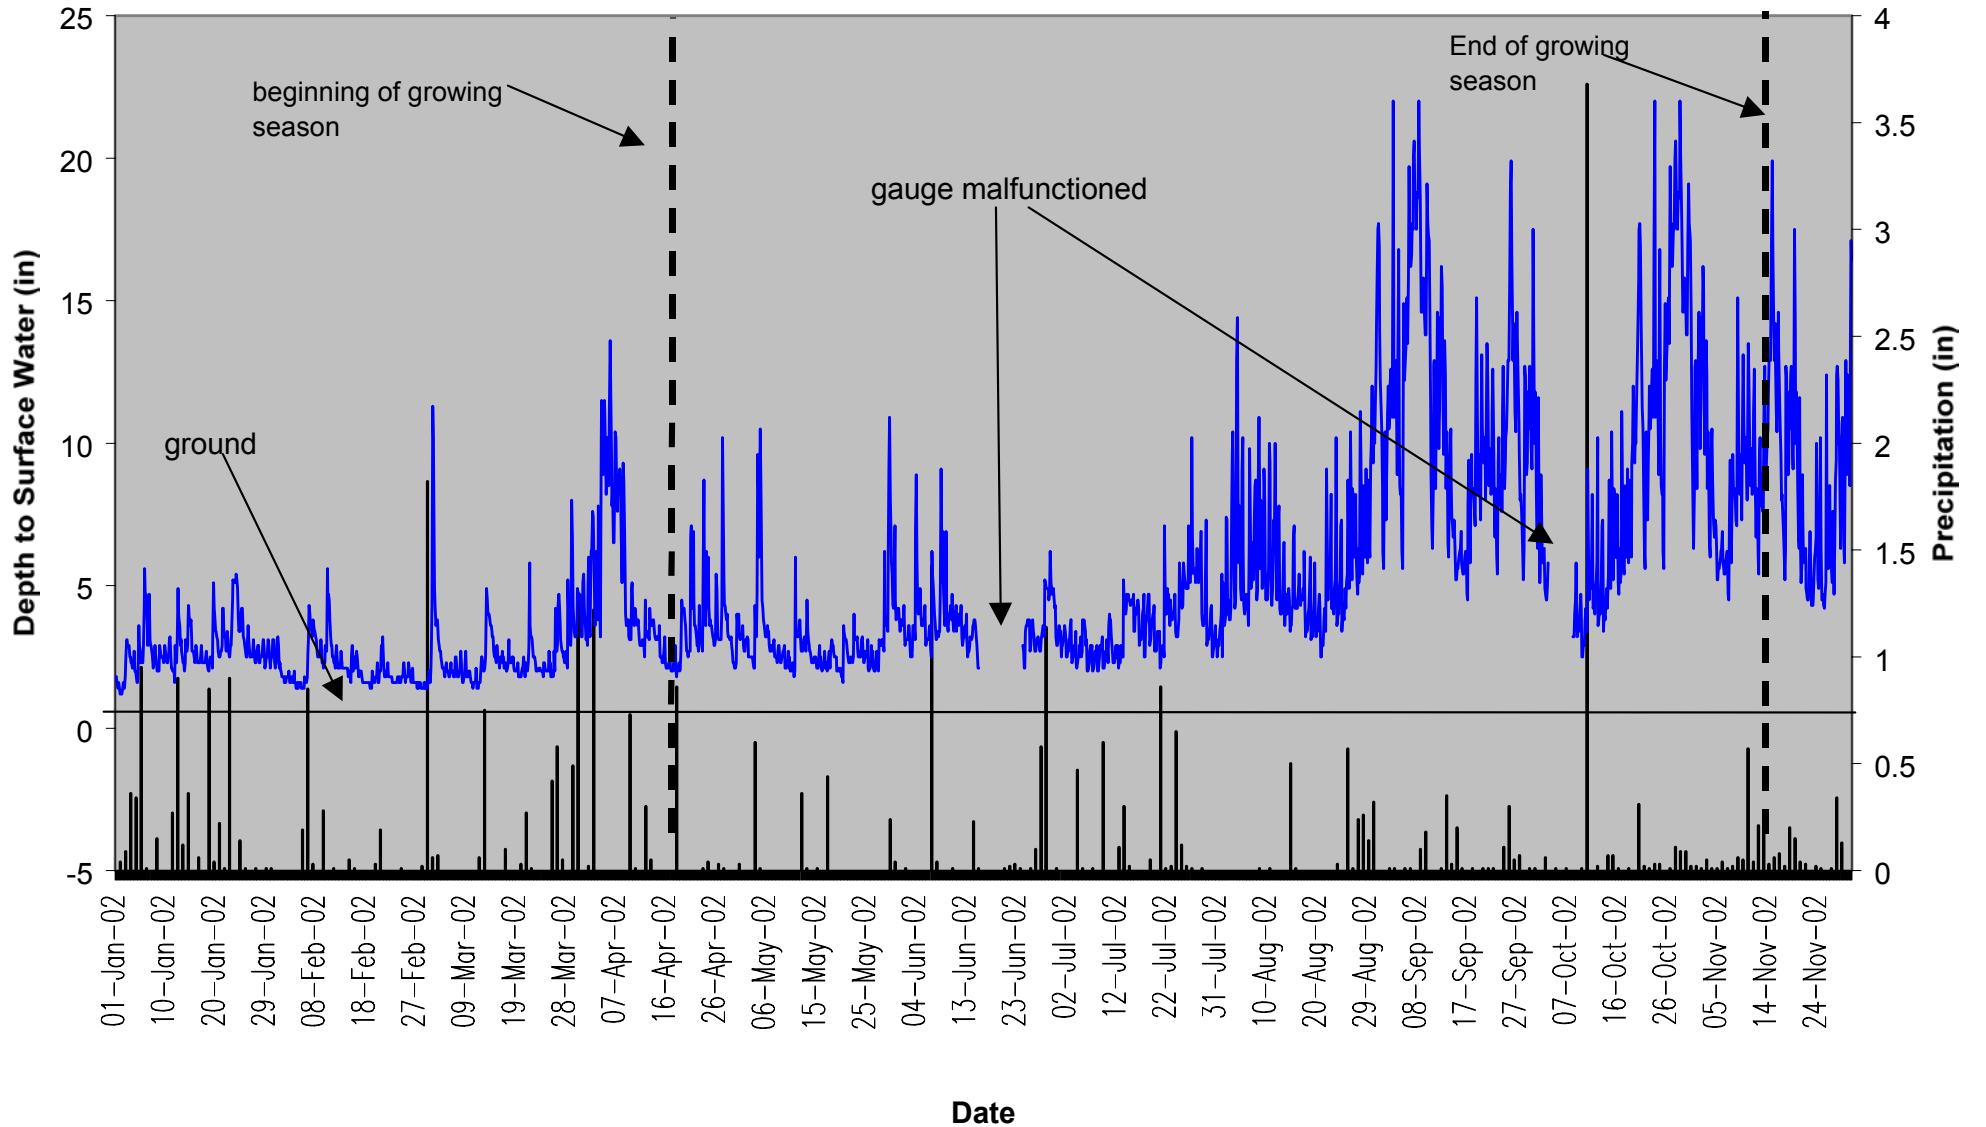
Grimesland - Surface Gauge 1

SG1: This gauge stopped reading between June 16 and June 24, when it was repaired. The gauge also did not record between October 3 and October 8.

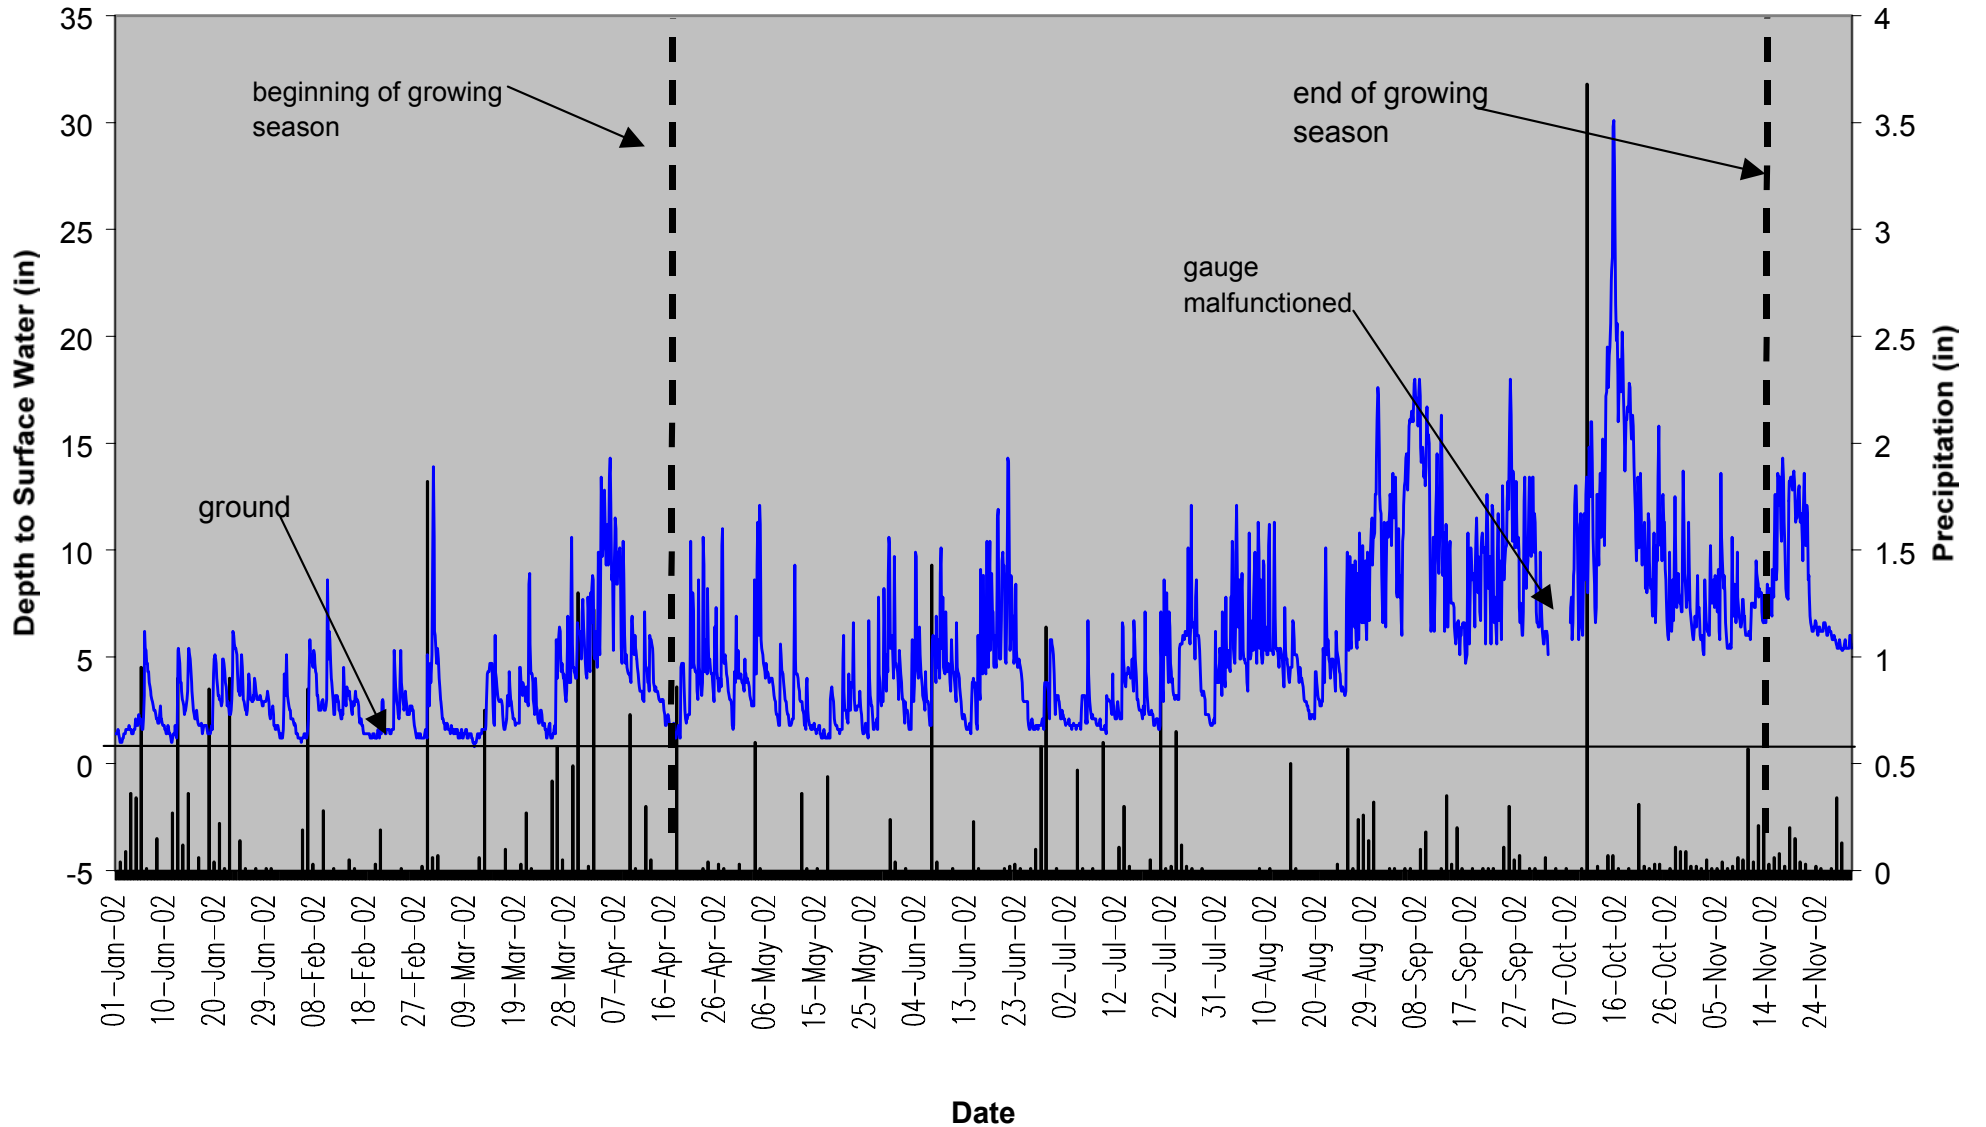
Grimesland - Surface Gauge 2

SG2: Gauge stopped recording between October 3 and October 7.
