# ANNUAL REPORT FOR 2004

**Grimesland Sand Pit Phase I Site**  
**Pitt County**  
**Project No. 8.T221801**  
**TIP No. R-2510 WM**

Office of Natural Environment & Roadside Environmental Unit  
North Carolina Department of Transportation  
December 2004

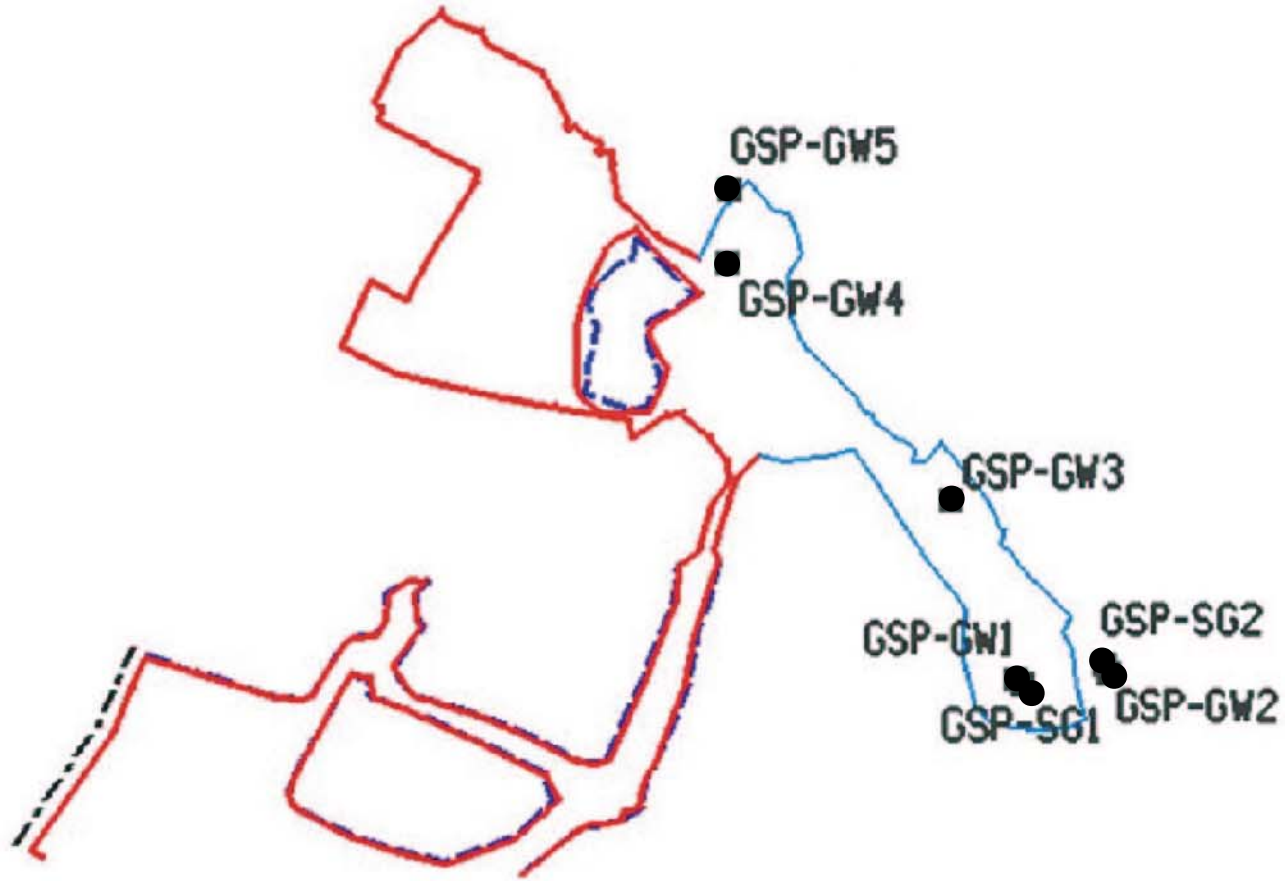
Figure 2. Gauge Location Map

Five groundwater and two surface water gauges were installed in the Phase I section in March of 2000 (Figure 2). The automatic monitoring gauges record daily readings of the groundwater depth, while the surface water gauges record water depth every three hours. A rain gauge installed onsite records daily rainfall totals; these rain events were incorporated into the monitoring results to examine how the site's groundwater level responded to rainfall.

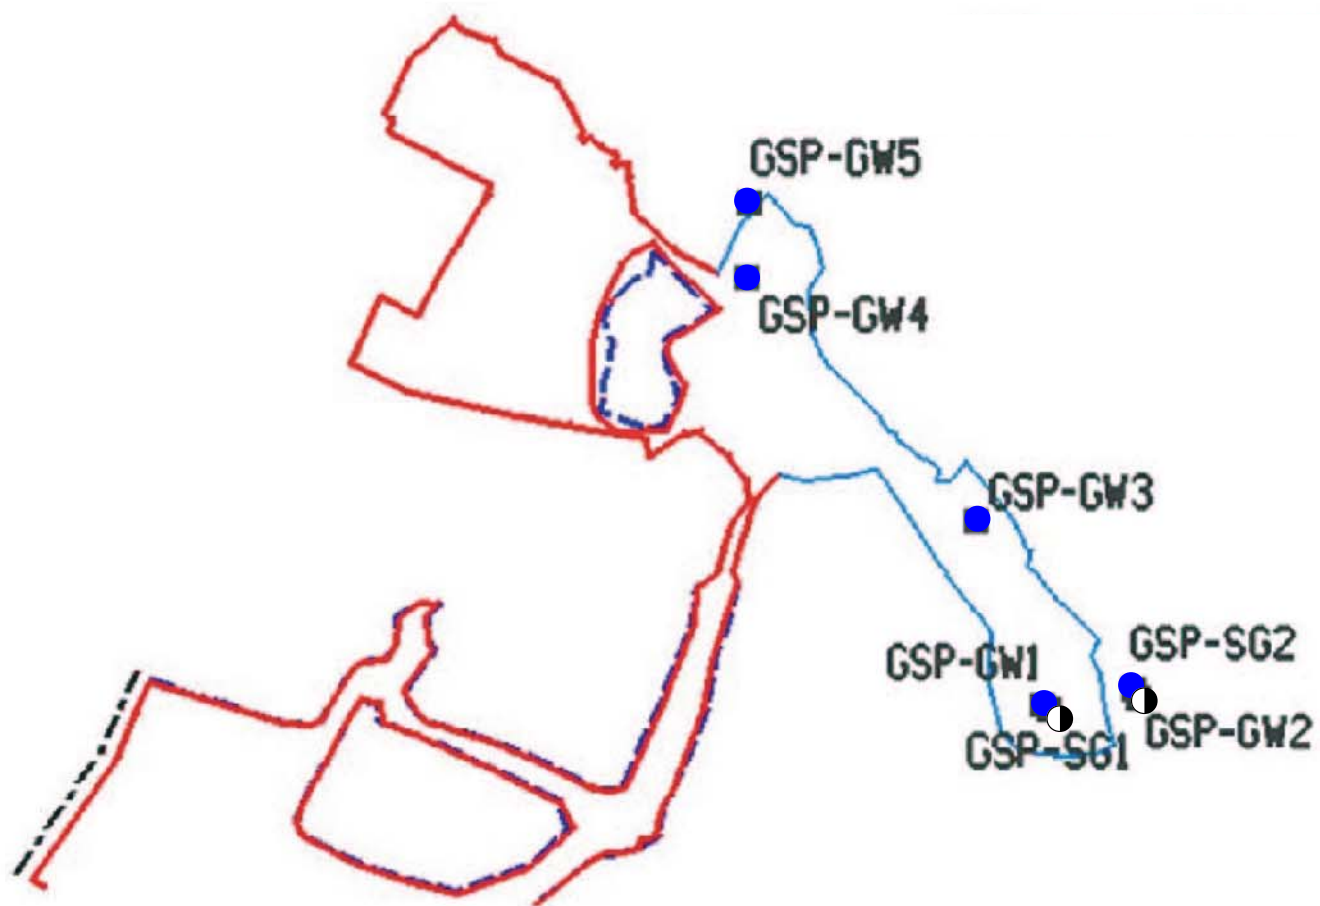
**Figure 3. 2004 Hydrologic Monitoring Gauge Results**

Table 1 shows the hydrologic results for 2004; Figure 3 is a graphical representation of these results. In Figure 3, a blue dot indicates the gauge showed success for more than 12.5% of the growing season; a red dot, between 8 and 12.5%; a green dot, between 5 and 8%, and a black dot, less than 5%.

<b>Monitoring Gauge</b>	<b>&lt; 5%</b>	<b>5 – 8%</b>	<b>8 – 12%</b>	<b>&gt; 12.5%</b>	<b>Actual %</b>	<b>Success Dates</b>
GSP-GW1+				×	48.2	March 15-April 24 May 23-July 14 July 21-Nov 16
GSP-GW2+				×	71.3	March 15-Sept 6
GSP-GW3+				×	100	March 15-Nov 16
GSP-GW4+				×	79.8	March 15-Aug 31 Sept 29-Nov 16
GSP-GW5+				×	38.9	May 21-Aug 24 Sept 29-Nov 16

In 2004, all five groundwater-monitoring gauges indicated success for at least 12.5% of the growing season. The two surface gauges provided data showing the consistent presence of surface water throughout the growing season.

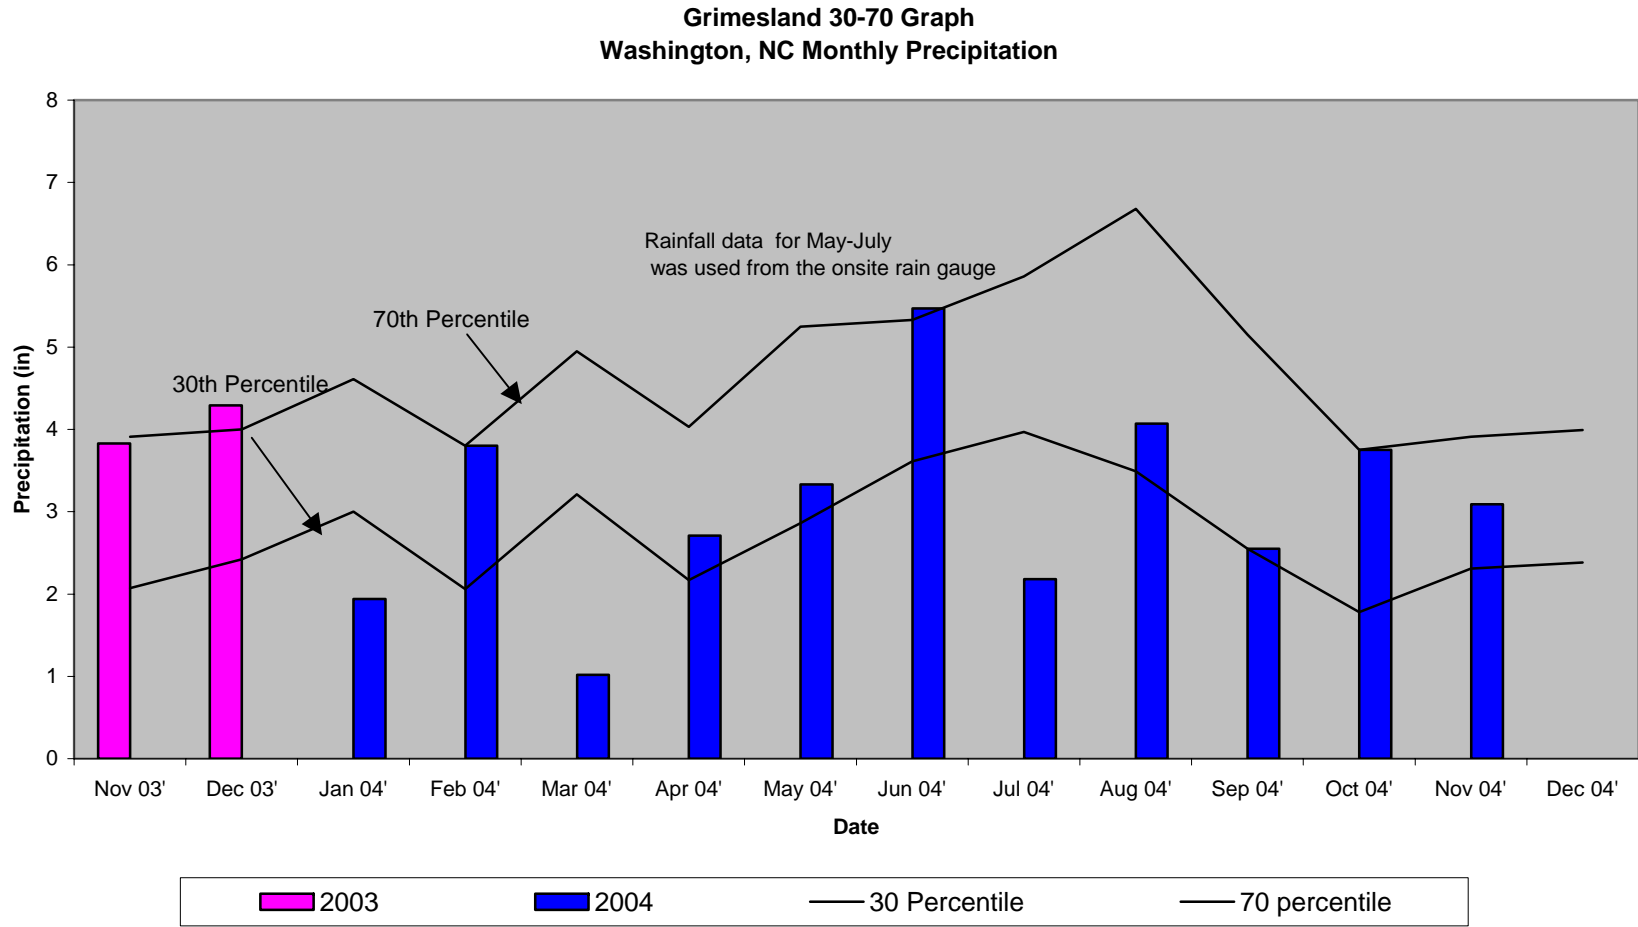
**Figure 4.** Grimesland Phase I 30-70 Percentile Graph, Washington, NC

Figure 4 is a graph of monthly rainfall for the period of November 2003 through November 2004 compared to historical precipitation data (collected between 1973 and 2004) for Washington, North Carolina. The NC State Climate Office provided the rainfall data. The comparison of 2004 rainfall versus historical values gives an indication of how 2004 compares to historical climate conditions.

For the 2004 monitoring year, December (03') and June experienced above average rainfall. The months of January, March, and June recorded below average rainfall for the site. November (03'), February, April, May, August, September, October, and November experienced average rainfall. Overall, 2004 experienced an average rainfall year.

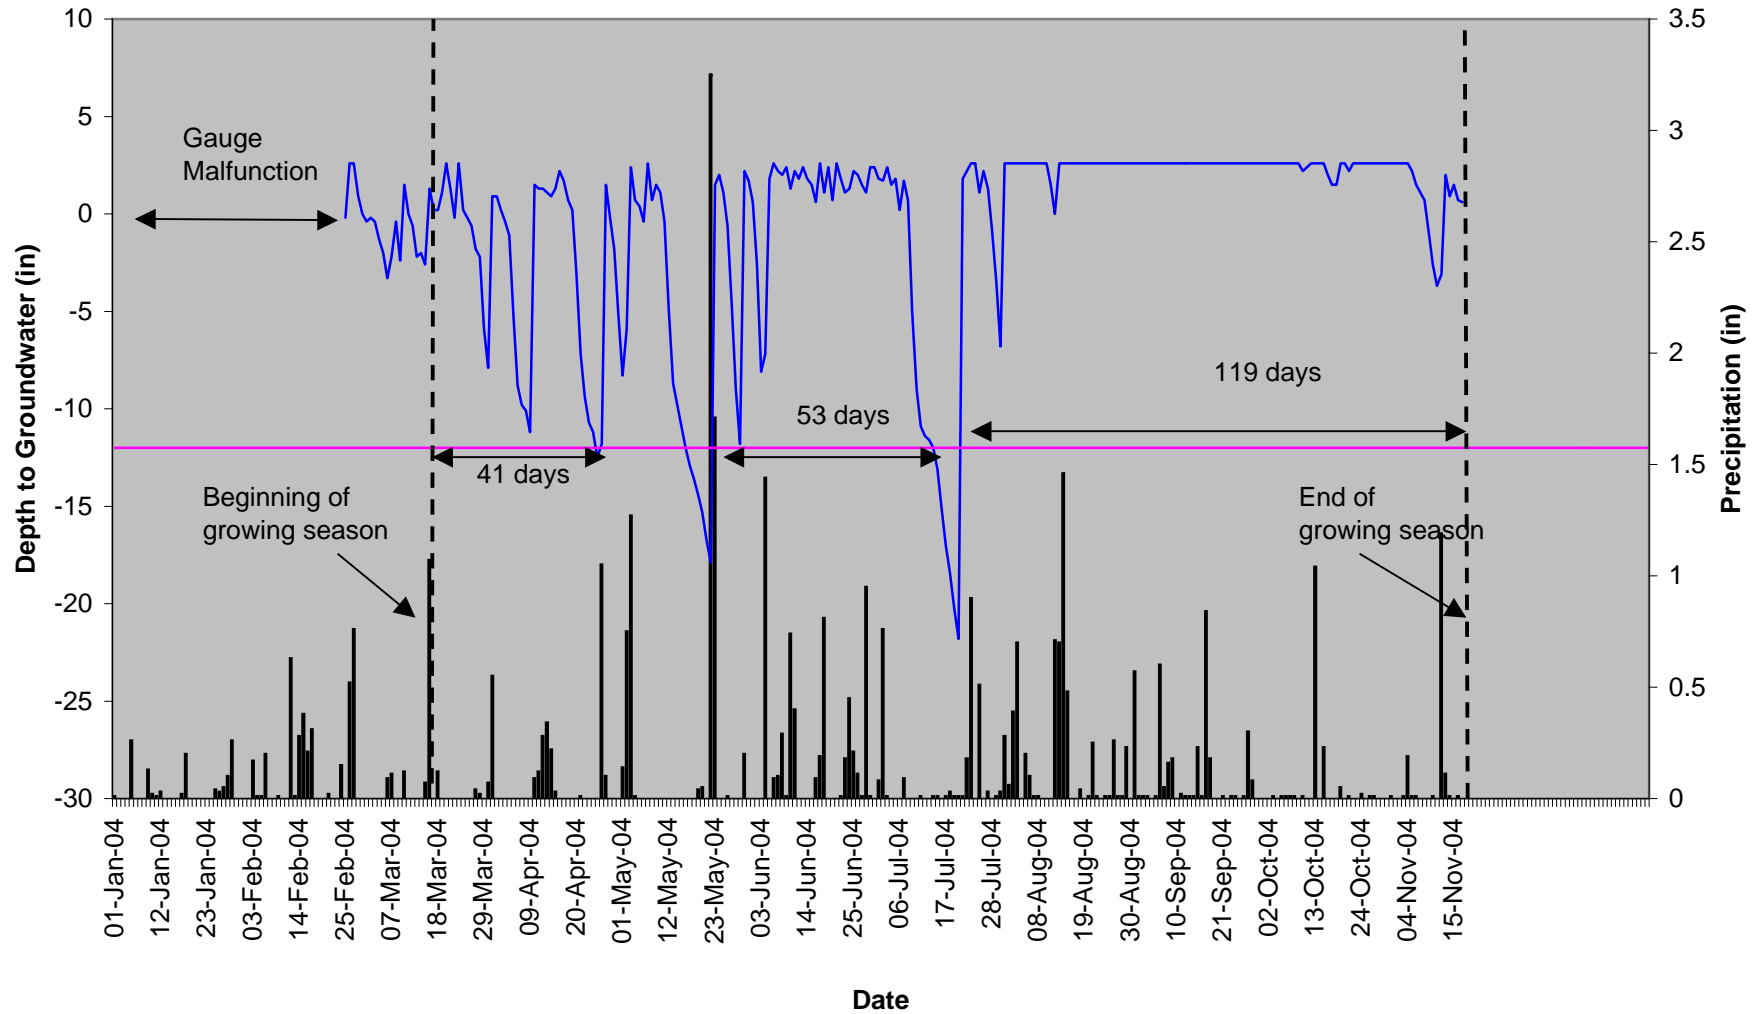
**Grimesland GSP-GW1  
Phase I  
40" Groundwater**

Appendix A contains plots of the groundwater depth at each monitoring gauge location during 2004. In addition to documenting the groundwater level relative to the ground surface (within 12”), these monitoring gauge graphs are designed to show the reaction of the groundwater level to specific rainfall events. The maximum number of consecutive days that the gauge indicates successful hydrology is noted on each graph. Precipitation events recorded by the onsite rain gauge are included on each graph. Plots of the data recorded at each of the two surface water gauges are also included in Appendix A.

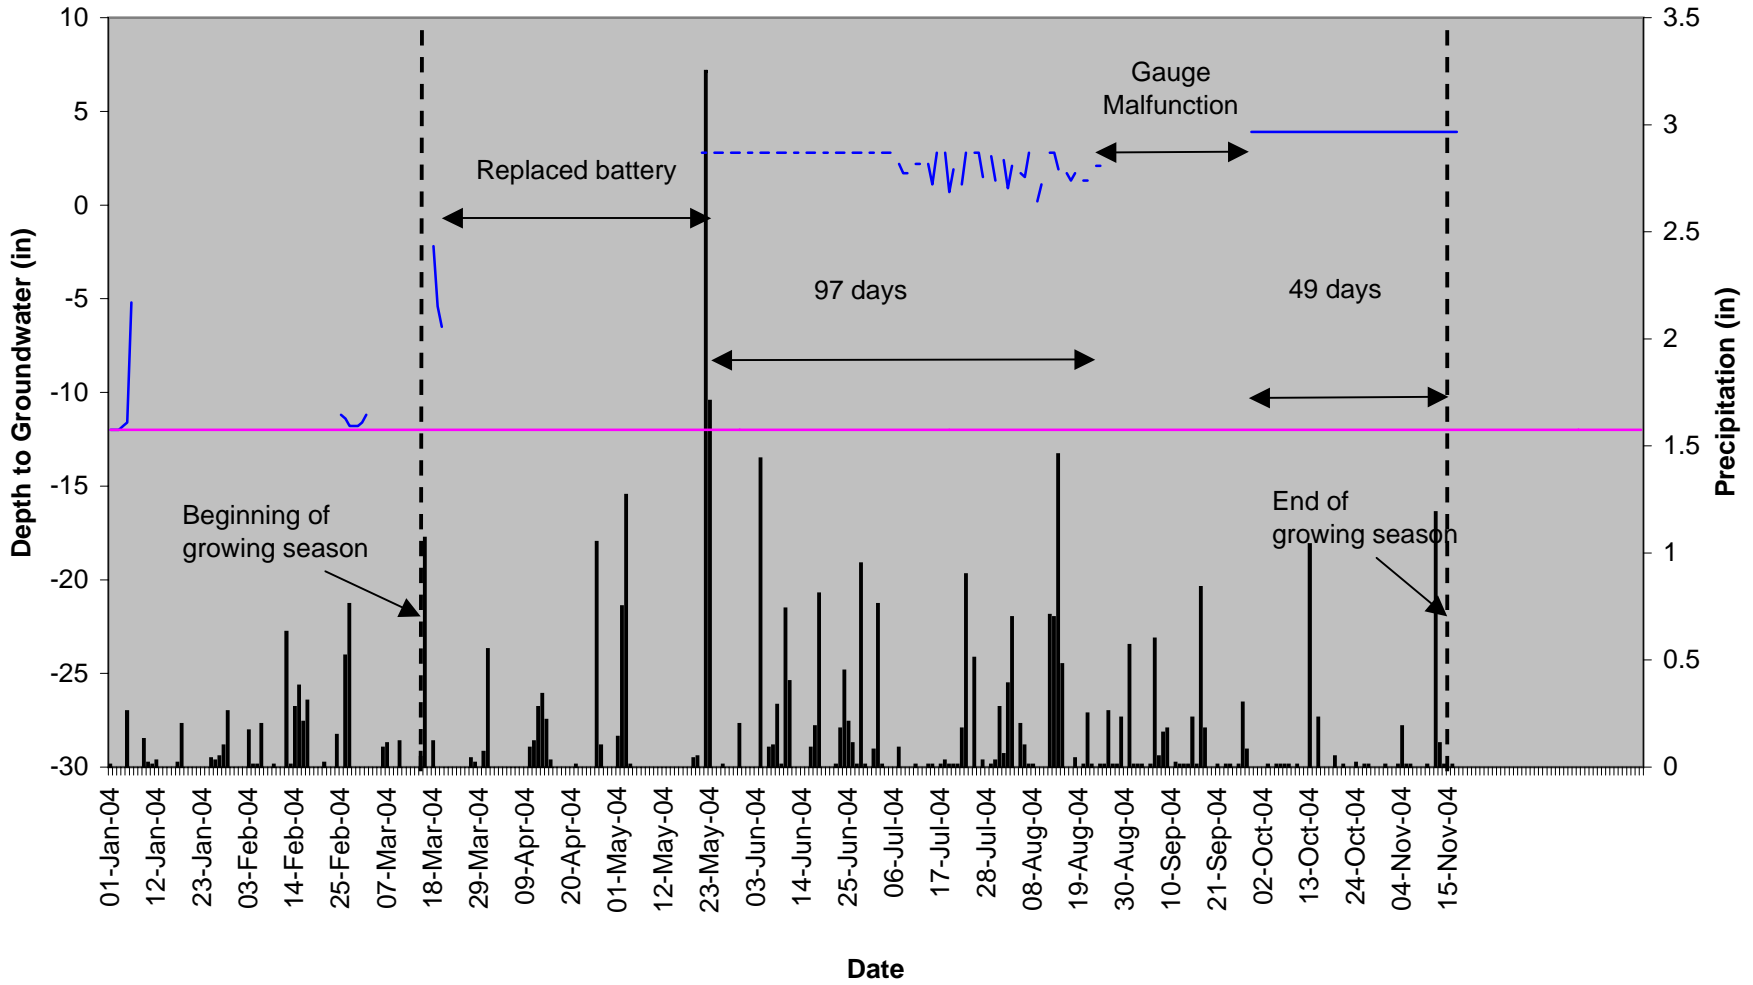
**Grimesland GSP-GW5  
Phase I  
40" Groundwater**

- GW5 was not set to record every 24 hours. This resulted in the gauge recording data every other day.
