# ANNUAL REPORT FOR 2006

**Grimesland Sand Pit Phase I Site**

**EEP Project No. 155**

**Monitoring Year 5 of 5**

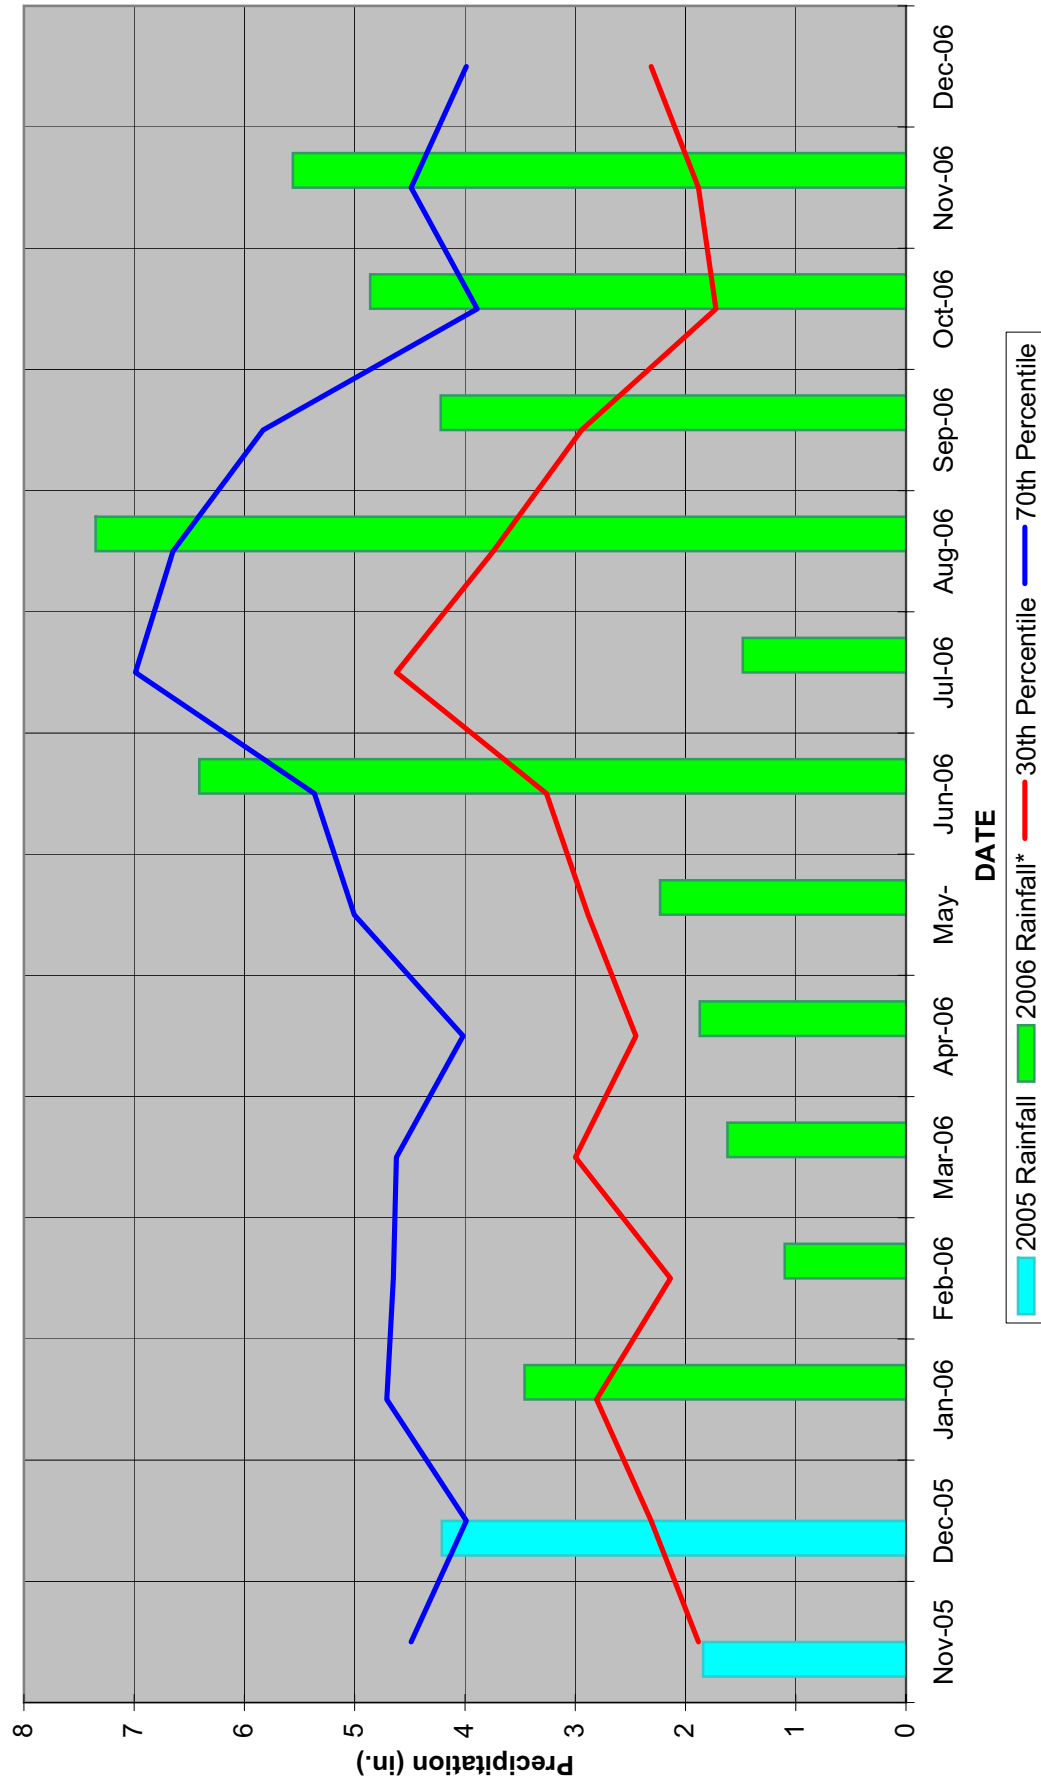
**Figure 4** \*Due to onsite rain gauge malfunction, rain fall data from KPGV - Pitt / Greenville Airport for the months of June, July, and August 2006.

Figure 4 is a graph of monthly rainfall for the period of November 2005 through November 2006 compared to historical precipitation data (collected between 1973 and 2004) for Washington, North Carolina. The onsite rain gauge provided rainfall data and the NC State Climate Office provided the historical rainfall data. The comparison of 2006 rainfall versus historical values gives an indication of how 2006 compares to historical climate conditions.

For the 2006 monitoring year, January and September experienced average rainfall. The months of February, March, April, May, and July recorded below average rainfall while June, August, and November recorded above average rainfall.

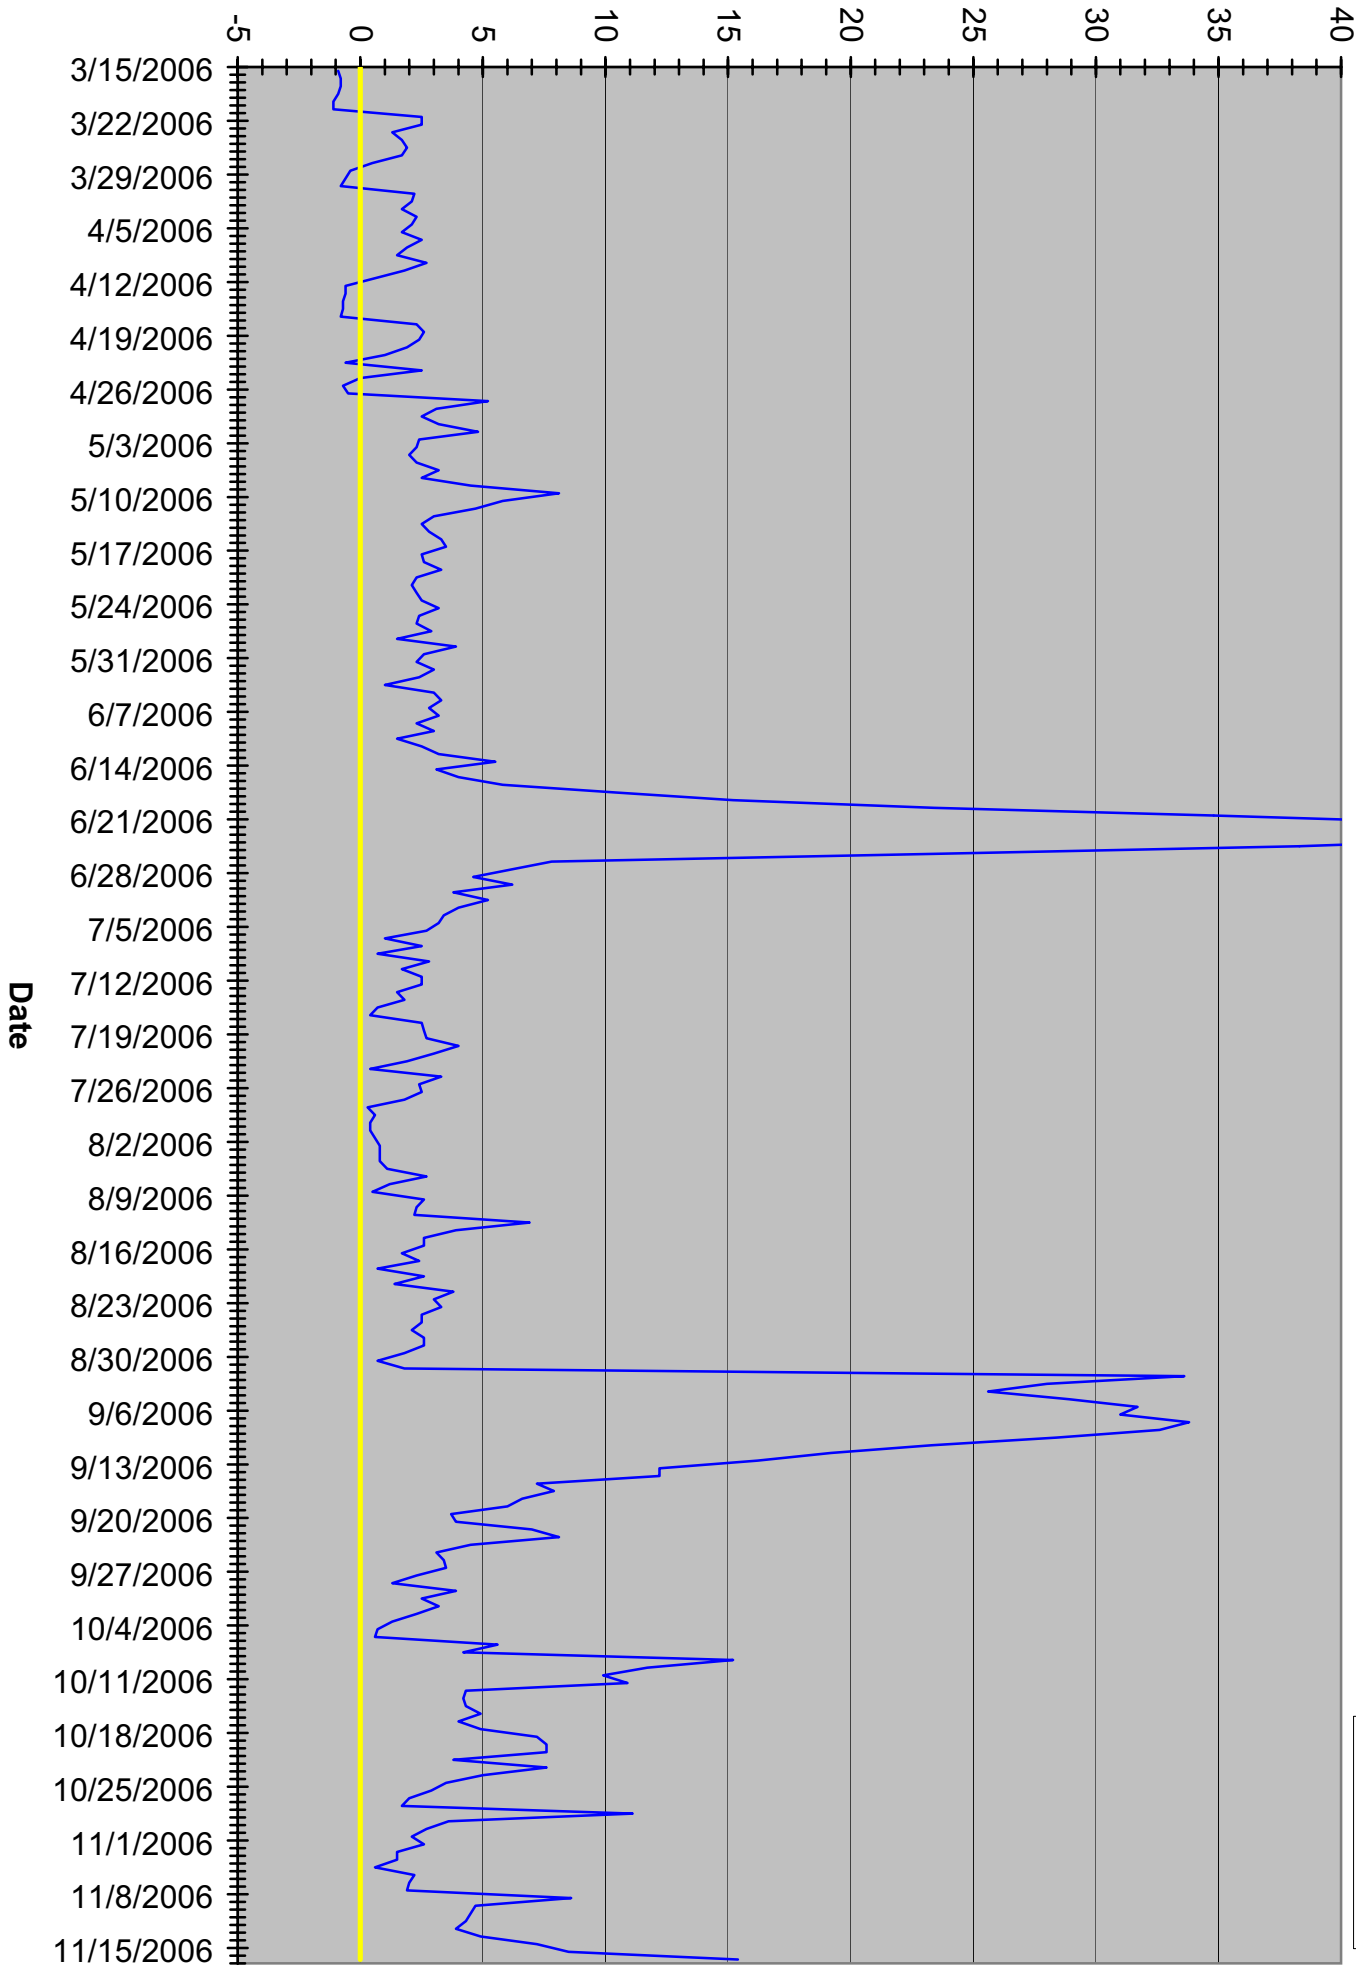
Gauge SG1 (B6514BF)-Surface Water

Appendix A contains plots of the groundwater depth at each monitoring gauge location during 2006. In addition to documenting the groundwater level relative to the ground surface (within 12”), these monitoring gauge graphs are designed to show the reaction of the groundwater level to specific rainfall events. The maximum number of consecutive days that the gauge indicates successful hydrology is noted on each graph. Precipitation events recorded by the onsite rain gauge are included on each graph. Plots of the data recorded at each of the two surface water gauges are also included in Appendix A.
