# ANNUAL MONITORING REPORT FOR 2006 GROVE CREEK

**GROVE CREEK MITIGATION SITE**  
**DUPLIN COUNTY, NORTH CAROLINA**  
**TIP No. R-2204 WM**  
**NCDOT Project No. 8.1241801**  
**(EEP Project Number .00038)**  
2006 Annual Monitoring Report (Year 1 of 5)

April 2007

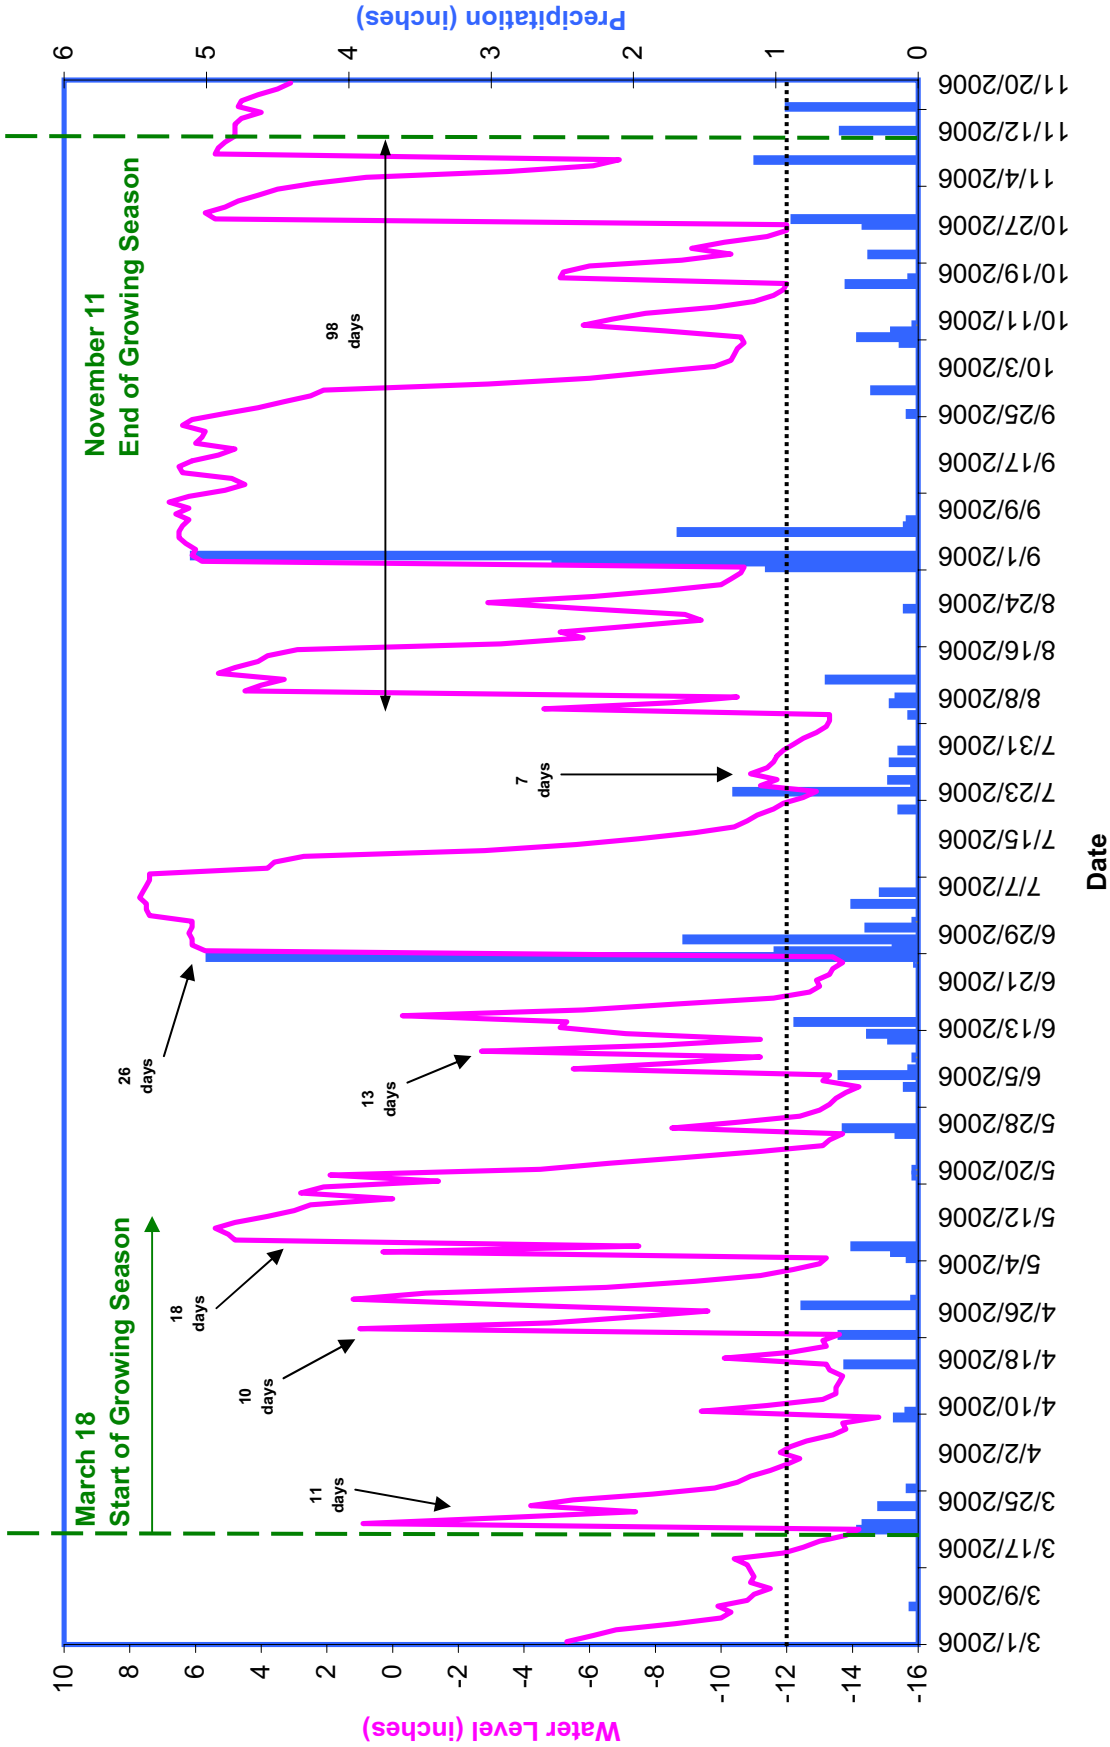
# GW2 (2006 Gauge Data)

Gauge	Success Criteria Achieved/Max Consecutive Days During Growing Season (Percentage)				
	Year 1 (2006)	Year 2 (2007)	Year 3 (2008)	Year 4 (2009)	Year 5 (2010)
GW2	Yes/98 days (41 percent)				
GW3	No/14 days (5.9 percent)				
GW4	Yes/46 days (19.2 percent)				
GW5	Yes/98 days (41 percent)				
GW8	Yes/239 days (100 percent)				
GW9	Yes/239 days (100 percent)				
GW11	Yes/31 days (13.0 percent)				
SG3	Yes/239 days (100 percent)				
SG4	Yes/239 days (100 percent)				
SG5	Yes/239 days (100 percent)				
SG6	Yes/239 days (100 percent)

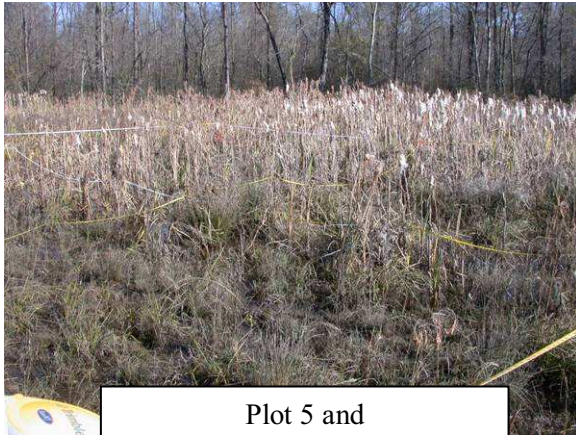
Plot 5 and  
Problem Area Photo 1

Based on the number of stems counted, the average plot density monitored at this Site is greater than 320 stems per acre and is considered successful. The average plot density has been measured at 497 stems per acre, or 12 stems per plot for 2006 (year 1) monitoring. The dominant species identified at the Site were bald cypress (*Taxodium distichum*) and water oak (*Quercus nigra*). Five out of the seven individual vegetation plots were well above the success criteria with 567 to 729 planted stems per acre. Vegetation plot 7 was low with 283 planted stems per acre as the result of high water levels; the only surviving species was bald cypress. Plot 5 had no planted stem survival.

Vegetation problem areas within the Site are depicted on Figure 4. Several areas of poor planted stem survival were observed throughout the Site during the year 1 (2006) monitoring, especially near vegetation plot 5. Poor survival in some areas may have resulted from drought during planting followed by excessive inundation.

Vegetation problem areas within the Site included several areas of poor planted stem survival, especially near vegetation plot 5. Poor survival may have resulted from drought during planting followed by excessive inundation. These areas will continue to be monitored.
