# ANNUAL MONITORING REPORT FOR 2008 GROVE CREEK

**GROVE CREEK MITIGATION SITE**  
**DUPLIN COUNTY, NORTH CAROLINA**  
**TIP No. R-2204 WM**  
**NCDOT Project No. 8.1241801**  
**(EEP Project Number .00038)**  
2008 Annual Monitoring Report (Year 3 of 5)

December 2008

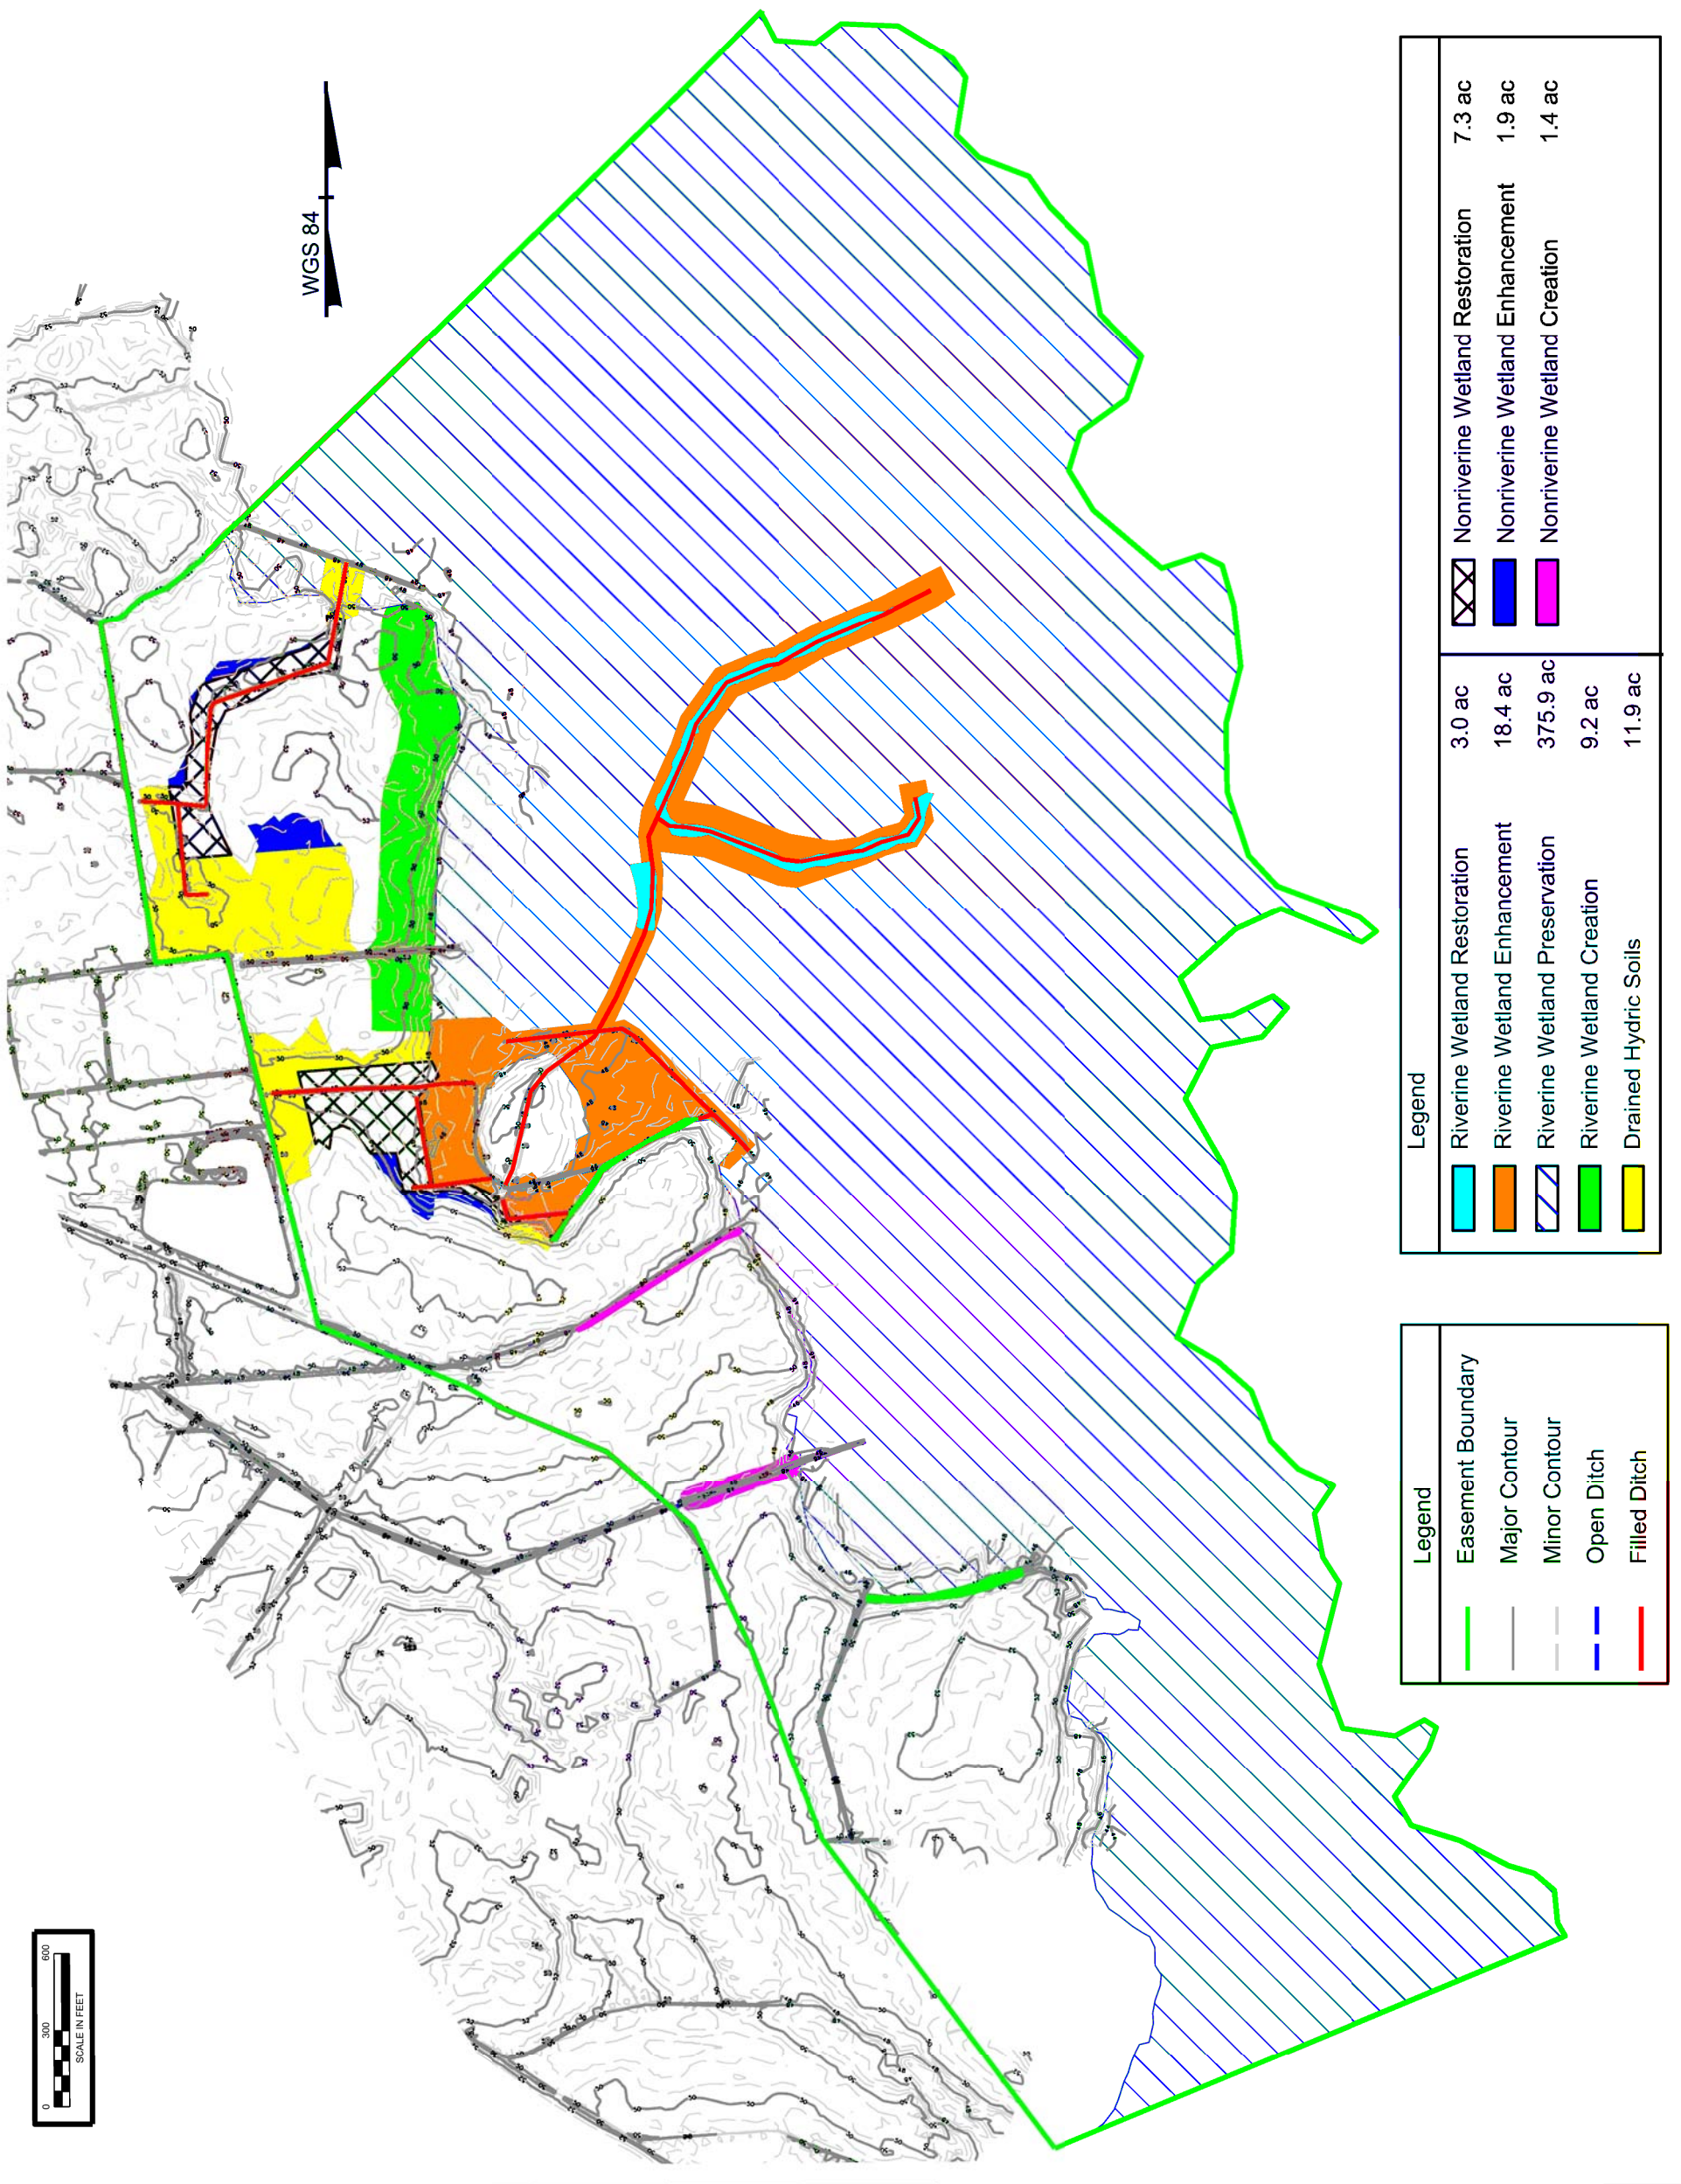
FIGURE NO.  
**2**

Wetland restoration and creation at the Site entailed 1) ditch cleaning prior to backfill, 2) impervious ditch plug construction, 3) ditch/canal backfilling, and 4) removal of fill material from wetlands.

Title:  
**As-Built  
 Wetland Restoration  
 Plan**

According to the January 2004 Mitigation Plan, the primary goals of the project include 1) maximizing the area returned to historic wetland function; 2) expand, enhance, and preserve 549 acres of the Northeast Cape Fear River riparian ecosystem; 3) protect the Site within a conservation easement in perpetuity; 4) provide valuable habitat to a diverse assemblage of flora and fauna; 5) serve as a wildlife corridor along the Northeast Cape Fear river; and 6) provide numerous wetland values including water storage, shoreline stabilization, pollutant removal, aquatic/wildlife habitat, recreation, and education. Project structures and objectives are summarized in Table 1 and depicted in Figure 2.

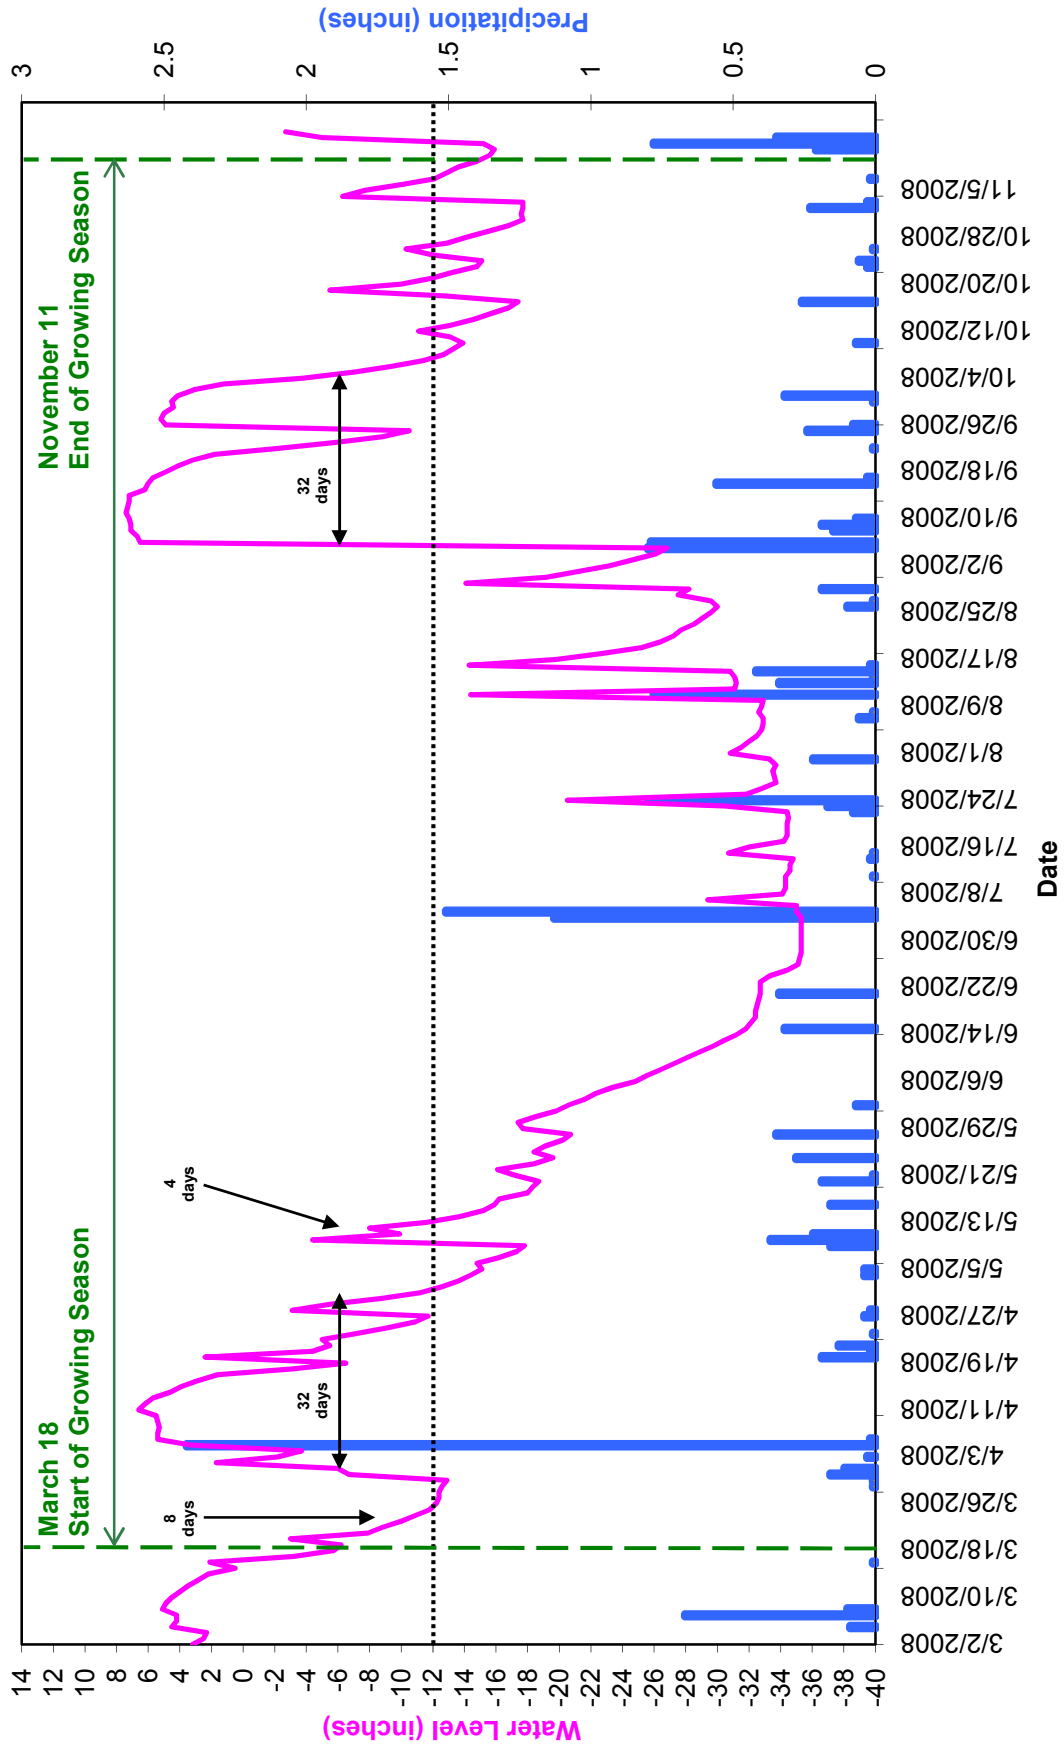
## Grove Creek Ground Water Gauge 2 Year 3 (2008 Data)

Eleven gauges were maintained and monitored for the year 3 (2008) growing season. Groundwater hydrology within 12 inches of the soil surface occurred for greater than 12.5 percent of the growing season at all gauges except Gauge GW3, which is located along an upland margin. Table 2 summarizes success criteria achievement for Site gauges.
