ANNUAL MONITORING REPORT FOR 2010 GROVE CREEK

GROVE CREEK MITIGATION SITE
DUPLIN COUNTY, NORTH CAROLINA
TIP No. R-2204 WM
NCDOT Project No. 8.1241801
(EEP Project Number .00038)
2010 Annual Monitoring Report (Year 5 of 5)

November 2010

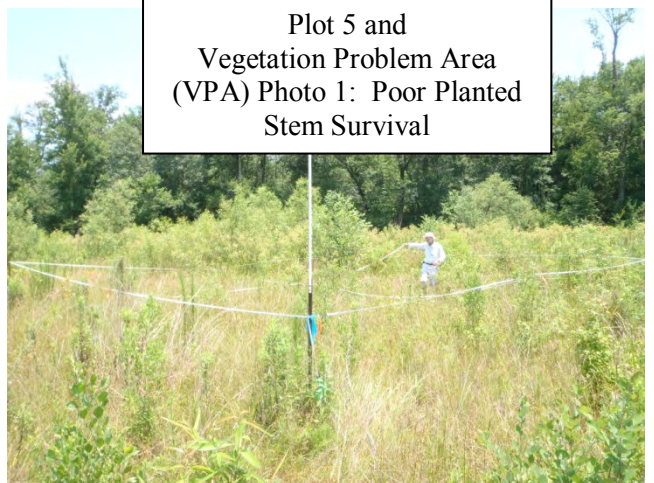
Plot 5 and
Vegetation Problem Area
(VPA) Photo 1: Poor Planted
Stem Survival

Problem areas within the Site are depicted on Figure 5 with pictures included in Appendix B. Poor planted stem survival has been observed in the vicinity of vegetation Plots 5 and 7 and surface water gauges (SG3-6). Natural recruits are colonizing these areas and aquatic herbaceous species proliferated during the year 5 (2010) monitoring season including cat tail (*Typha latifolia*), woolgrass (*Scirpus cyperinus*), and bigpod sesbania (*Sesbania herbacea*). Poor survival of planted stems may have resulted from drought during planting followed by excessive inundation. Other problems within the Site include beaver activity, an area of poor herbaceous growth, and continual mowing of access roads and a small patch for deer hunting as well as four wheeler tracks throughout the Site.

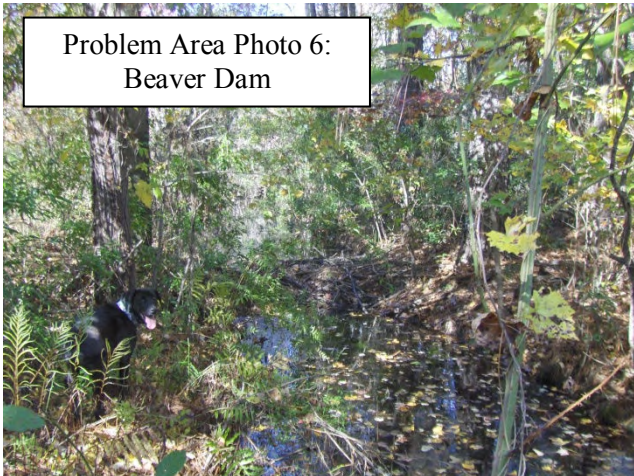
Problem Area Photo 6:
 Beaver Dam

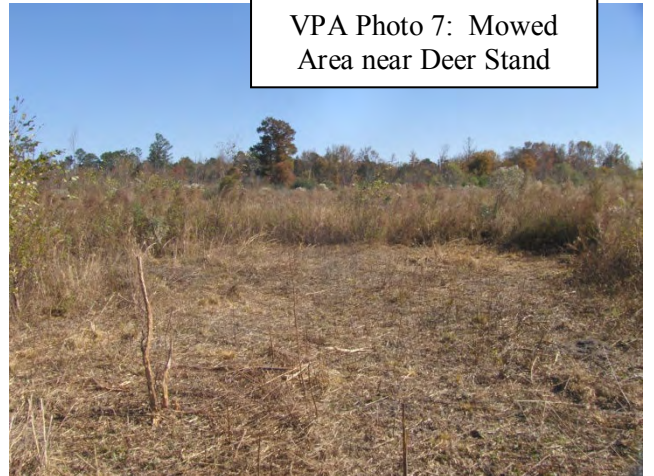
VPA Photo 7: Mowed
 Area near Deer Stand
