**HALL PROPERTY
DETAILED STREAM AND WETLAND RESTORATION PLAN
RICHMOND COUNTY, NORTH CAROLINA**

**North Carolina Department of Environment and Natural Resources
Ecosystem Enhancement Program
Raleigh, North Carolina**

**EcoScience Corporation
1101 Haynes Street, Suite 101
Raleigh, North Carolina 27604**

August 2004

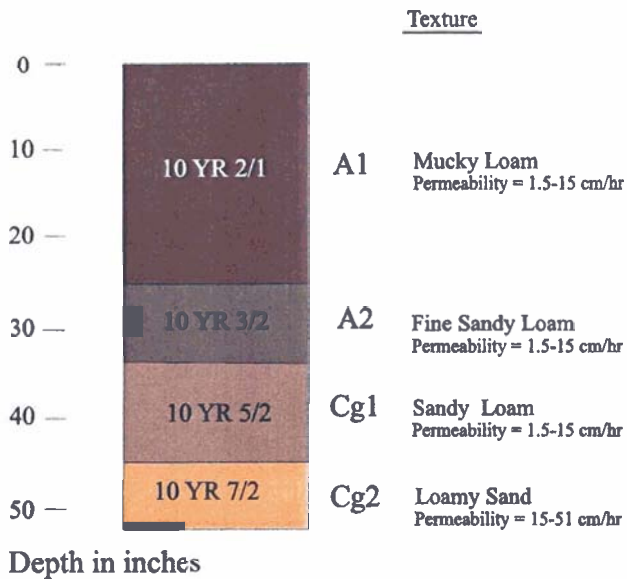
Johnston Mucky Loam

Typical Pedon as Depicted in NRCS 1999
Soil Survey of Richmond County, North Carolina

Based on NRCS mapping, the Site is underlain by Johnston mucky loam (*Cumulic Humaquepts*) and Ailey loamy sand (*Arenic Kanhapludults*). The Johnston series is characterized by very deep, very poorly drained soils with moderately rapid permeability found on river and stream valleys of the Sandhills. This series is frequently flooded with a seasonal high water table ranging from 1.0 foot above to 1.5 feet below the soil surface. The Johnston series is considered hydric (Type A) in Richmond County (NRCS 1997). The Ailey series is characterized by very deep, well-drained soils with slow permeability found on broad ridges and side slopes of uplands in the Sandhills. The seasonal high water table occurs at a depth greater than 6 feet. The Ailey series is non-hydric with the potential for hydric inclusions (Type B) in Richmond County (NRCS 1997).

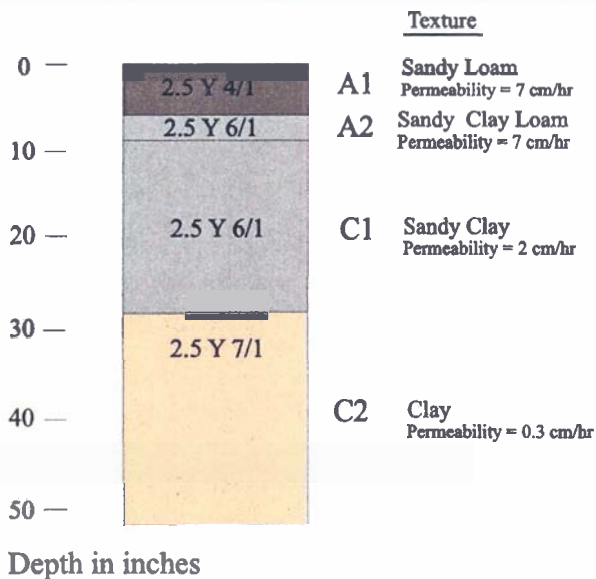
Johnston

Hydic Floodplain Soils Adjacent to Downstream Channel
as Observed in the Field

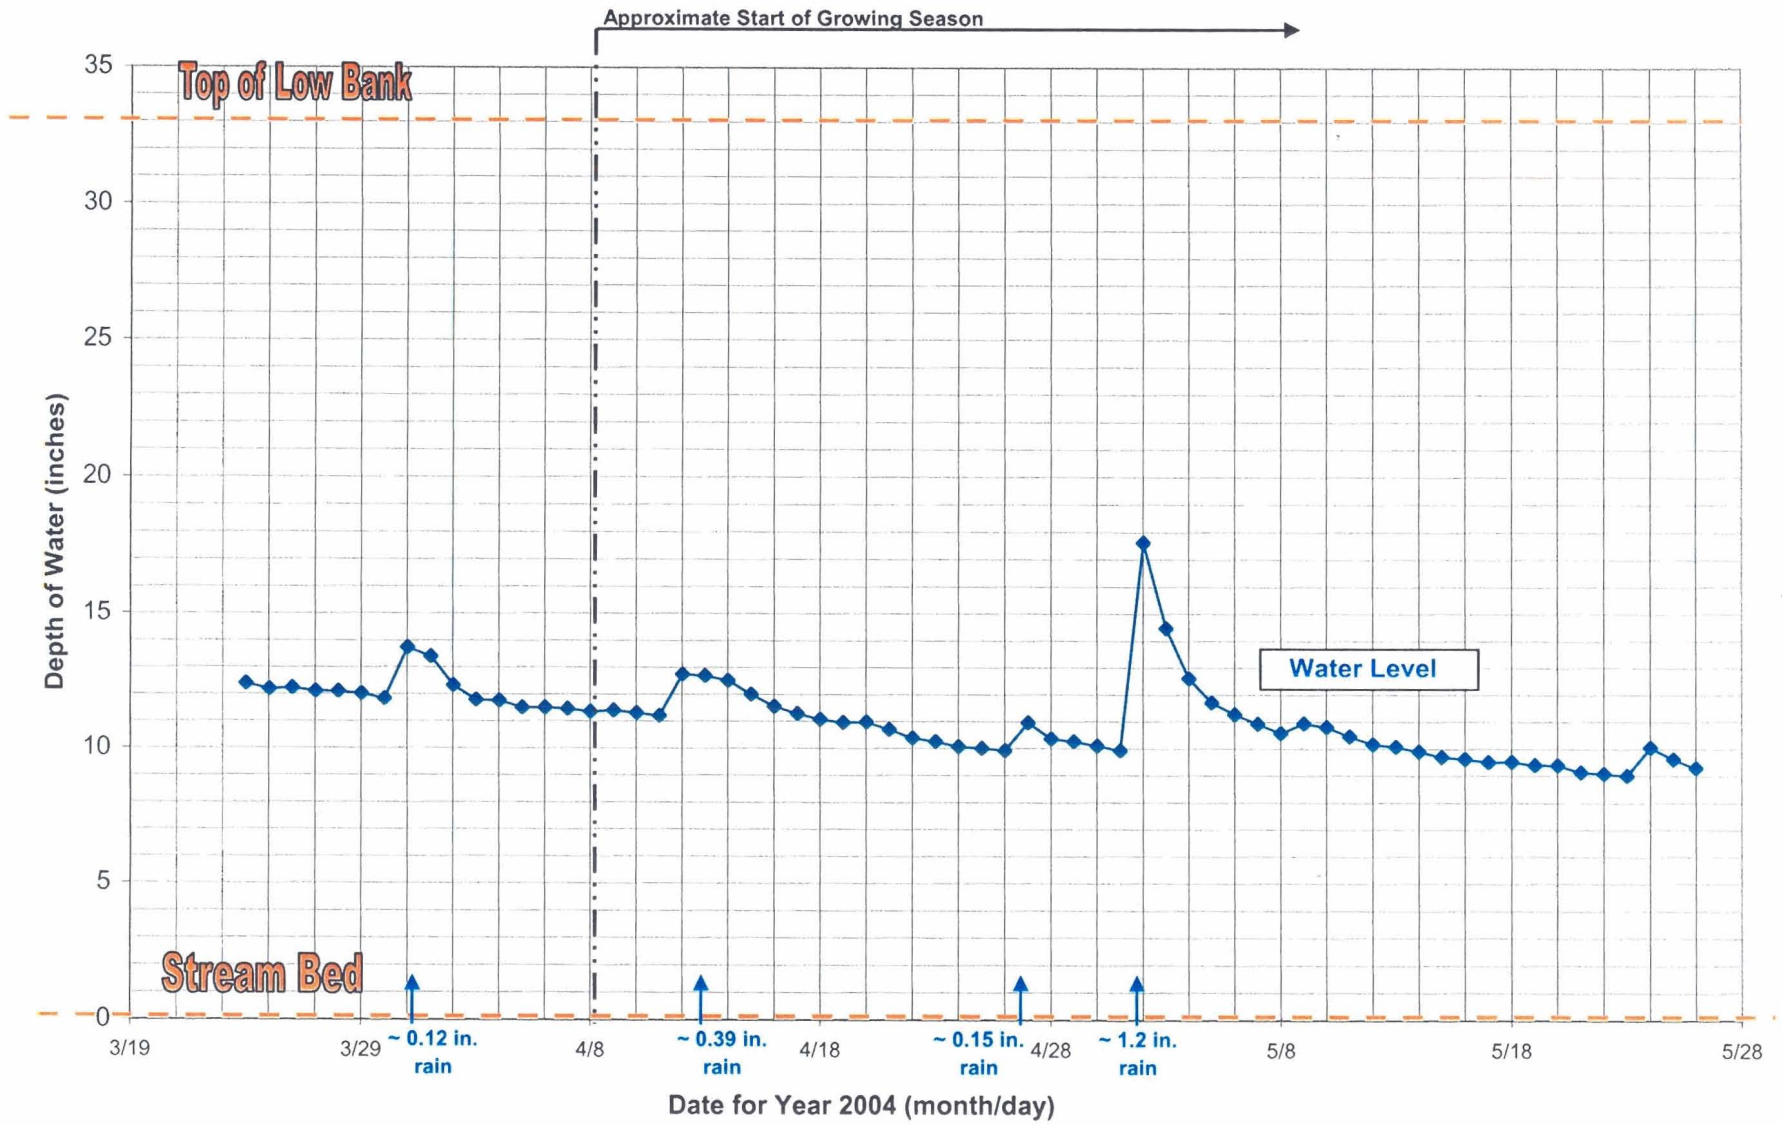
On-Site Stream Gauge Data

Date	Depth of Water (inches)	Date	Depth of Water (inches)
23-Mar-2004	1	12-May-2004	10.16
24-Mar-2004	12.4	13-May-2004	10.07
25-Mar-2004	12.2	14-May-2004	9.89
26-Mar-2004	12.23	15-May-2004	9.7
27-Mar-2004	12.12	16-May-2004	9.62
28-Mar-2004	12.1	17-May-2004	9.51
29-Mar-2004	12.02	18-May-2004	9.52
30-Mar-2004	11.84	19-May-2004	9.4
31-Mar-2004	13.74	20-May-2004	9.39
01-Apr-2004	13.4	21-May-2004	9.13
02-Apr-2004	12.33	22-May-2004	9.08
03-Apr-2004	11.79	23-May-2004	9.01
04-Apr-2004	11.76	24-May-2004	10.05
05-Apr-2004	11.51	25-May-2004	9.61
06-Apr-2004	11.51	26-May-2004	9.29
07-Apr-2004	11.46		
08-Apr-2004	11.36		
09-Apr-2004	11.4		
10-Apr-2004	11.31		
11-Apr-2004	11.2		
12-Apr-2004	12.75		
13-Apr-2004	12.69		
14-Apr-2004	12.51		
15-Apr-2004	12		
16-Apr-2004	11.55		
17-Apr-2004	11.28		
18-Apr-2004	11.08		
19-Apr-2004	10.96		
20-Apr-2004	10.98		
21-Apr-2004	10.7		
22-Apr-2004	10.39		
23-Apr-2004	10.26		
24-Apr-2004	10.07		
25-Apr-2004	10.01
