Hammocks Beach Shoreline Stabilization and  
Wetland Restoration Project  
Hammocks Beach State Park  
Swansboro, Onslow County, North Carolina

2003 Annual Monitoring Report

**Hammocks Beach Shoreline Stabilization and Wetland Restoration Site  
Fall 2003 Monitoring Summary**

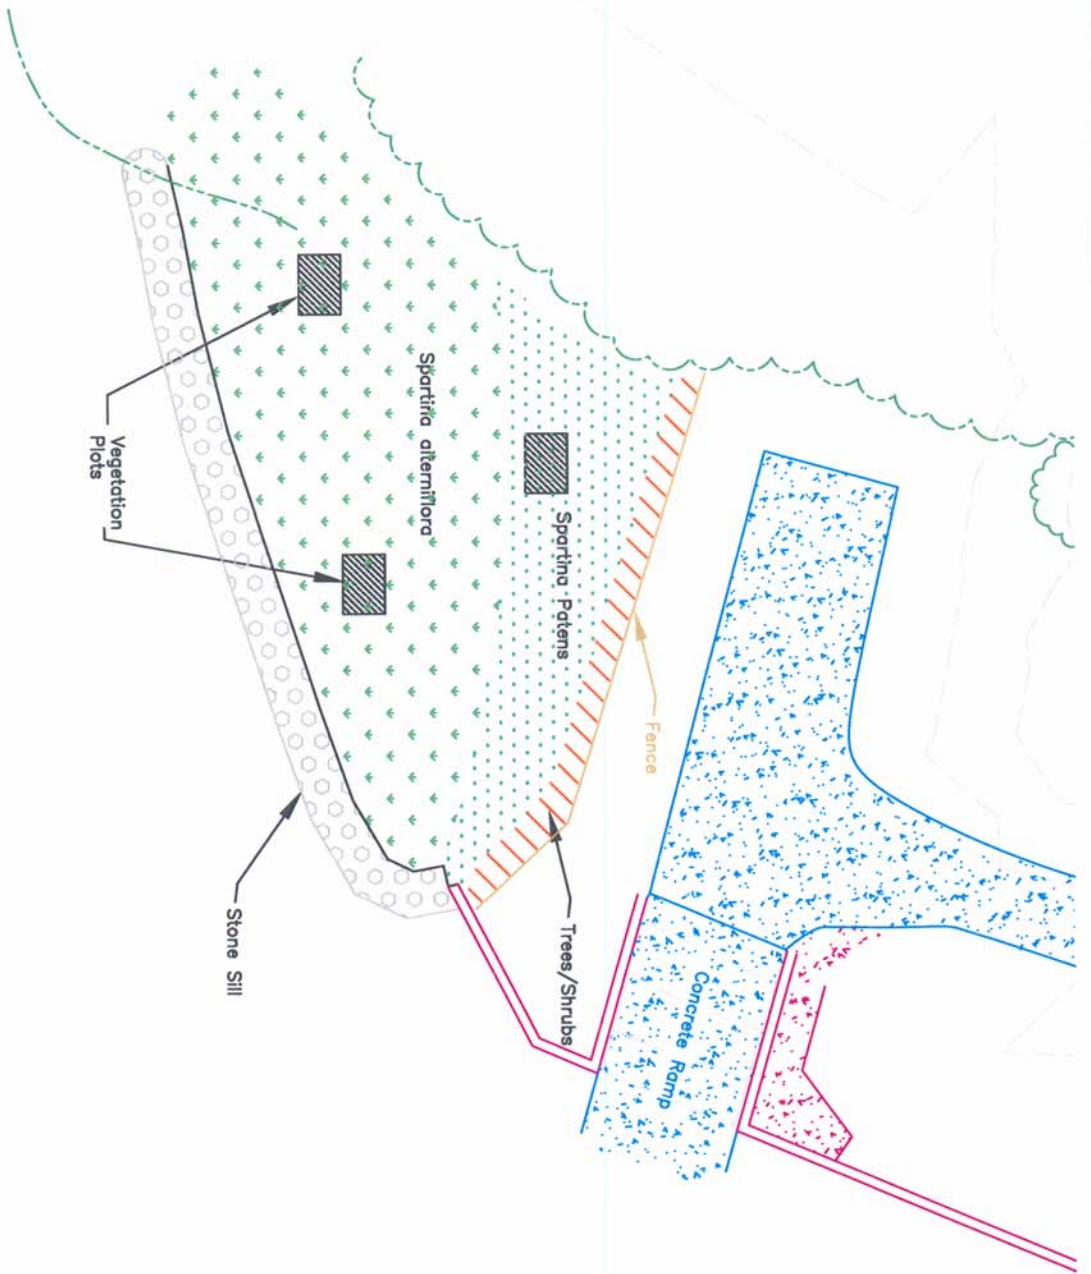
# Monitoring Locations Map

West Side — Ramp Area  
Hammocks Beach  
Shoreline Stabilization and Wetlands Restoration Project

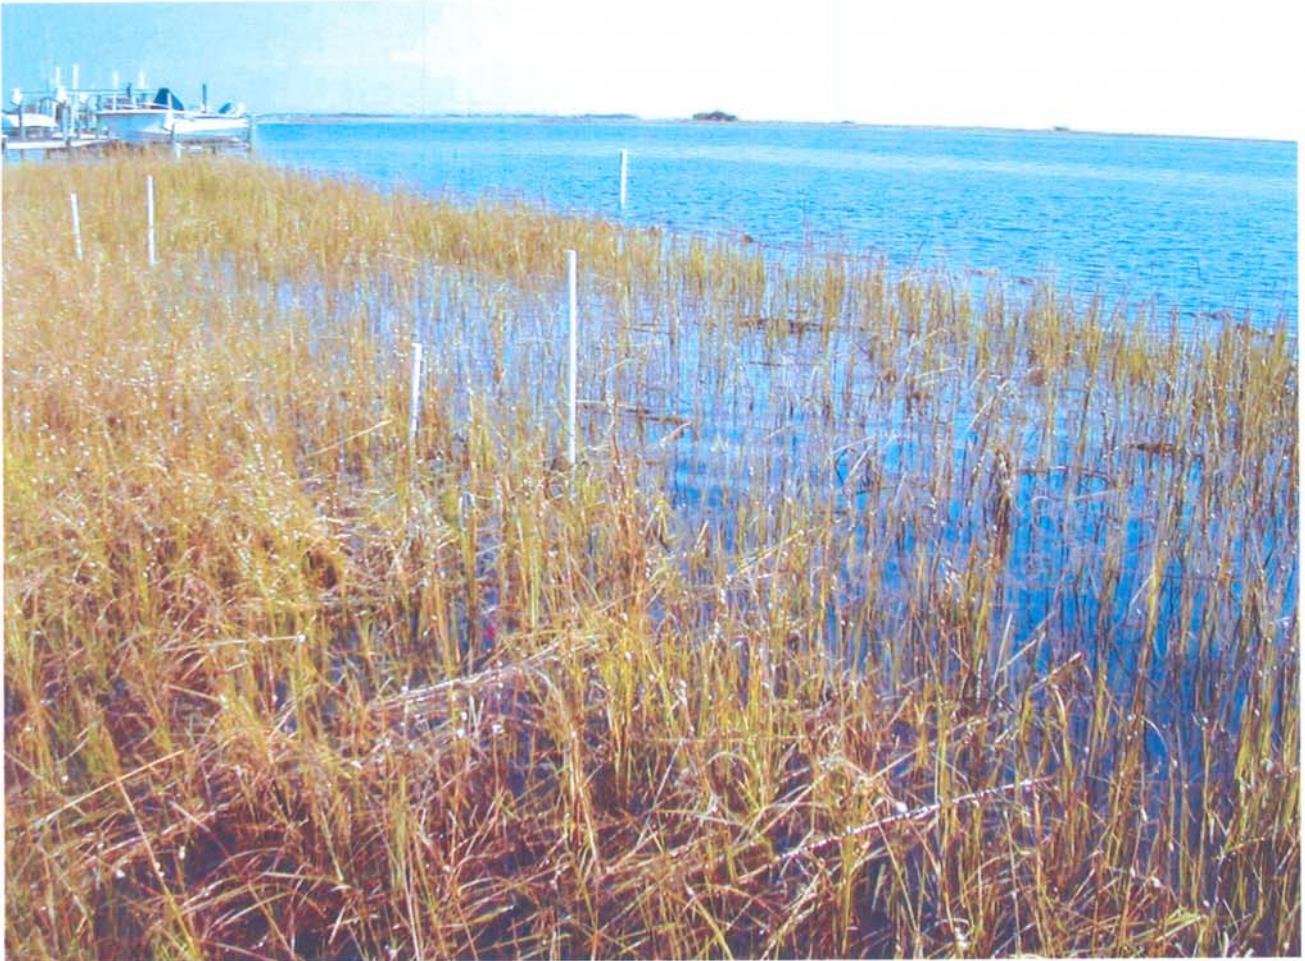
Vegetation plots in the lower marsh areas revealed a healthy stand of *Spartina alterniflora* (Smooth Cordgrass). Several other volunteer plant species were found in the plots including Olneg’s three square and Glaswort. Total stem counts for *S. alterniflora* ranged from 98 to 149 stems for an average of 130 stems/plot. This results in an impressive increase in plant density when compared to the original planting density of 2.5 stems/plot. Olneg’s three square and other volunteers ranged from 0-25 stems/plot with an average of 10 stems/plot. The plots show a population comprised of an average of 92% of the planted species and 8% volunteer species. *S. alterniflora* ranged from 2-3.5 feet tall, with a few stems rising to 5 feet. covered between 40-70% of the surface area of the plots with an average of 50% coverage. Olneg’s three square comprised about 1% coverage in the plots where it was found.

Photo 1. Picnic Shelter side. Lower marsh.

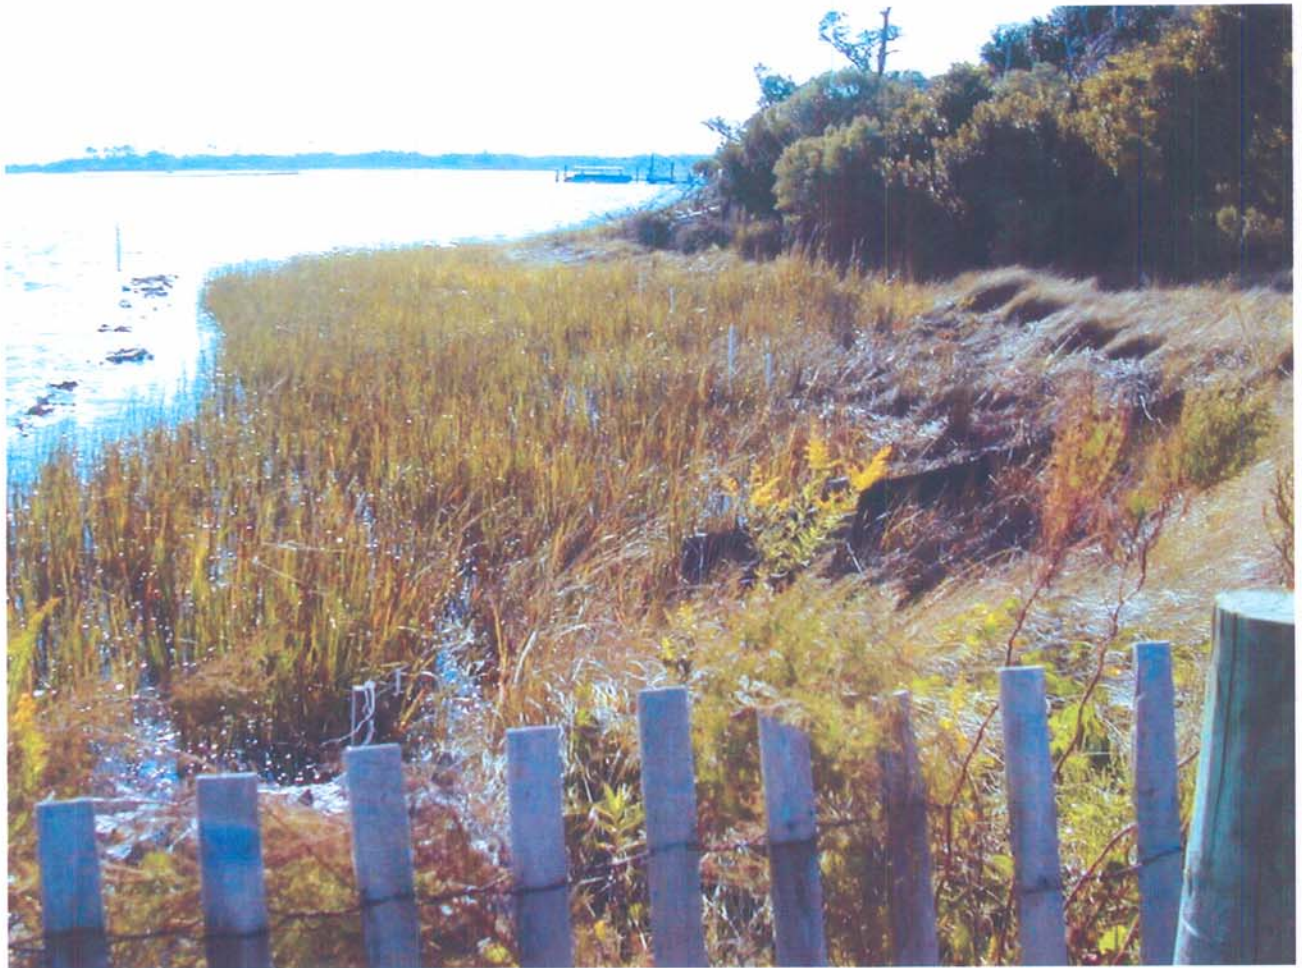
Transitional wetland/buffer areas were planted with *Ilex vomitoria* (Youpon Holly), *Quercus virginiana* (Live Oak), *Ilex glabra* (Inkberry), and *Myrica cerifera* (Wax Myrtle). These trees and shrubs were found to be growing well and very few of the planted species were not found to be alive. Wax Myrtle is showing robust growth and has propogated around the site in several places. The fringe area on the boat ramp side is healthy, but has only exhibited moderate growth

Photo 2. Boat ramp side marsh.

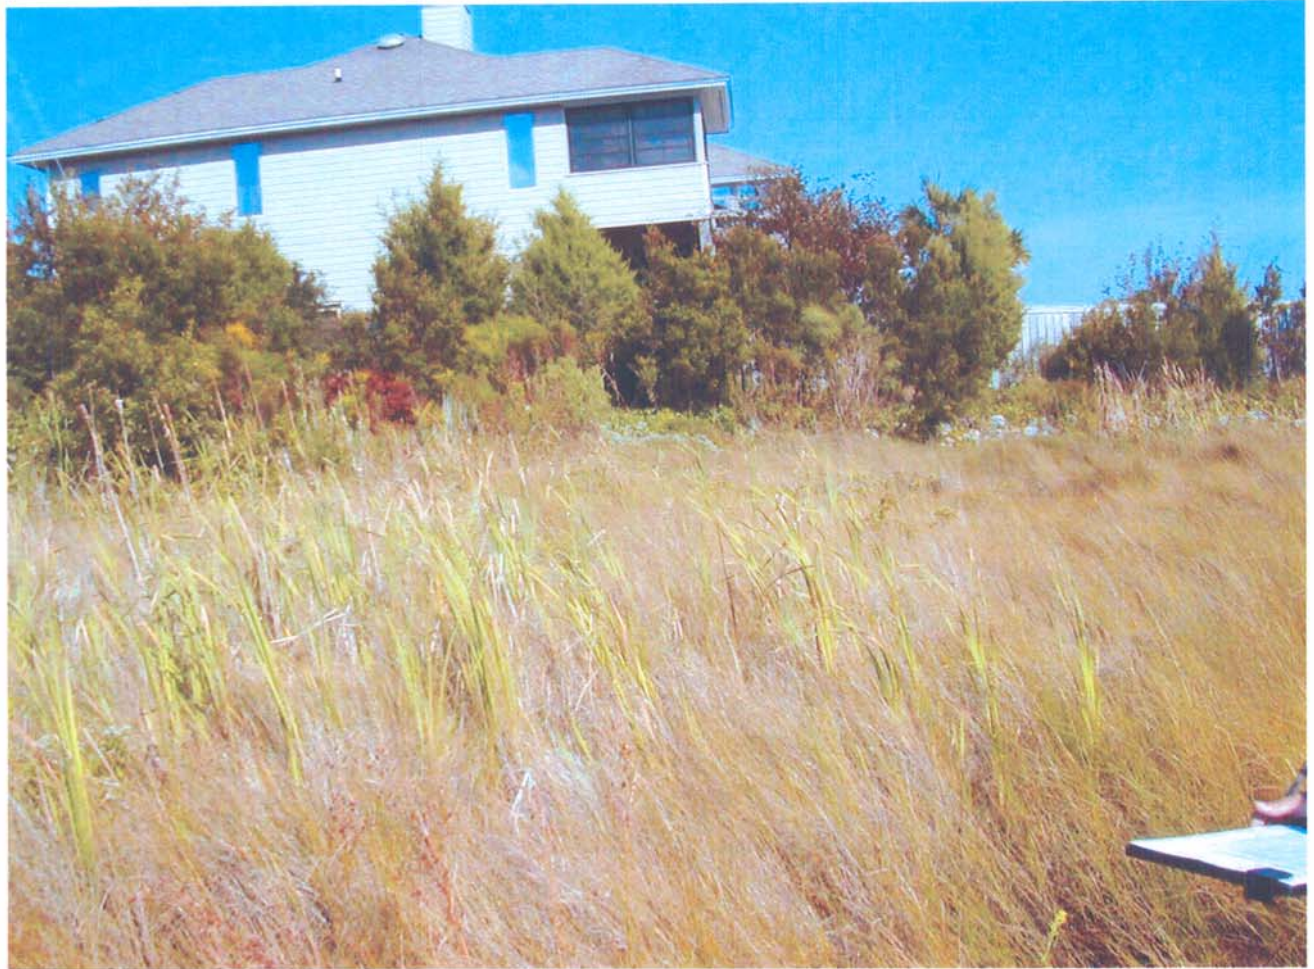
Upper marsh plots revealed extremely dense stands of *Spartina patens* (Saltmeadow Cordgrass). The number of stems in each plot were too numerous to count. Vegetation in these plots covered 100% of the ground surface beneath them. *S. patens* stems ranged from 2-4 feet in height. Several volunteer species were observed in upper marsh areas. Species such as cattails, morning glory, pennywort, and some juncus were found.

Photo 3. Picnic Shelter side. Upper marsh

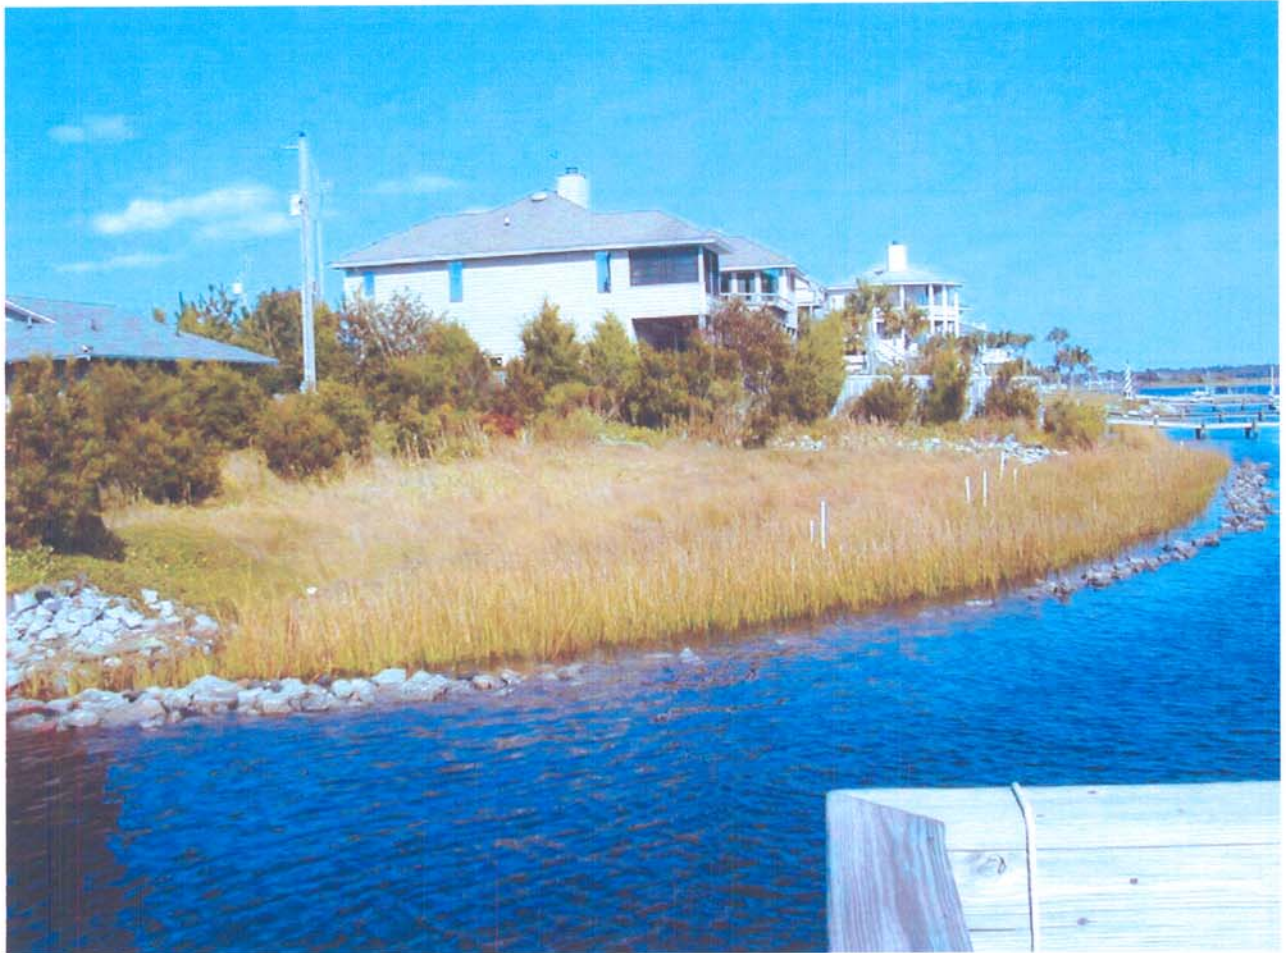
Photo 4. Picnic Shelter side. Marsh overview.

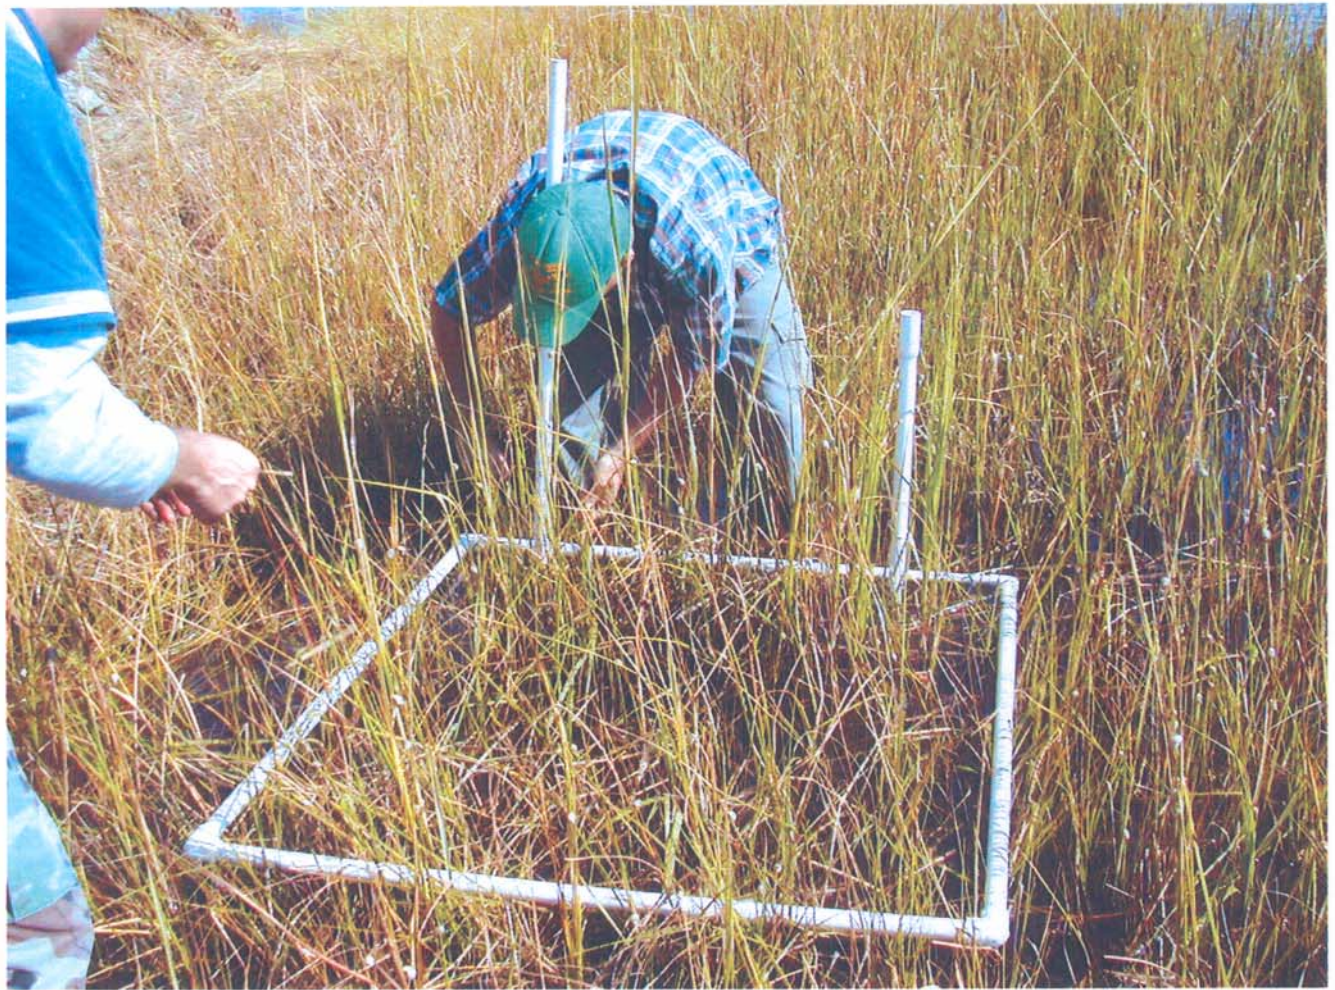
Photo 5. Stem count plot. Lower marsh.
