Hanging Rock Stream Restoration 2005 Monitoring Report Monitoring Year Two

Ecosystem Enhancement Program Project Number 165

Prepared by: EcoLogic Associates, P.C.
4321-A S. Elm-Eugene St.
Greensboro, NC 27406

Submitted: October, 2006 (Rev 1)

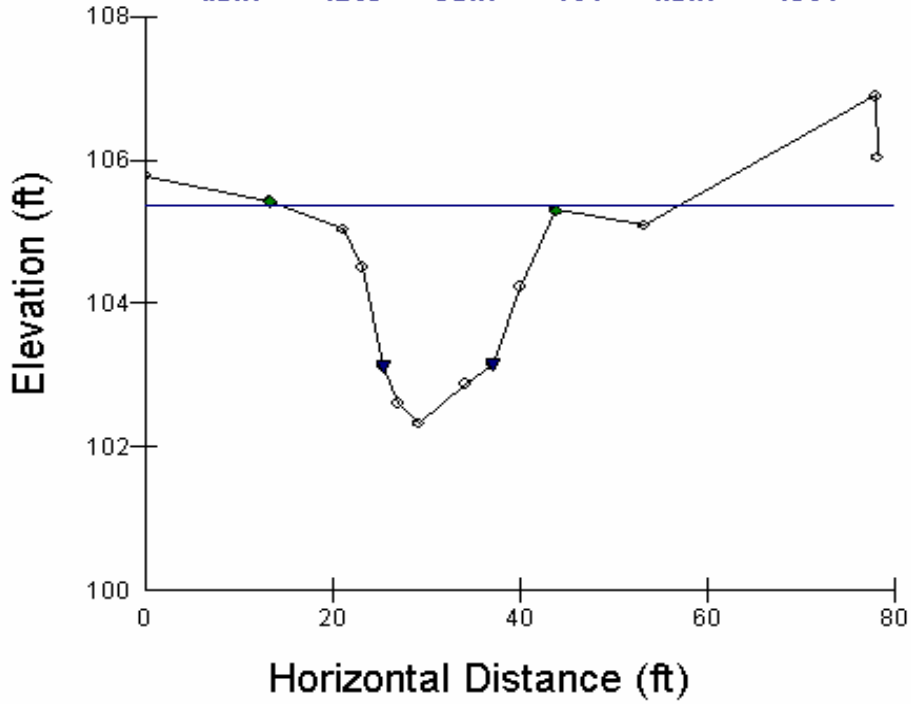
River Name: Watauga River
 Reach Name: Hanging Rock Creek
 Cross Section Name: HRxs1
 Survey Date: 09/05/05

○ Ground Points ◆ Bankfull Indicators ▼ Water Surface Points

Wbkf = 42.5 Dbkf = 1.1 Abkf = 46.1

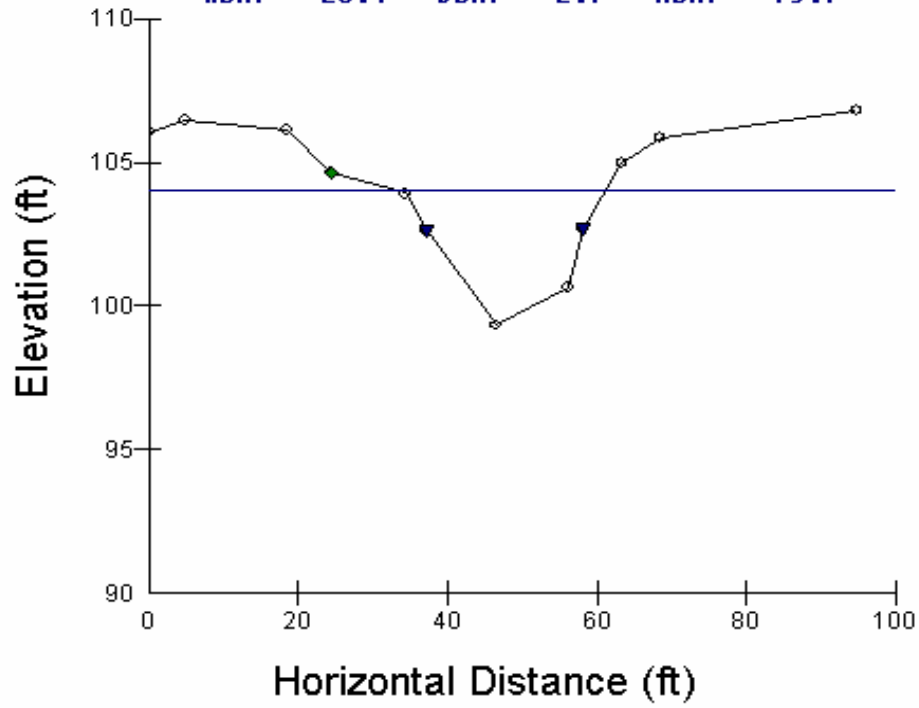
River Name: Watauga River
 Reach Name: Hanging Rock Creek
 Cross Section Name: HRxs2
 Survey Date: 09/05/05

◇ Ground Points ◆ Bankfull Indicators ▼ Water Surface Points

Wbkf = 28.1 Dbkf = 2.7 Abkf = 75.7

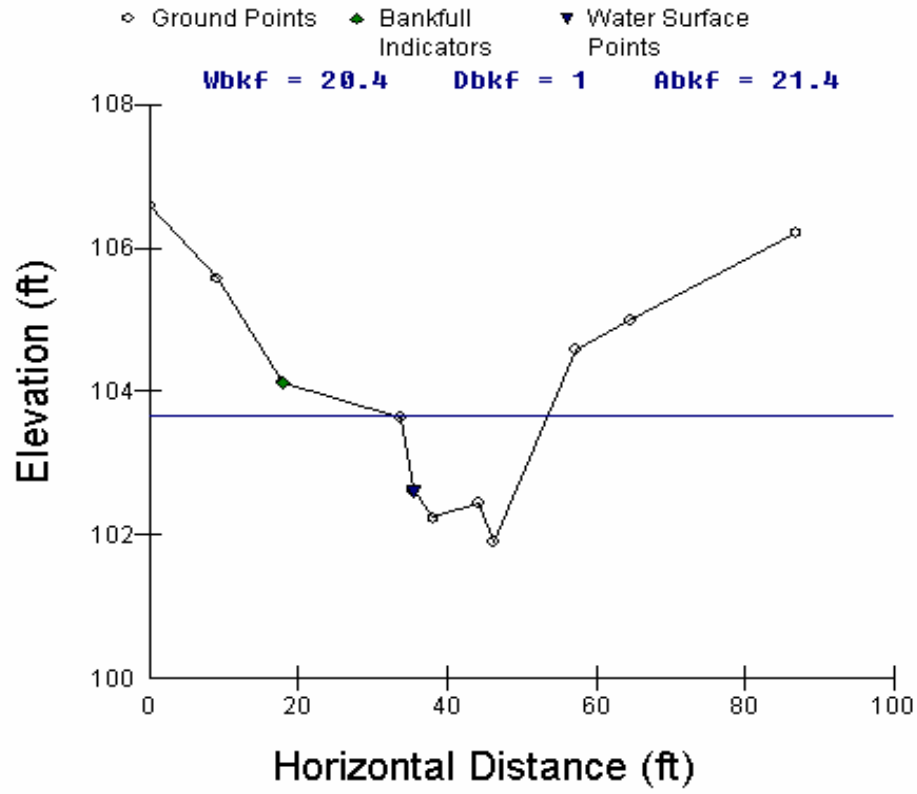
River Name: Watauga River
 Reach Name: Hanging Rock Creek
 Cross Section Name: HRxs3
 Survey Date: 09/05/05

Channel	Left Side	Right Side
Slope			
Shear Stress (lb/sq ft)			
Movable Particle (mm)

Hanging Rock xs3

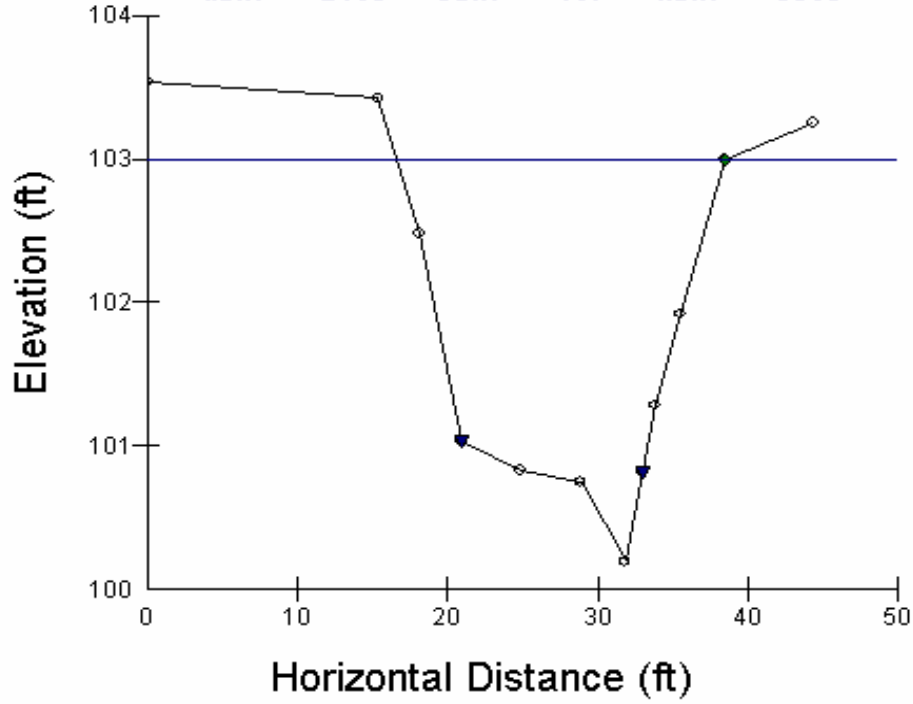
River Name: Watauga River
 Reach Name: Hanging Rock Creek
 Cross Section Name: HRxs4
 Survey Date: 09/05/05

◊ Ground Points ◆ Bankfull Indicators ▼ Water Surface Points

Wbkf = 21.8 Dbkf = 1.7 Abkf = 36.6

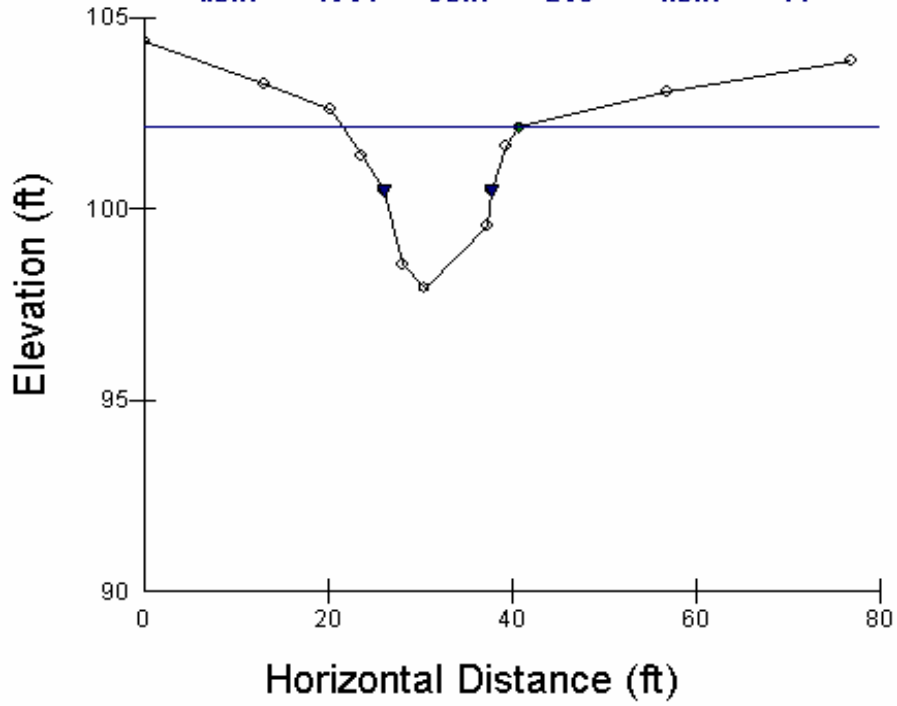
River Name: Watauga River
 Reach Name: Hanging Rock Creek
 Cross Section Name: HRxs5
 Survey Date: 09/05/05

◇ Ground Points ◆ Bankfull Indicators ▼ Water Surface Points

Wbkf = 19.1 Dbkf = 2.3 Abkf = 44

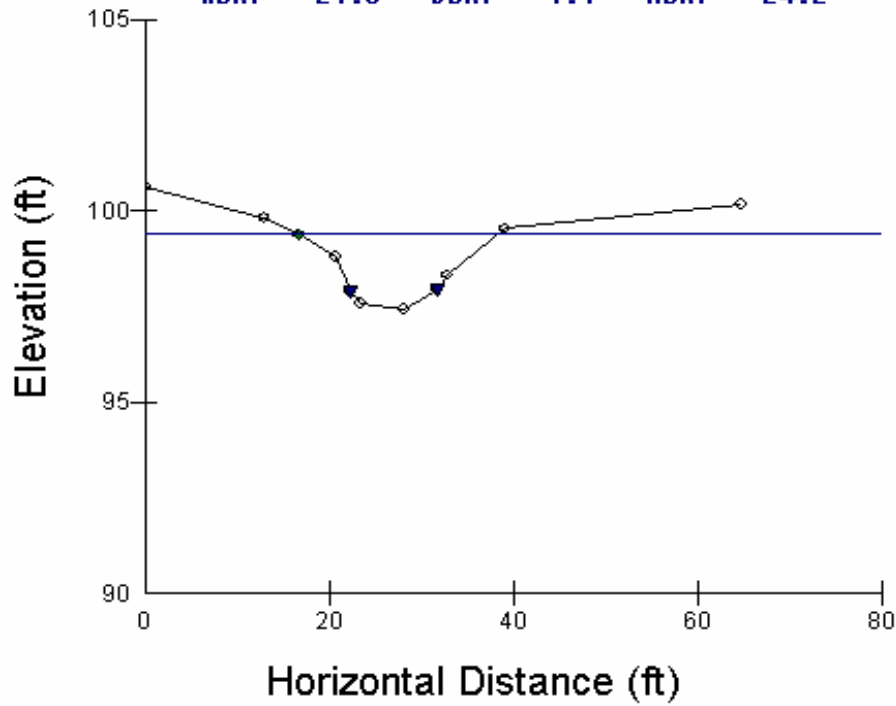
River Name: Watauga River
 Reach Name: Hanging Rock Creek
 Cross Section Name: HRxs6
 Survey Date: 09/05/05

◇ Ground Points ◆ Bankfull Indicators ▼ Water Surface Points

Wbkf = 21.8 Dbkf = 1.1 Abkf = 24.2

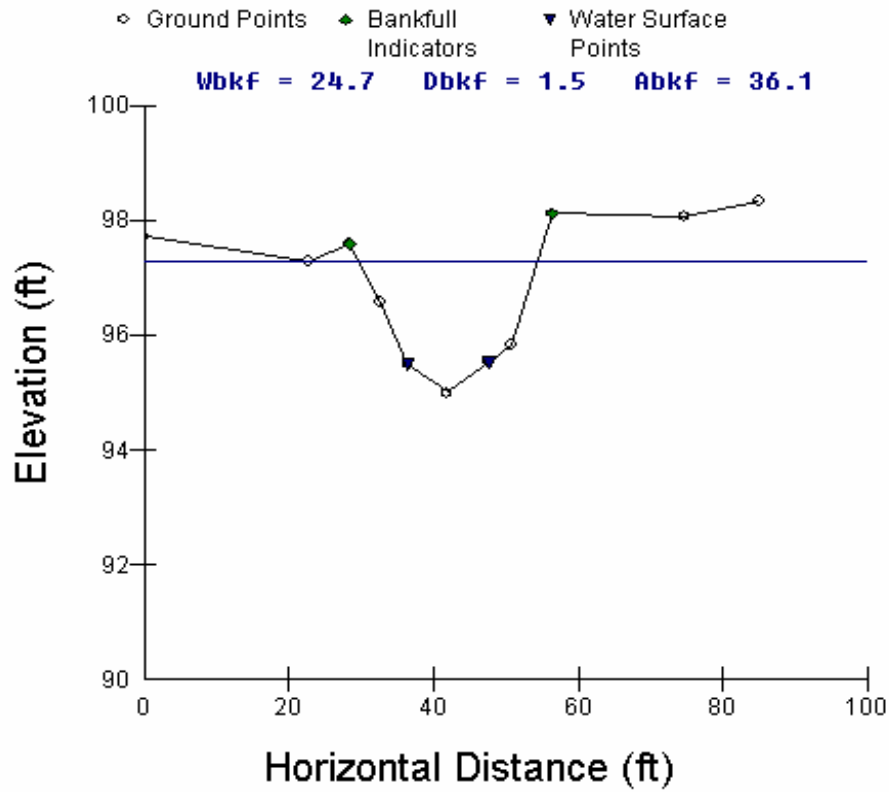
River Name: Watauga River
 Reach Name: Hanging Rock Creek
 Cross Section Name: HRxs7
 Survey Date: 09/05/05

Channel	Left Side	Right Side
Slope			
Shear Stress (lb/sq ft)			
Movable Particle (mm)

Hanging Rock xs7

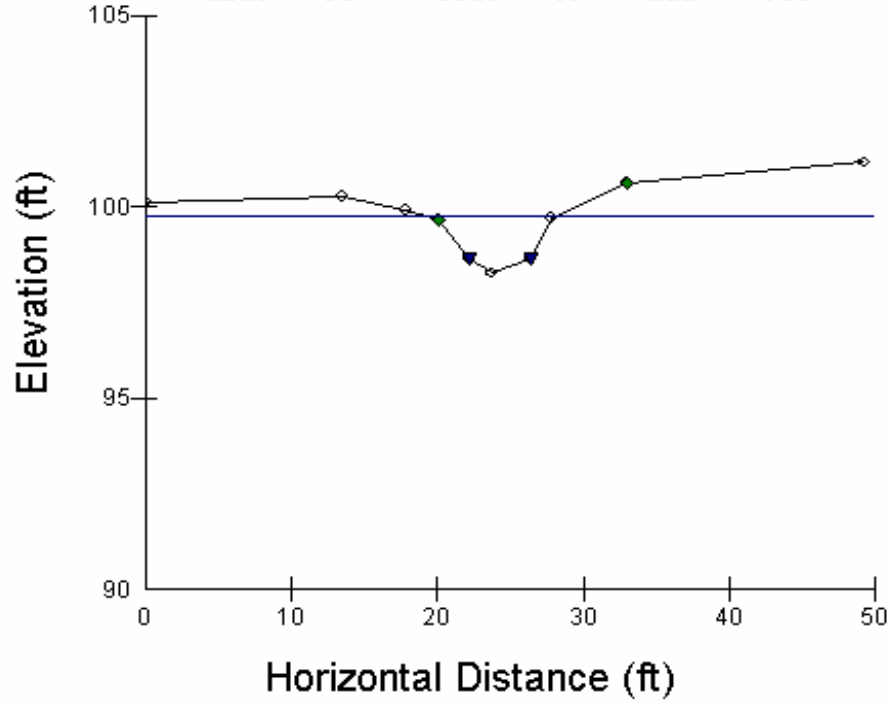
River Name: Watauga River
 Reach Name: Hanging Rock Trib
 Cross Section Name: HR Trib 1
 Survey Date: 09/07/05

◇ Ground Points ◆ Bankfull Indicators ▼ Water Surface Points

Wbkf = 8.7 Dbkf = .9 Abkf = 7.5

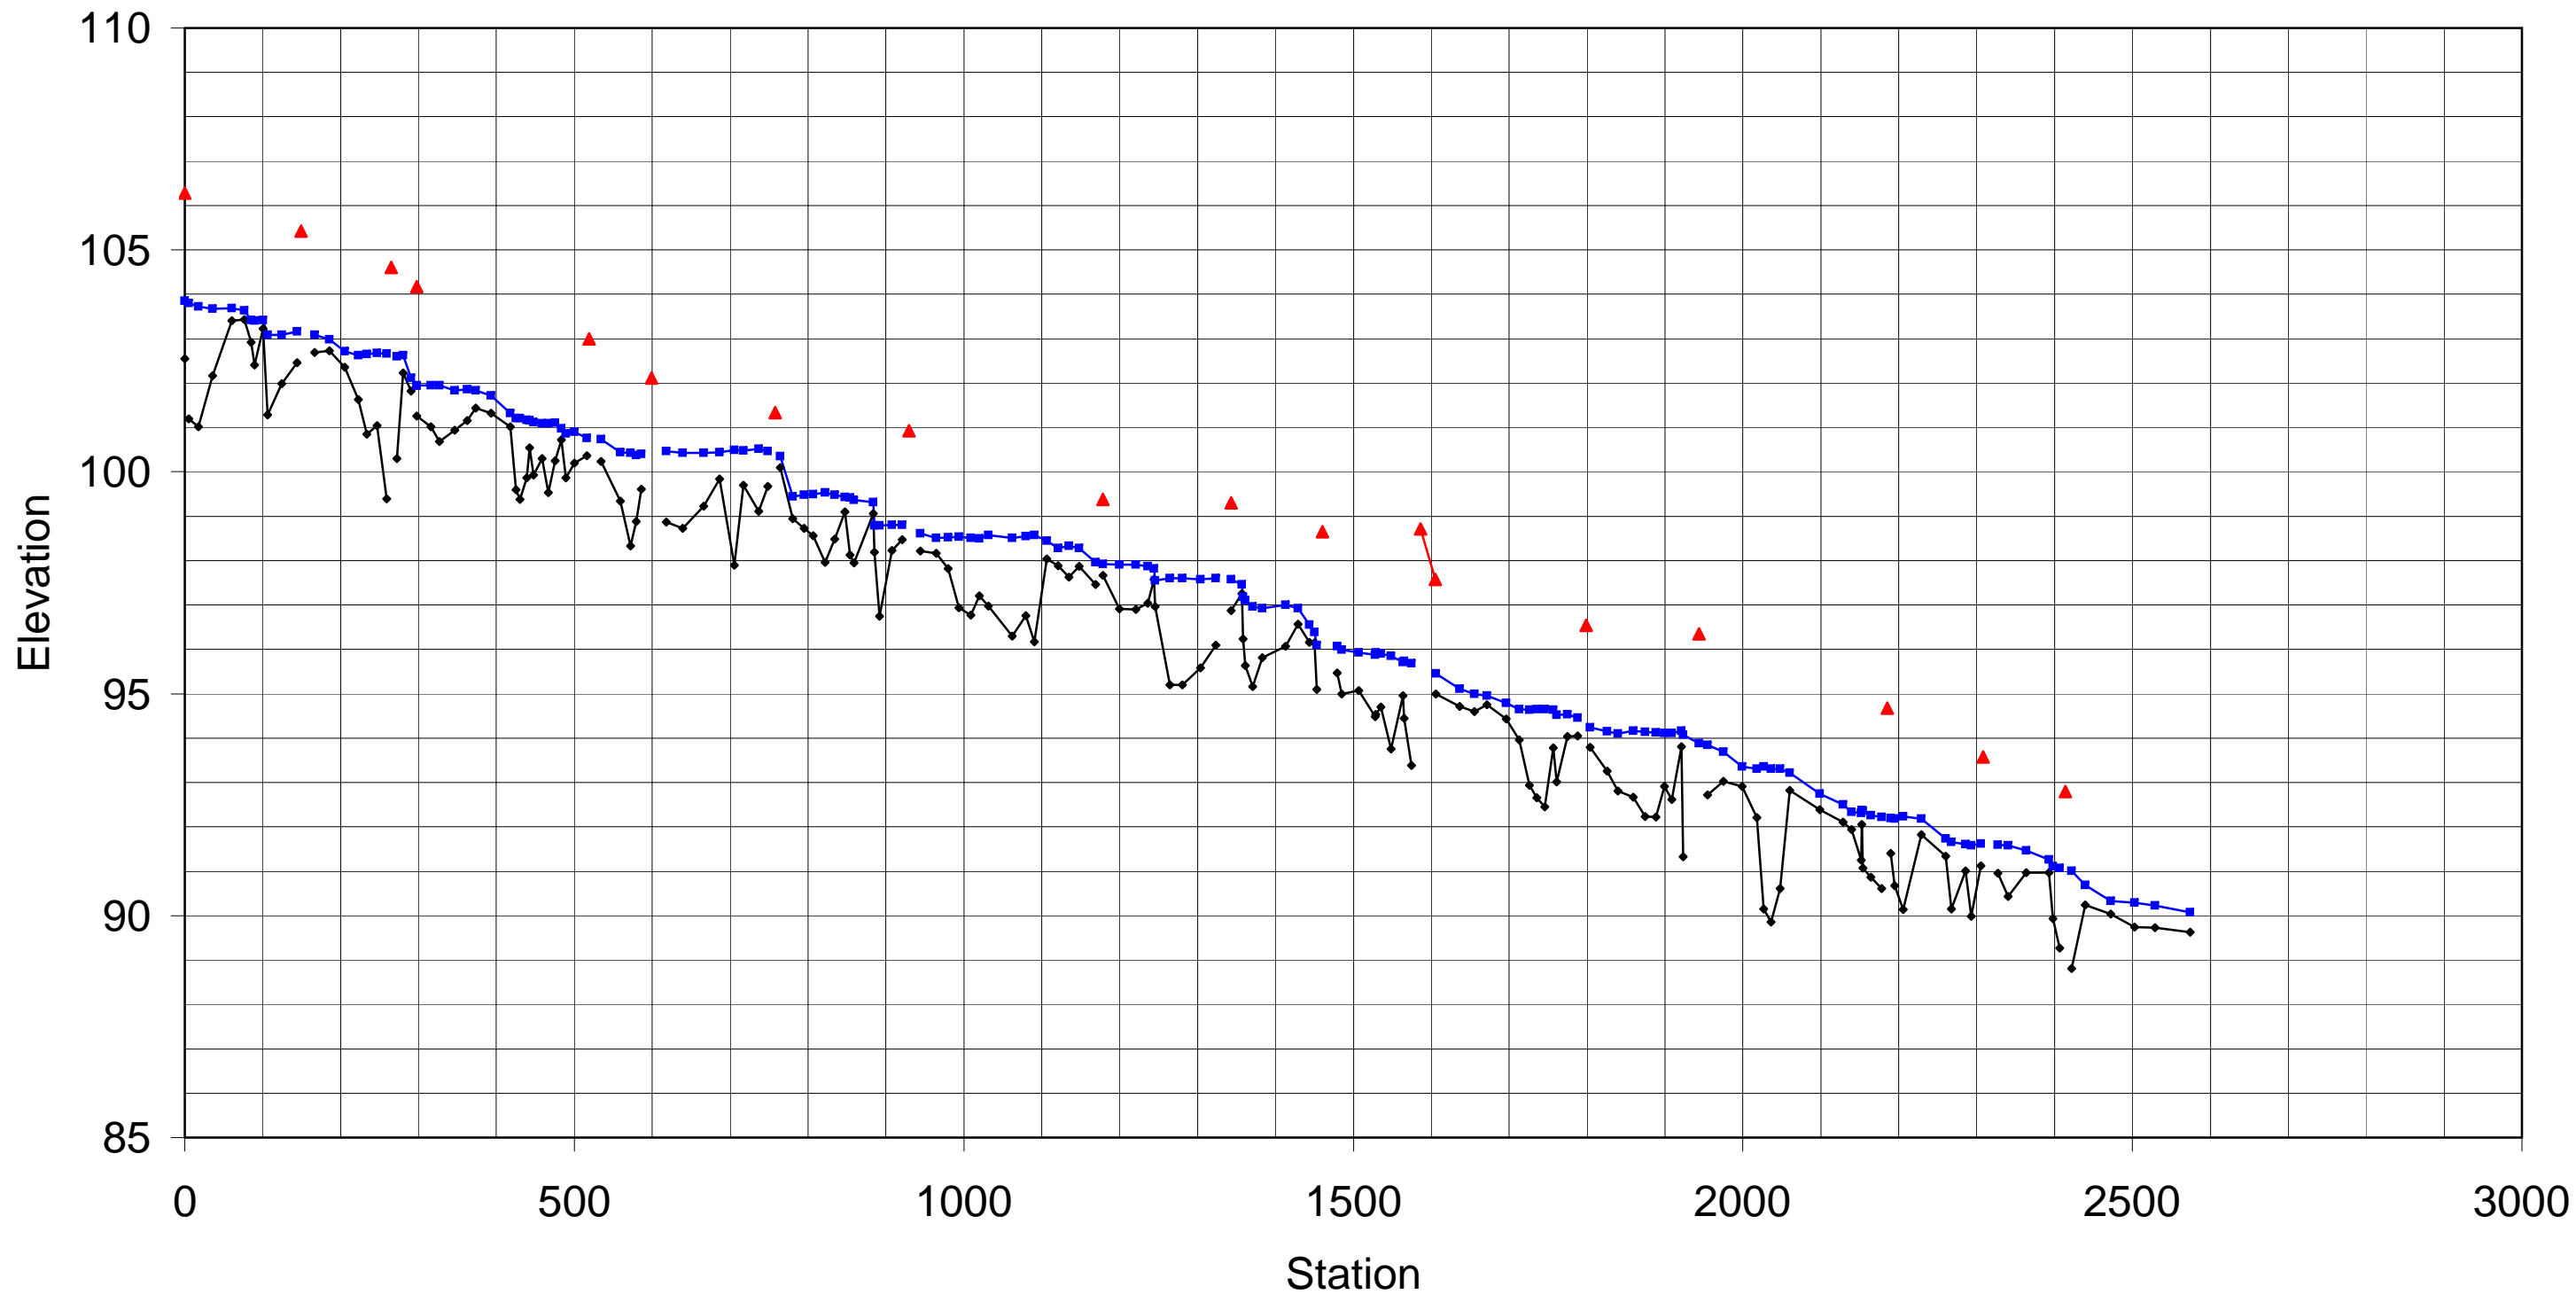
Hanging Rock Creek Long Pro 2005 (MY2)

—●— Thalweg —■— Water Surface —▲— Bankfull

River Name: Watauga River
 Reach Name: Hanging Rock Creek
 Profile Name: Hanging Rock main
 Survey Date: 08/25/05

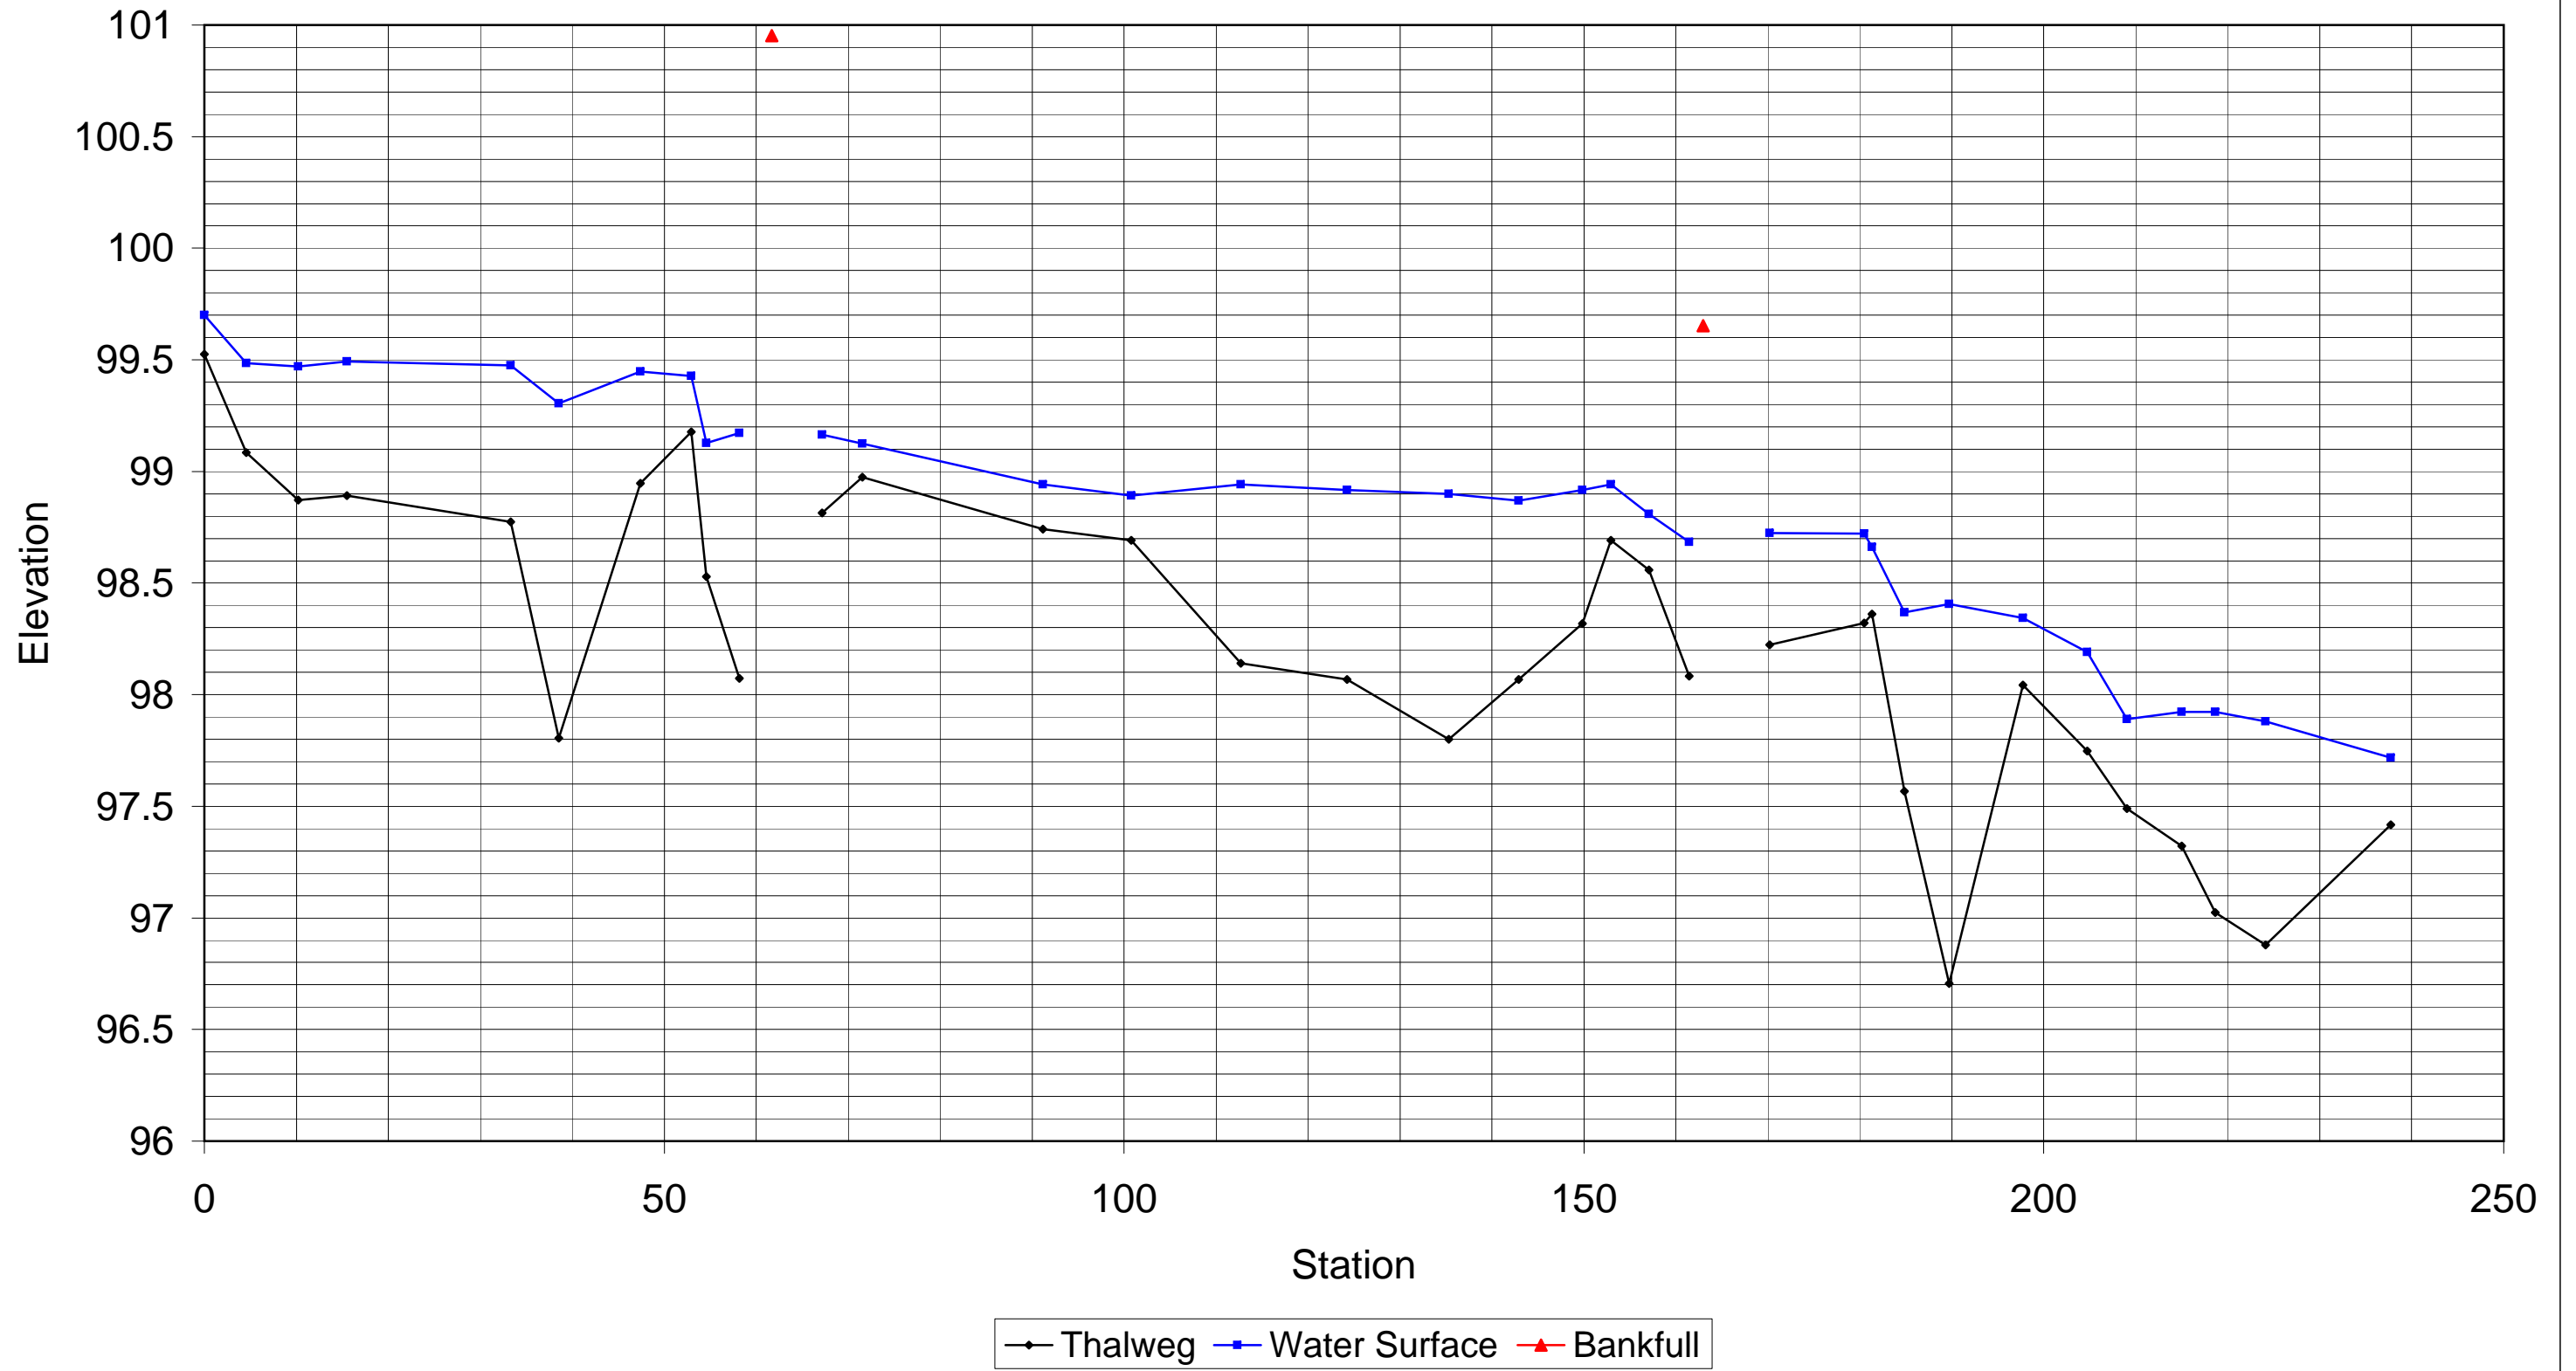
UT to Hanging Rock Ck Long Pro 2005 (MY2)

River Name: Watauga River
 Reach Name: Hanging Rock Trib
 Profile Name: Hanging Rock Trib
 Survey Date: 09/07/05

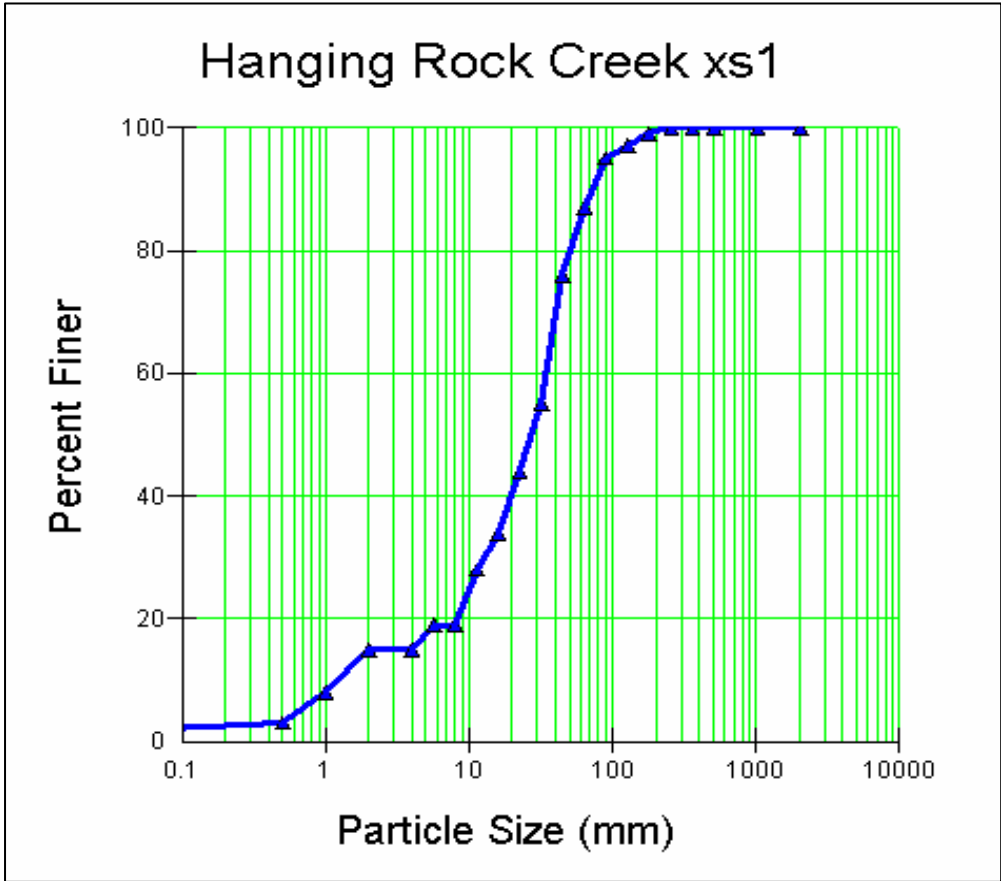
River Name: Watauga River
 Reach Name: Hanging Rock Creek
 Sample Name: PC1
 Survey Date: 10/13/05

D16 (mm)	4.42
D35 (mm)	16.66
D50 (mm)	27.73
D84 (mm)	58.82
D95 (mm)	90
D100 (mm)	255.99
Silt/Clay (%)	0
Sand (%)	15
Gravel (%)	72
Cobble (%)	13
Boulder (%)	0
Bedrock (%)	0

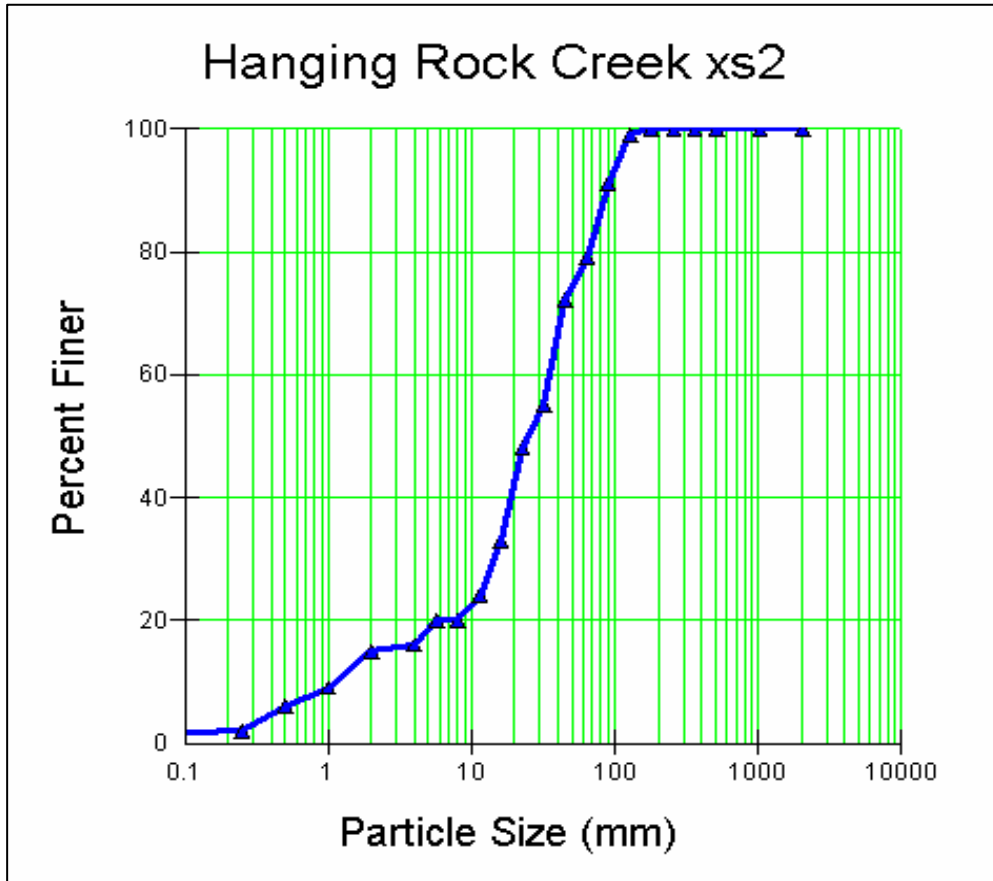
River Name: Watauga River
 Reach Name: Hanging Rock Creek
 Sample Name: PC2
 Survey Date: 09/08/05

D16 (mm)	4
D35 (mm)	16.88
D50 (mm)	25.29
D84 (mm)	74.83
D95 (mm)	109
D100 (mm)	179.99
Silt/Clay (%)	0
Sand (%)	15
Gravel (%)	64
Cobble (%)	21
Boulder (%)	0
Bedrock (%)	0

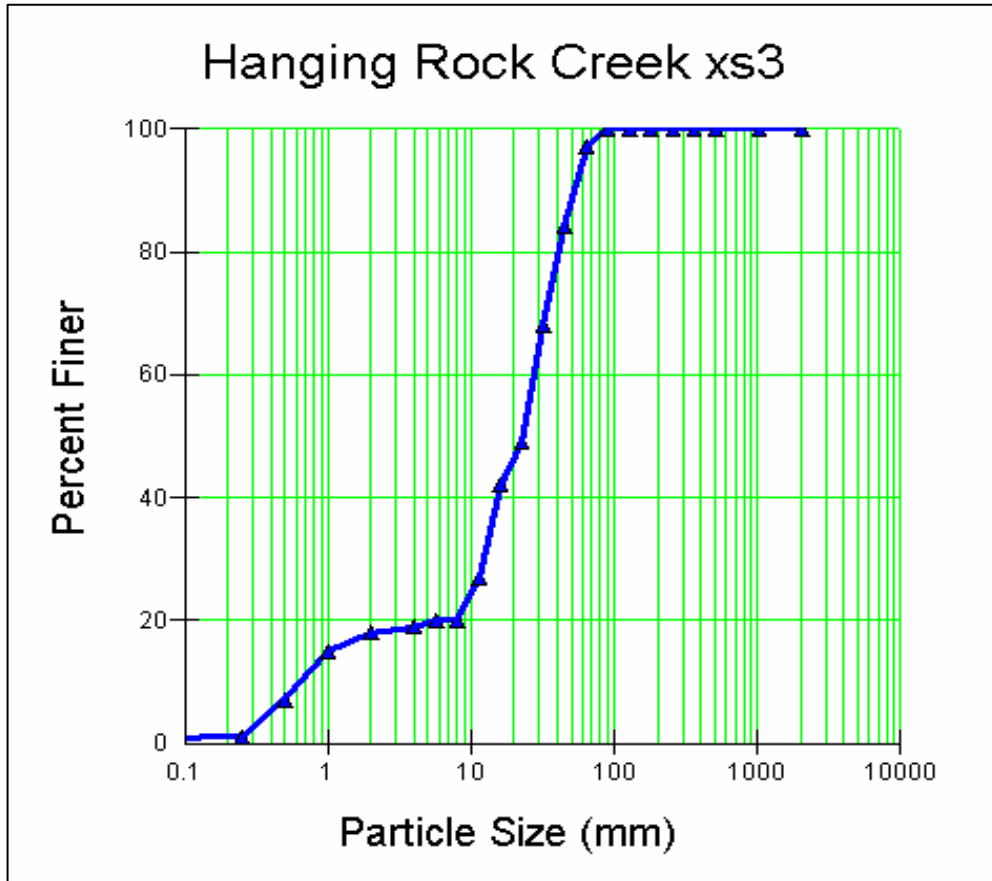
River Name: Watauga River
 Reach Name: Hanging Rock Creek
 Sample Name: PC3
 Survey Date: 10/13/05

Size (mm)	TOT #	ITEM %	CUM %
0 - 0.062	0	0.00	0.00
0.062 - 0.125	0	0.00	0.00
0.125 - 0.25	1	1.00	1.00
0.25 - 0.50	6	6.00	7.00
0.50 - 1.0	8	8.00	15.00
1.0 - 2.0	3	3.00	18.00
2.0 - 4.0	1	1.00	19.00
4.0 - 5.7	1	1.00	20.00
5.7 - 8.0	0	0.00	20.00
8.0 - 11.3	7	7.00	27.00
11.3 - 16.0	15	15.00	42.00
16.0 - 22.6	7	7.00	49.00
22.6 - 32.0	19	19.00	68.00
32 - 45	16	16.00	84.00
45 - 64	13	13.00	97.00
64 - 90	3	3.00	100.00
90 - 128	0	0.00	100.00
128 - 180	0	0.00	100.00
180 - 256	0	0.00	100.00
256 - 362	0	0.00	100.00
362 - 512	0	0.00	100.00
512 - 1024	0	0.00	100.00
1024 - 2048	0	0.00	100.00
2048 -	0	0.00	100.00

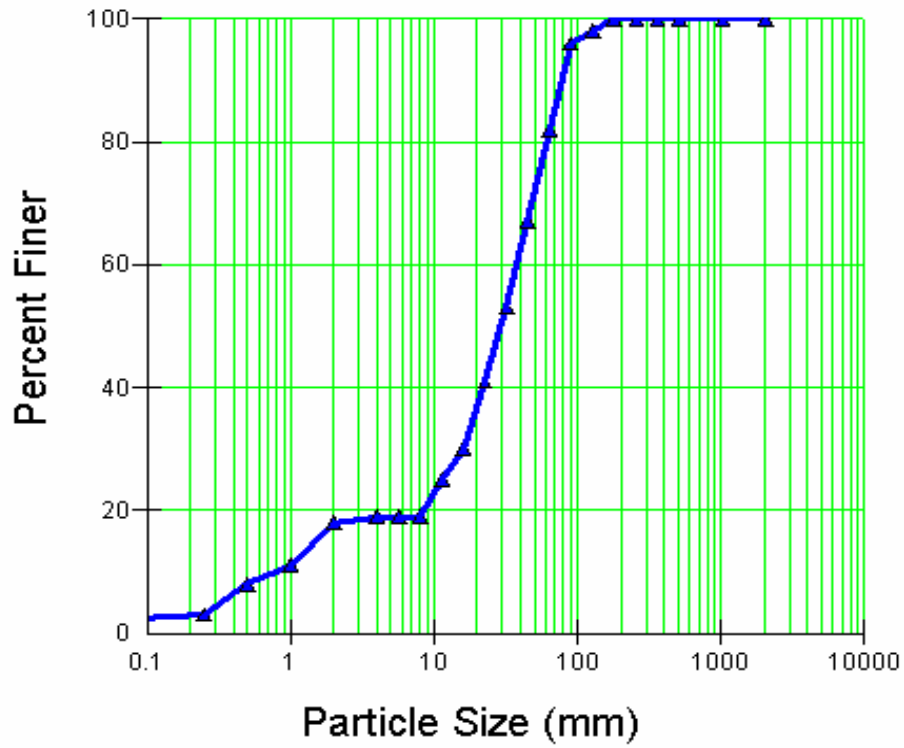
River Name: Watauga River
 Reach Name: Hanging Rock Creek
 Sample Name: PC4
 Survey Date: 10/13/05

D16 (mm)	1.71
D35 (mm)	19
D50 (mm)	29.65
D84 (mm)	67.71
D95 (mm)	88.14
D100 (mm)	180
Silt/Clay (%)	0
Sand (%)	18
Gravel (%)	64
Cobble (%)	18
Boulder (%)	0
Bedrock (%)	0

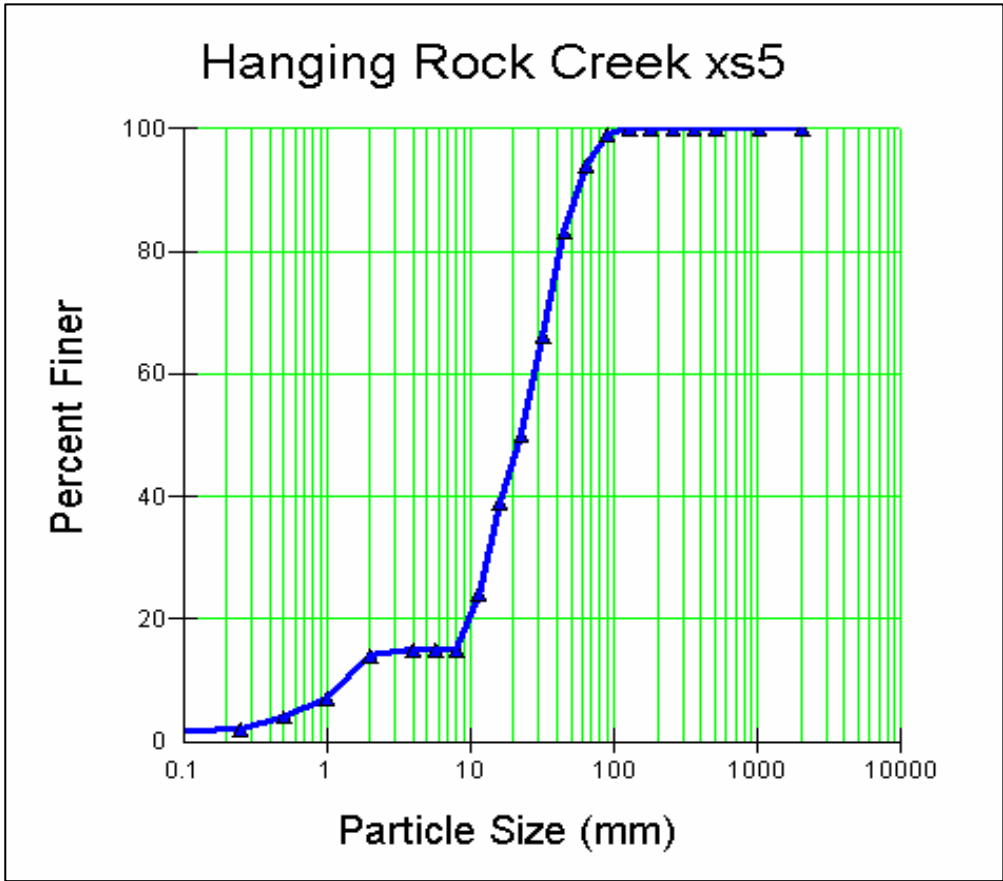
River Name: Watauga River
 Reach Name: Hanging Rock Creek
 Sample Name: PC5
 Survey Date: 09/08/05

D16 (mm)	8.37
D35 (mm)	14.75
D50 (mm)	22.6
D84 (mm)	46.73
D95 (mm)	69.2
D100 (mm)	128
Silt/Clay (%)	0
Sand (%)	14
Gravel (%)	80
Cobble (%)	6
Boulder (%)	0
Bedrock (%)	0

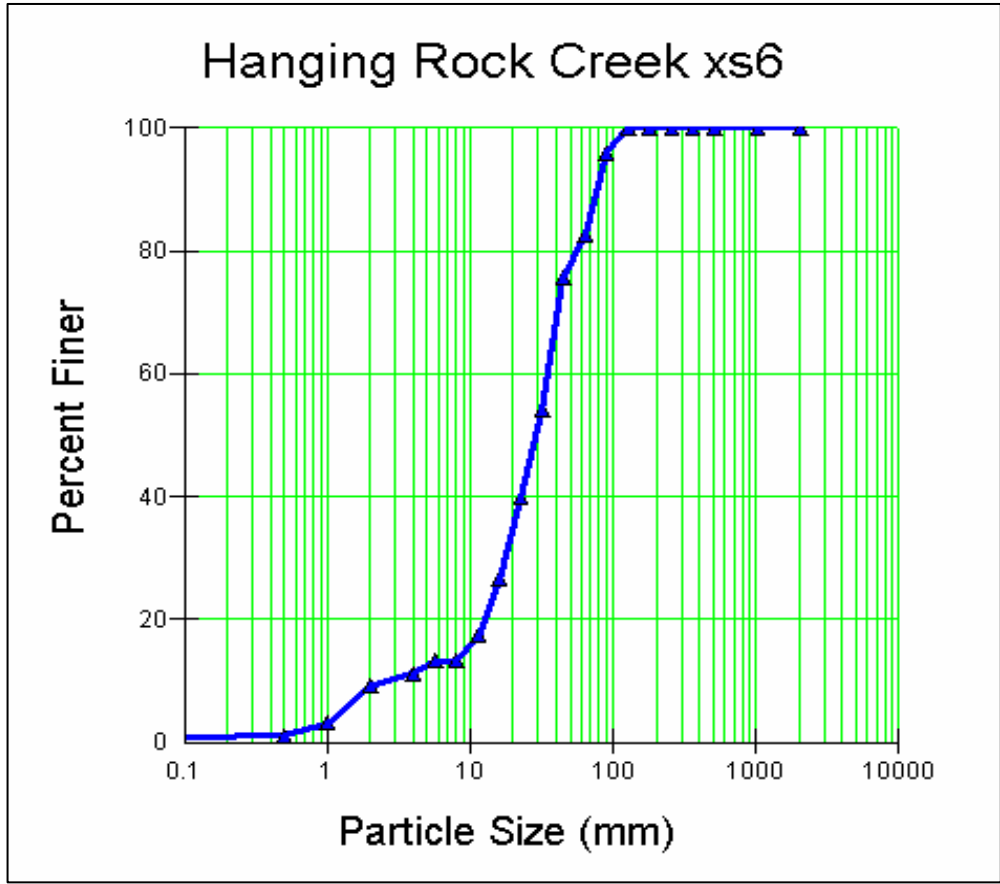
River Name: Watauga River
 Reach Name: Hanging Rock Creek
 Sample Name: PC6
 Survey Date: 09/08/05

D16 (mm)	10.21
D35 (mm)	20.21
D50 (mm)	29.31
D84 (mm)	66.65
D95 (mm)	88.2
D100 (mm)	128
Silt/Clay (%)	0
Sand (%)	9.18
Gravel (%)	73.47
Cobble (%)	17.35
Boulder (%)	0
Bedrock (%)	0

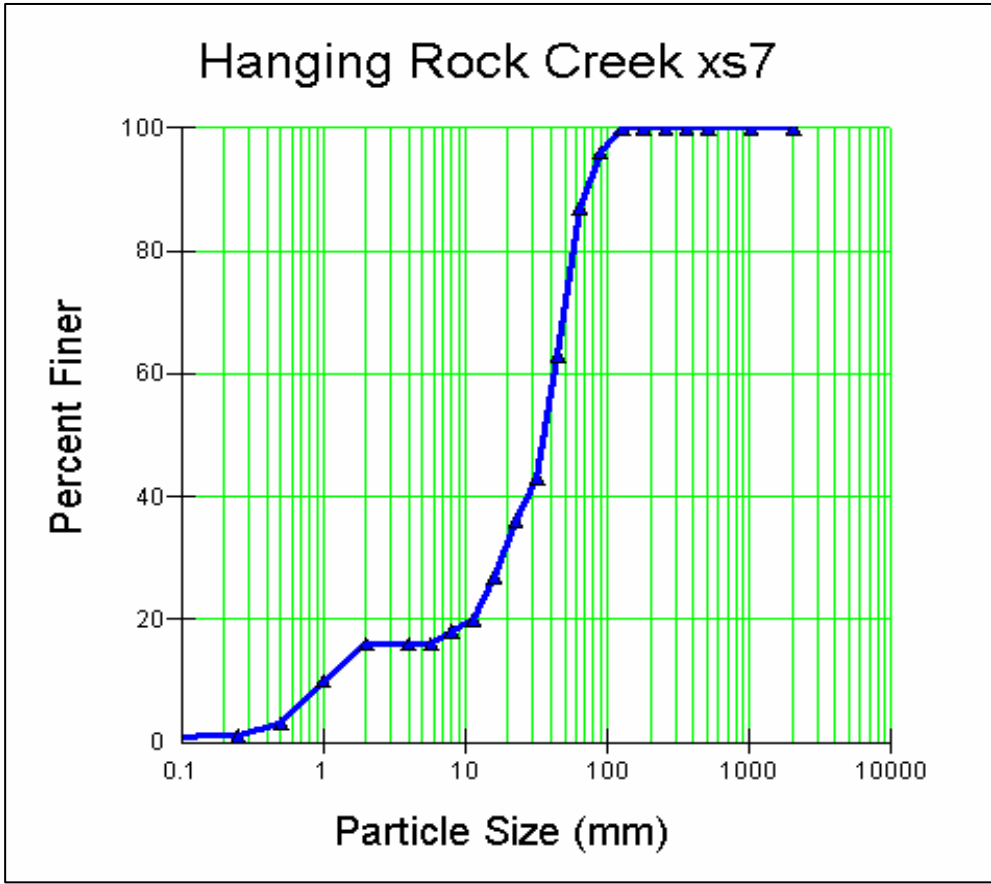
River Name: Watauga River
 Reach Name: Hanging Rock Creek
 Sample Name: PC7
 Survey Date: 09/08/05

D16 (mm)	2
D35 (mm)	21.87
D50 (mm)	36.55
D84 (mm)	61.63
D95 (mm)	87.11
D100 (mm)	128
Silt/Clay (%)	0
Sand (%)	16
Gravel (%)	71
Cobble (%)	13
Boulder (%)	0
Bedrock (%)	0

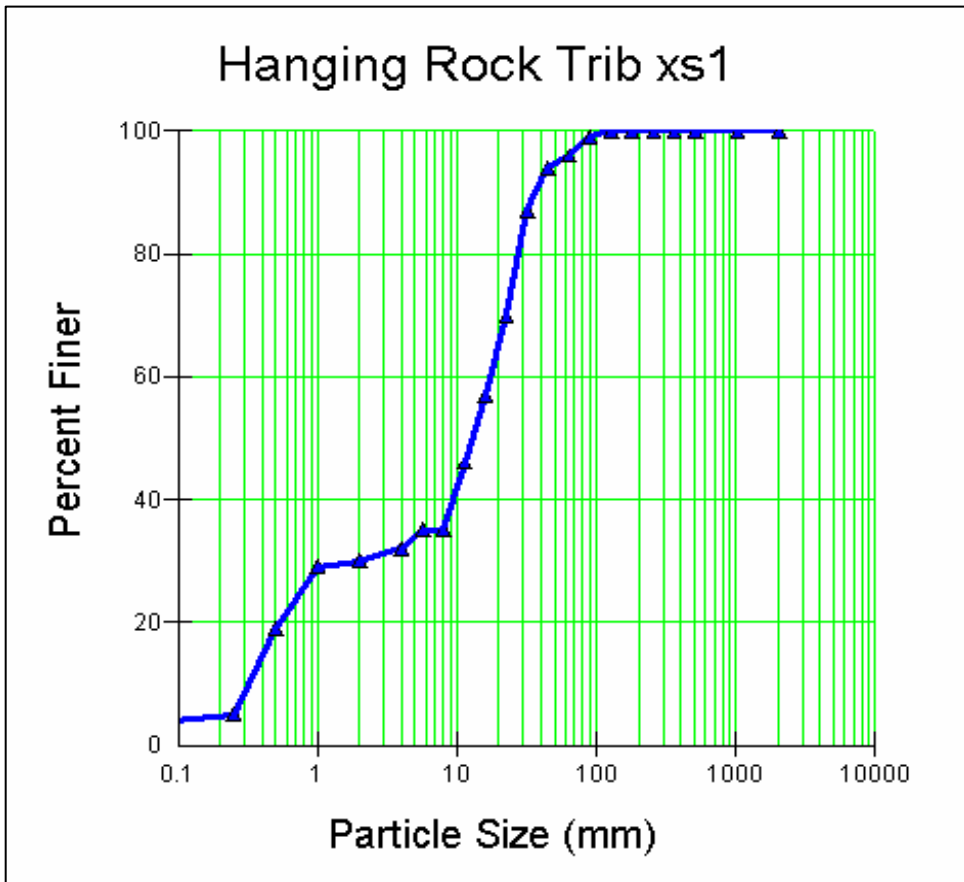
River Name: Watauga River
 Reach Name: Hanging Rock Trib
 Sample Name: PC1
 Survey Date: 09/07/05

Size (mm)	TOT #	ITEM %	CUM %
0 - 0.062	0	0.00	0.00
0.062 - 0.125	0	0.00	0.00
0.125 - 0.25	5	5.00	5.00
0.25 - 0.50	14	14.00	19.00
0.50 - 1.0	10	10.00	29.00
1.0 - 2.0	1	1.00	30.00
2.0 - 4.0	2	2.00	32.00
4.0 - 5.7	3	3.00	35.00
5.7 - 8.0	0	0.00	35.00
8.0 - 11.3	11	11.00	46.00
11.3 - 16.0	11	11.00	57.00
16.0 - 22.6	13	13.00	70.00
22.6 - 32.0	17	17.00	87.00
32 - 45	7	7.00	94.00
45 - 64	2	2.00	96.00
64 - 90	3	3.00	99.00
90 - 128	1	1.00	100.00
128 - 180	0	0.00	100.00
180 - 256	0	0.00	100.00
256 - 362	0	0.00	100.00
362 - 512	0	0.00	100.00
512 - 1024	0	0.00	100.00
1024 - 2048	0	0.00	100.00
2048 -	0	0.00	100.00
