**Harrell Site  
Edgecombe County, North Carolina**

***Stream and Wetland  
Restoration Plan***

# Harrell Stream and Wetland Restoration Plan

SCO Contract No. D05025-1

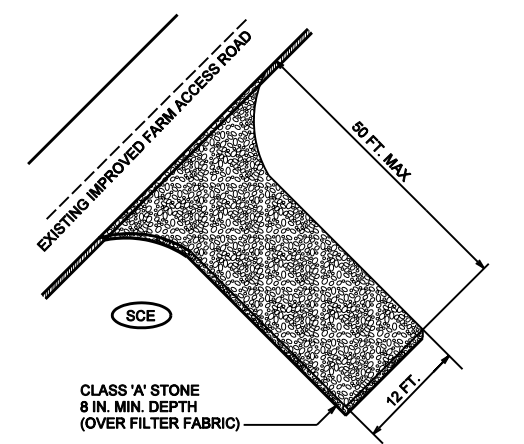
**STABILIZED CONSTRUCTION ENTRANCE** (SCE)  
 SCALE: NTS

- NOTES:
1. TURNING RADIUS SUFFICIENT TO ACCOMMODATE LARGE TRUCKS SHALL BE PROVIDED.
  2. ENTRANCE(S) SHOULD BE LOCATED TO PROVIDE FOR UTILIZATION BY ALL CONSTRUCTION VEHICLES.
  3. MUST BE MAINTAINED IN A CONDITION WHICH WILL PREVENT TRACKING OR DIRECT FLOW OF MUD ONTO STREETS. PERIODIC TOPDRESSING WITH STONE WILL BE NECESSARY.
  4. ANY MATERIAL TRACKED ONTO THE ROADWAY MUST BE CLEANED UP IMMEDIATELY.
  5. GRAVEL CONSTRUCTION ENTRANCE SHALL BE LOCATED AT ALL POINTS OF INGRESS AND EGRESS UNTIL SITE IS STABILIZED. FREQUENT CHECKS OF THE DEVICE AND TIMELY MAINTENANCE MUST BE PROVIDED.

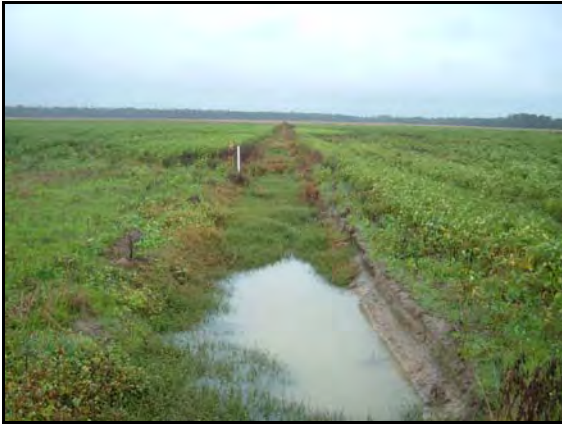
A view downstream from the first road crossing; gauge 1 is seen on the left.

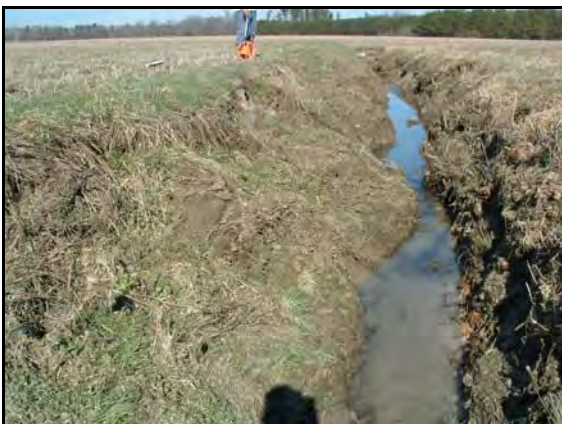
Eroding banks along the project stream.

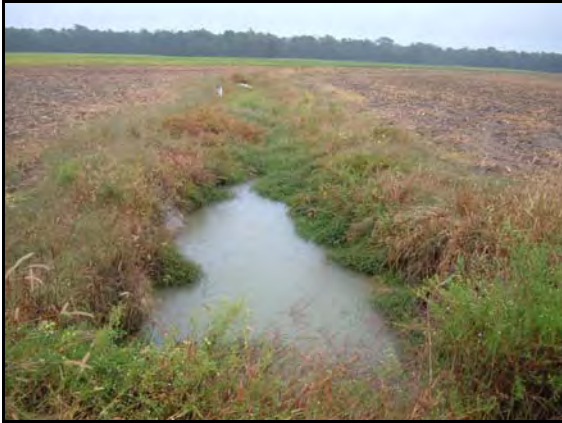
A view downstream from the second road crossing with gauge 2 on the left.

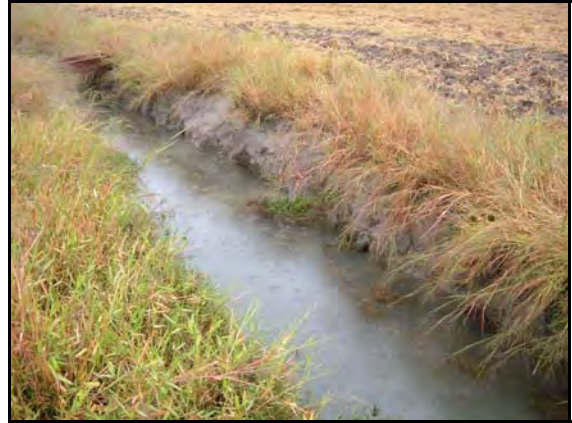
Exposed banks along the project stream.

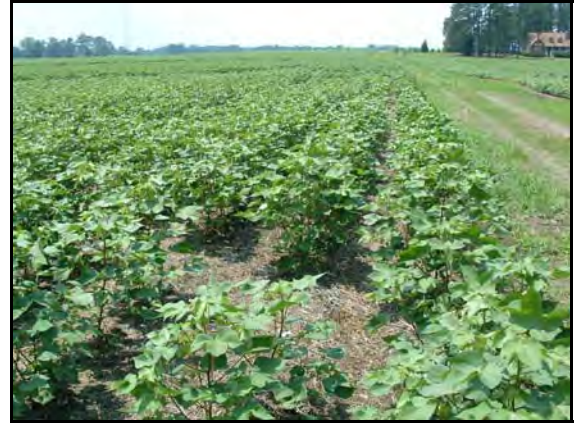
An overview of the wetland site looking toward the southeast.

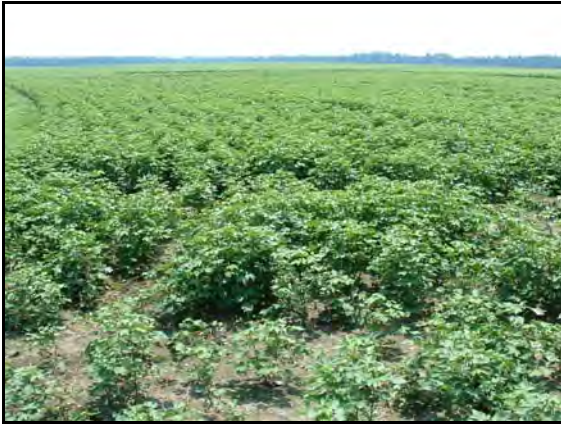
A look at the wetland site (to the left) from the upper northern boundary.

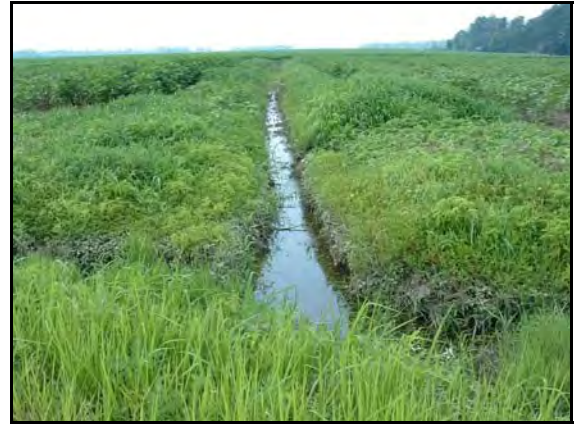
The entire wetland site is under agricultural production.

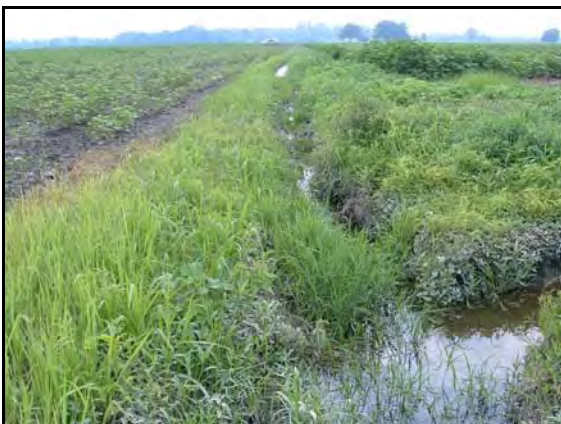
A look at the confluence of three ditches that currently drain the wetland site.

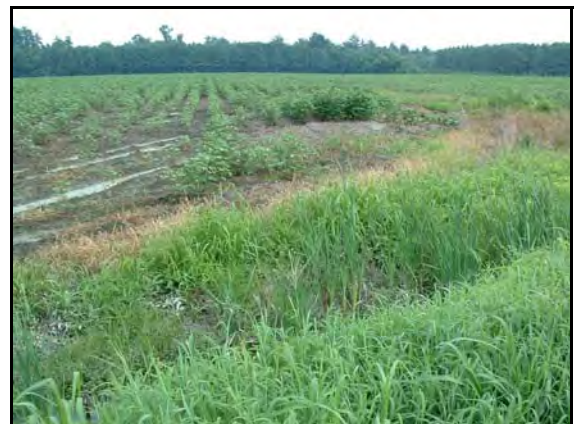
Looking upstream of the ditch that drains the southern portion of the wetland site.

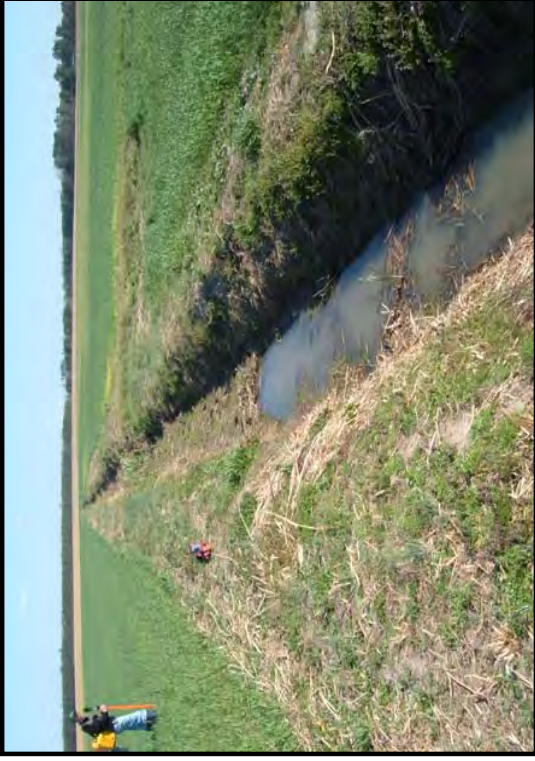
<b>River Basin:</b>	Tar-Pamlico
<b>Watershed:</b>	UTSC
<b>XS ID</b>	XS 2
<b>Drainage Area (sq mi):</b>	0.23
<b>Date:</b>	April 2006
<b>Field Crew:</b>	Hayes, Helms, Patterson

**Stream Type:** E5

SUMMARY DATA	
<b>Bankfull Elevation:</b>	80.1
<b>Bankfull Cross-Sectional Area:</b>	8.0
<b>Bankfull Width:</b>	6.5
<b>Flood Prone Area Elevation:</b>	82.0
<b>Flood Prone Width:</b>	>70
<b>Max Depth at Bankfull:</b>	1.9
<b>Mean Depth at Bankfull:</b>	1.2
<b>W / D Ratio:</b>	5.3
<b>Entrenchment Ratio:</b>	10.8
<b>Bank Height Ratio:</b>	1.4
<b>Slope (ft/ft):</b>	0.006
<b>Discharge (cfs)</b>	31

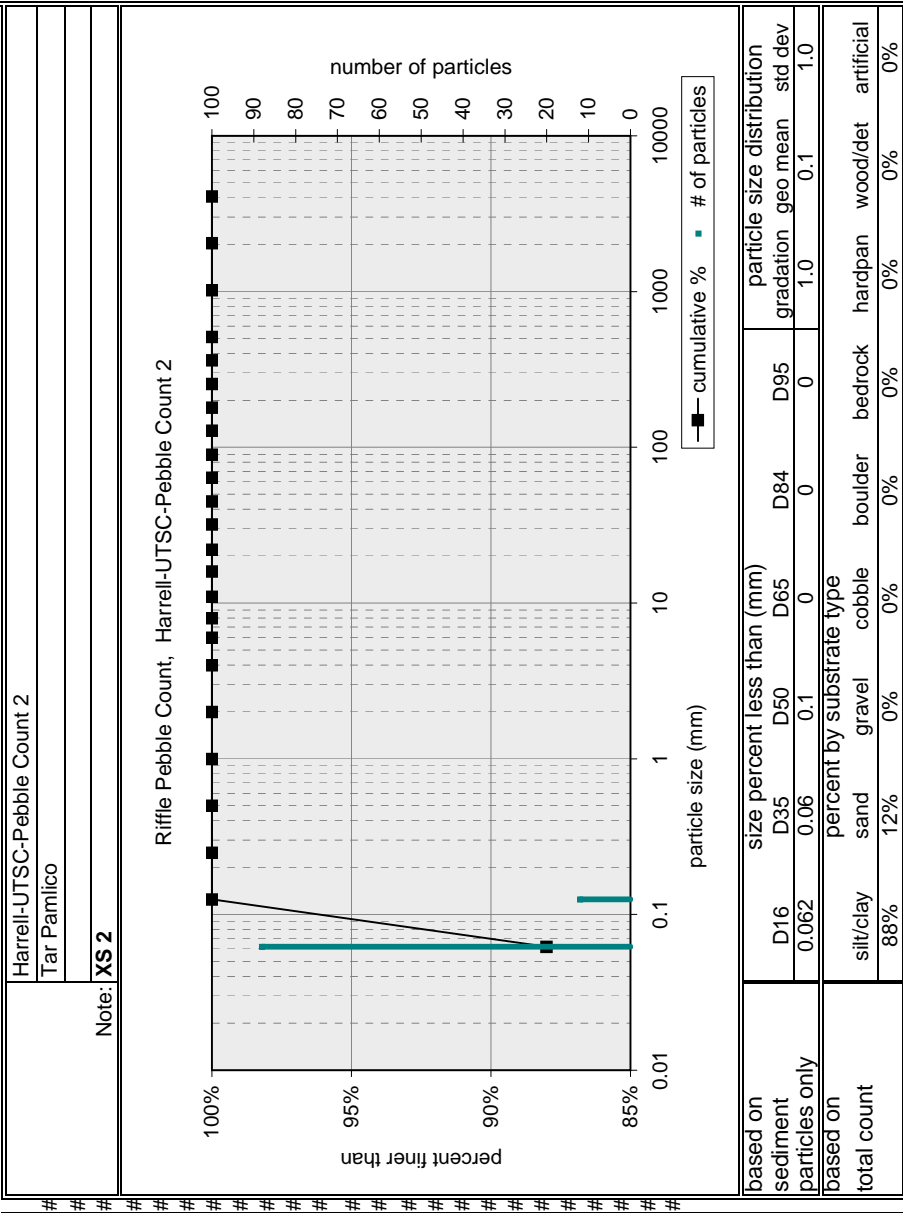
**Pebble Count of Channel Reach**

Material	Size Range (mm)	Count
silt/clay	0	93
very fine sand	0.062	7
fine sand	0.13	
medium sand	0.25	
coarse sand	0.5	
very coarse sand	1	
very fine gravel	2	
fine gravel	4	
fine gravel	6	
medium gravel	8	
medium gravel	11	
coarse gravel	16	
coarse gravel	22	
coarse gravel	32	
very coarse gravel	45	
very coarse gravel	64	
small cobble	90	
medium cobble	128	
large cobble	180	
very large cobble	256	
small boulder	362	
small boulder	512	
medium boulder	1024	
large boulder	2048	
very large boulder	4096	
total particle count:		100

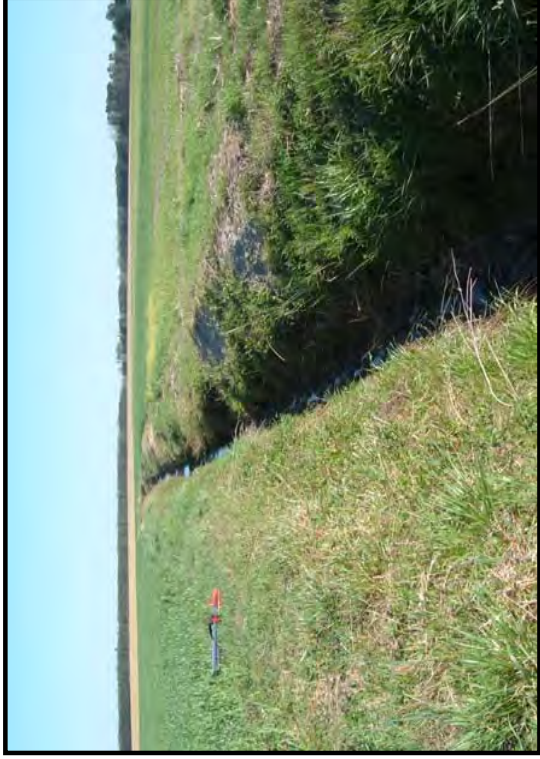
Tar-Pamlico River Basin, UTSC, XS 3

Station	Elevation
0	78.86
15	78.97
25	78.84
30	78.71
32	78.40
33.5	77.79
34	77.15
35	75.63
36	75.02
37	74.51
38.5	74.41
39	74.45
39.5	75.60
40.5	76.63
42	77.72
44	77.95
47	77.95
53	77.89
60	77.87
65	78.00

SUMMARY DATA	
<b>Bankfull Elevation:</b>	76.4
<b>Bankfull Cross-Sectional Area:</b>	7.5
<b>Bankfull Width:</b>	5.7
<b>Flood Prone Area Elevation:</b>	78.3
<b>Flood Prone Width:</b>	>65
<b>Max Depth at Bankfull:</b>	1.9
<b>Mean Depth at Bankfull:</b>	1.3
<b>W / D Ratio:</b>	4.3
<b>Entrenchment Ratio:</b>	11.4
<b>Bank Height Ratio:</b>	1.8
<b>Slope (ft/ft):</b>	0.007
<b>Discharge (cfs)</b>	31

Stream Type: E5

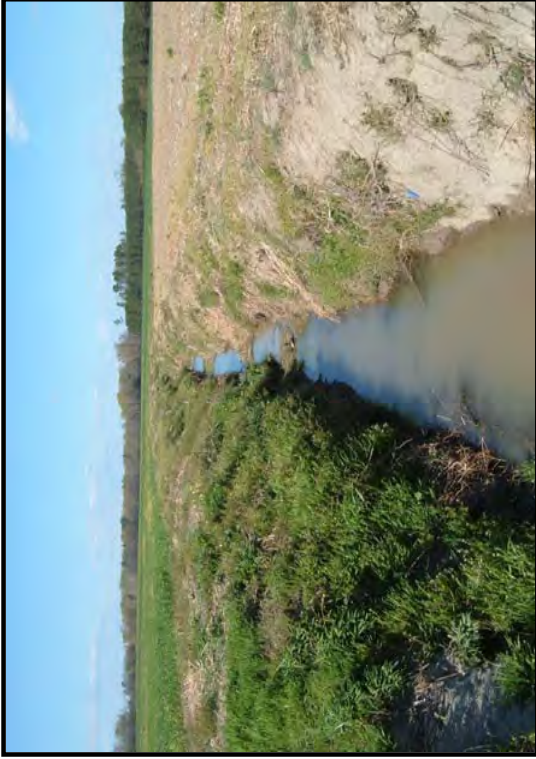
<b>River Basin:</b>	Tar-Pamlico
<b>Watershed:</b>	UTSC
<b>XS ID</b>	XS 4
<b>Drainage Area (sq mi):</b>	0.385
<b>Date:</b>	April 2006
<b>Field Crew:</b>	Hayes, Helms, Patterson

Stream Type: E5

SUMMARY DATA	
Bankfull Elevation:	73.6
Bankfull Cross-Sectional Area:	10.4
Bankfull Width:	7.4
Flood Prone Area Elevation:	75.9
Flood Prone Width:	>70
Max Depth at Bankfull:	2.4
Mean Depth at Bankfull:	1.4
W / D Ratio:	5.3
Entrenchment Ratio:	9.5
Bank Height Ratio:	1.6
Slope (ft/ft):	0.008
Discharge (cfs)	50

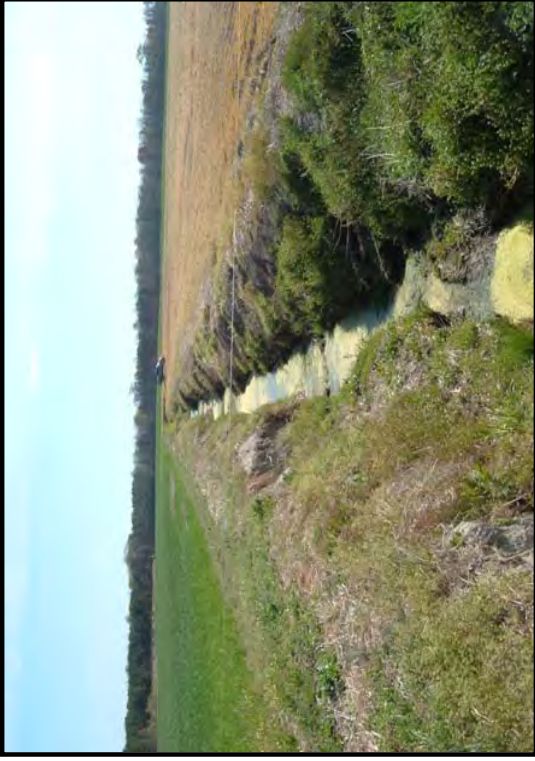
<b>River Basin:</b>	Tar-Pamlico
<b>Watershed:</b>	UTSC
<b>XS ID</b>	XS 5
<b>Drainage Area (sq mi):</b>	0.424
<b>Date:</b>	April 2006
<b>Field Crew:</b>	Hayes, Helms, Patterson

Stream Type: E5

Station	Elevation
0	71.65
10	71.45
20	70.95
27	71.12
30	71.18
31	70.80
32	69.76
33	66.86
34.5	66.47
35	66.11
36	66.50
37	66.95
37.8	67.86
38.5	68.82
39.5	69.89
41	70.94
45	70.94
55	70.93
65	70.93
70	71.21

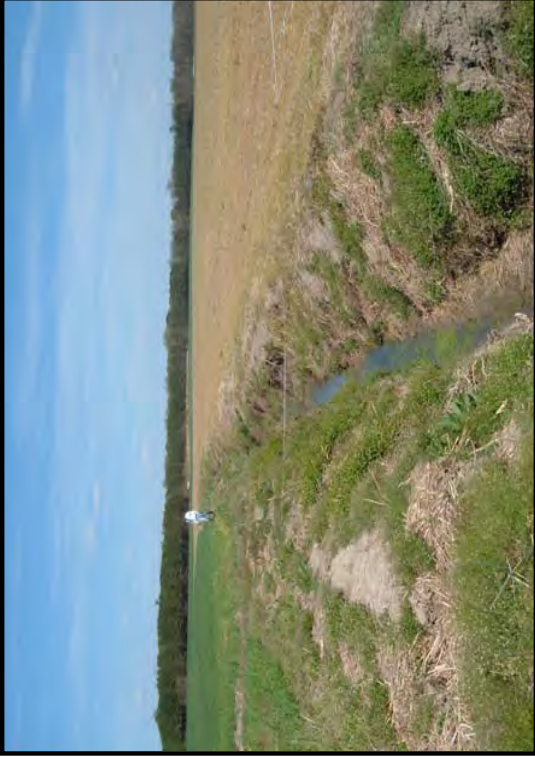
<b>River Basin:</b>	Tar-Pamlico
<b>Watershed:</b>	UTSC
<b>XS ID</b>	XS 6
<b>Drainage Area (sq mi):</b>	0.424
<b>Date:</b>	April 2006
<b>Field Crew:</b>	Hayes, Helms, Patterson

**Stream Type:** E5

SUMMARY DATA	
Bankfull Elevation:	69.8
Bankfull Cross-Sectional Area:	11.9
Bankfull Width:	7.9
Flood Prone Area Elevation:	72.5
Flood Prone Width:	>80
Max Depth at Bankfull:	2.7
Mean Depth at Bankfull:	1.5
W / D Ratio:	5.2
Entrenchment Ratio:	10.1
Bank Height Ratio:	1.5
Slope (ft/ft):	0.005
Discharge (cfs)	44

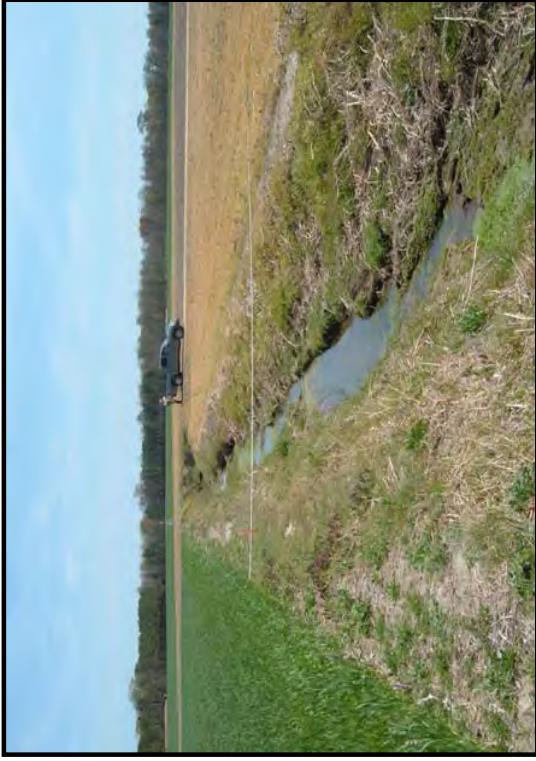
<b>River Basin:</b>	Tar-Pamlico
<b>Watershed:</b>	UTSC
<b>XS ID</b>	XS 7
<b>Drainage Area (sq mi):</b>	0.424
<b>Date:</b>	April 2006
<b>Field Crew:</b>	Hayes, Helms, Patterson

Stream Type: E5

SUMMARY DATA	
Bankfull Elevation:	67.3
Bankfull Cross-Sectional Area:	12.0
Bankfull Width:	8.6
Flood Prone Area Elevation:	70.0
Flood Prone Area Width:	>65
Max Depth at Bankfull:	2.7
Mean Depth at Bankfull:	1.4
W / D Ratio:	6.2
Entrenchment Ratio:	7.6
Bank Height Ratio:	1.6
Slope (ft/ft):	0.005
Discharge (cfs)	48

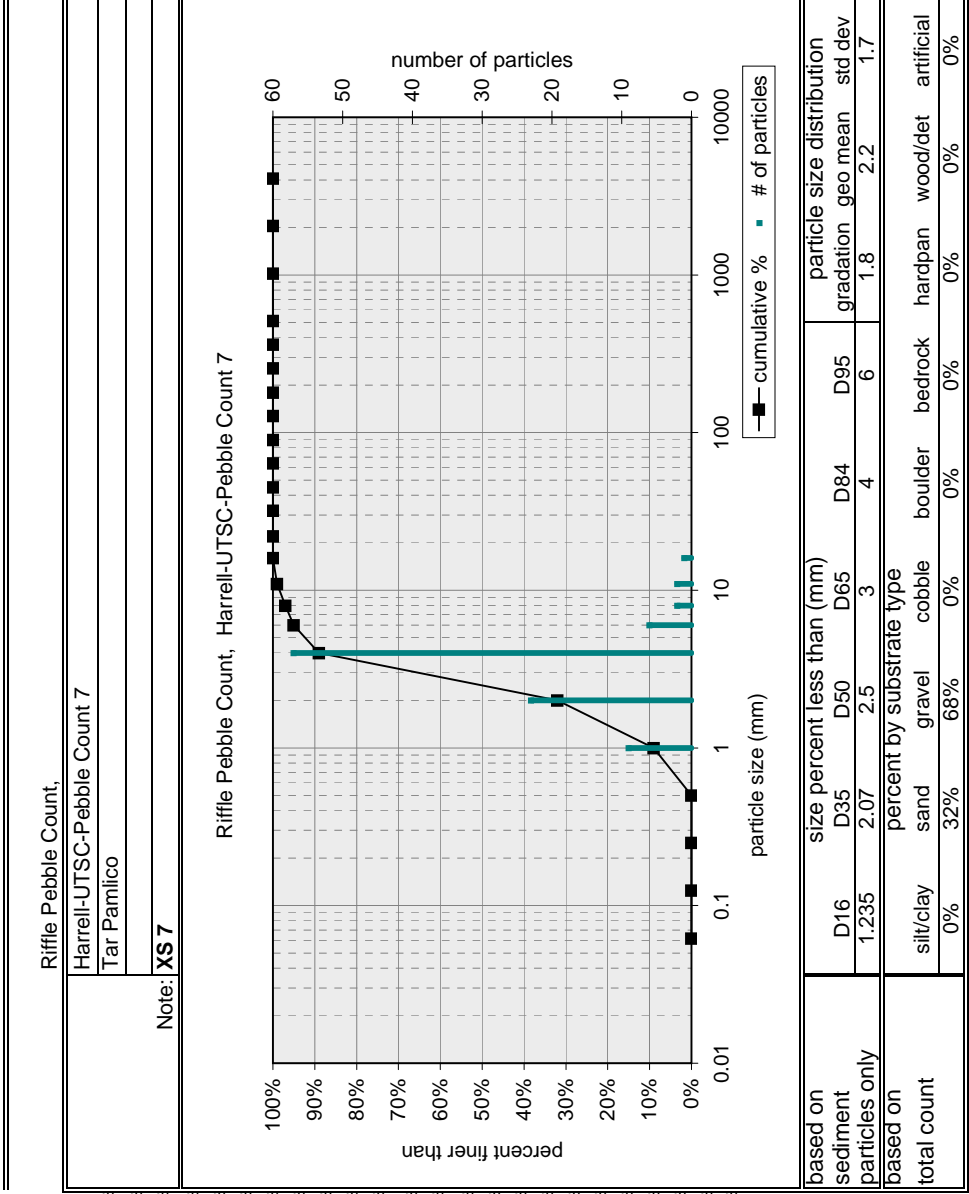
**Pebble Count of Channel Reach**

Material	Size Range (mm)	Count
silt/clay	0	2
very fine sand	0.062	
fine sand	0.13	
medium sand	0.25	
coarse sand	0.5	
very coarse sand	1	35
very fine gravel	2	4
fine gravel	4	51
fine gravel	6	4
fine gravel	8	6
medium gravel	11	2
medium gravel	16	
coarse gravel	22	
coarse gravel	32	
very coarse gravel	45	
very coarse gravel	64	
small cobble	90	
medium cobble	128	
large cobble	180	
very large cobble	256	
small boulder	362	
small boulder	512	
medium boulder	1024	
large boulder	2048	
very large boulder	4096	
total particle count:		100

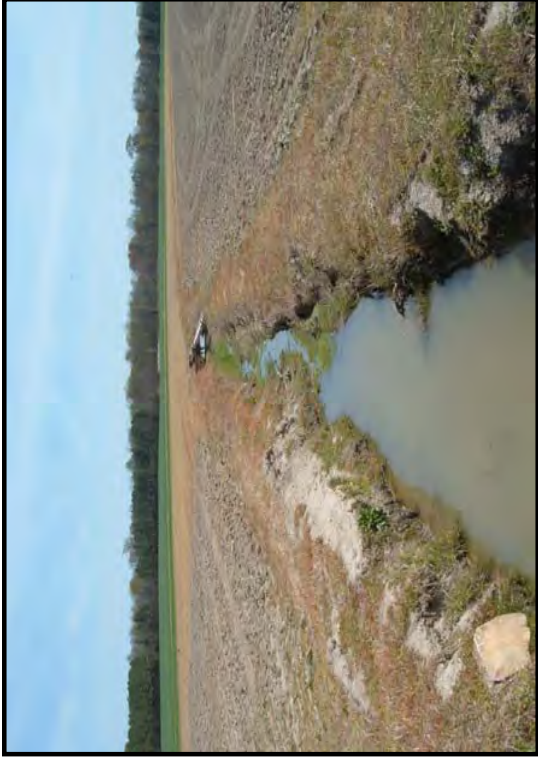
Tar-Pamlico River Basin, UTSC, XS 8

Station	Elevation
0	67.69
10	67.39
20	66.70
24	66.54
24.8	66.41
25.5	66.00
26.8	64.96
28	64.88
29	64.88
30	64.96
30.5	65.14
31.4	65.40
32.4	65.65
33	65.96
34	66.89
35	67.19
36	67.25
38	67.20
46	66.89
56	67.40
60	67.58

SUMMARY DATA	
<b>Bankfull Elevation:</b>	66.4
<b>Bankfull Cross-Sectional Area:</b>	10.4
<b>Bankfull Width:</b>	9.6
<b>Flood Prone Area Elevation:</b>	67.9
<b>Flood Prone Width:</b>	>70
<b>Max Depth at Bankfull:</b>	1.5
<b>Mean Depth at Bankfull:</b>	1.1
<b>W / D Ratio:</b>	8.8
<b>Entrenchment Ratio:</b>	7.3
<b>Bank Height Ratio:</b>	1.0
<b>Slope (ft/ft):</b>	0.004
<b>Discharge (cfs)</b>	31

Stream Type: E5

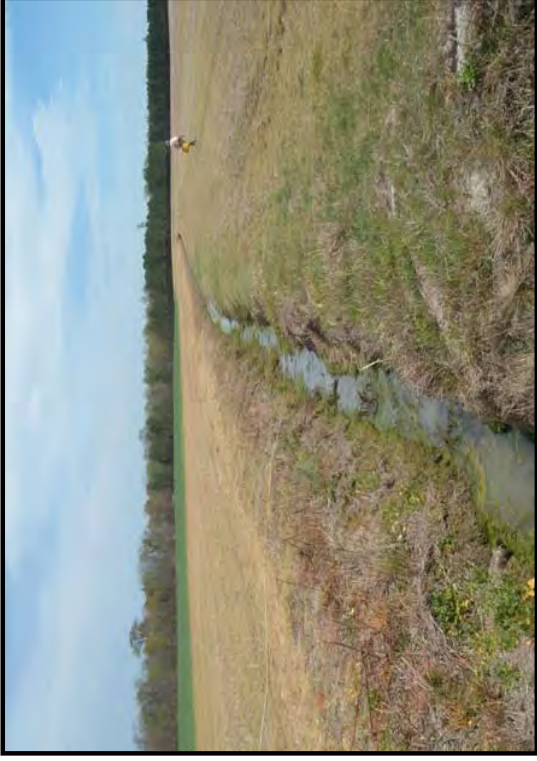
<b>River Basin:</b>	Tar-Pamlico
<b>Watershed:</b>	UTSC
<b>XS ID</b>	XS 9
<b>Drainage Area (sq mi):</b>	0.605
<b>Date:</b>	April 2006
<b>Field Crew:</b>	Hayes, Helms, Patterson

Stream Type: E5

Station	Elevation
0	68.50
10	67.99
20	67.47
30	66.59
36	66.69
39	66.27
41.4	65.54
42	64.67
42.7	64.09
43.5	63.55
44.2	63.51
45.3	63.69
46	64.69
46.5	65.27
48	66.11
50	66.32
60	66.37
70	66.69
75	66.57

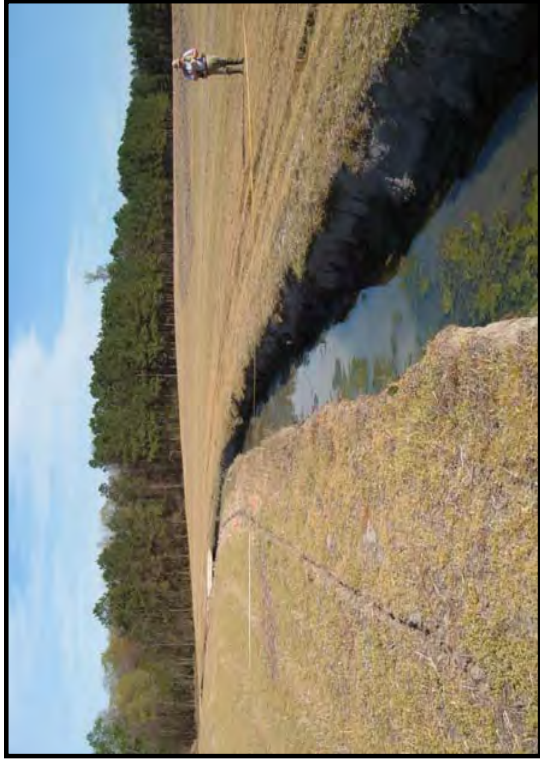
<b>River Basin:</b>	Tar-Pamlico
<b>Watershed:</b>	UTSC
<b>XS ID</b>	XS 10
<b>Drainage Area (sq mi):</b>	0.605
<b>Date:</b>	April 2006
<b>Field Crew:</b>	Hayes, Helms, Patterson

**Stream Type:** E5

SUMMARY DATA	
<b>Bankfull Elevation:</b>	63.8
<b>Bankfull Cross-Sectional Area:</b>	18.4
<b>Bankfull Width:</b>	8.4
<b>Flood Prone Area Elevation:</b>	66.8
<b>Flood Prone Width:</b>	>60
<b>Max Depth at Bankfull:</b>	3.0
<b>Mean Depth at Bankfull:</b>	2.2
<b>W / D Ratio:</b>	3.8
<b>Entrenchment Ratio:</b>	7.1
<b>Bank Height Ratio:</b>	1.2
<b>Slope (ft/ft):</b>	0.00026
<b>Discharge (cfs)</b>	20

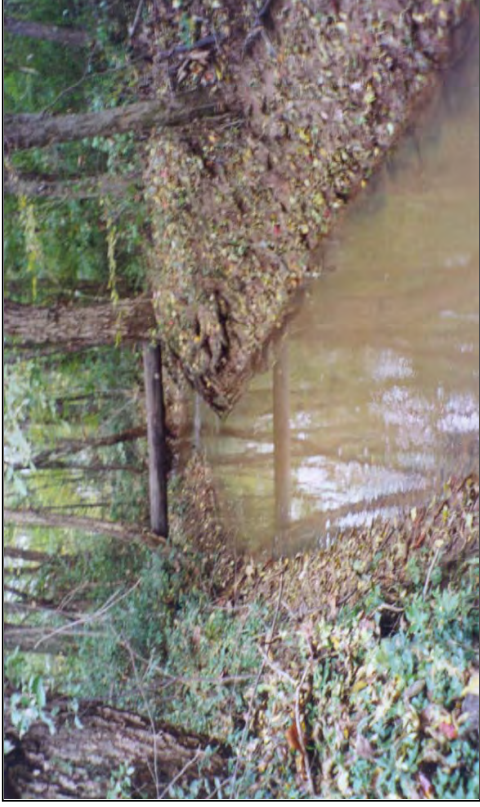
<b>River Basin:</b>	Cape Fear
<b>Watershed:</b>	North Prong (Northeast Creek)
<b>XS ID</b>	XS 1 Riffle
<b>Drainage Area (sq mi):</b>	3.04
<b>Date:</b>	September 2002
<b>Field Crew:</b>

Stream Type: C5

SUMMARY DATA	
Bankfull Elevation:	99.7
Bankfull Cross-Sectional Area:	22.6
Bankfull Width:	13.6
Flood Prone Area Elevation:	102.3
Flood Prone Width:	325.0
Max Depth at Bankfull:	2.6
Mean Depth at Bankfull:	1.7
W/D Ratio:	8.2
Entrenchment Ratio:	23.8
Bank Height Ratio:	1.0
Slope (ft/ft):	0.002
Discharge (cfs)	70

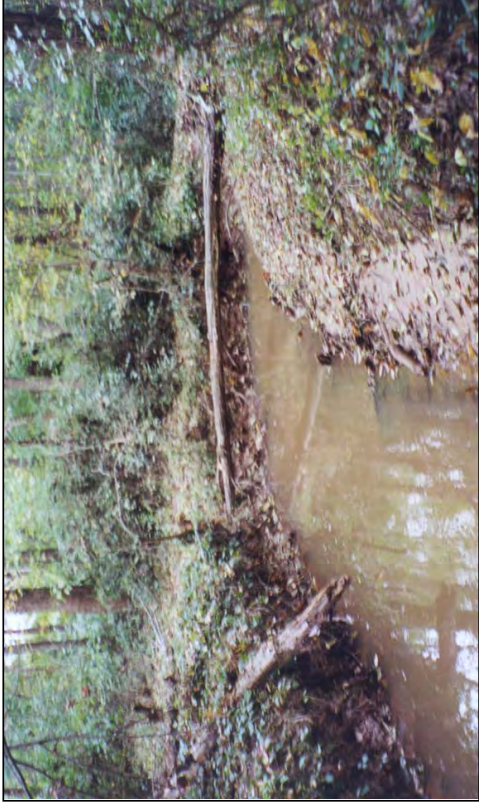
<b>River Basin:</b>	Cape Fear
<b>Watershed:</b>	North Prong (Northeast Creek)
<b>XS ID</b>	XS 3 Pool
<b>Drainage Area (sq mi):</b>	3.04
<b>Date:</b>	November 2002
<b>Field Crew:</b>

Stream Type: C5

SUMMARY DATA	
Bankfull Elevation:	99.6
Bankfull Cross-Sectional Area:	30.9
Bankfull Width:	26.1
Flood Prone Area Elevation:	
Flood Prone Width:	
Max Depth at Bankfull:	3.7
Mean Depth at Bankfull:	1.2
W / D Ratio:	21.8
Entrenchment Ratio:	
Bank Height Ratio:	1.0
Slope (ft/ft):	0.000
Discharge (cfs)

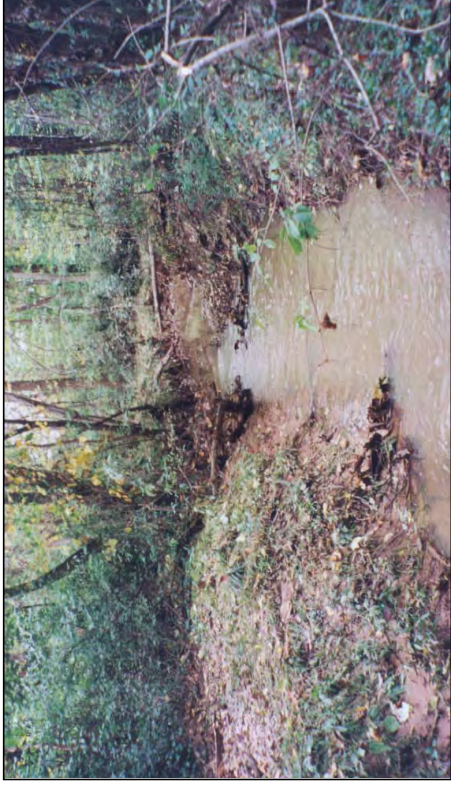
<b>River Basin:</b>	Cape Fear
<b>Watershed:</b>	North Prong (Northeast Creek)
<b>XS ID</b>	XS 4 Riffle
<b>Drainage Area (sq mi):</b>	3.04
<b>Date:</b>	September 2002
<b>Field Crew:</b>

Stream Type: C5

SUMMARY DATA	
Bankfull Elevation:	99.2
Bankfull Cross-Sectional Area:	26.2
Bankfull Width:	17.8
Flood Prone Area Elevation:	102.2
Flood Prone Width:	600.0
Max Depth at Bankfull:	3.0
Mean Depth at Bankfull:	1.5
W/D Ratio:	11.9
Entrenchment Ratio:	33.7
Bank Height Ratio:	1.0
Slope (ft/ft):	0.003
Discharge (cfs)	83

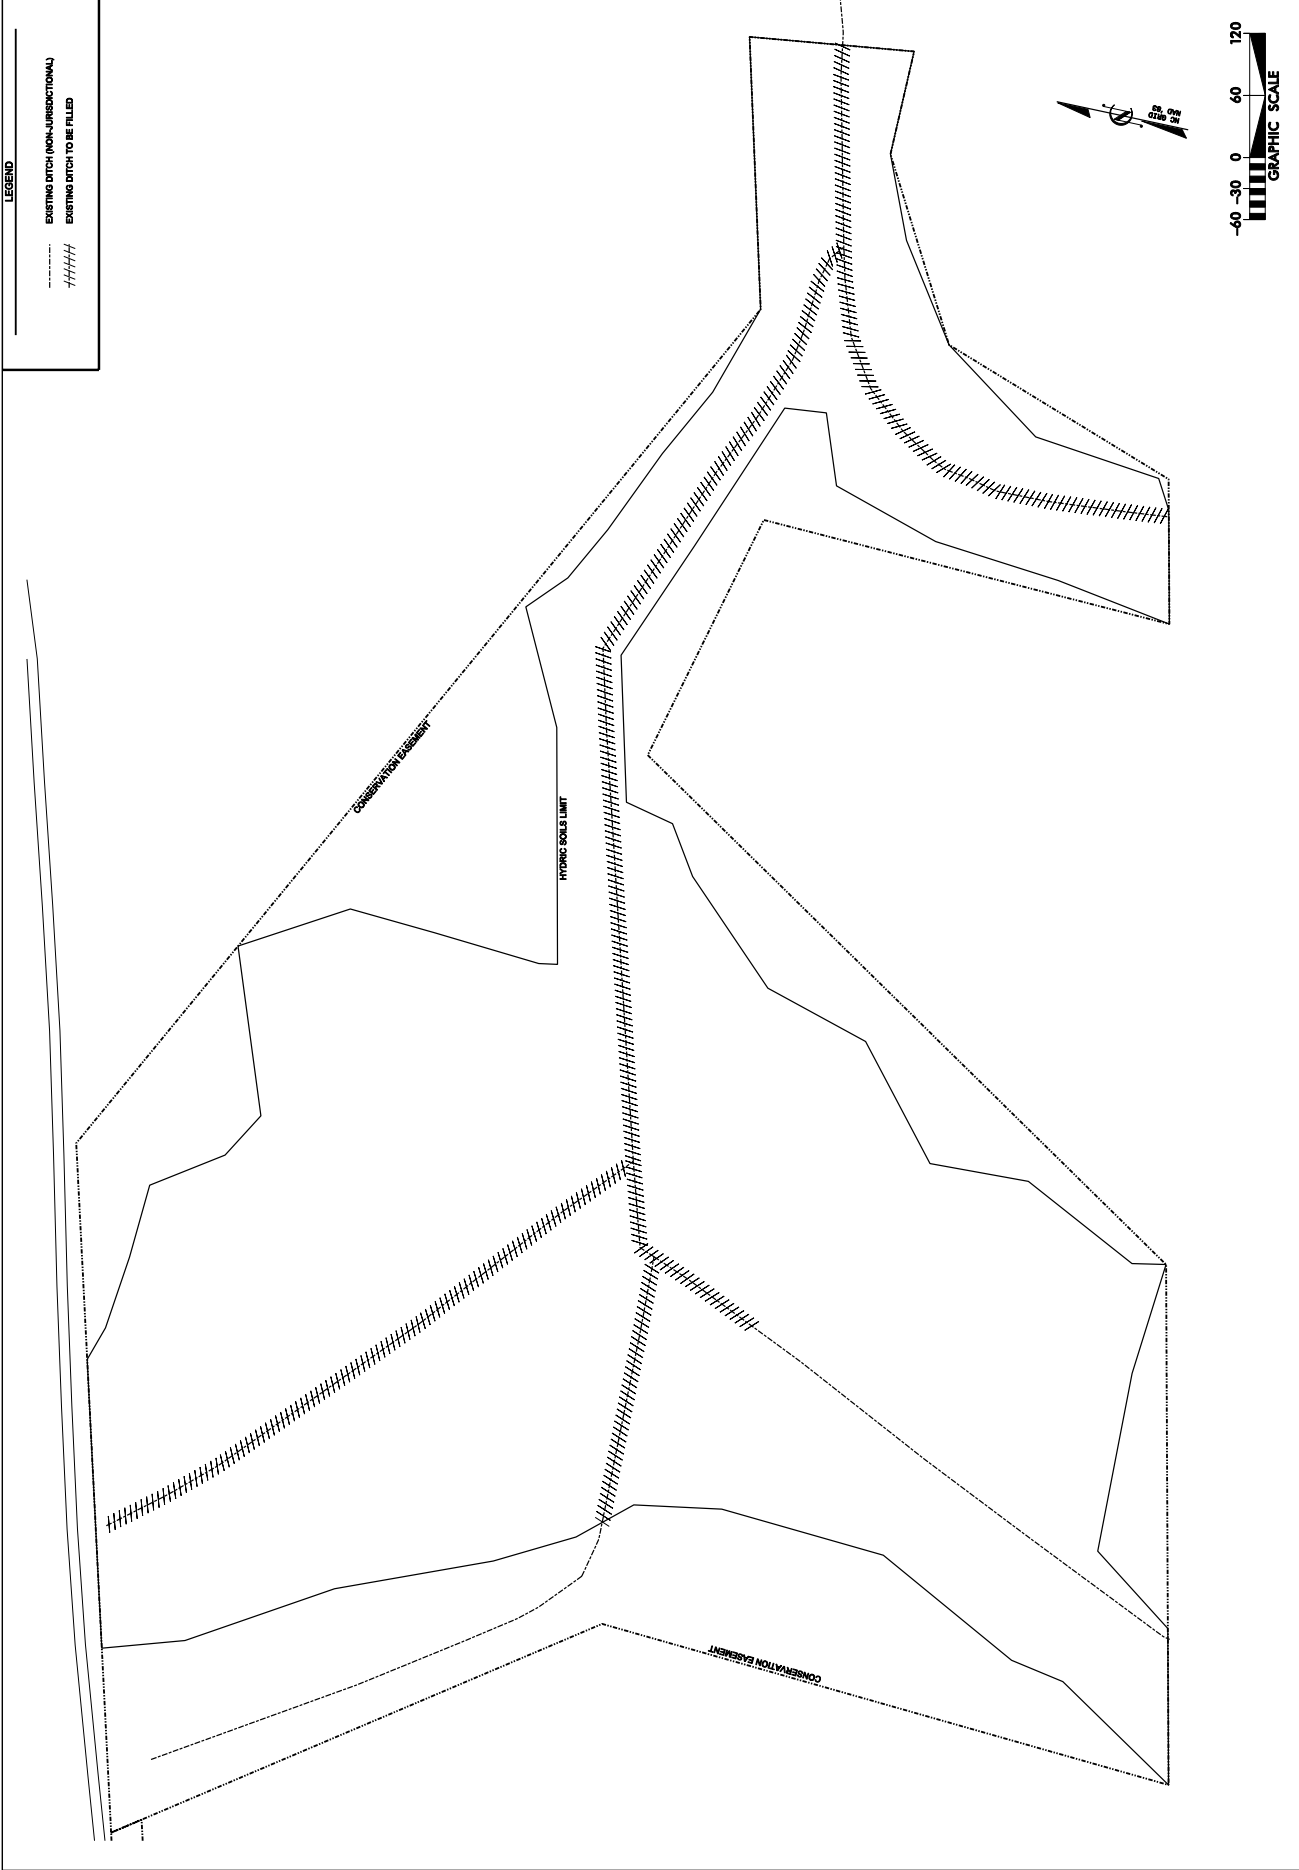
SITE PLAN

To restore the wetland, the existing ditch network will be plugged and filled to block water from leaving the site. Ditch plugs will be placed in the four existing ditch outlets. At the downstream end of the wetland site, a rock-stabilized outlet will be installed to prevent the channel from reforming. In addition to blocking the major outlets from the site, KCI will also recreate wetland microtopography. The site will be graded to form small depressions and rises throughout the site that resemble the minor variations in elevation found in a natural wetland system. These modifications will allow precipitation and overland flow to remain on the wetland site. The removal of the ditches will also raise the groundwater level.

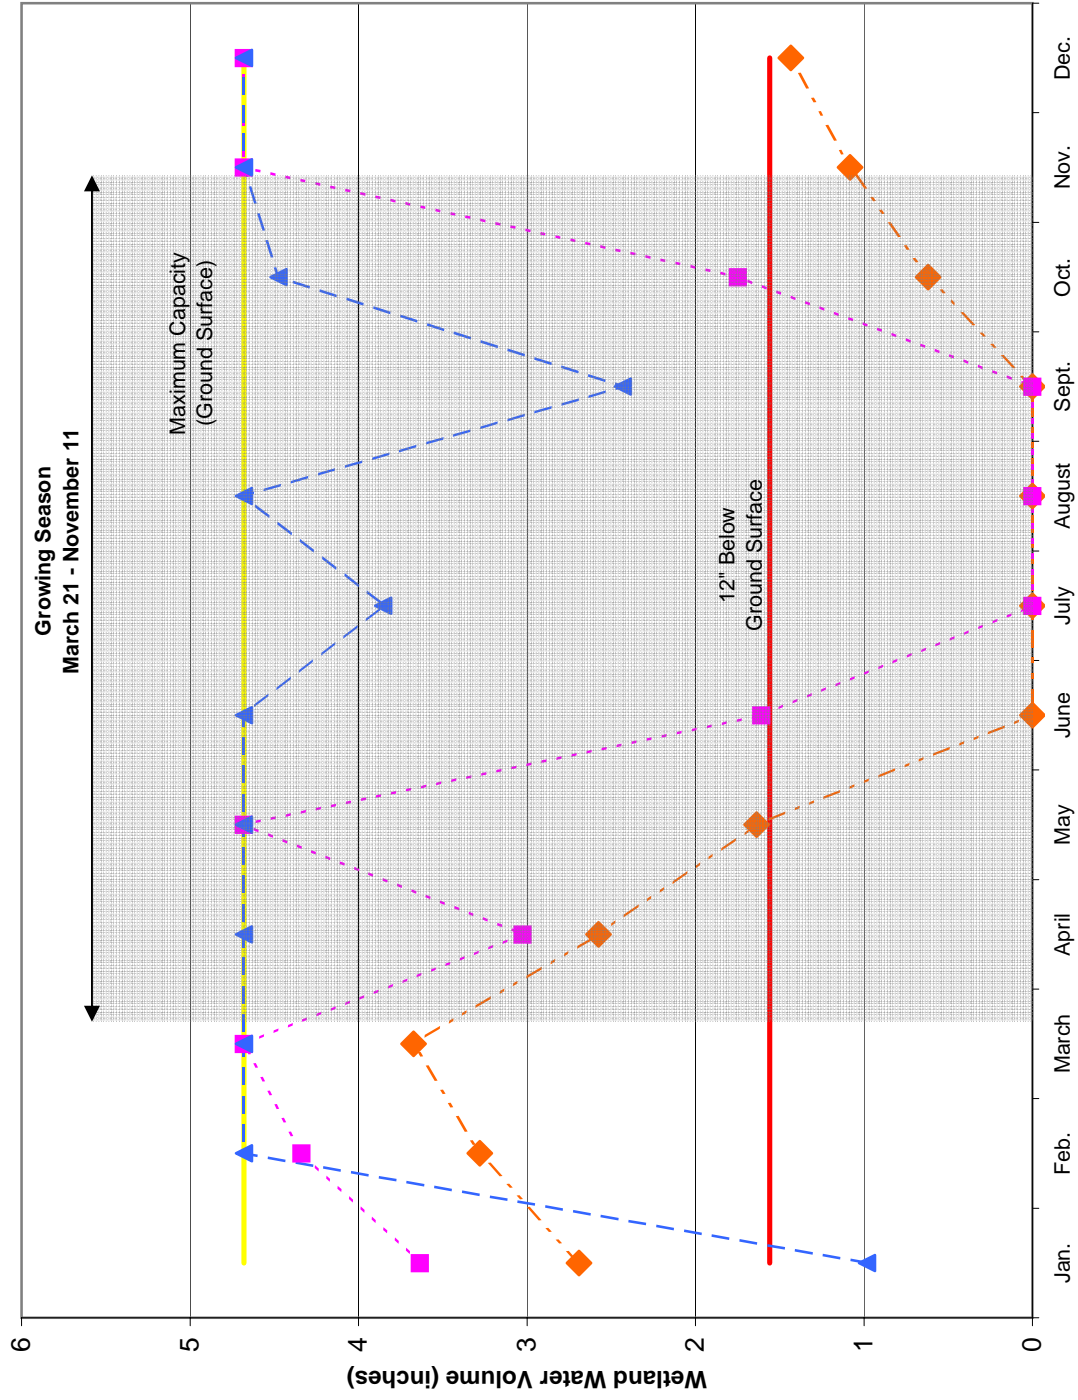
# Water Budget Proposed Conditions

- 4.68 in - Maximum Capacity/Soil Surface
- 1.56 in. - Jurisdictional Boundary (12" below ground)
- Dry Year (1988)
- Average Year (1977)
- Wet Year (1989)
