Harrell Stream and Wetland Restoration Site Monitoring Report – MY03 Edgecombe County, NC

December 2010

**Project Manager: Gary M. Mryncza, P.H., P.E.
Email: gary.mryncza@kci.com
KCI Project No: 12054239_MO10**

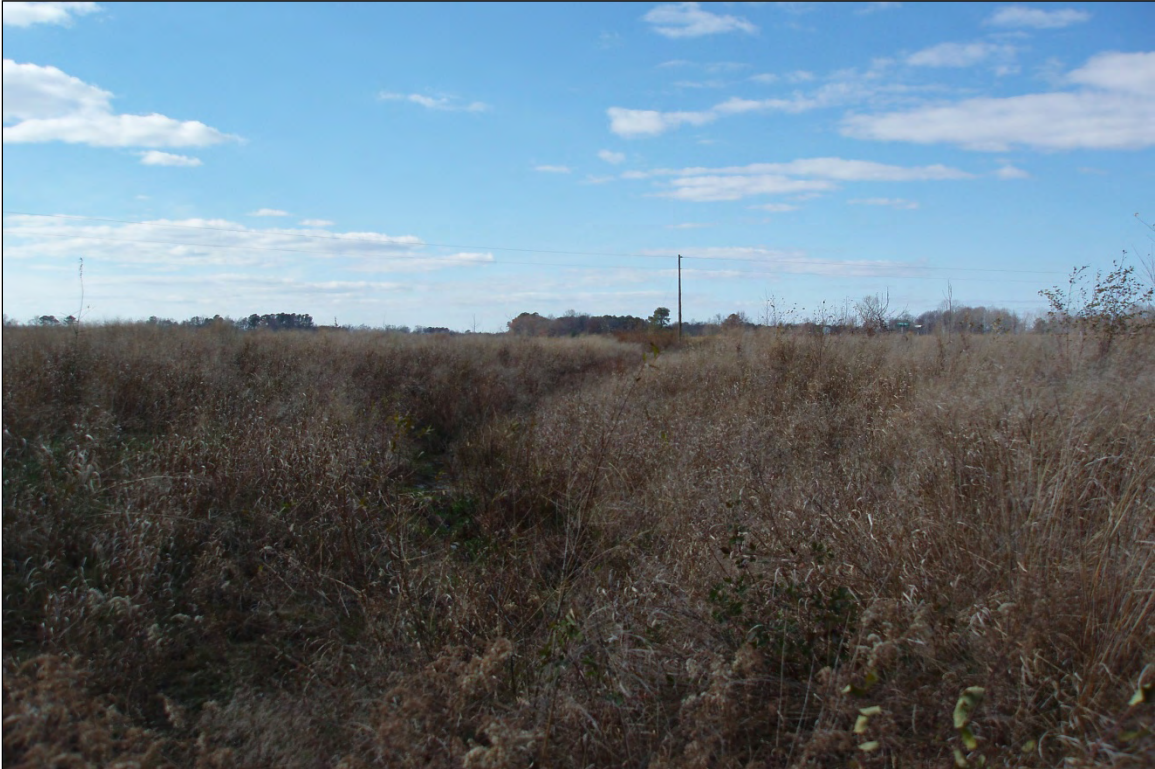
Photo Point S1: View looking upstream near Station 12+75. 12/6/10 – MY-03

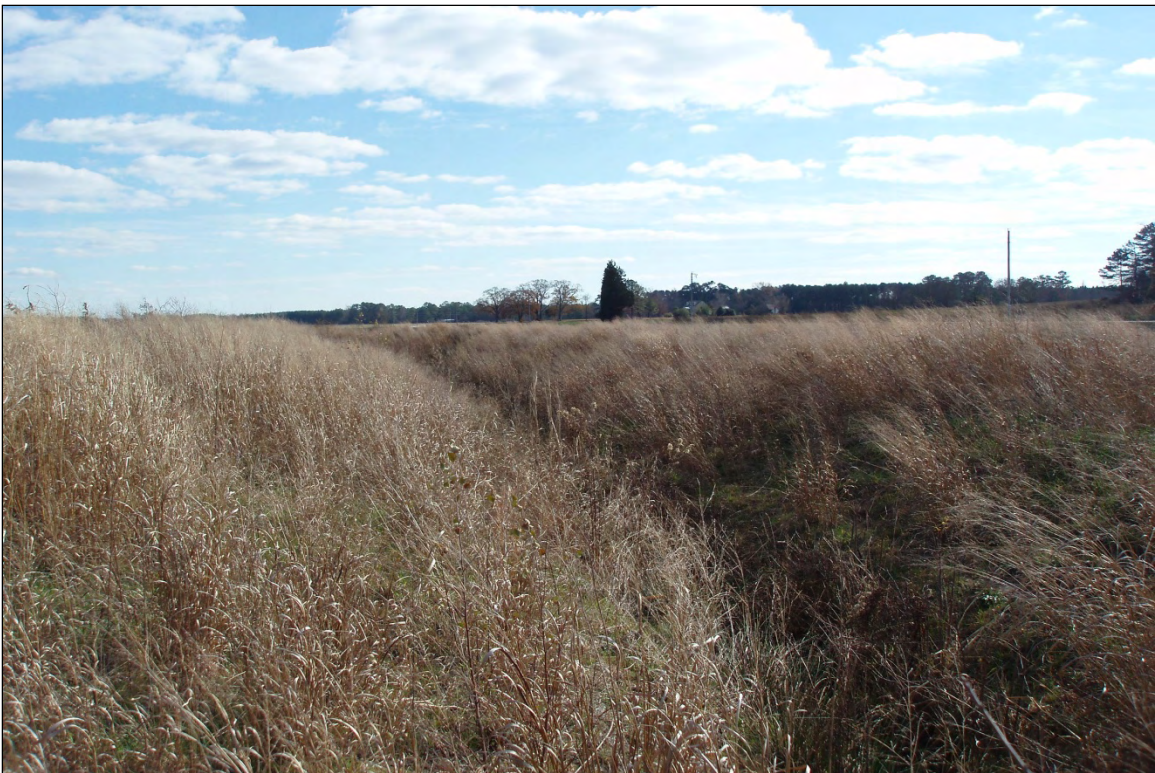
Photo Point S1: View looking downstream near Station 12+75. 12/6/10 – MY-03

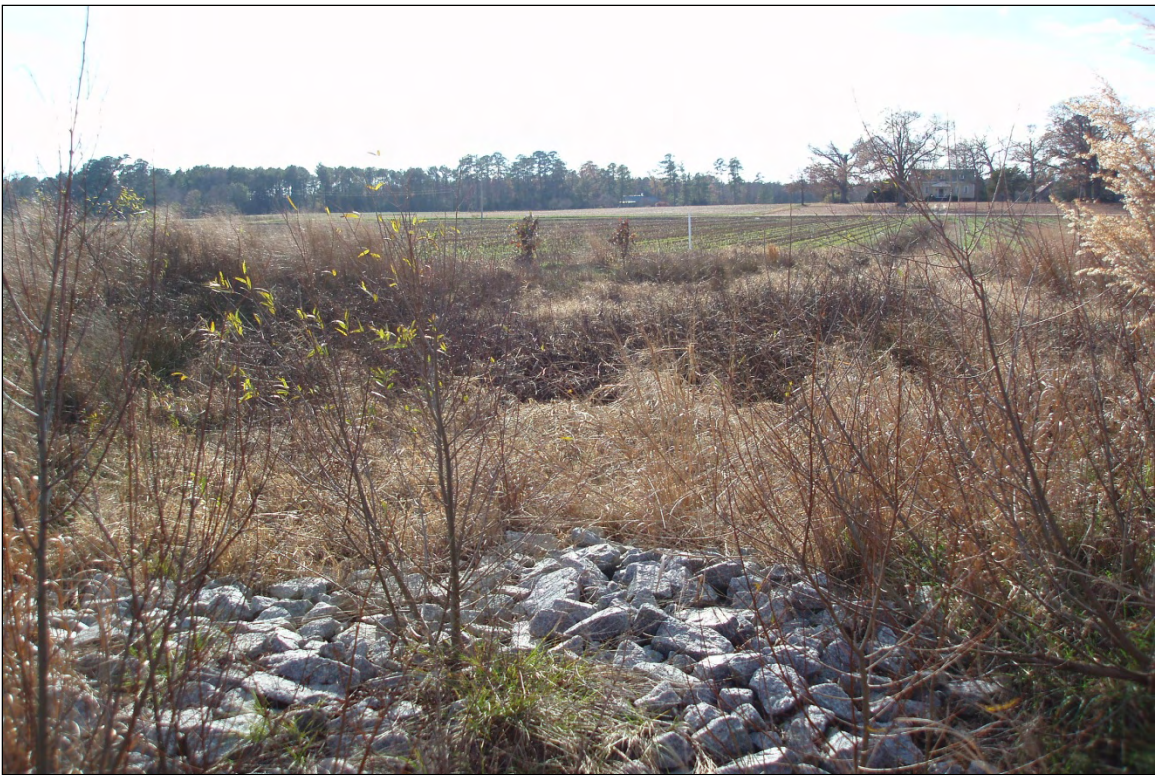
Photo Point S4: View of water quality treatment structure near Station 32+25. 12/6/10 – MY-03

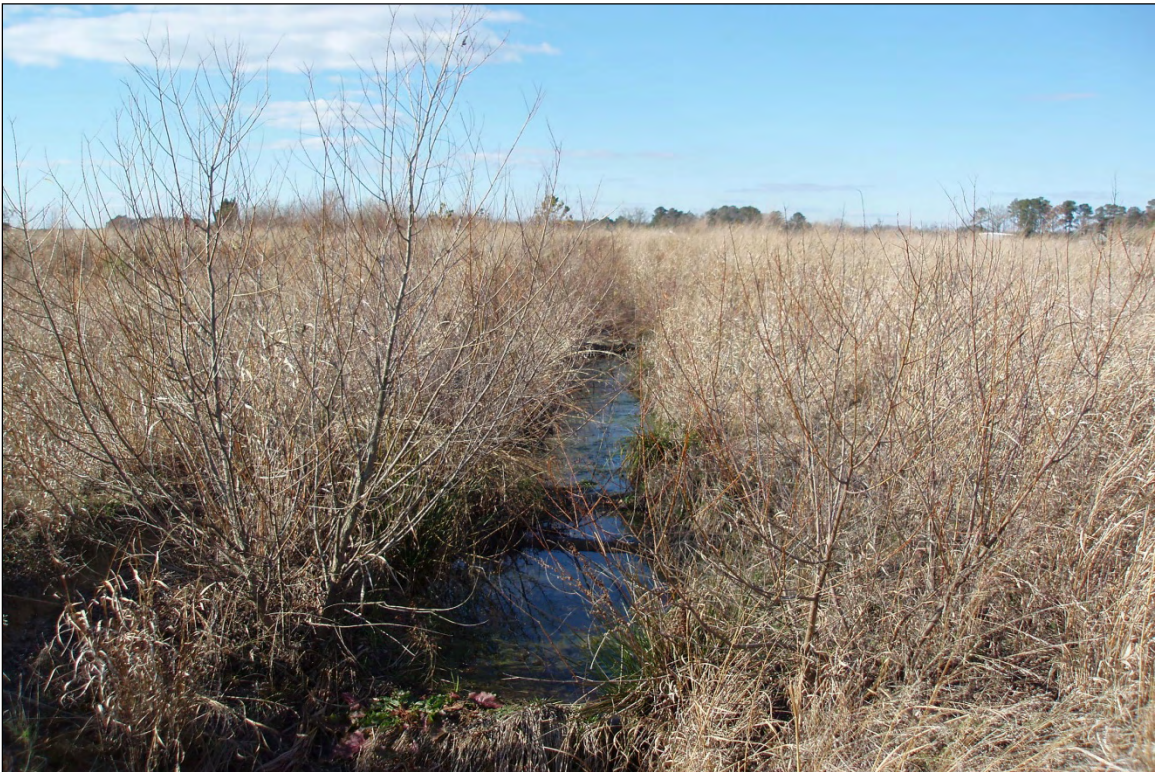
Photo Point S5: View looking at log drop structures, near Station 33+35. 12/6/10 – MY-03

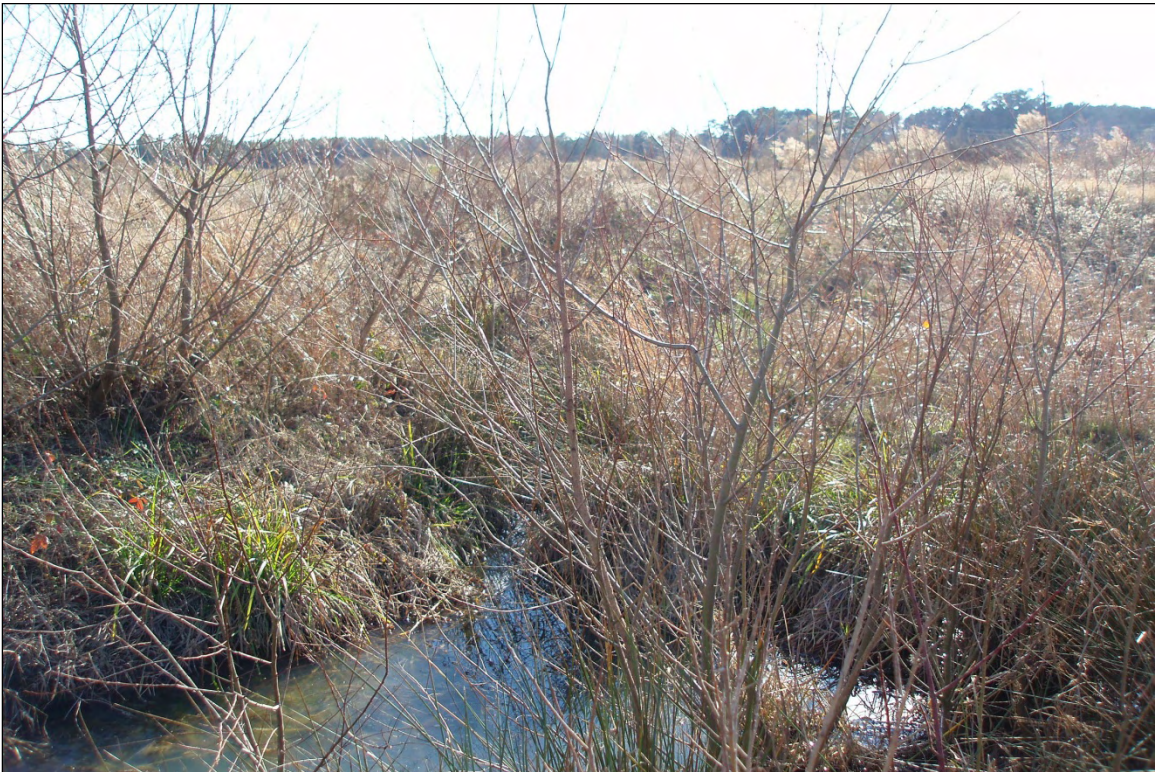
Photo Point S6: View of incoming drainage ditch near Station 37+25. 12/6/10 – MY-03

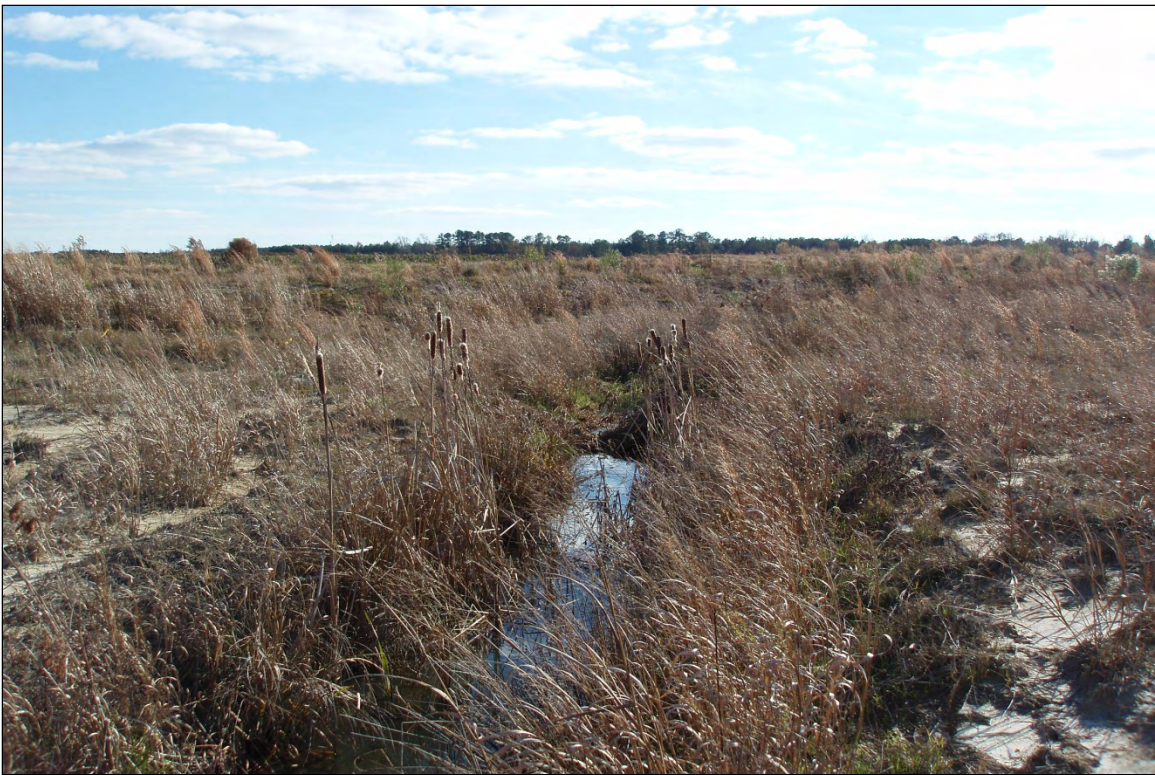
Photo Point S8: View of log drop structure near Station 39+50. 12/6/10 – MY-03

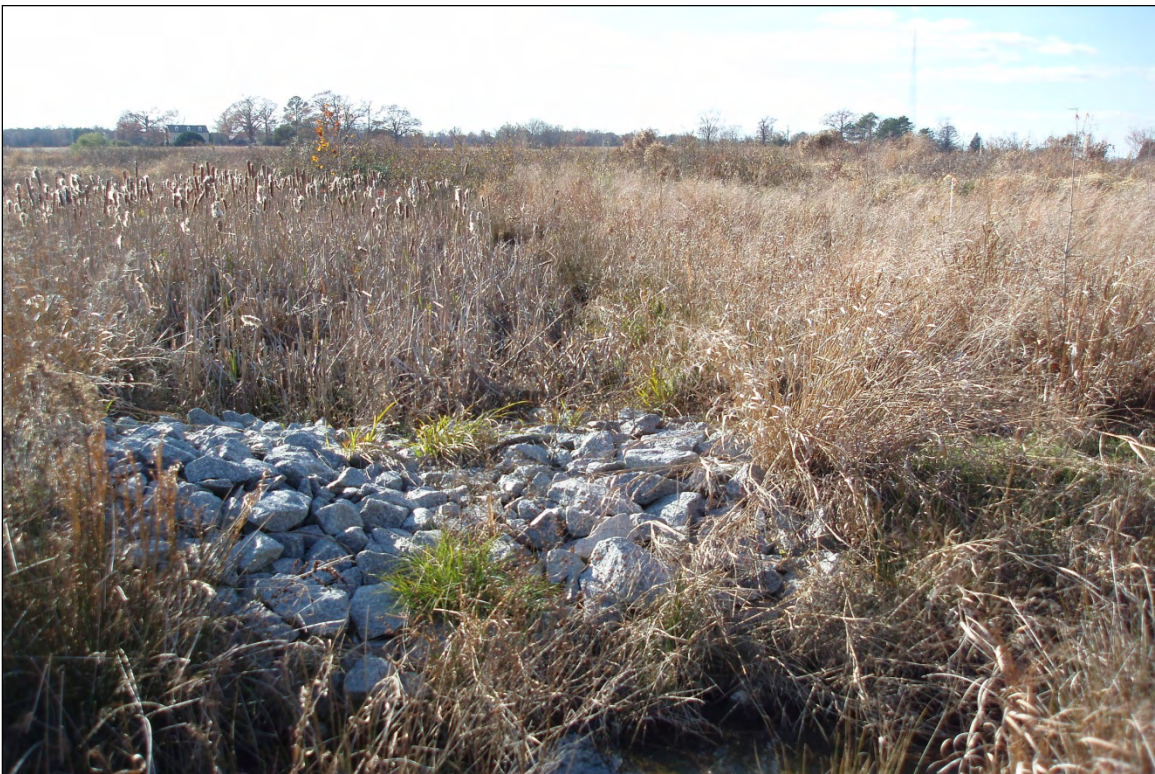
Photo Point S9: View of water quality treatment structure near Station 41+75. 12/6/10 – MY-03

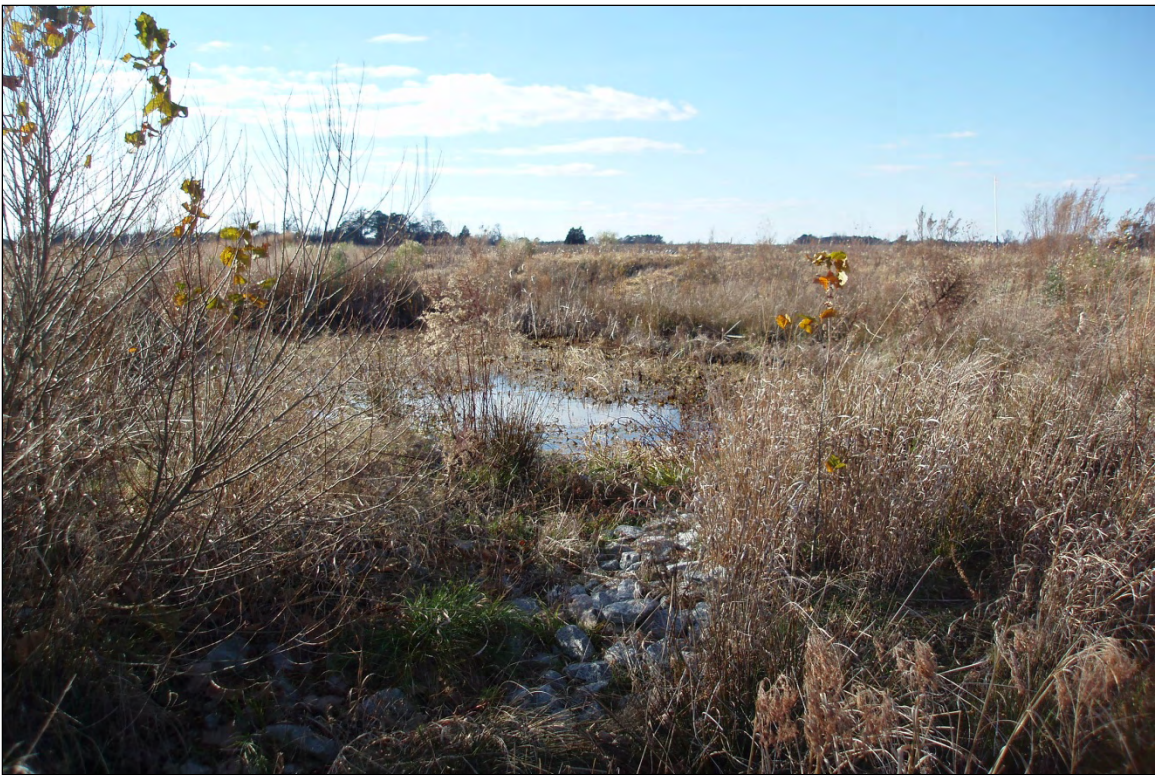
Photo Point S11: View of water quality treatment structure near Station 47+00. 12/6/10 – MY-03

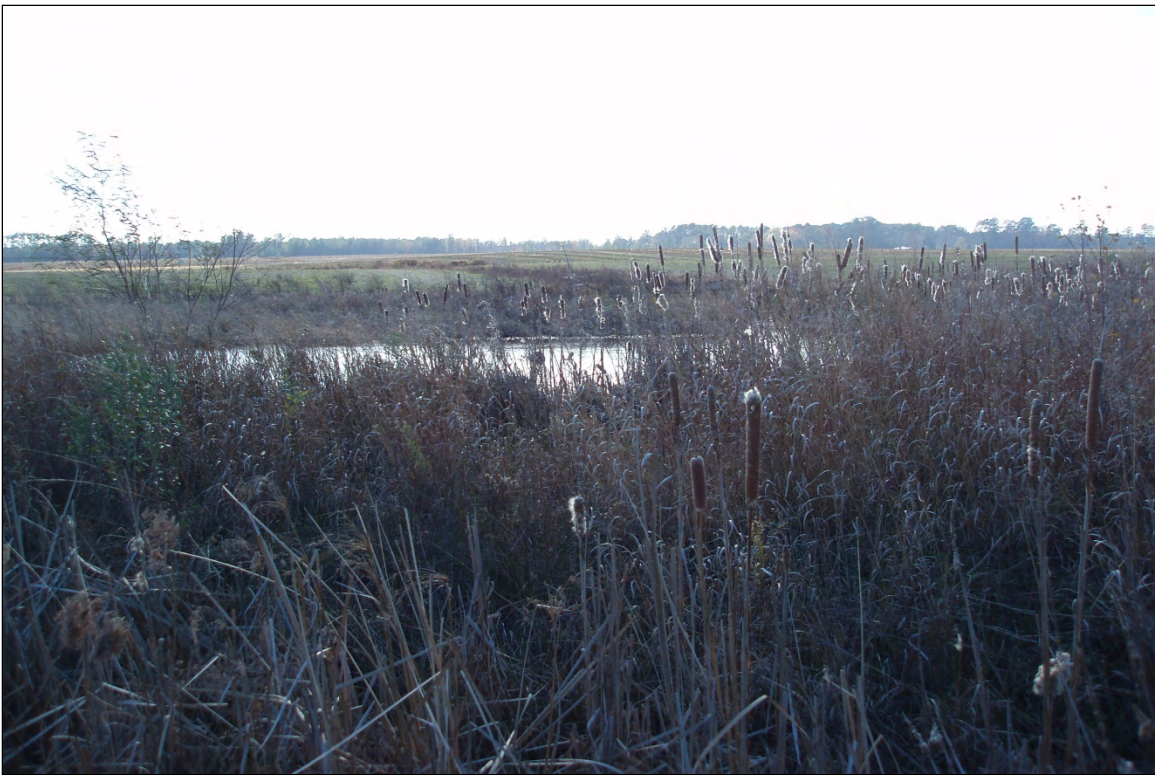
Photo Point S13: View of water quality treatment structure near Station 61+50. 12/6/10 – MY-03

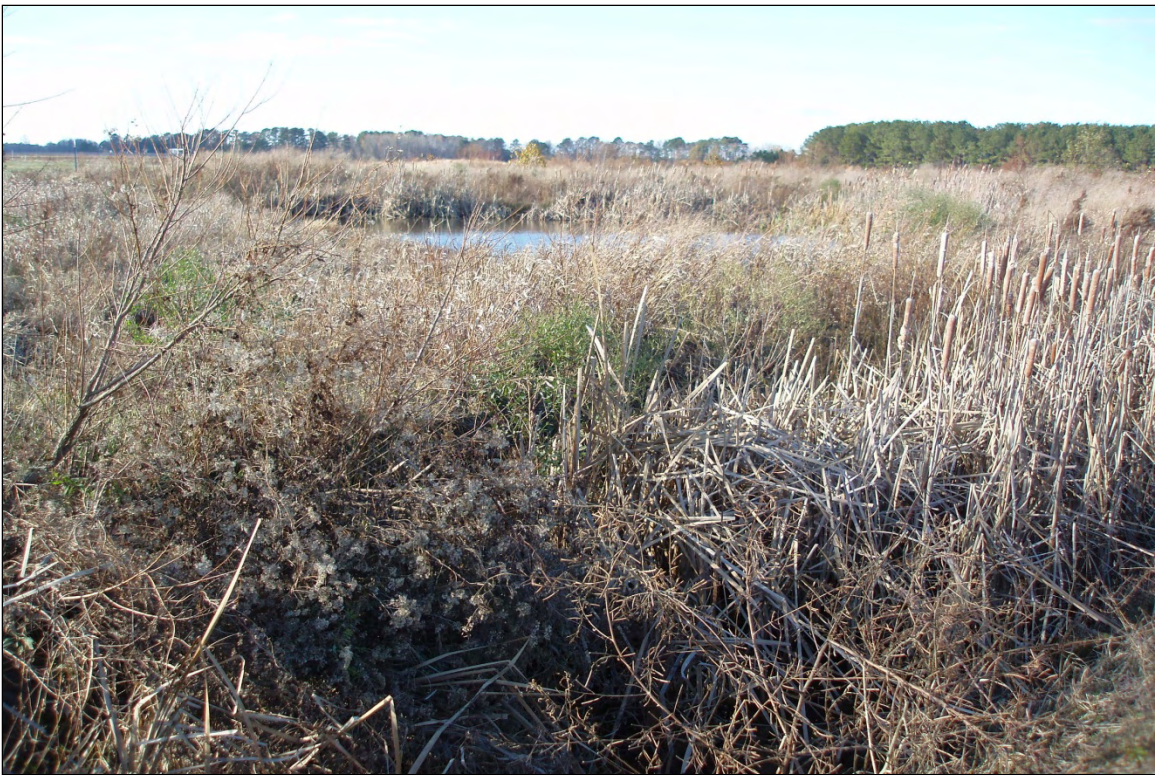
Photo Point S14: View of stream with water quality treatment structure in the background near Station 62+60. 12/6/10 – MY-03

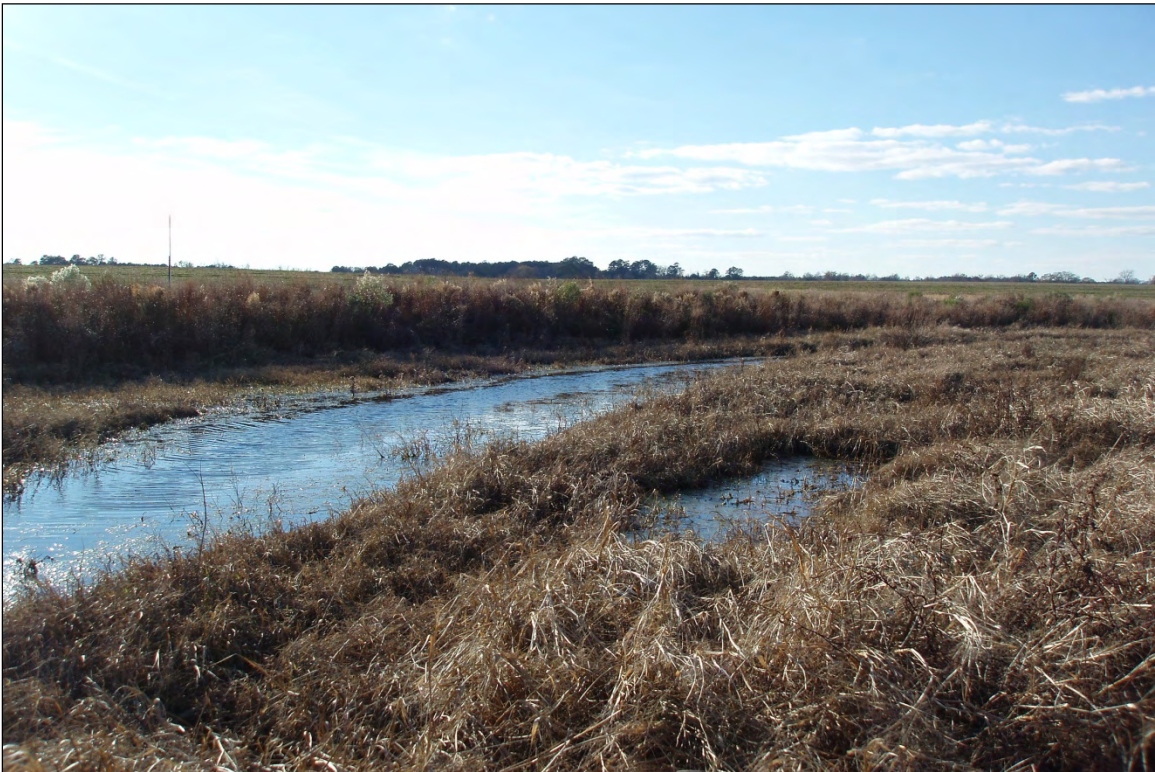
Photo Point S16: View looking upstream near Station 76+75. (Photo taken farther away from stream due to water depth) 12/6/10 – MY-03

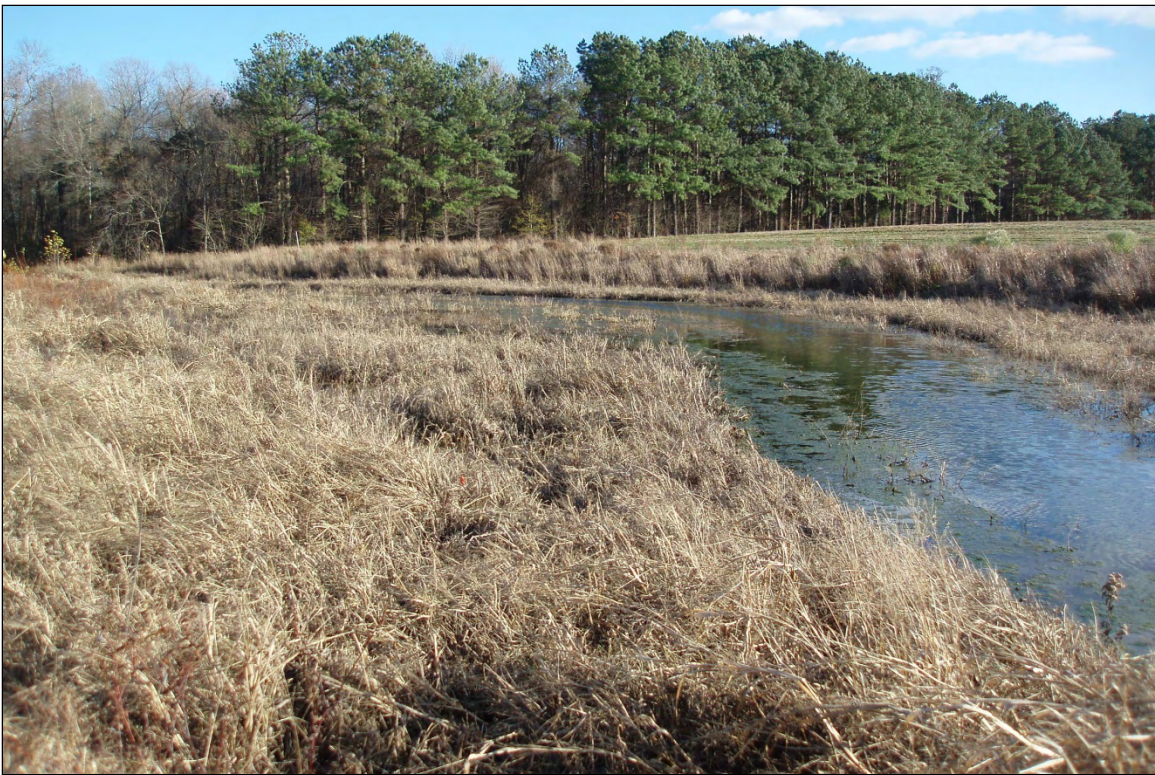
Photo Point S16: View looking downstream toward project end before the stream joins Swift Creek near Station 76+75. (Photo taken farther away from stream due to water depth) 12/6/10 – MY-03

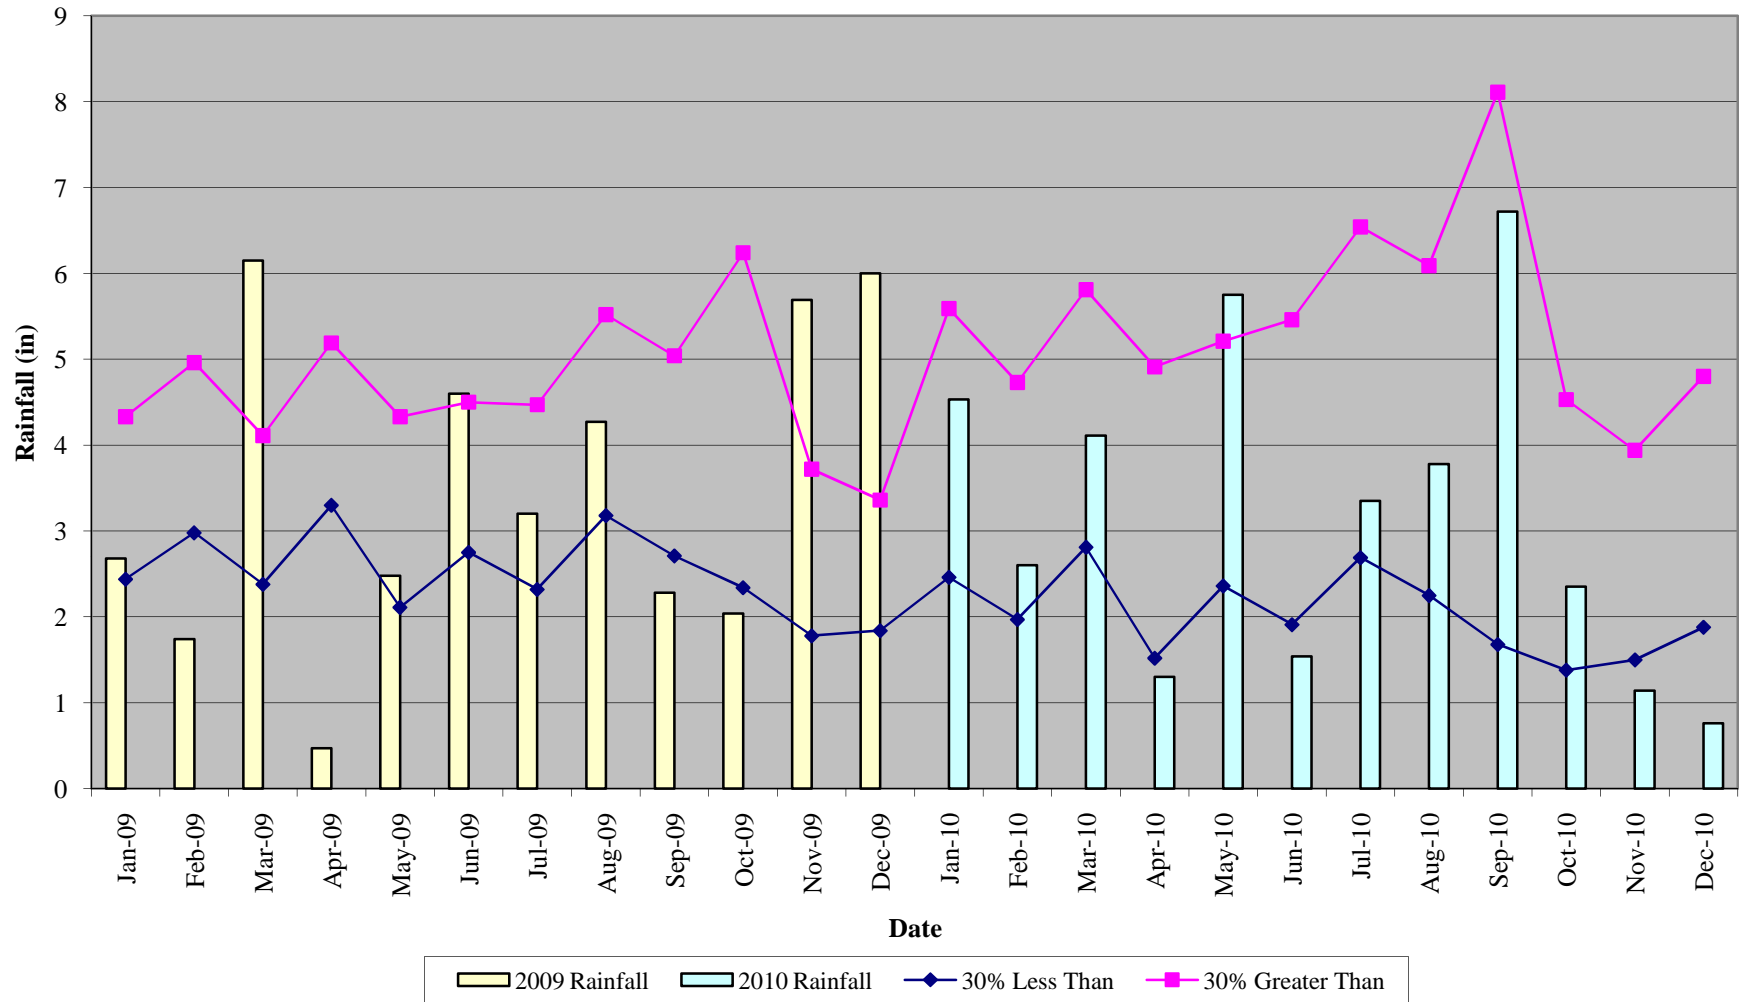
Harrell 30-70 Percentile Graph 2009-2010
Rocky Mount, NC Monthly Rainfall

The daily rainfall data depicted on the gauge data graphs were obtained from the on-site precipitation gauge. The precipitation gauge was installed on the site prior to project implementation. The daily rainfall data obtained from a local weather station shows that the area had average rainfall during the 2010 growing season and correlated to the precipitation data recorded on-site.
