Haw Branch Wetland and Stream Restoration Plan Onslow County, North Carolina

Design Report Prepared By Buck Engineering PC

January 2005
DRAFT REPORT

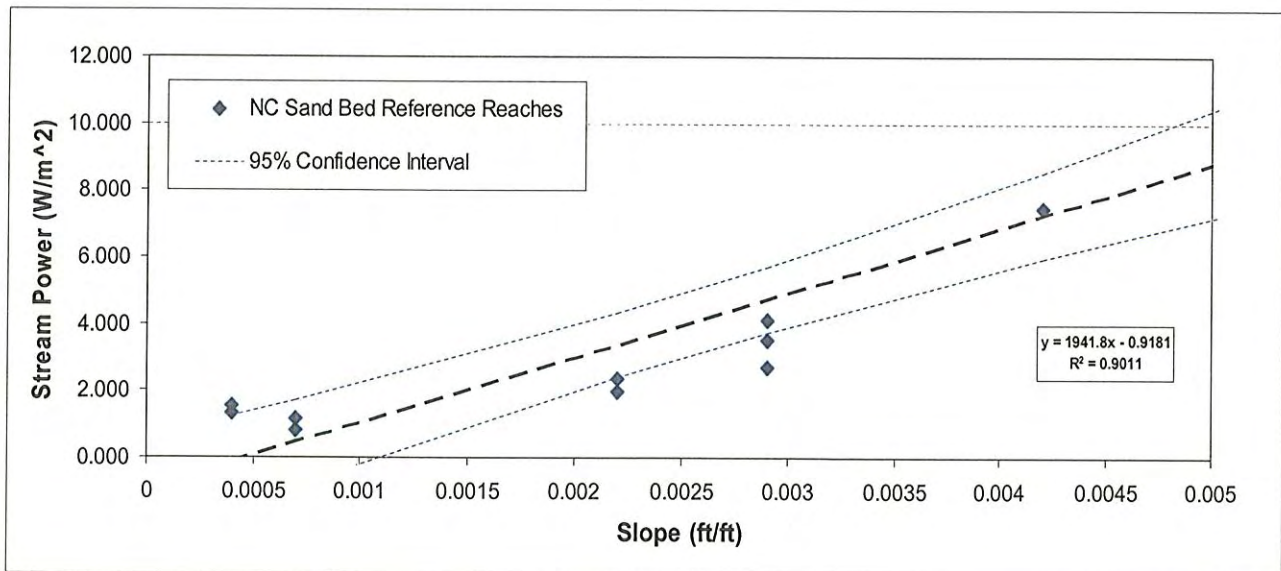
Figure 2.3

Comparison between stream power and channel slope for the design reaches and Coastal Plain reference reach data.

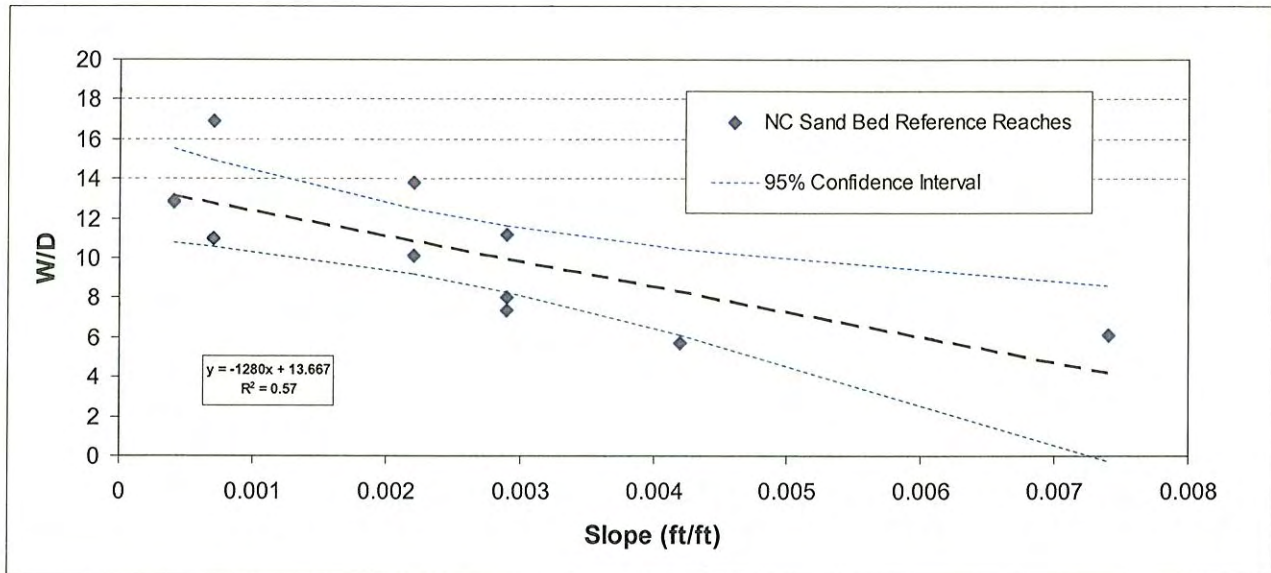
Figure 2.4

Comparison between width-to-depth ratio (W/D) and channel slope for the design reaches and Coastal Plain reference reach data.

As an additional check of stream design stability, the design width-to-depth ratios (W/D) are plotted against slope and compared with data from sand-bed reference reaches in the Coastal Plain. Data collected on sand-bed systems in the Coastal Plain of North Carolina indicate a strong correlation between W/D and slope, with W/D decreasing as channel slope increases. The design W/D ratios are compared with reference reach data in Figure 2.4, which shows bankfull W/D ratio versus channel slope. If the design points for the design reaches fall within the range of W/D values shown for reference reaches under similar slope conditions, it is even more likely that the design dimensions of the restored channels will remain stable.

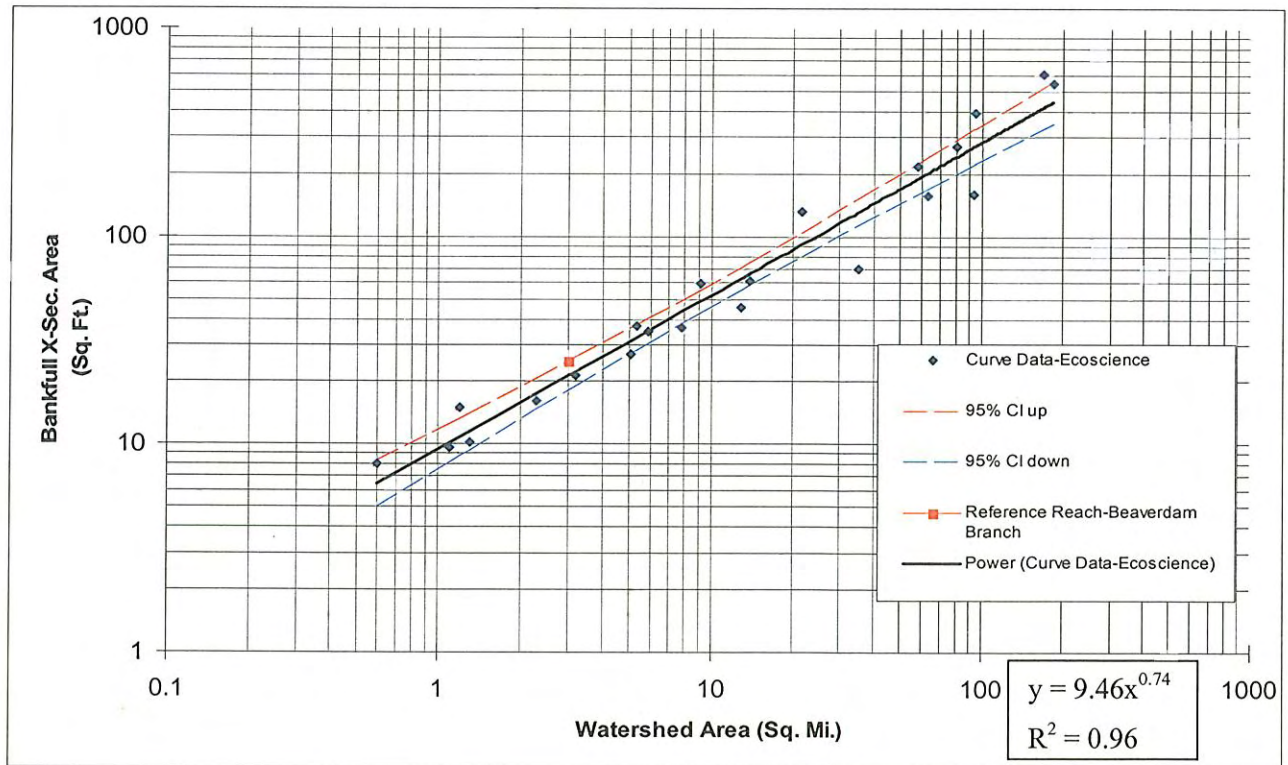
Figure 5.1

NC Coastal Plain Regional Curve, including data from the Beaverdam Branch reference reach.

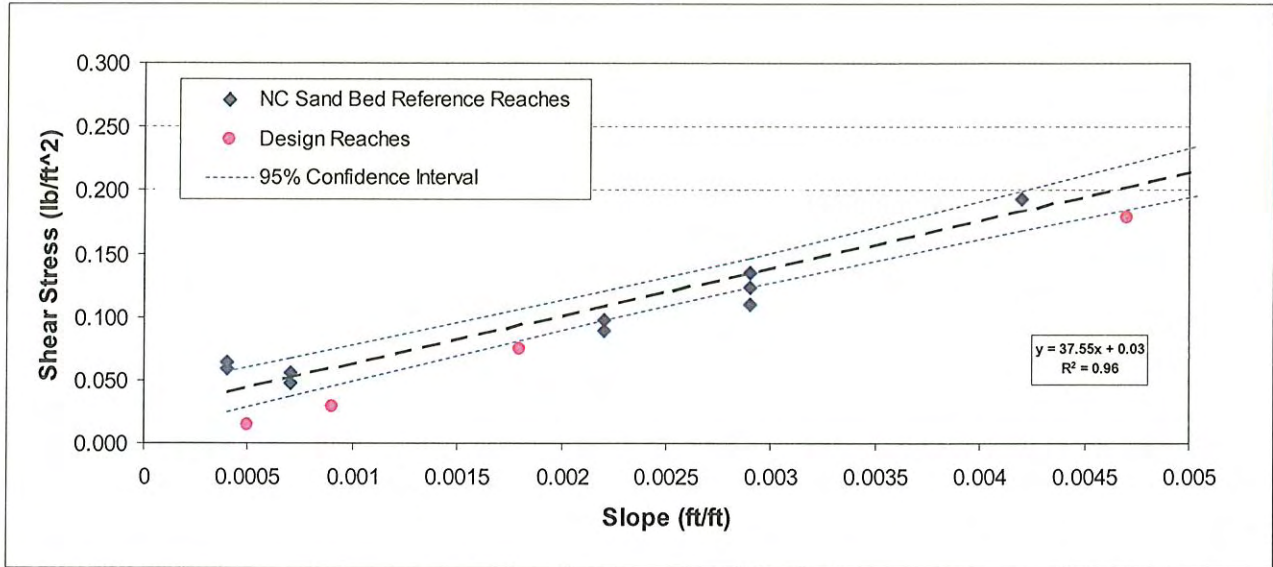
Figure 7.1

Comparison between bankfull shear stress and channel slope for the design reaches and Coastal Plain reference reach data.

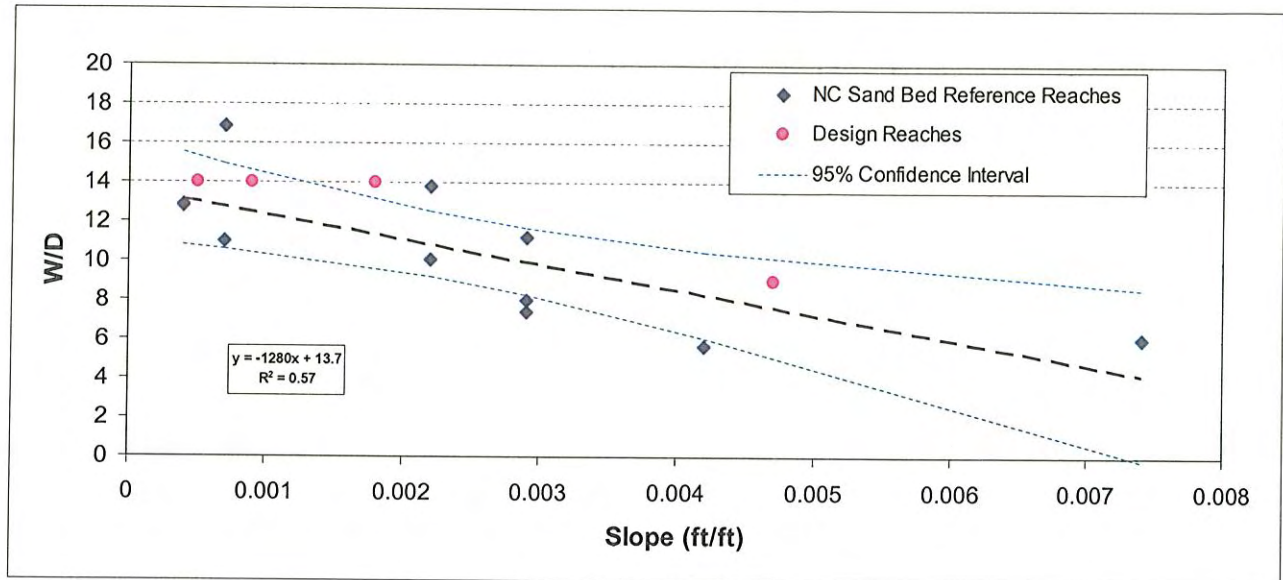
Figure 7.3

Comparison between width-to-depth ratio (W/D) and channel slope for the design reaches and Coastal Plain reference reach data.
