# ANNUAL REPORT FOR 2000

**Haws Run Mitigation Site**  
**Pender and Onslow County**  
**Project No. 6.259002T**  
**TIP No. R-2405WM**

Prepared By:  
Natural Systems Unit & Roadside Environmental Unit  
North Carolina Department of Transportation  
December 2000

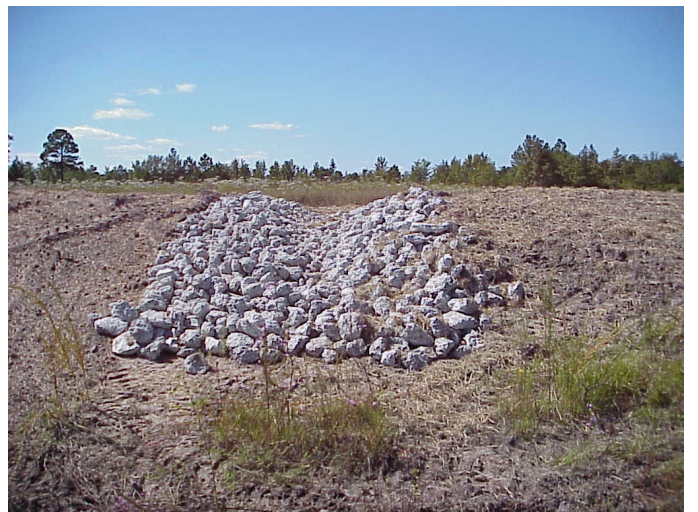
Photo 10 (Rock flume)

The washouts along the northern side of the site adjacent to the swamp forest area were repaired and are stabilizing.

NCDOT recommends grading the slope to 4:1 and backfilling the washouts. This reduced slope will minimize the potential for failure during rapid rises in the savanna area water table and erosion by surface water runoff. NCDOT recommends installing stone lined drainage channels for surface water drainage from savanna to swamp forest. NCDOT also recommends providing a low berm at top of slope along northern perimeter to direct water toward drainage channels. This should eliminate the potential of surface erosion on the slope face between the savanna and the swamp forest.
