ANNUAL REPORT FOR 2001

Haws Run Mitigation Site
Pender and Onslow County
Project No. 6.259002T
TIP No. R-2405WM

Prepared By:
Natural Systems Unit & Roadside Environmental Unit
North Carolina Department of Transportation
December 2001

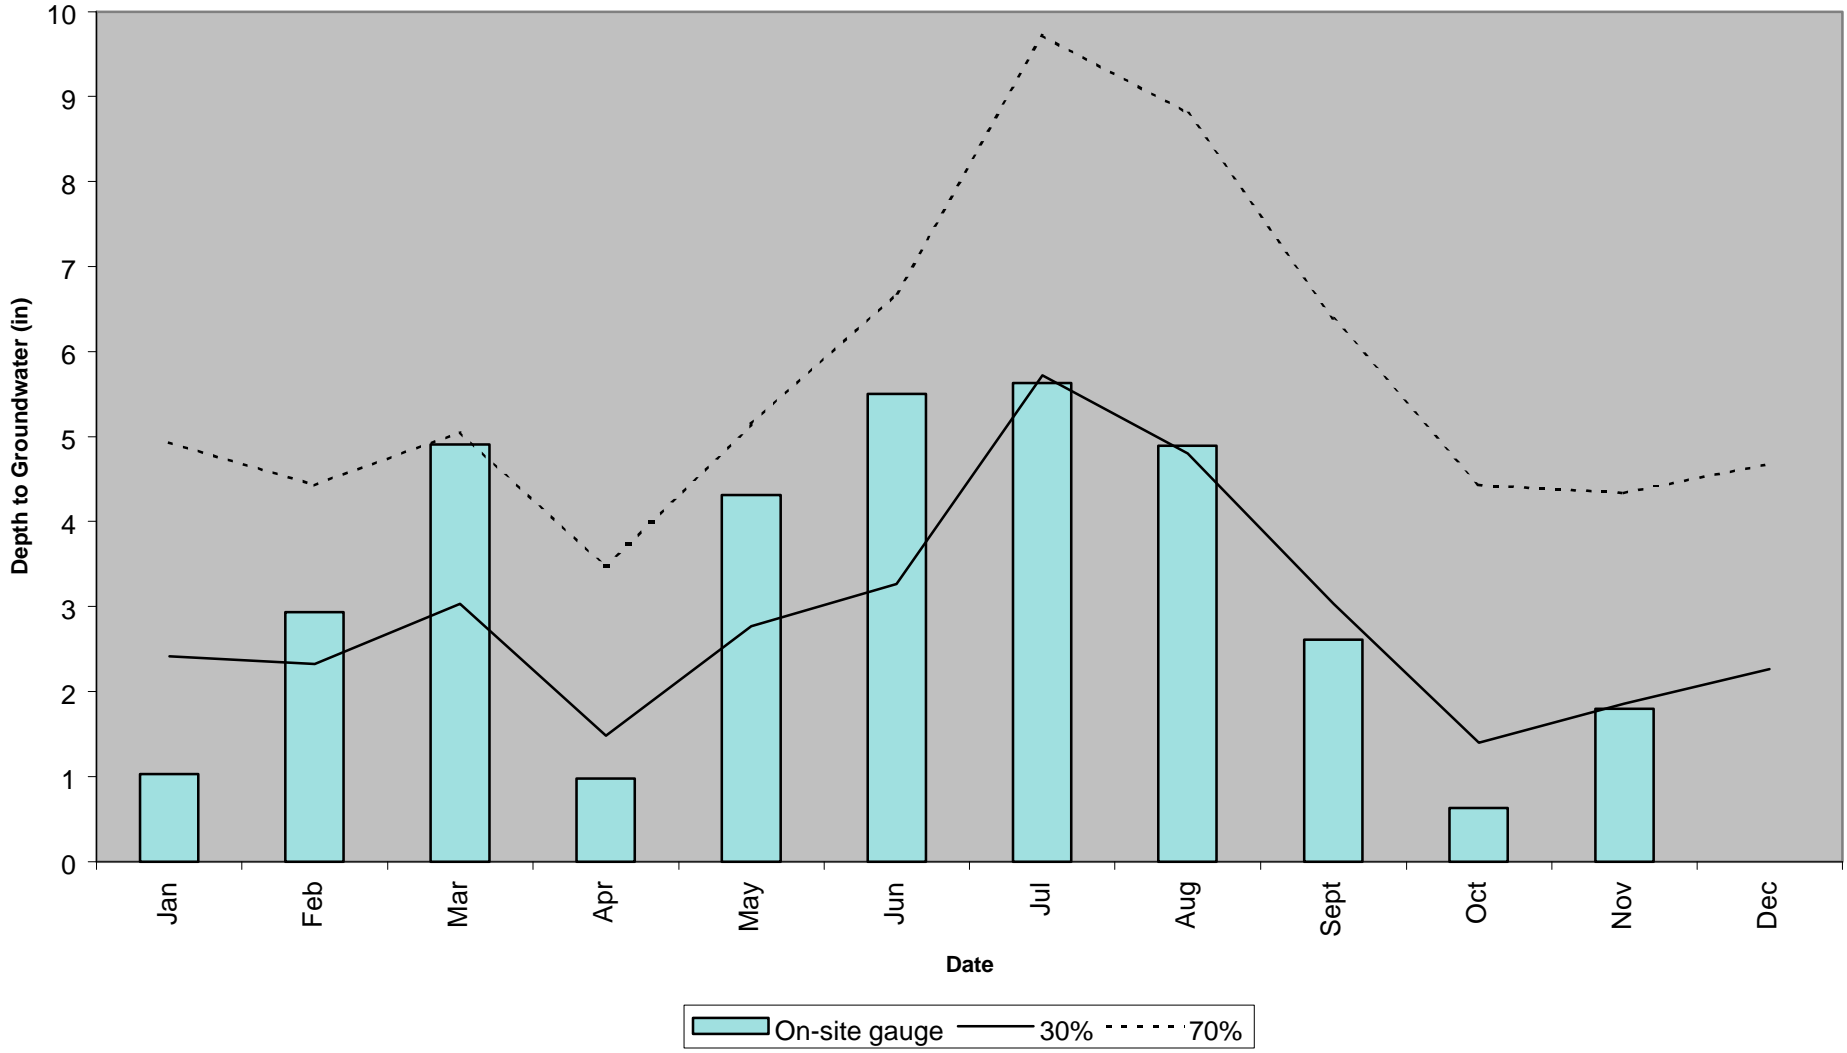
Figure 4: Monthly Rainfall Totals

Figure 4 represents an examination of the local climate in comparison with historical data to determine if 2001 rainfall is within the normal rainfall range of the area. The historical data was provided by the National Climatic Data Center from the Trenton station; the 2001 rainfall data was recorded with an on-site Infinities rain gauge. The Trenton station was used in place of the Marine Corp Air Station at New River station because of incomplete data records.

Rainfall during January, April, August, September, and November were below the normal range for the area. Rainfall for the rest of the months fell within the normal range. Data after November was not available.

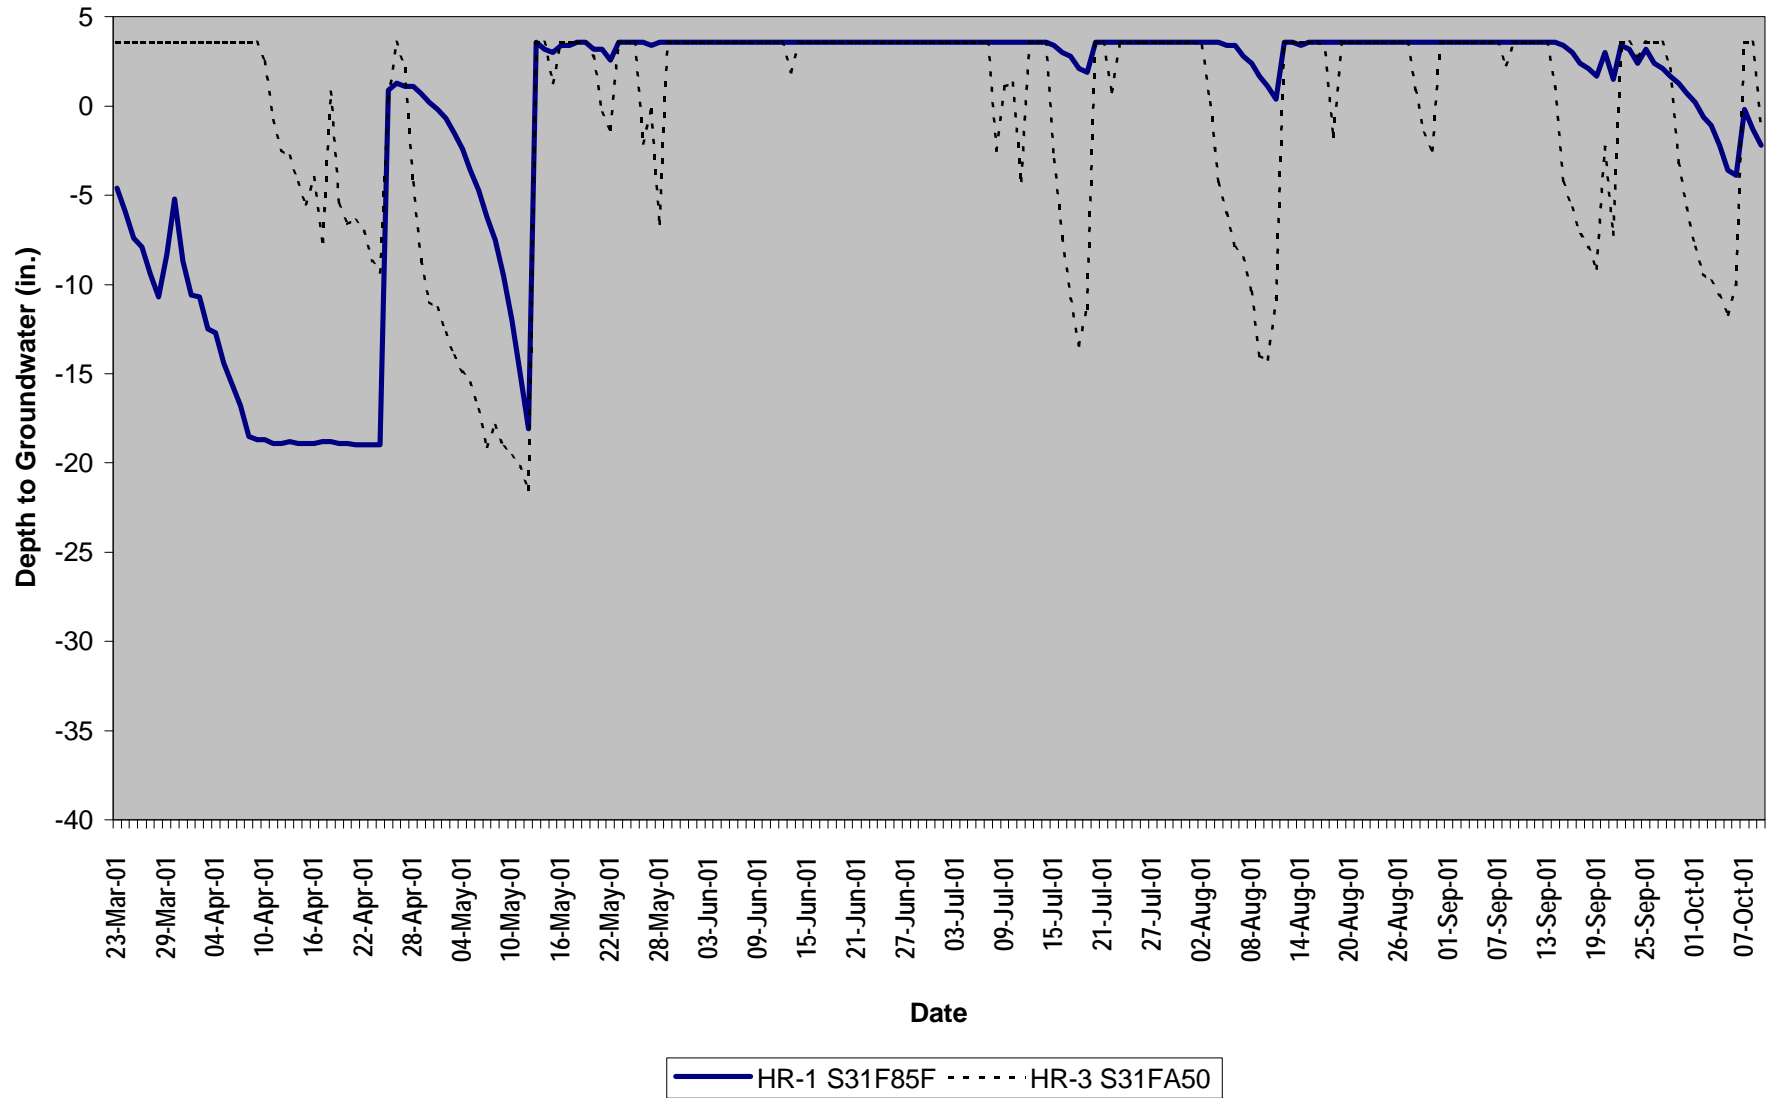
2001 Haws Run
Comparison of HR-1 vs HR-3

- Average Swamp restoration area was comparable for 56% of days in the Average Swamp reference area.
- MW-3: 60% of days at MW-1.
- MW-5: 20% of days at MW-2.

- Average Swamp restoration area hydroperiod was 50% of Average Swamp reference area hydroperiod.
- MW-3: 44% of MW-1.
- MW-5: 27% of MW-2.
- MW-6: 92% of MW-4.
- Average Pine Savanna restoration area hydroperiod was 125% of Average Pine Savanna reference area hydroperiod.
- Average Haul road restoration area hydroperiod was 134% of Average Haul road reference area hydroperiod.

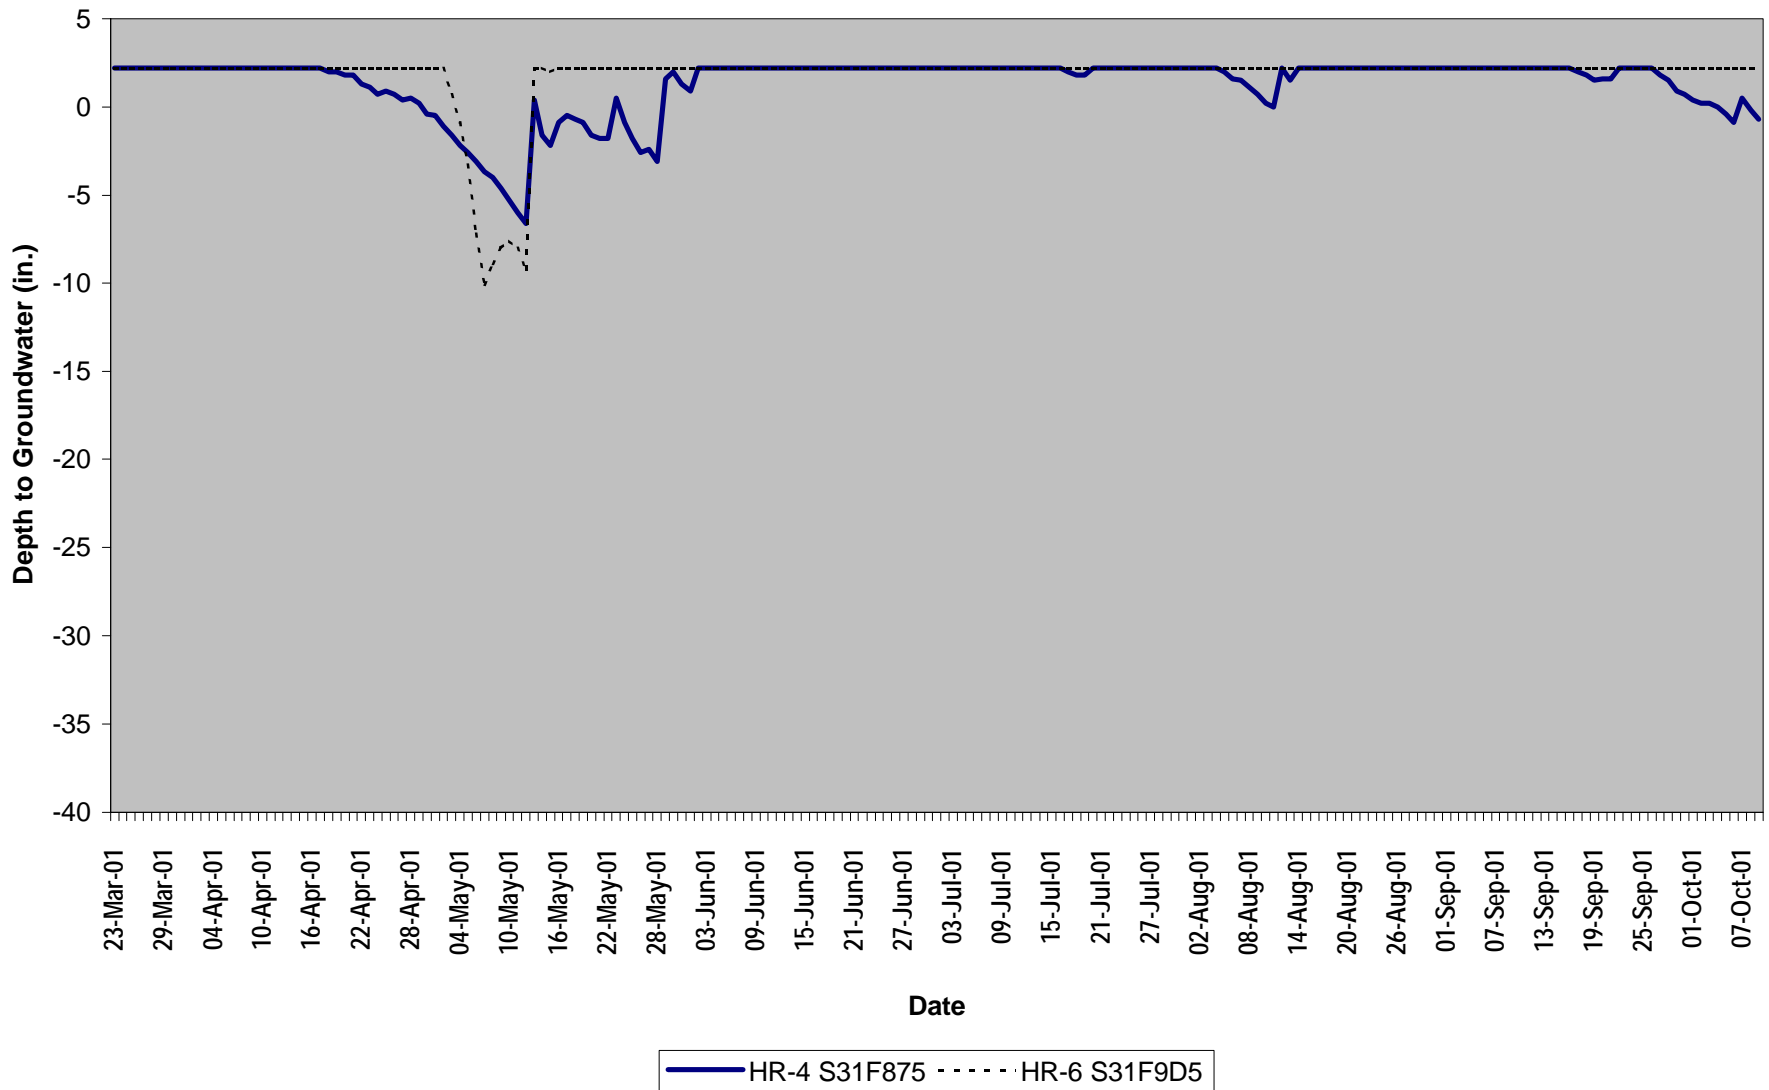
2001 Haws Run Comparison of HR-4 vs HR-6

- MW-6: 91% of days at MW-4.
- Average Pine Savanna restoration area was comparable for 47% of days in the Average Pine Savanna reference area.
- Average Haul road restoration area was comparable for 76% of days in the Average Haul road reference area.

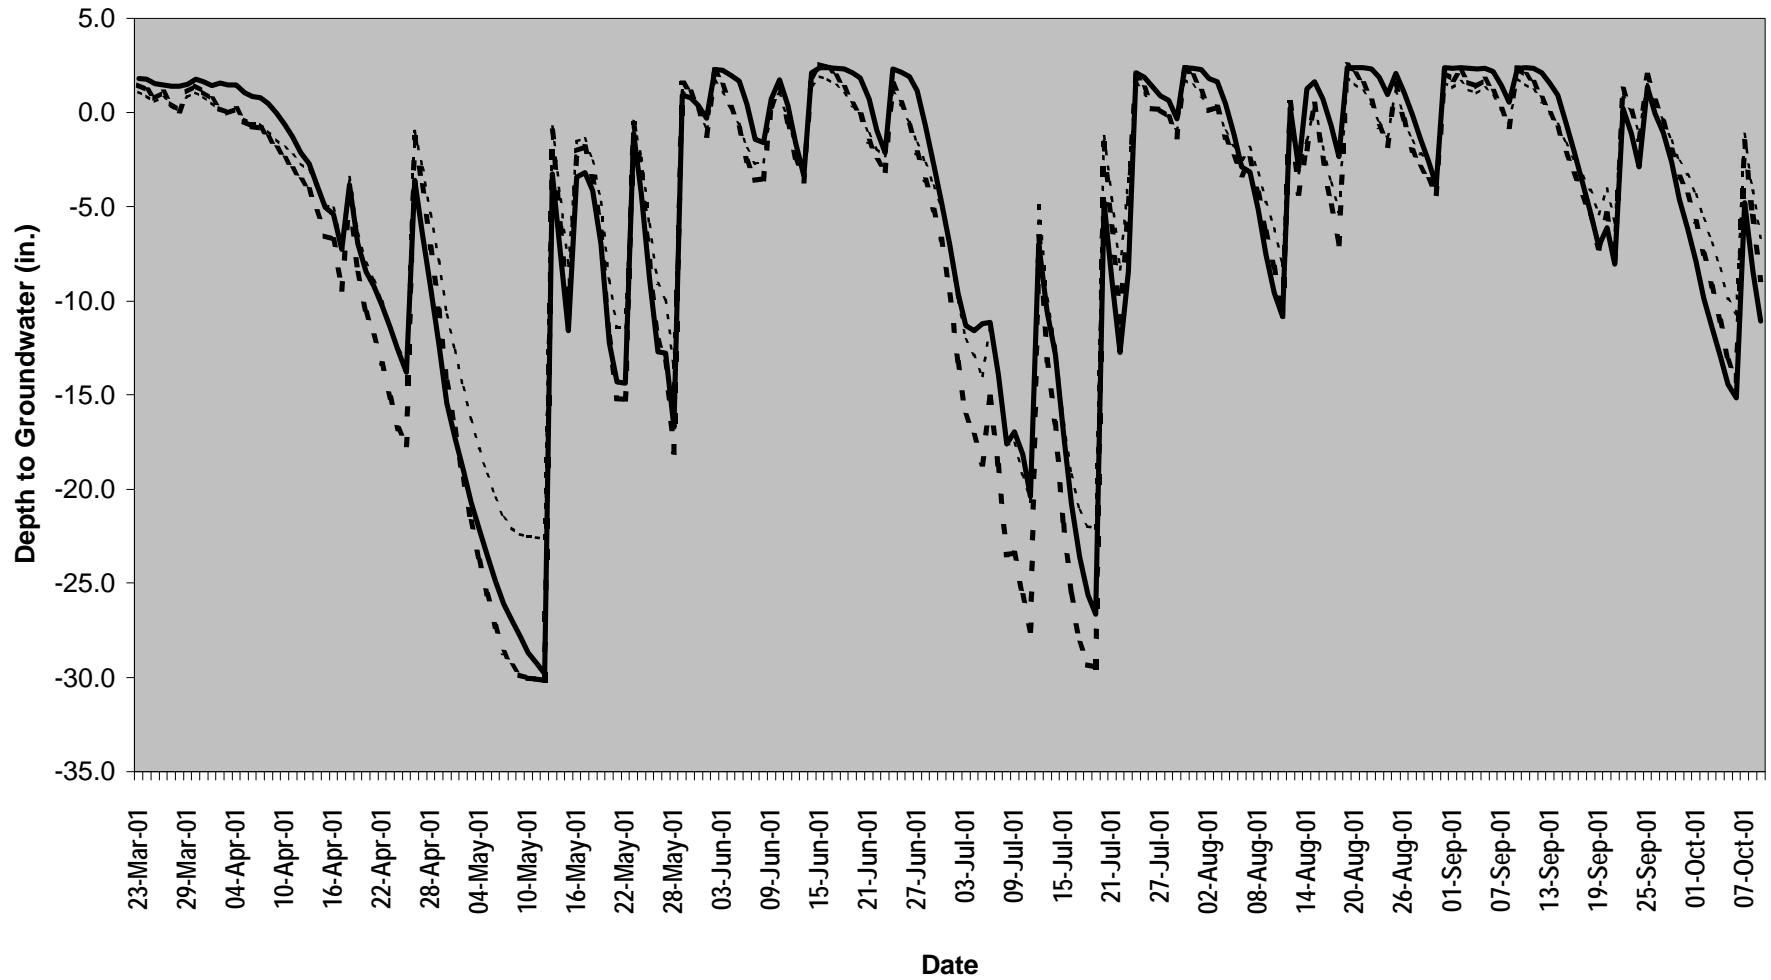
2001 Haws Run Savanna Average Reference vs. Average Restoration

Water table fluctuations in the pine savanna area were more variable between gauges. However, average restoration and reference area values were very similar. The plots in Appendix B show the similarities in hydrologic regime between the savanna reference and restoration areas. The daily average depth to groundwater in the pine savanna restoration area matched the reference area 47% of the growing season.

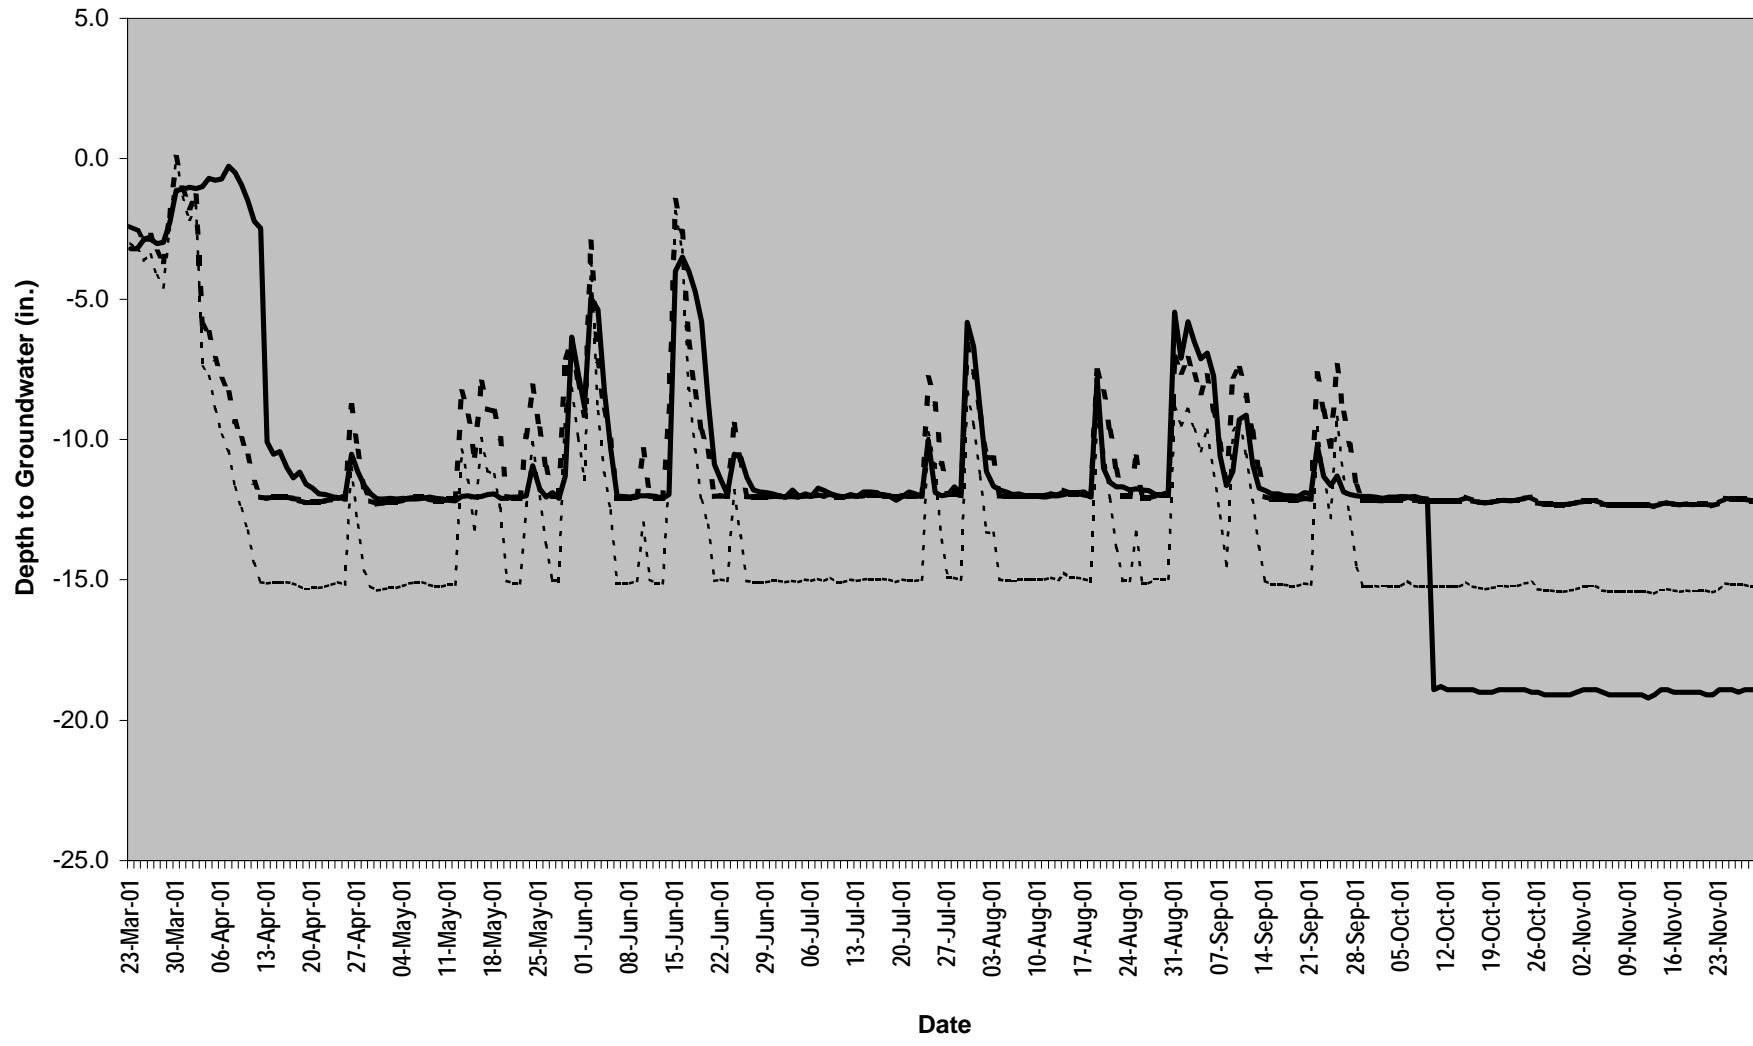
2001 Haws Run Haul Road Average Reference vs. Average Restoration

The average hydrologic regime for the haul road restoration area was very similar to the reference area. Although the actual values varied substantially, the flooding patterns coincided very well. The data illustrated the effects of removal of the haul road, reestablishing the hydrologic connection of the isolated area to the southern swamp area.

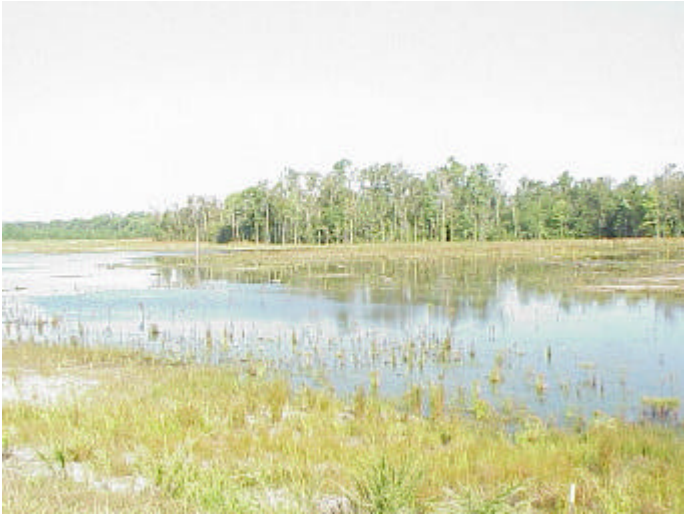
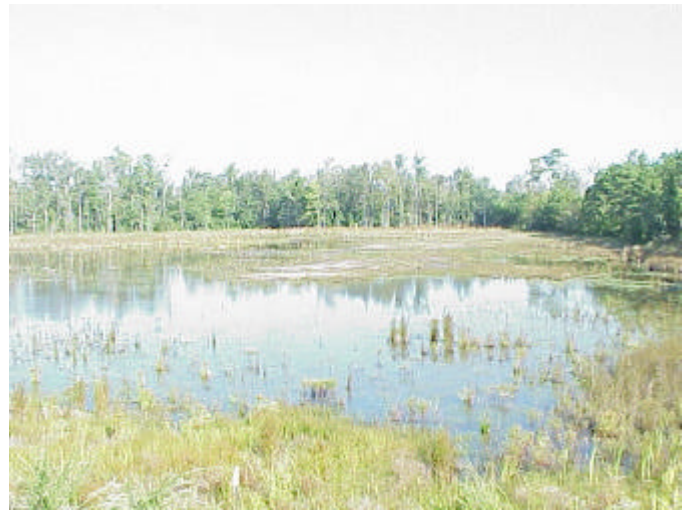
Photo 1

The area around plot one has been inundated with water at every site visit (See photos 1 and 2). The planted tree seedlings have not been able to survive in this area. NCDOT will supplementally plant this area in 2002 with baldcypress, water tupelo, and green ash. It is hoped that these more wet tolerant trees will stand a better chance of survival in this wet area.

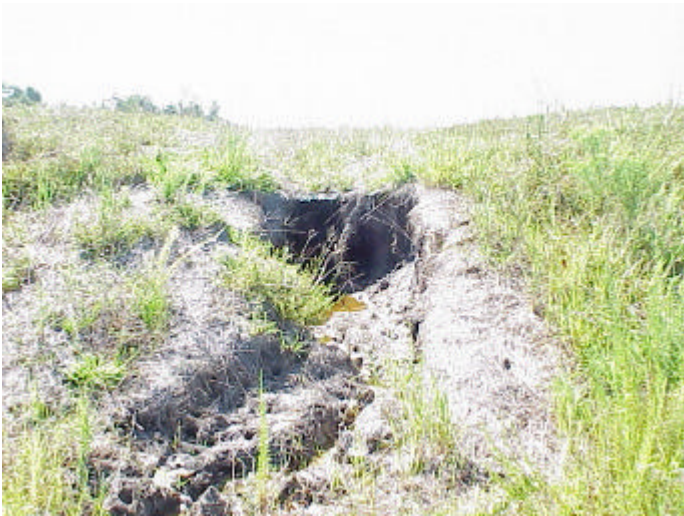
Photo 13

The washouts along the northern side of the site adjacent to the swamp forest area were repaired and are stabilizing. Those washes stabilized with stone are doing well. One of the washes stabilized only with matting and vegetation has minor erosion problems (see photo 13). DOT will continue to monitor these washes throughout the year to determine if further repair is necessary.
