ANNUAL REPORT FOR 2002

Haws Run Mitigation Site
Pender and Onslow County
Project No. 6.259002T
TIP No. R-2405WM

Prepared By:
Office of Natural Environment & Roadside Environmental Unit
North Carolina Department of Transportation
December 2002/ Revised March 2003

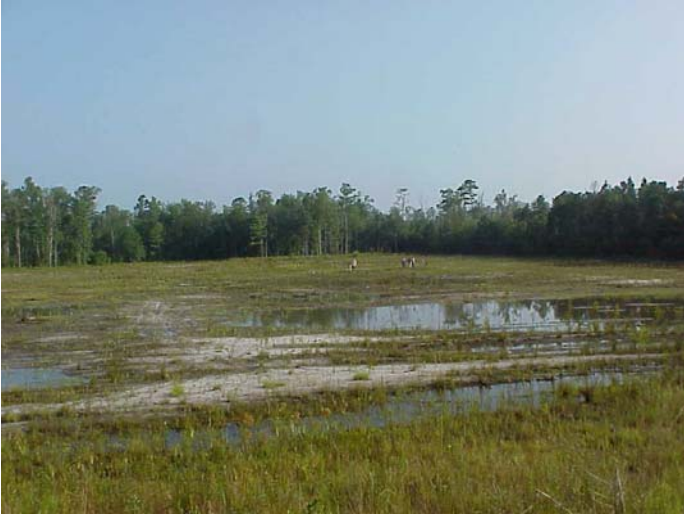
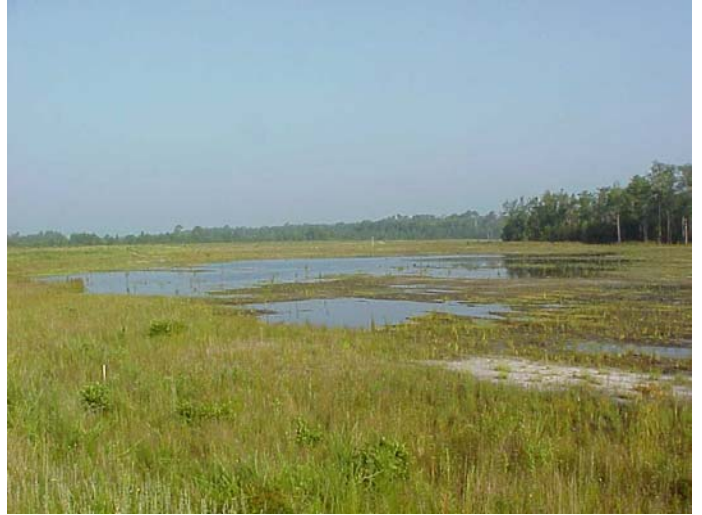
The area around plot one has been inundated with water at every site visit (See photos 1 and 2). The planted tree seedlings have not been able to survive in this area. NCDOT supplementally planted this area in March 2002 with bald cypress, swamp blackgum, overcup oak, and green ash. These more wet tolerant trees have survived well in the wet area.

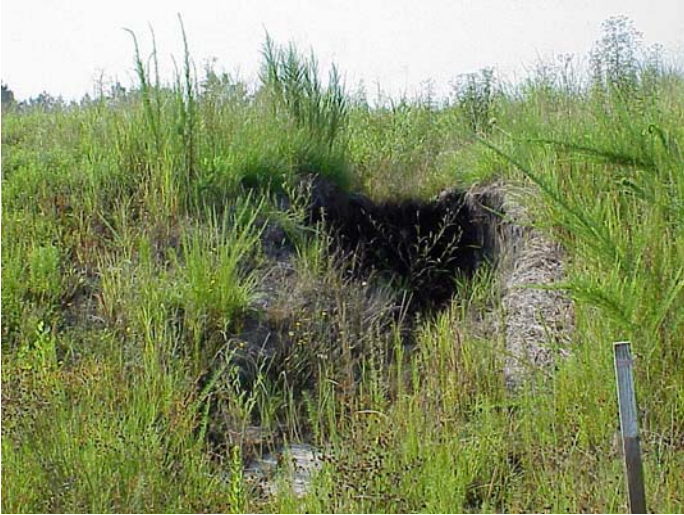
Photo 6

The washouts along the northern side of the site adjacent to the swamp forest area were repaired and are stabilizing. The washes stabilized with stone are doing well. One of the washes stabilized only with matting and vegetation has minor erosion problems (see photo 6 and 7). DOT will continue to monitor these washes throughout the year to determine if further repair is necessary.

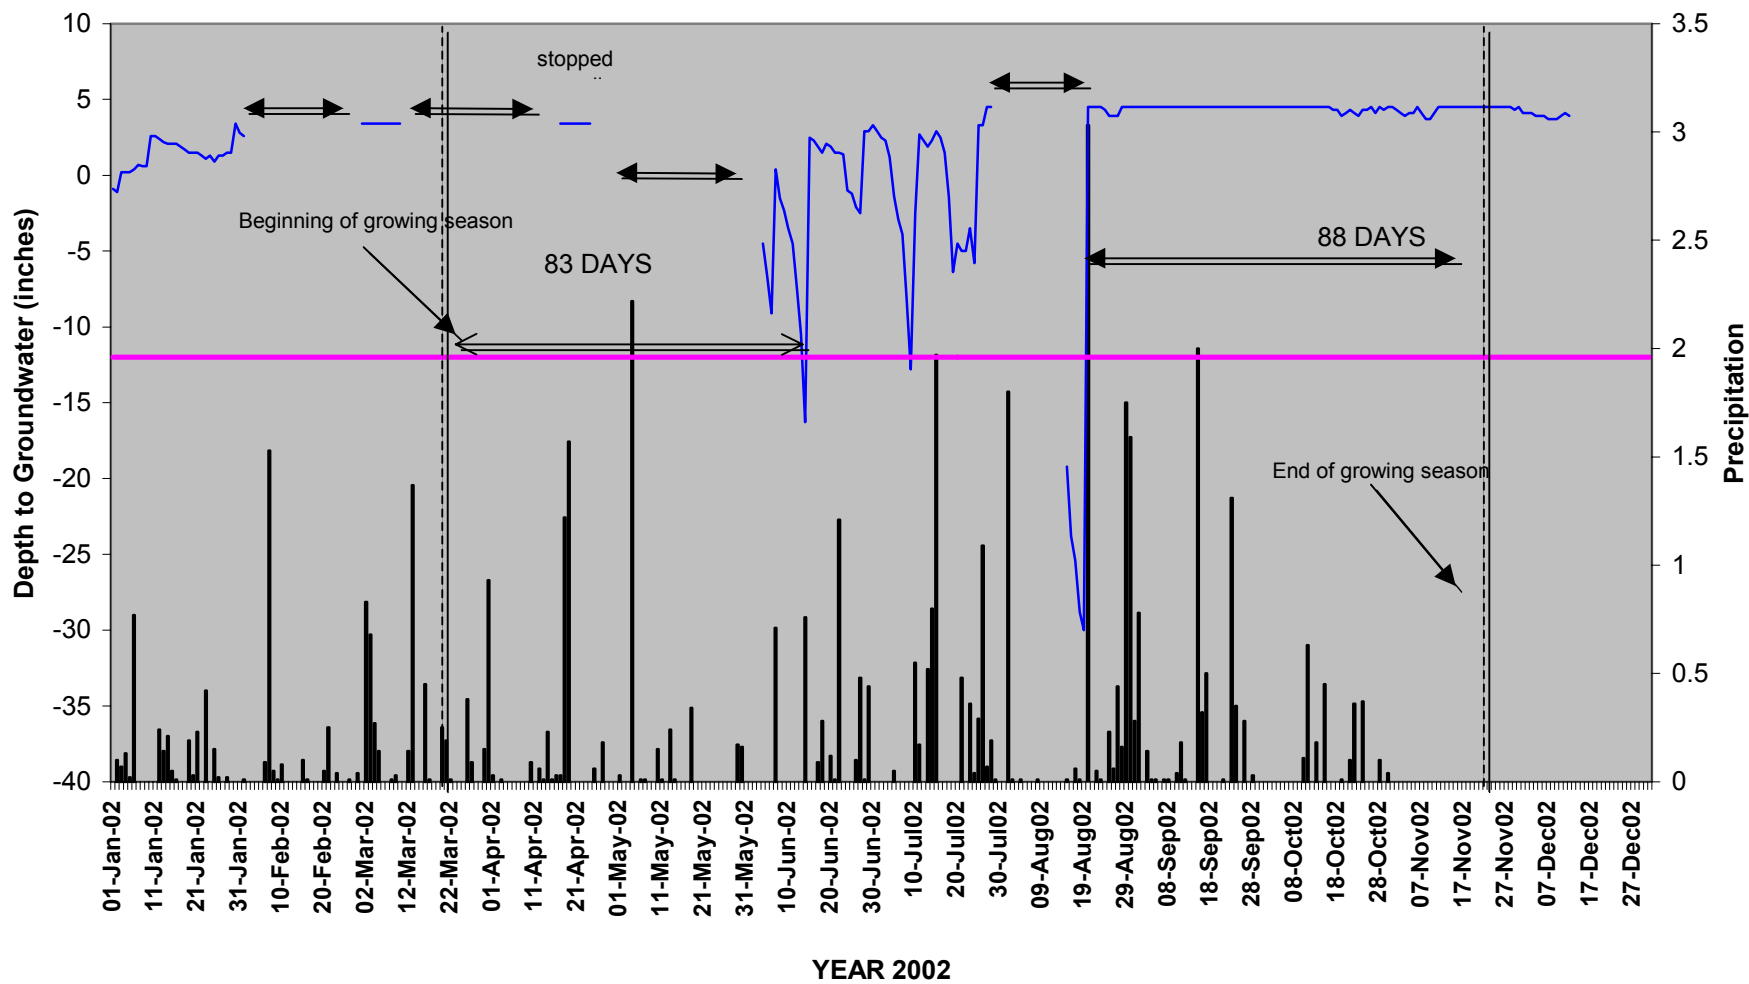
HR1 S31691C Reference

- HR-1 experienced gauge malfunctions and stopped recording data (3/11-4/16) (4/25-6/3) (7/29-8/14)
- HR-20 experienced gauge malfunctions and stopped recording data (3/22-4/15) (5/25-7/19)
- Reference Gauge HR-24 showed minimal saturation in existing wetland and will not be included in the reference averages. NCDOT will investigate this gauge.
- HR-19 is located in the southern swamp restoration area therefore it was not included in the restoration average since it's performing in a different system.
