ANNUAL REPORT FOR 2003

**Haws Run Mitigation Site
Pender and Onslow Counties
Project No. 6.259002T
TIP No. R-2405WM**

Prepared By:
Office of Natural Environment & Roadside Environmental Unit
North Carolina Department of Transportation
December 2003

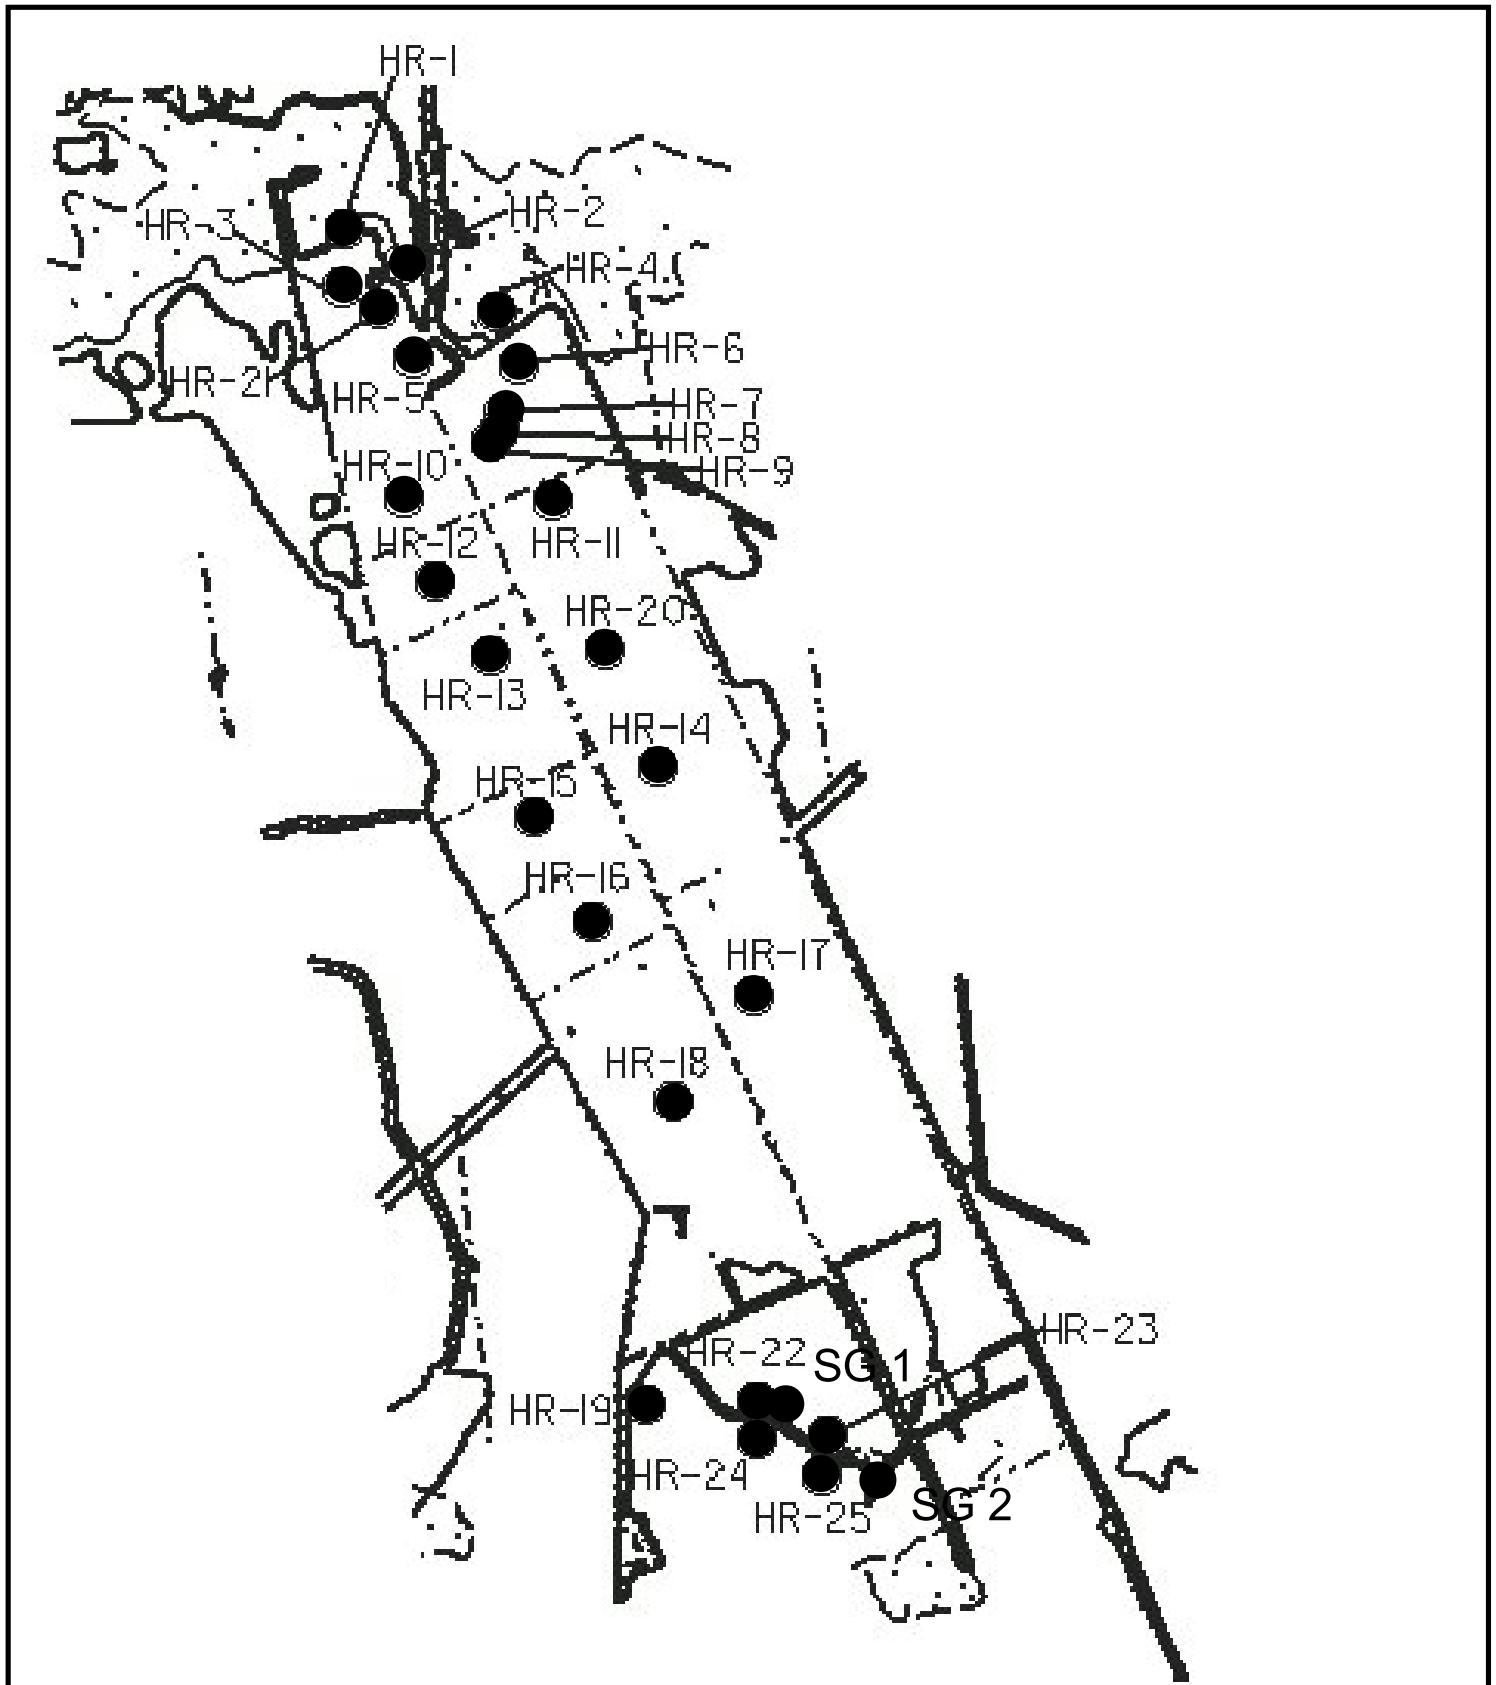
Figure 2. Gauge Location Map

After site construction, nineteen groundwater-monitoring gauges (RDS WL-40) were installed on the site (Figure 2). Two additional gauges, HR-20 and HR-21, were installed in early Spring 2000. HR-15 was reported in the 1999 Monitoring report as being located in the delineated wetland in the pine savanna reference area. A GPS survey placed the actual location in the pine savanna restoration area. This revised location is reported below along with all of the gauges located at Haws Run.

- Three in the swamp reference area (HR -1, HR-2, HR-4).
- Five in the swamp restoration area (HR-3, HR-5, HR-6, HR-21).
- Two on the slope transition area (HR-7, HR-8).
- Six in the pine savanna restoration area (HR-9 through 12, HR-15, HR-20).
- Five in the pine savanna jurisdictional wetlands (HR-13, HR-14, HR-16, HR-17, HR-18).
- Three in the southern swamp restoration (haul road) area (HR-19, HR-22, HR-23).
- Two in the southern swamp reference (haul road) area (HR-24, HR-25).

After field inspection in April 1999, monitoring gauges HR-1 through HR-6 were relocated (as shown on Figure 2) to better represent site conditions. Ground surface elevation was surveyed at each well and was used to correlate well data for restoration area and reference area comparisons. Based on similar elevations, the following wells were paired for hydrologic monitoring:

- HR-1 and HR-3 at a relative elevation of 6.2 ft
- HR-2 and HR-5 at a relative elevation of 5.8 ft
- HR-4 and HR-6 at a relative elevation of 4.9 ft

There are also four groundwater gauges, HR-22 through 25, and two surface gauges, SG-1 and SG-2, located along the forestry haul road (southern swamp), which were installed during the pre-construction monitoring phase. All of the monitoring gauges automatically record daily depth to groundwater or surface water on the site. Appendix A contains the graphs for each gauge along with daily rainfall data. Appendix B contains comparison graphs of the restoration and reference areas.

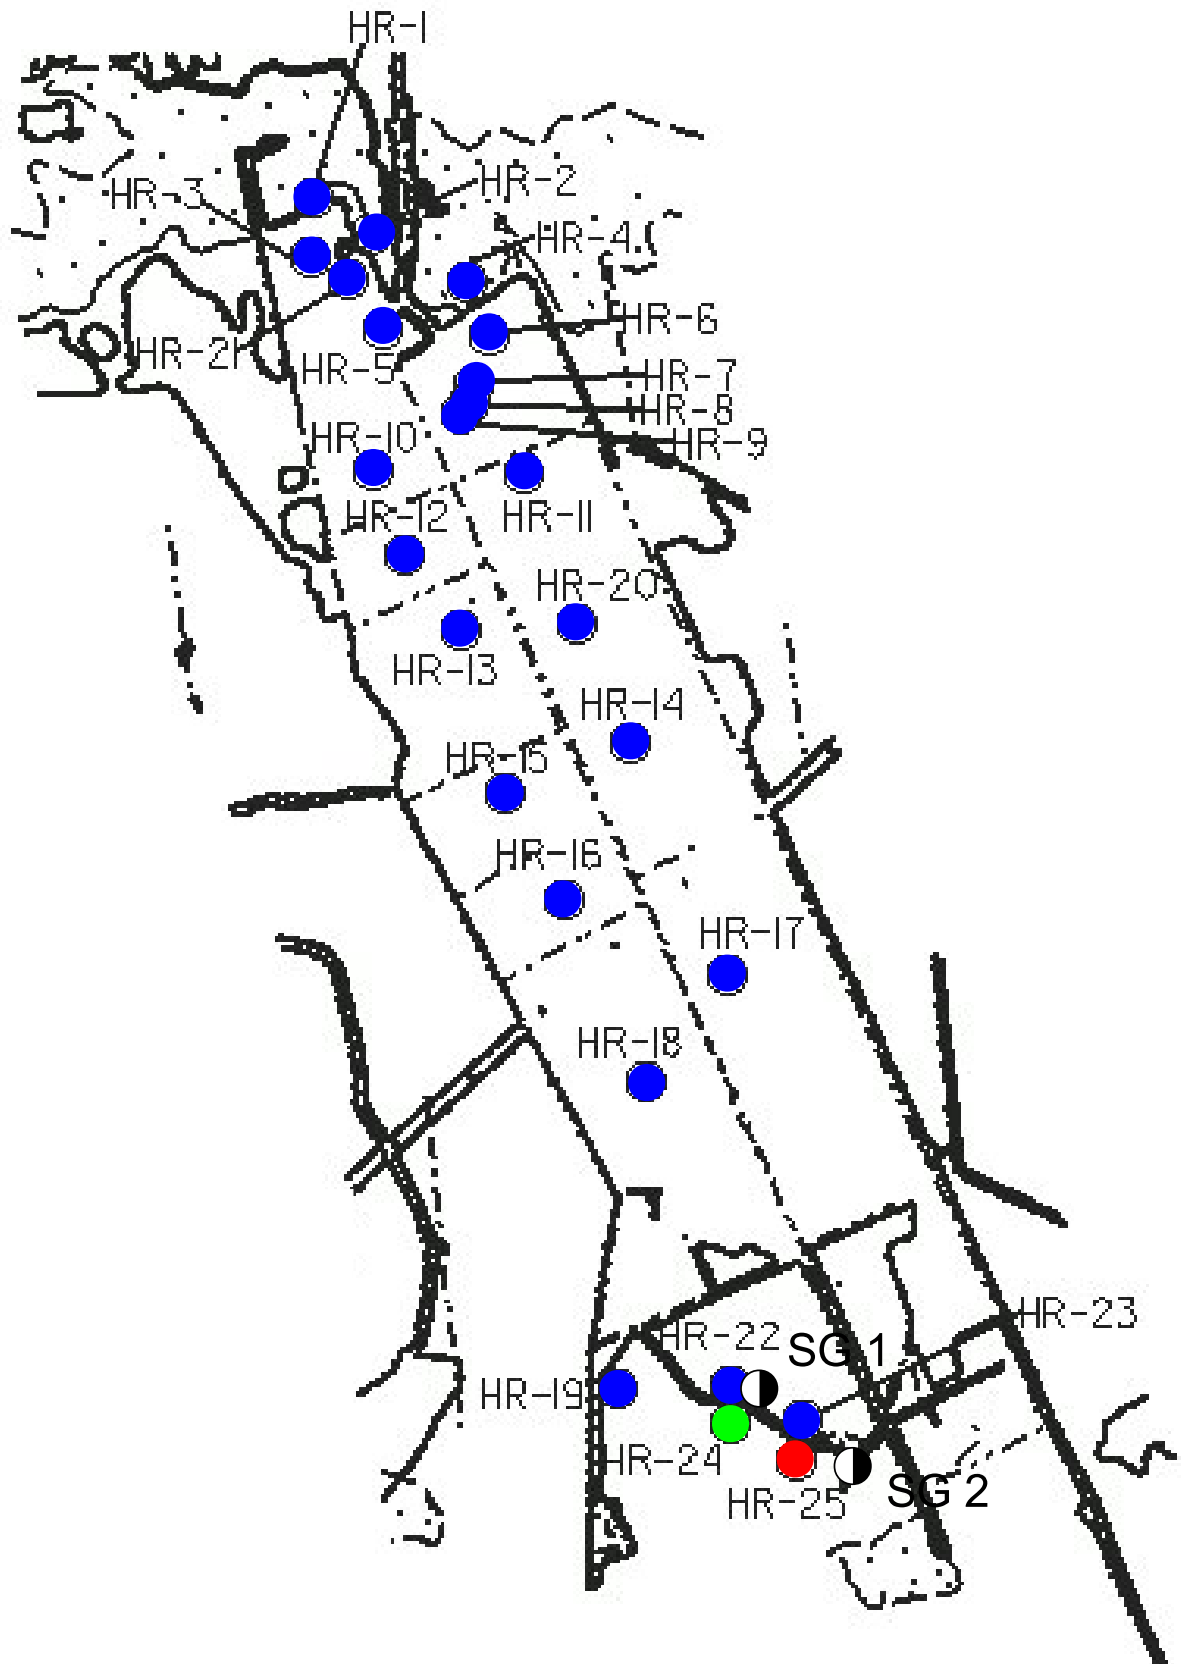
Figure 3. 2003 Hydrologic Monitoring Results

The maximum number of consecutive days that the groundwater was within twelve inches of the surface was determined at each gauge. This number was converted into a percentage of the 238-day growing season. Because of the variability between wetland systems and within wetland types, the monitoring gauge results are segmented into percentage ranges (Figure 3). Table 1 presents the monitoring results for the 2003 growing season as a range of percentages, actual percentages, and success dates of the longest hydroperiod for each gauge on the site. The reference gauges are also provided in Table 1.

Hydrology Results

- < 5%
- 5 - 8%
- 8 - 12%
- >12.5%

Based on jurisdictional wetland criteria, the Haws Run Mitigation Site met hydrologic success for the 2003-year. In the swamp forest area, all gauges exceeded the 12.5% jurisdictional wetland criteria. The three swamp reference area gauges showed similar data and resulted in 100% of the growing season. For the pine savanna area, all gauges recorded hydroperiods of 8% of the growing season or greater. The pine savanna reference area at Haws Run also showed similar results as the restoration area. Three gauges along the haul road (southern swamp) met the jurisdictional criteria of 12.5%. Neither reference gauge (HR 24, HR-25) for the southern swamp met the success criteria of 12.5%. All gauges met the optimum hydrology for wetland success, with the exception of HR-24 and HR-25.

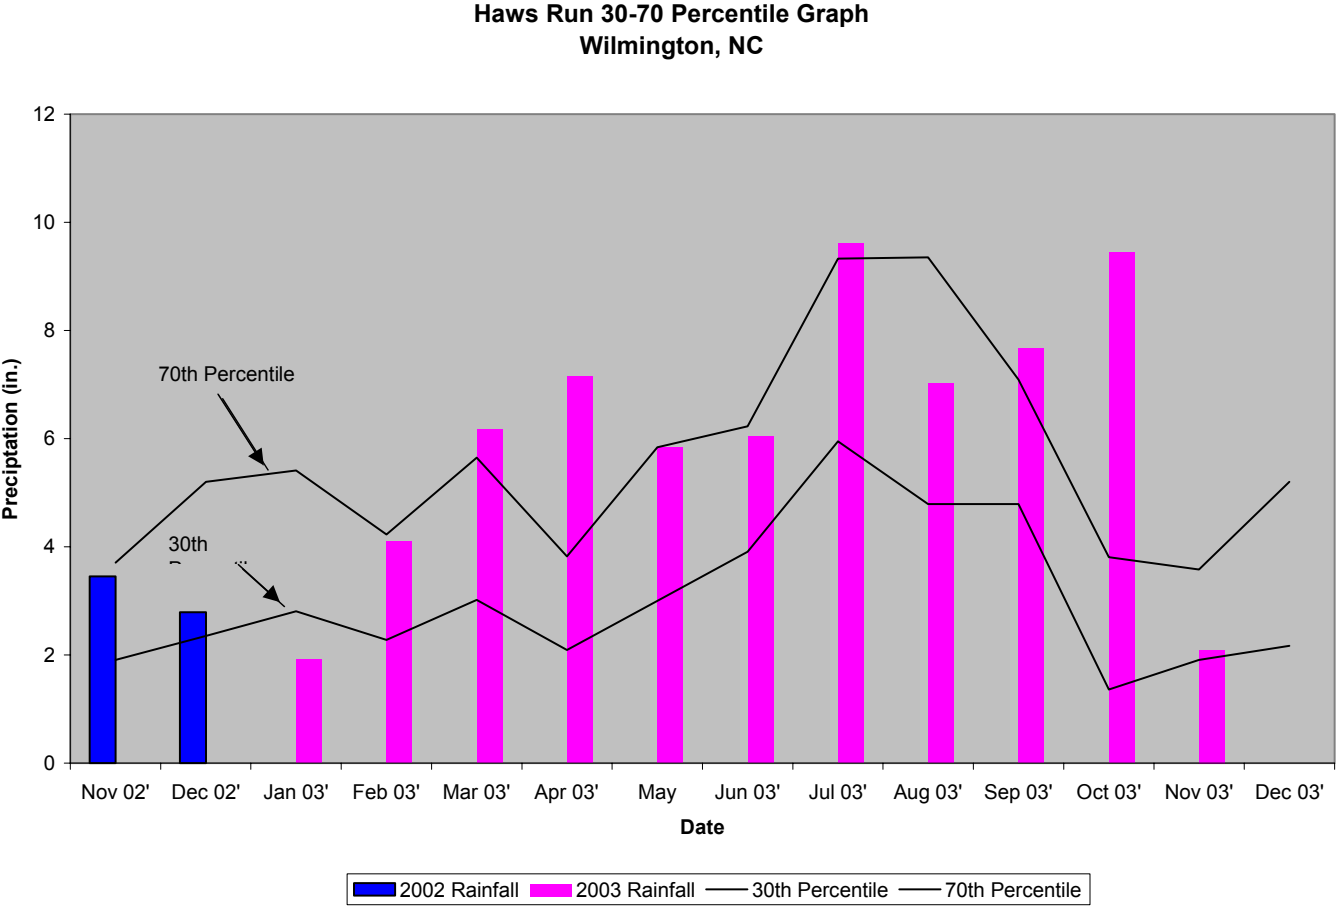
Figure 4. 30-70 Percentile Graph

Figure 4 represents an evaluation of the local climate in comparison with historical data in order to determine whether 2003 was “average” in terms of climate conditions. The two lines represent the 30th and 70th percentiles of monthly precipitation for Wilmington, NC. The bars are monthly rainfall totals for 2002 and 2003. The historical data was collected from the State Climate Office of North Carolina.

For the 2003-year, March, April, July, September, and October experienced above average rainfall. The month of January recorded below average rainfall and November (02'), December (02'), February, May, June, August, and November experienced average rainfall. Overall, 2003 experienced an average rainfall year.

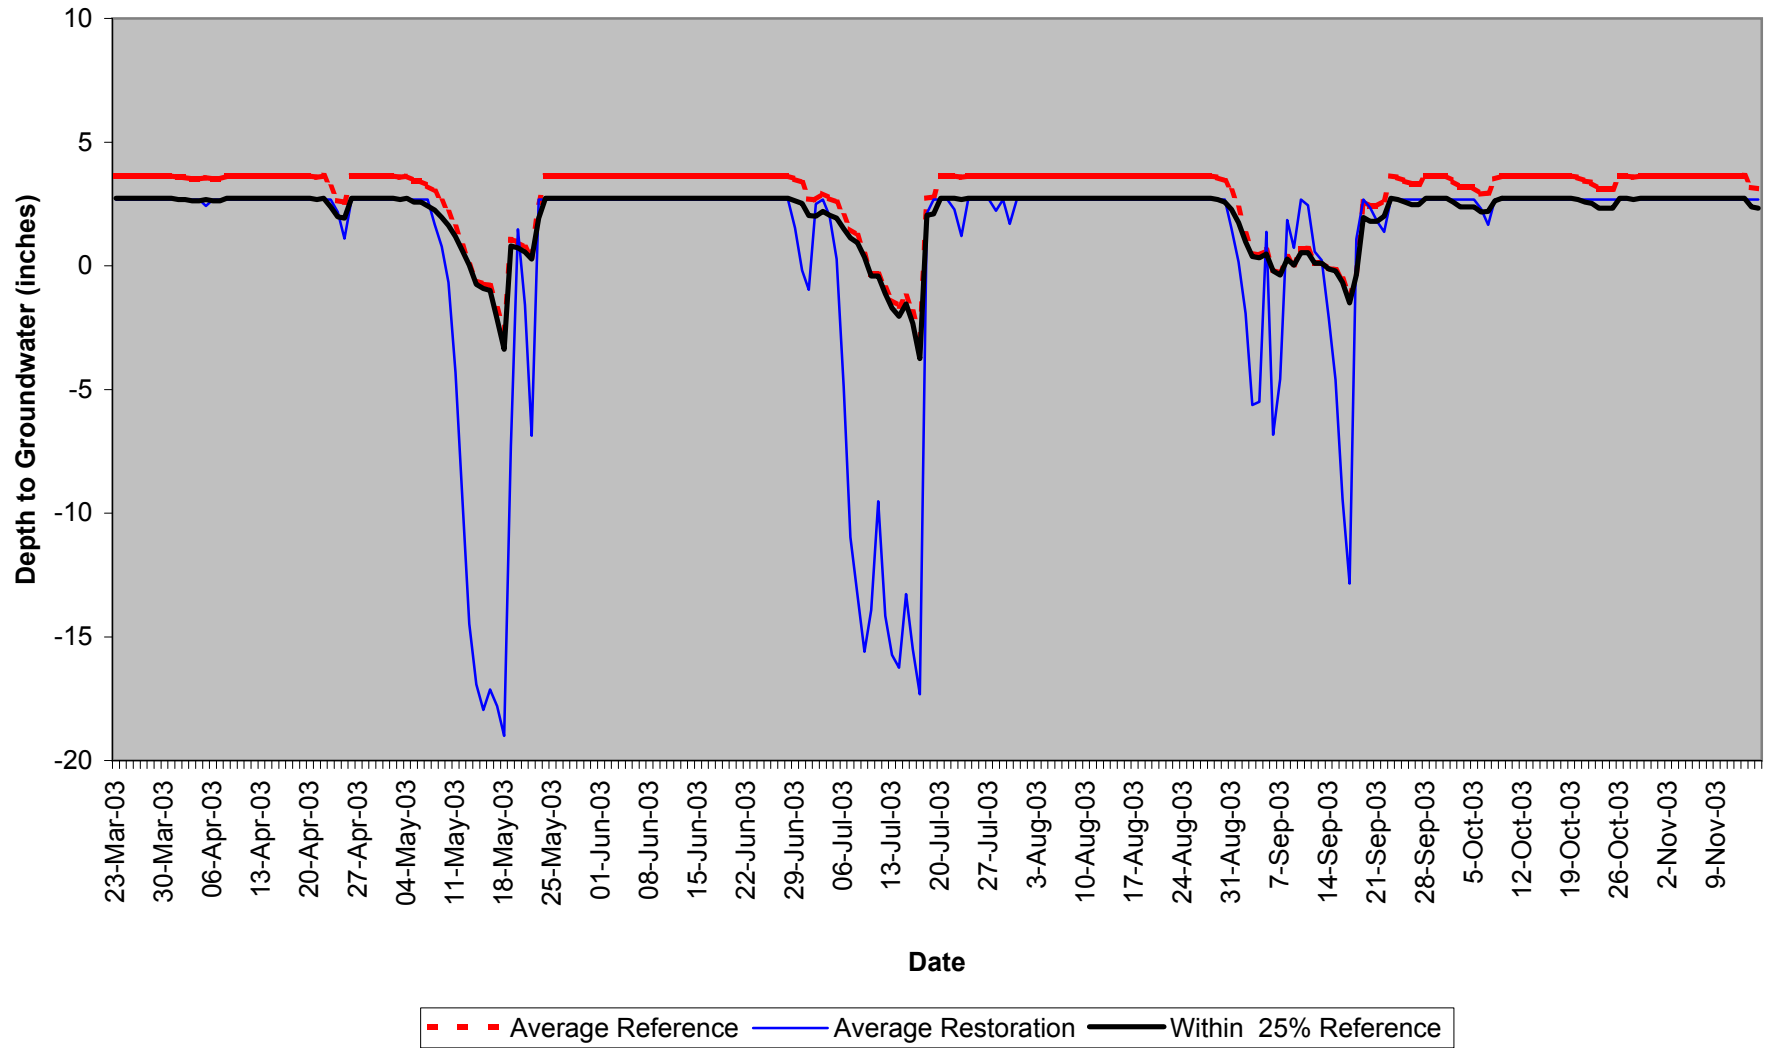
Haws Run Swamp Forest 2003 Average Reference vs. Average Restoration

Average Swamp Restoration Area was comparable for 17.6% of days in the Average Swamp Reference Area.

Average Swamp Restoration Area hydroperiod was 56.4% of Average Swamp Reference Area hydroperiod.

Hydrologic patterns in the restoration areas across the Haws Run Mitigation Site followed patterns in the reference areas. Flooding frequency and depth in the swamp restoration area coincided with flooding in the swamp reference area. The comparison plots in Appendix B clearly illustrate the restoration hydrologic regime coinciding with the reference area hydrologic regime. The water table did decline quicker in the swamp restoration area than in the swamp reference area, resulting in less storage time. This can be partially attributed to differences in soil organic matter content and surface roughness between the two areas. Gauge HR-19 is located in the southern swamp restoration area; therefore it was not included in the restoration average since it's performing in a different system.

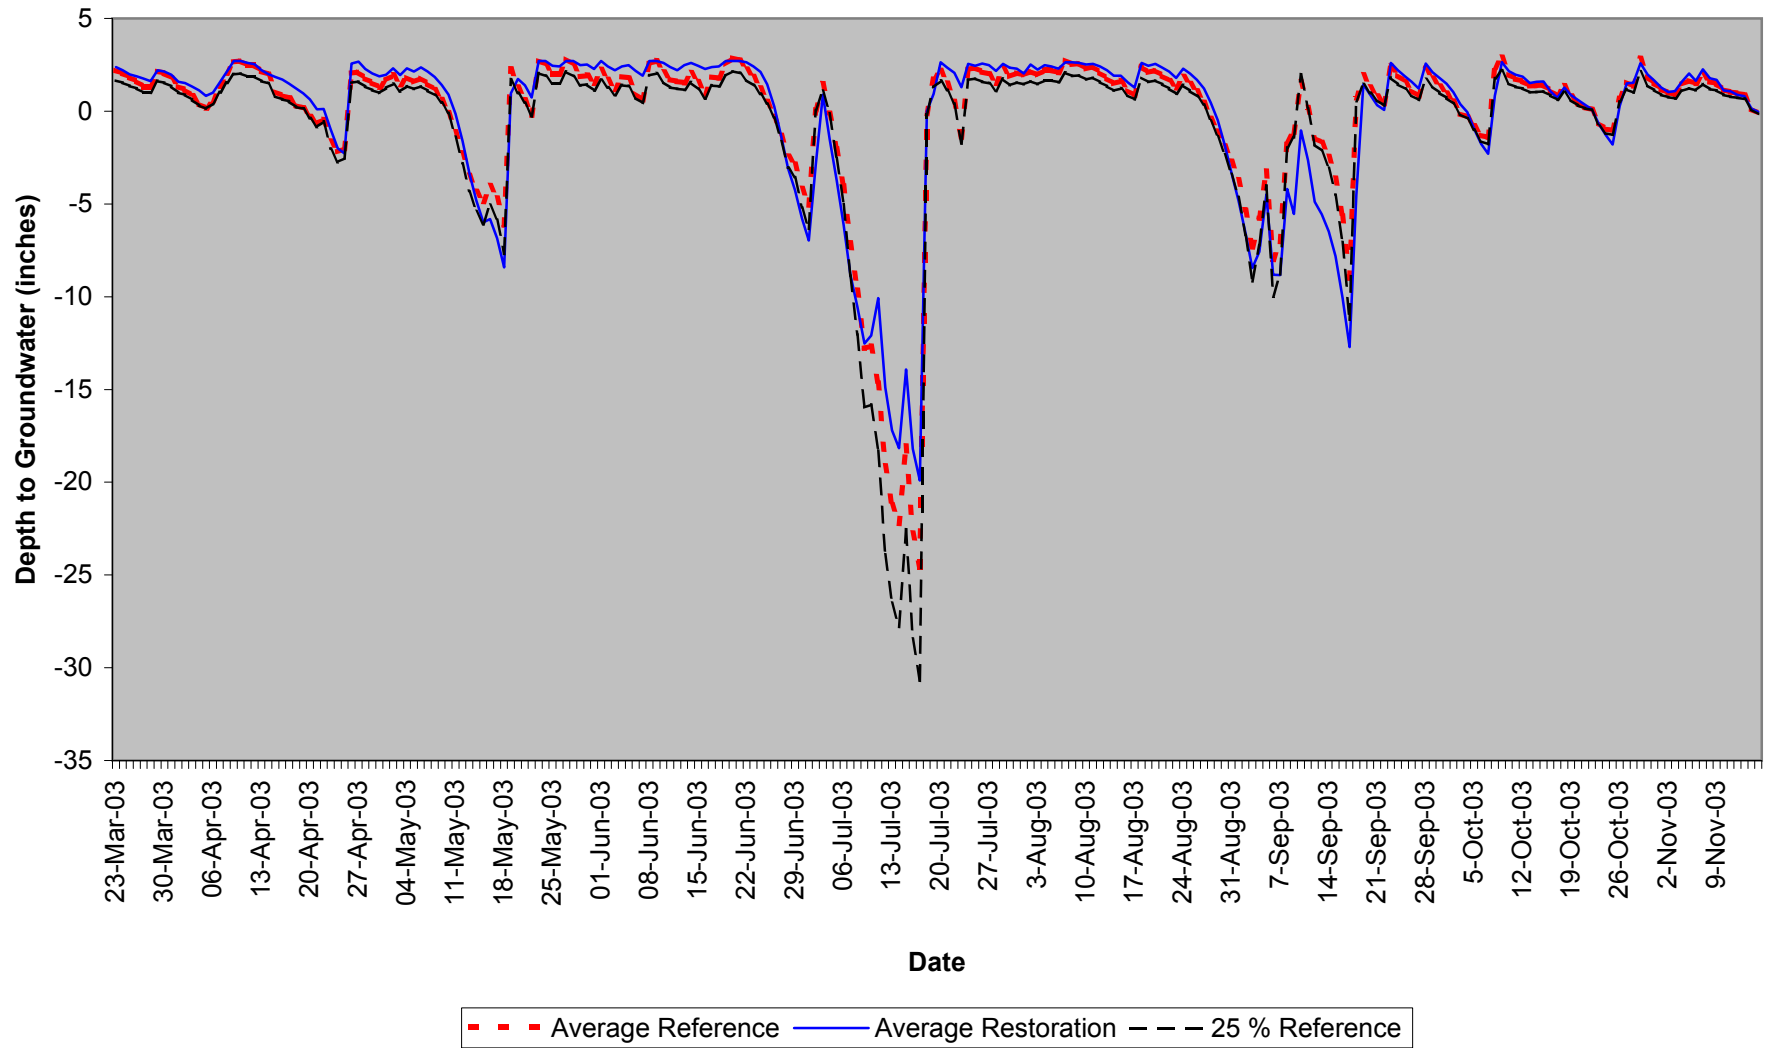
Average Reference vs. Average Restoration

The Average Pine Savanna Restoration Area was comparable for 83.6% of days in the Average Pine Savanna Reference Area.

Average Pine Savanna Restoration Area hydroperiod was 127.5% of Average Pine Savanna Reference Area hydroperiod.

The plots in Appendix B show the similarities in hydrologic regime between the savanna reference and restoration areas. Average restoration and reference area values were very similar in the pine savanna area.

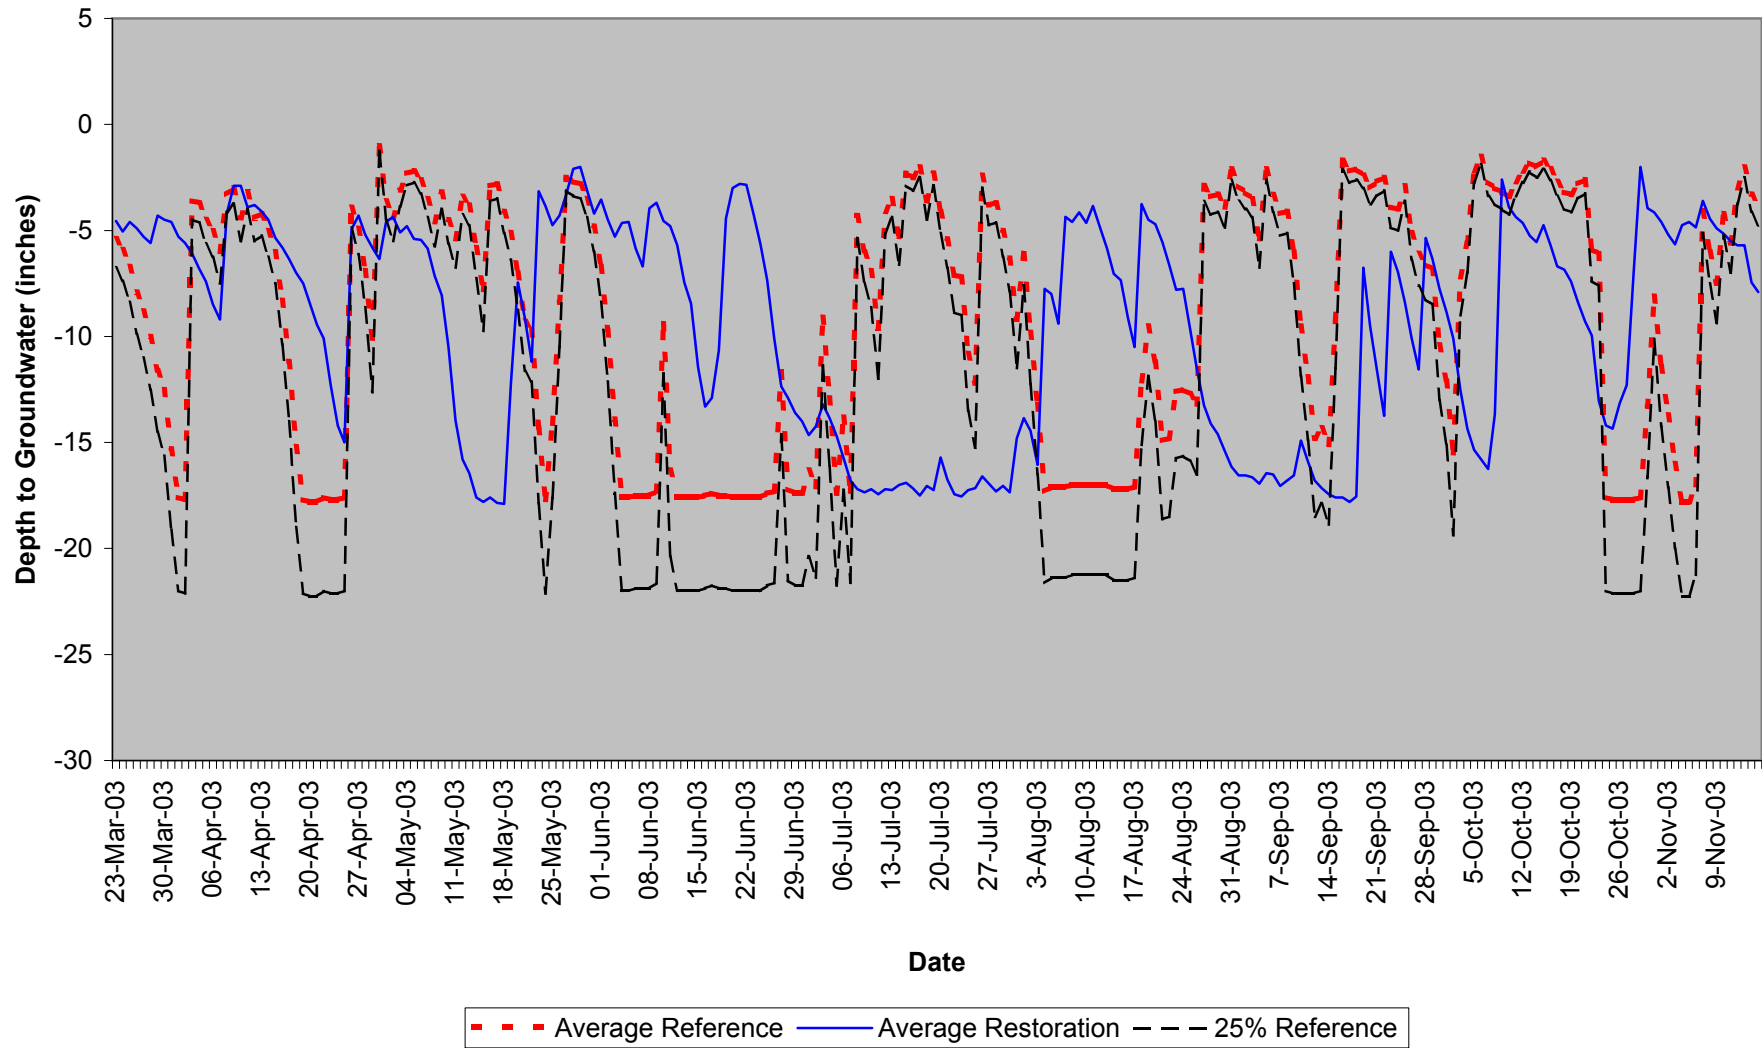
Average Reference vs. Average Restoration

The Average Haul Road (southern swamp) Restoration Area was comparable for 55.5% of days in the Average Haul Road (southern swamp) Reference Area.

Average Haul Road (southern swamp) Restoration Area hydroperiod was 129.6% of Average Haul Road (southern swamp) Reference Area hydroperiod.

The average hydrologic regime for the haul road (southern swamp) restoration area was similar to the reference area; the flooding patterns coincided well. The data illustrated the effects of removal of the haul road (southern swamp) (re-establishing the hydrologic connection of the isolated area to the southern swamp area). Data for reference gauge HR-24 in the haul road (southern swamp) was not used in the reference averages due to its minimal saturation. NCDOT will further investigate this gauge.

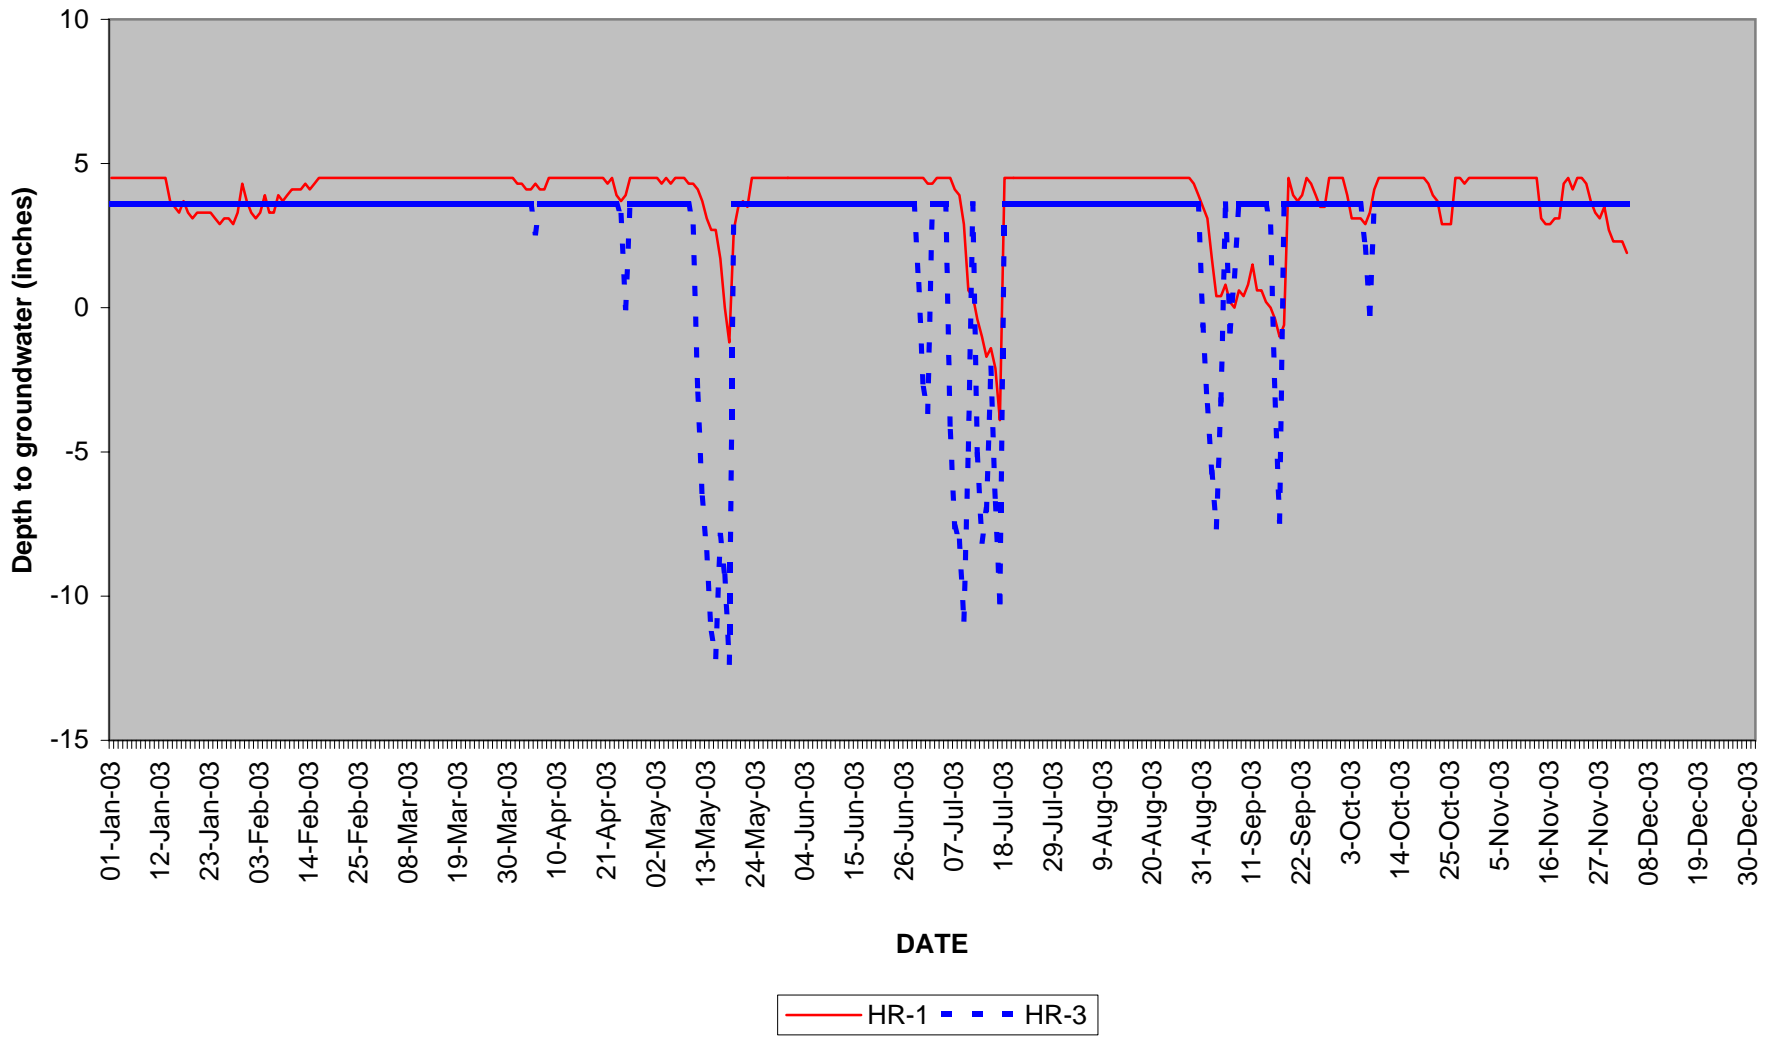
Comparison of HR-1 & HR-3 Swamp Forest

- HR-3: 85.3% of days at HR-1.
- HR-5: 8.8% of days at HR-2.
- HR-6: 100% of days at HR-4.

- HR-3: 76.1% of HR-1.
- HR-5: 24.8% of HR-2.
- HR-6: 100% of HR-4 (Gauge exceeded hydroperiod in reference).

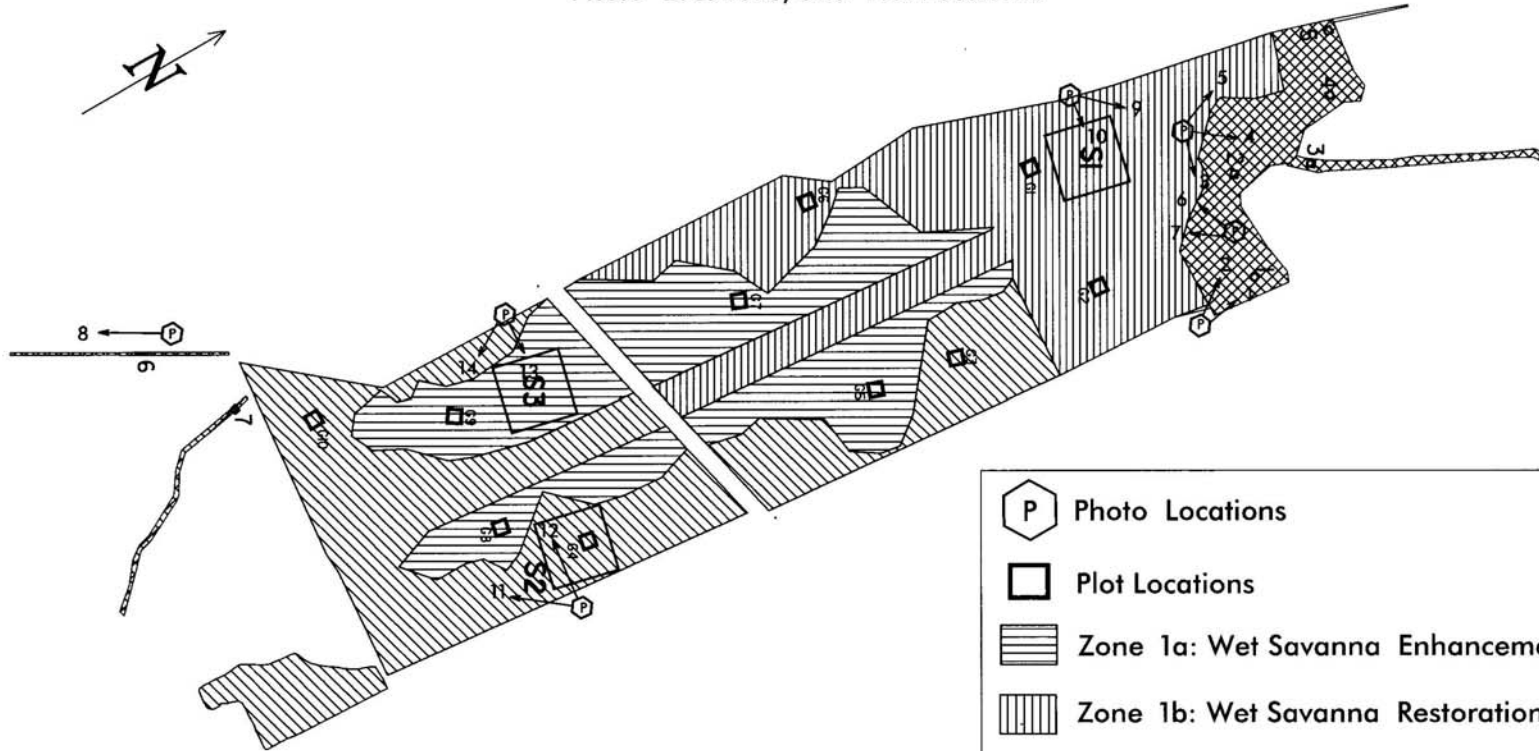
Planting Plan,
Photo Locations, and Plot Locations

Photo Locations
-   Plot Locations
-

Zone 1a: Wet Savanna Enhancement
-

Zone 1b: Wet Savanna Restoration
-   Zone 2: Dry Savanna
-   Zone 3: Swamp Forest
