ANNUAL REPORT FOR 2004

**Haws Run Mitigation Site
Pender and Onslow Counties
Project No. 6.259002T
TIP No. R-2405WM**

Prepared By:
Office of Natural Environment & Roadside Environmental Unit
North Carolina Department of Transportation
December 2004

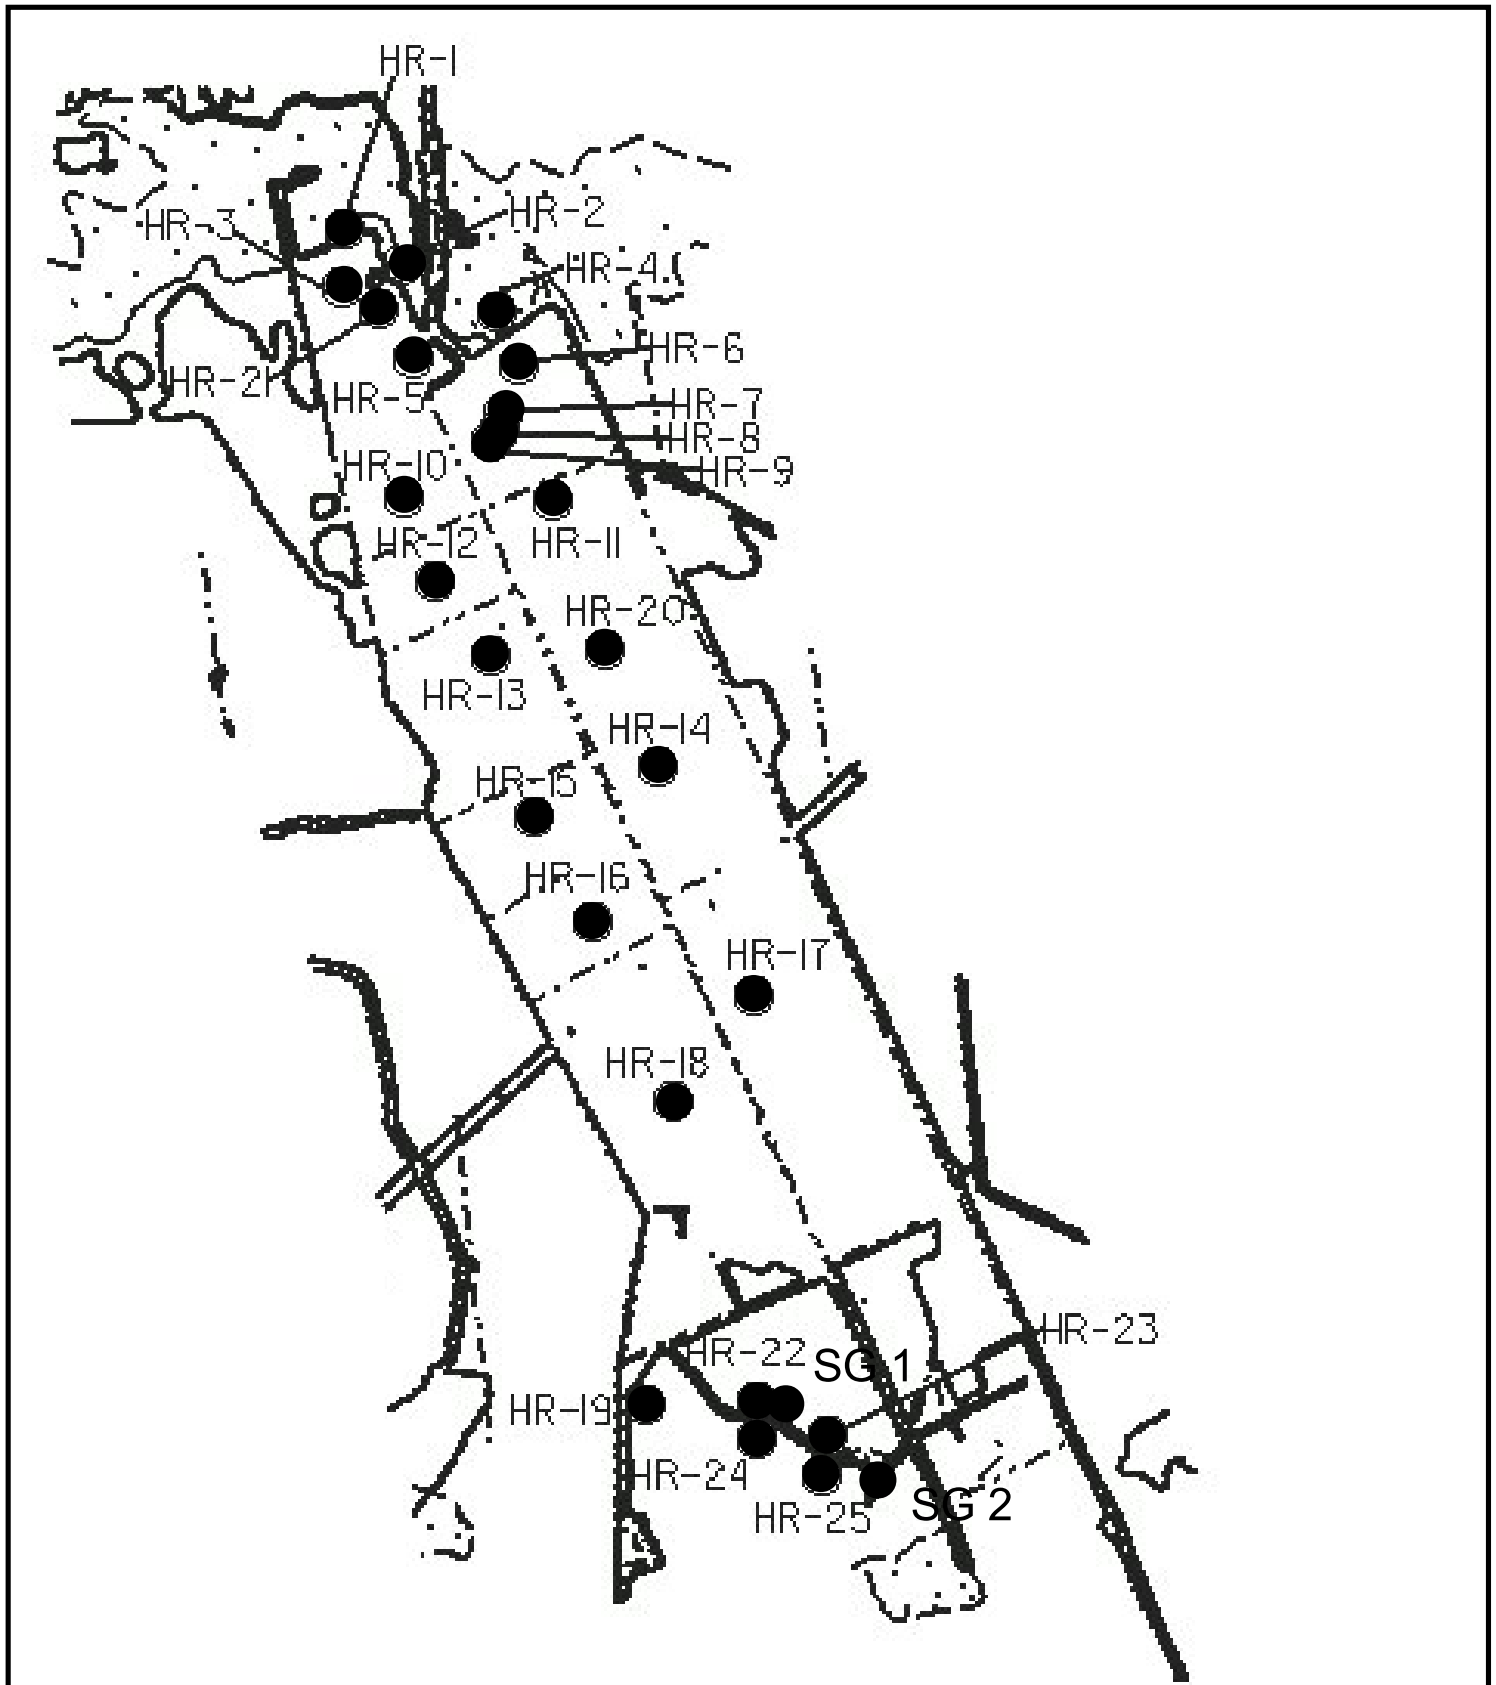
Figure 2. Gauge Location Map

After site construction, nineteen groundwater-monitoring gauges (RDS WL-40) were installed on the site (Figure 2). Two additional gauges, HR-20 and HR-21, were installed in early Spring 2000. HR-15 was reported in the 1999 Monitoring report as being located in the delineated wetland in the pine savanna reference area. A GPS survey placed the actual location in the pine savanna restoration area. This revised location is reported below along with all of the gauges located at Haws Run.

After field inspection in April 1999, monitoring gauges HR-1 through HR-6 were relocated (as shown on Figure 2) to better represent site conditions. The ground surface elevation was surveyed at each well and was used to correlate well data for restoration area and reference area comparisons. Based on similar elevations, the following wells were paired for hydrologic monitoring:

- HR-1 and HR-3 at a relative elevation of 6.2 ft
- HR-2 and HR-5 at a relative elevation of 5.8 ft
- HR-4 and HR-6 at a relative elevation of 4.9 ft

There are also four groundwater gauges, HR-22 through 25, and two surface gauges, SG-1 and SG-2, located along the forestry haul road (southern swamp), which were installed during the pre-construction monitoring phase. All of the monitoring gauges automatically record daily depth to groundwater or surface water on the site. Appendix A contains the graphs for each gauge along with daily rainfall data. Appendix B contains comparison graphs of the restoration and reference areas.

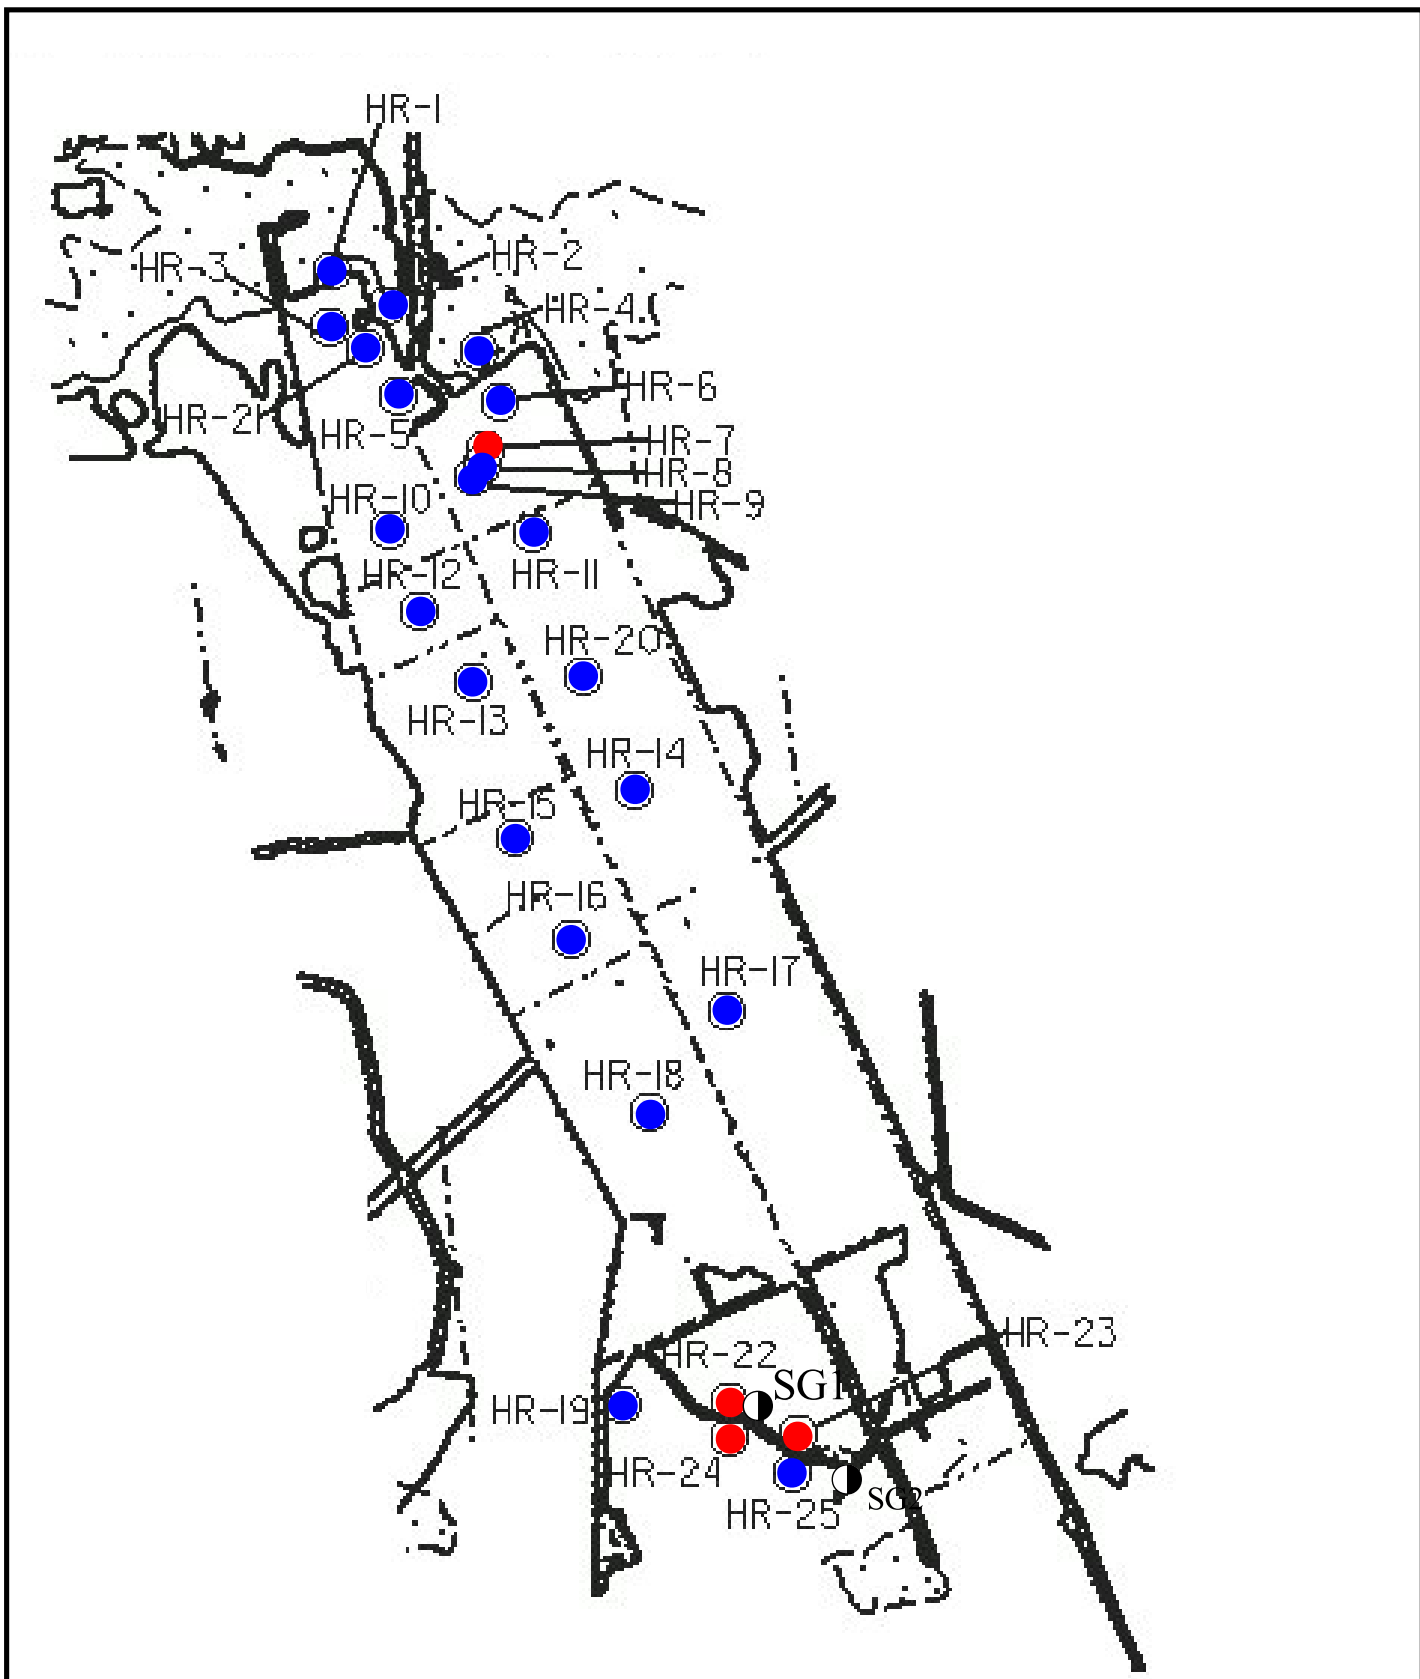
Figure 3. 2004 Hydrologic Monitoring Gauge Results

The maximum number of consecutive days that the groundwater was within twelve inches of the surface was determined at each gauge. This number was converted into a percentage of the 238-day growing season. Because of the variability between wetland systems and within wetland types, the monitoring gauge results are segmented into percentage ranges (Figure 3). Table 1 presents the monitoring results for the 2004 growing season as a range of percentages, actual percentages, and success dates of the longest hydroperiod for each gauge on the site. The reference gauges are also provided in Table 1.

- < 5%
- 5 - 8%
- 8 - 12.5%
- > 12.5%

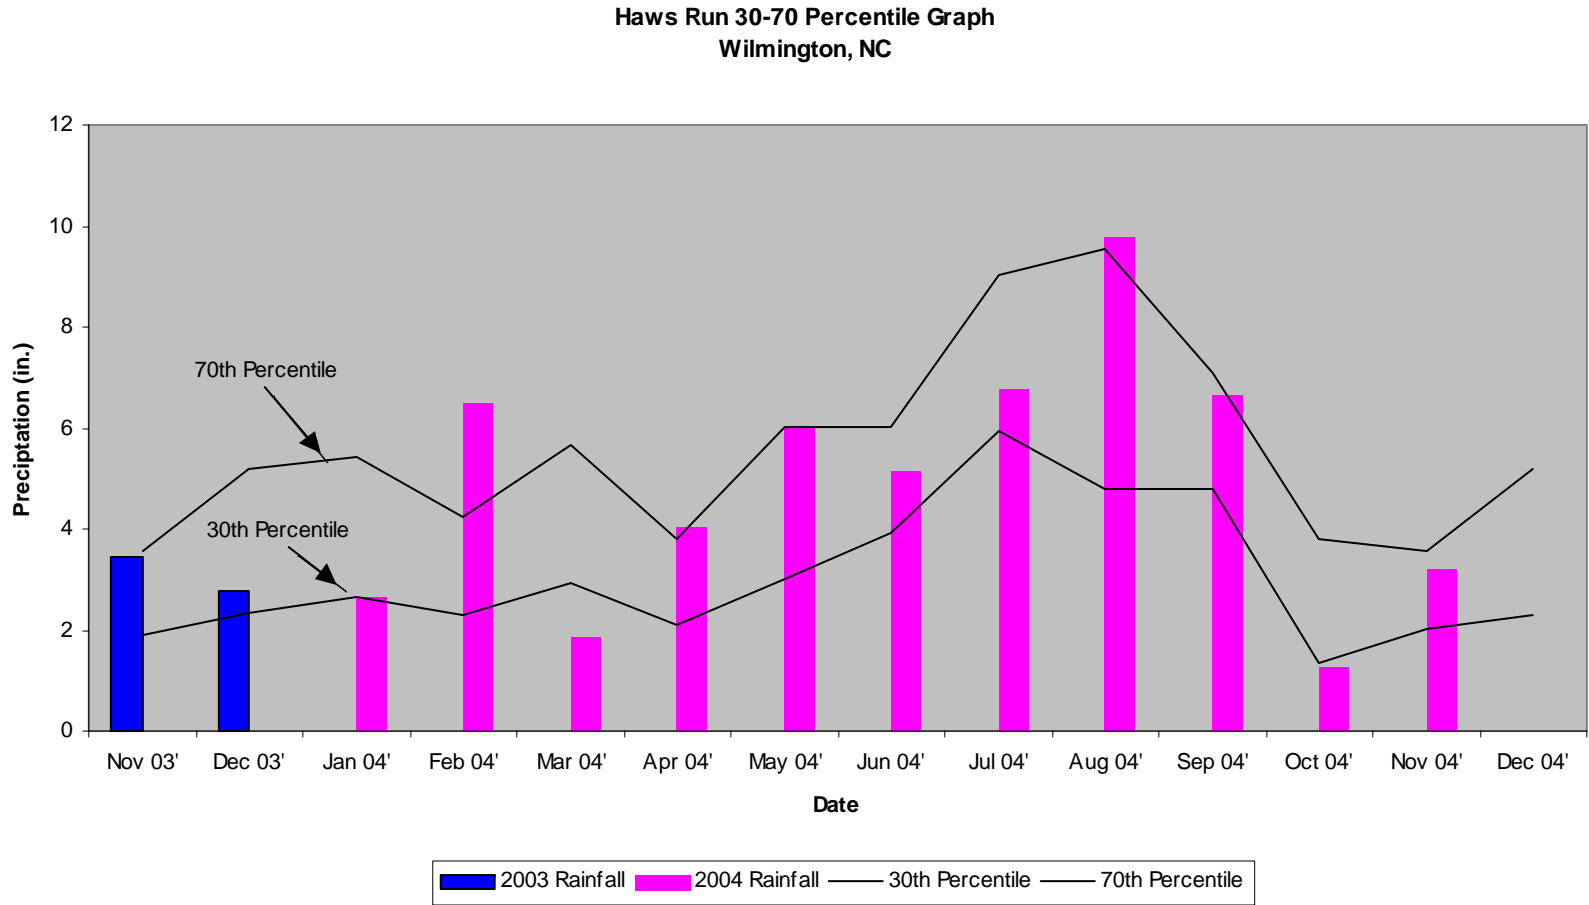
Figure 4. 30-70 Percentile Graph

Figure 4 is a comparison of monthly rainfall for the period of November 2003 through October 2004 to historical precipitation (collected between 1973 and 2004) for Wilmington, North Carolina. This comparison gives an indication of how 2004 relates to historical data in terms of climate conditions. The NC State Climate Office provided all offsite data.

For the 2004-year, February and August experienced above average rainfall. The months of March and October recorded below average rainfall for the site and November (03'), December (03'), January, April, May, June, July, September, and November experienced average rainfall. Overall, 2004 experienced an average rainfall year.

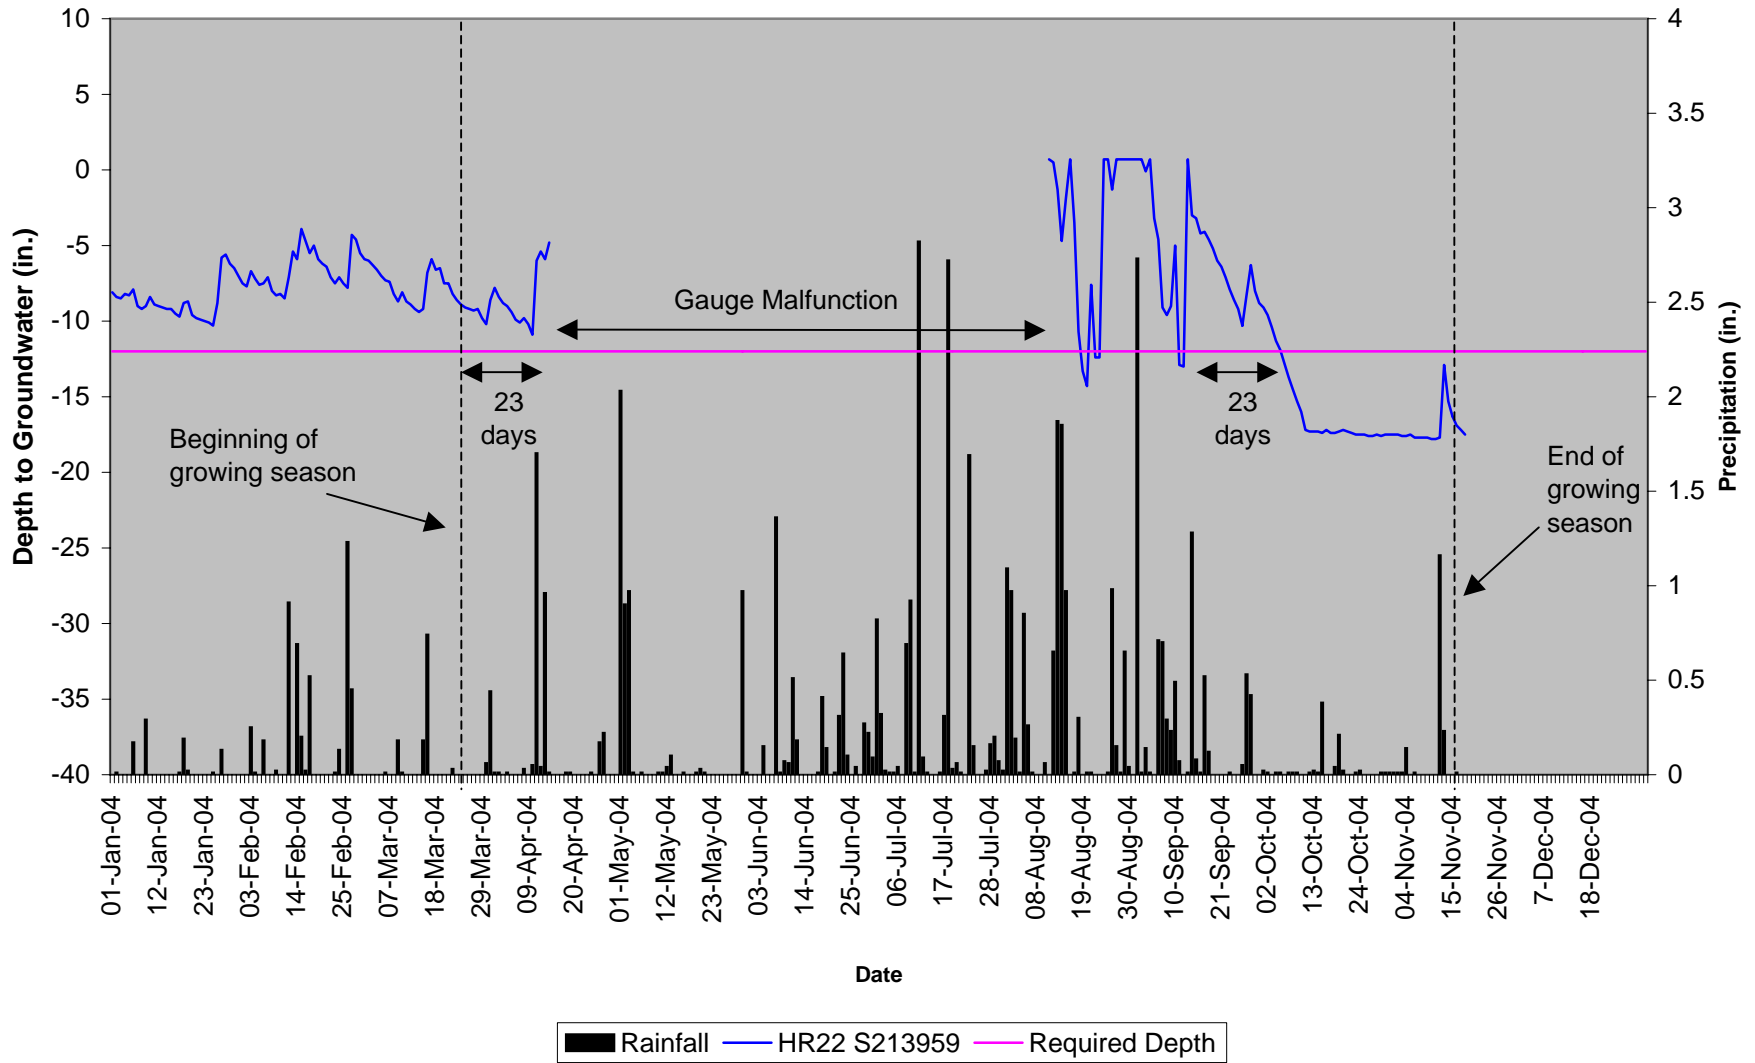
Haws Run HR-22 20" Groundwater

- Gauge HR-22 malfunctioned during the growing season (April 15-August 10).

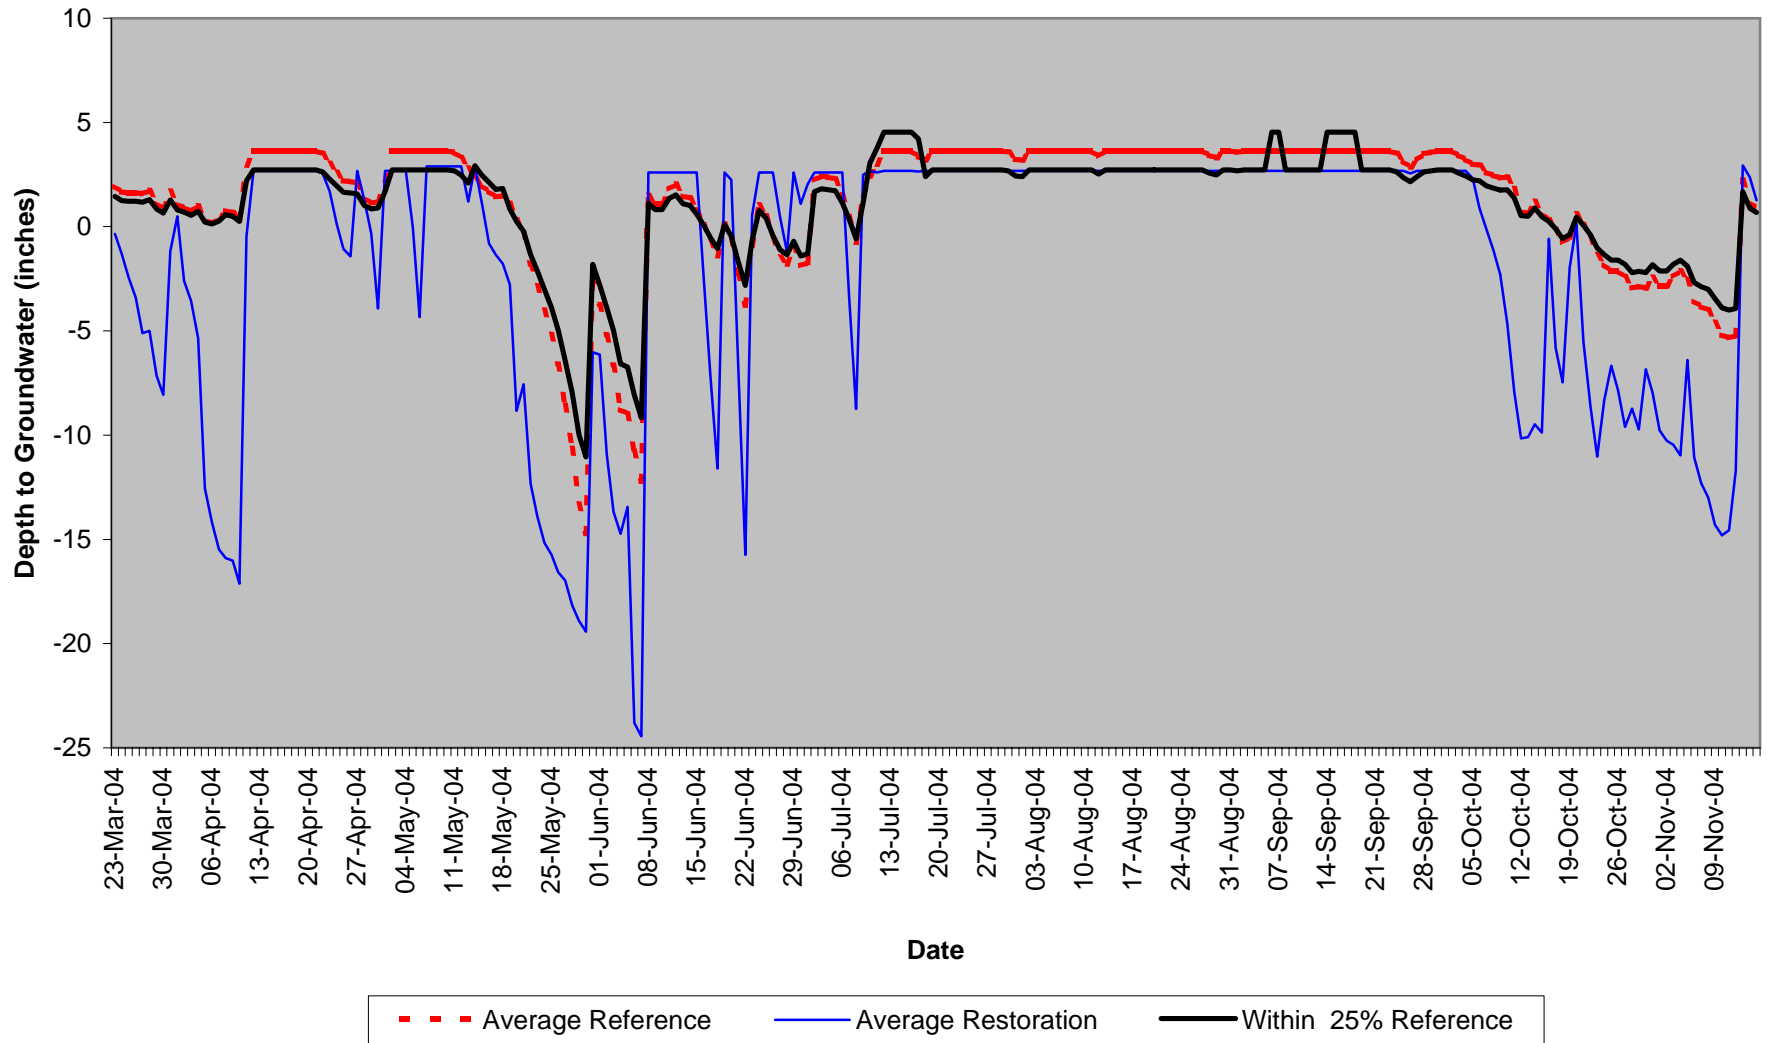
Haws Run Swamp Forest 2004 Average Reference vs. Average Restoration

The average depth to groundwater for both the reference and restoration area gauges was calculated and plotted for the growing season (Appendix B). Appendix B also contains the comparisons of depth to groundwater for paired gauges. The results are presented as a percentage of the days when the depth to groundwater in the restoration area was at, above, or no deeper than 25% of the depth to groundwater in the reference area. The results are as follows.

Average Swamp Restoration Area was comparable for 21.4% of days in the Average Swamp Reference Area:

- HR-3: 61.3% of days at HR-1.
- HR-5: 29.8% of days at HR-2.
- HR-6: 82.4% of days at HR-4.

Hydrologic patterns in the restoration areas across the Haws Run Mitigation Site followed patterns in the reference areas. Flooding frequency and depth in the swamp restoration area coincided with flooding in the swamp reference area. The comparison plots in Appendix B clearly illustrate the restoration hydrologic regime coinciding with the reference area hydrologic regime. The water table did decline quicker in the swamp restoration area than in the swamp reference area, resulting in less storage time. This can be partially attributed to differences in soil organic matter content and surface roughness between the two areas. Gauge HR-19 is located in the southern swamp restoration area; therefore it was not included in the restoration average since it's performing in a different system.

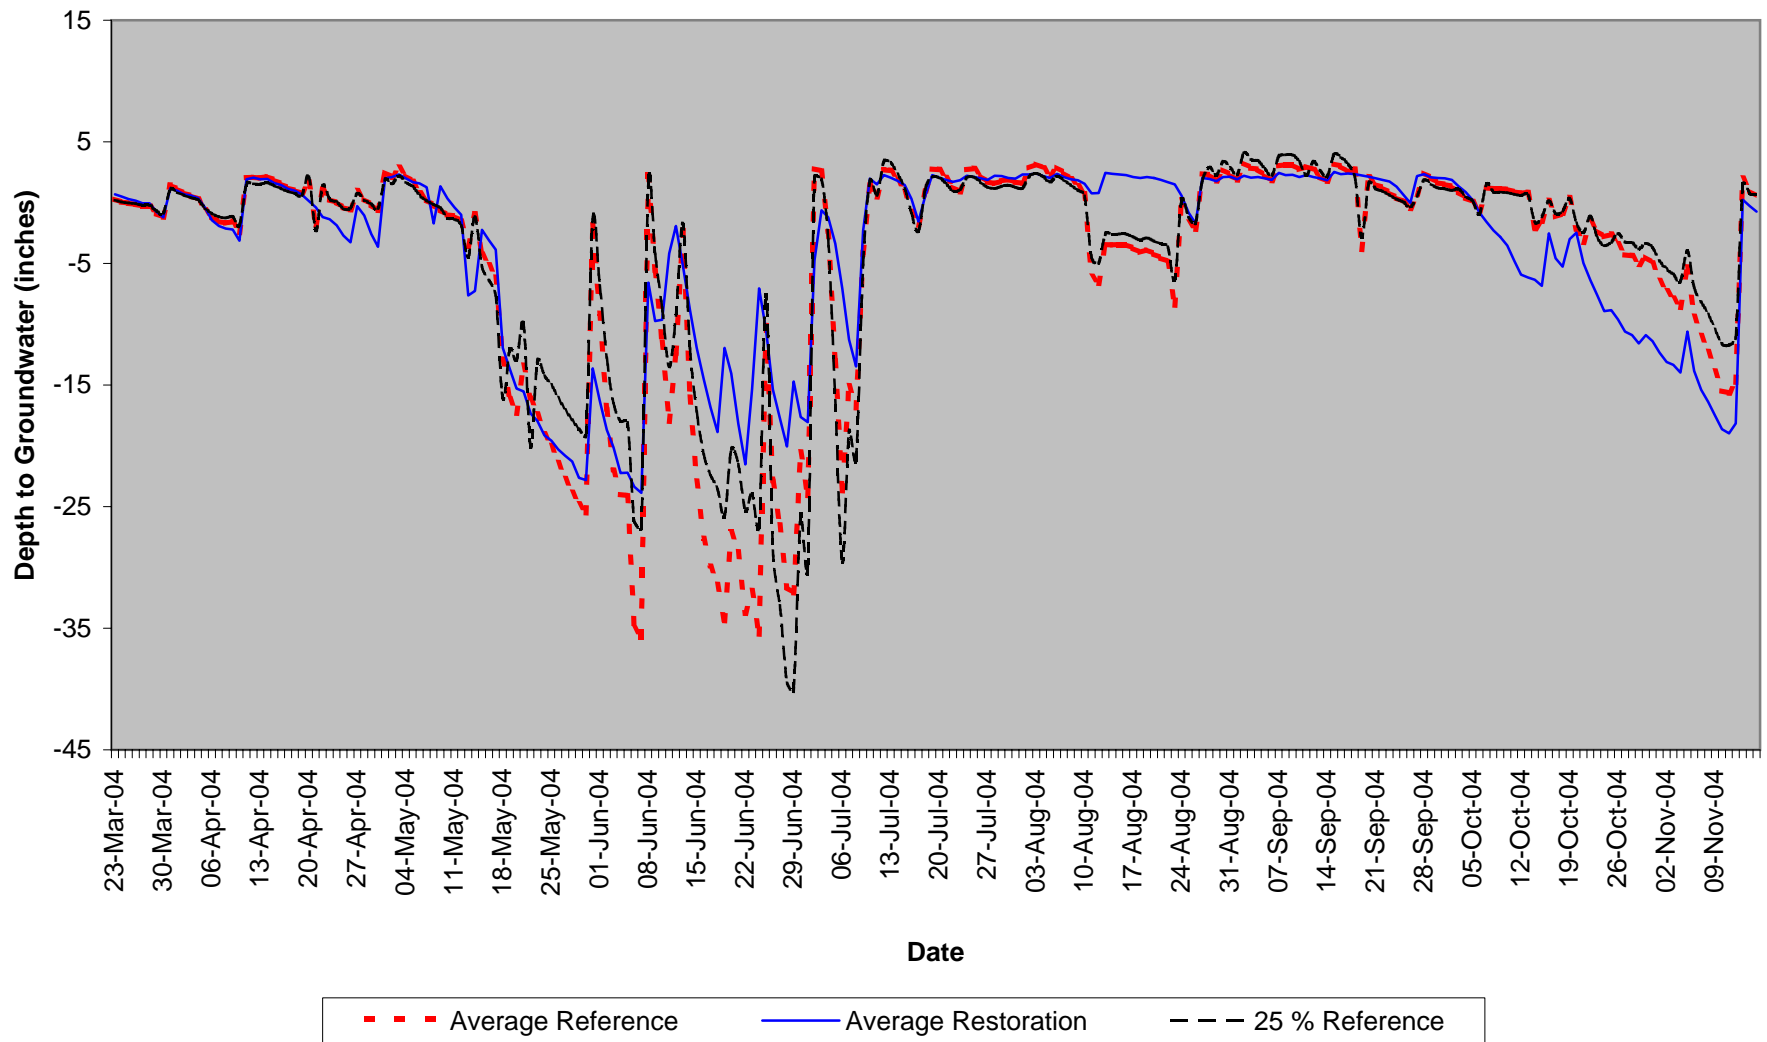
Haws Run Savanna 2004 Average Reference vs. Average Restoration

The Average Pine Savanna Restoration Area was comparable for 53.8% of days in the Average Pine Savanna Reference Area.

The plots in Appendix B show the similarities in hydrologic regime between the savanna reference and restoration areas. Average restoration and reference area values were very similar in the pine savanna area.

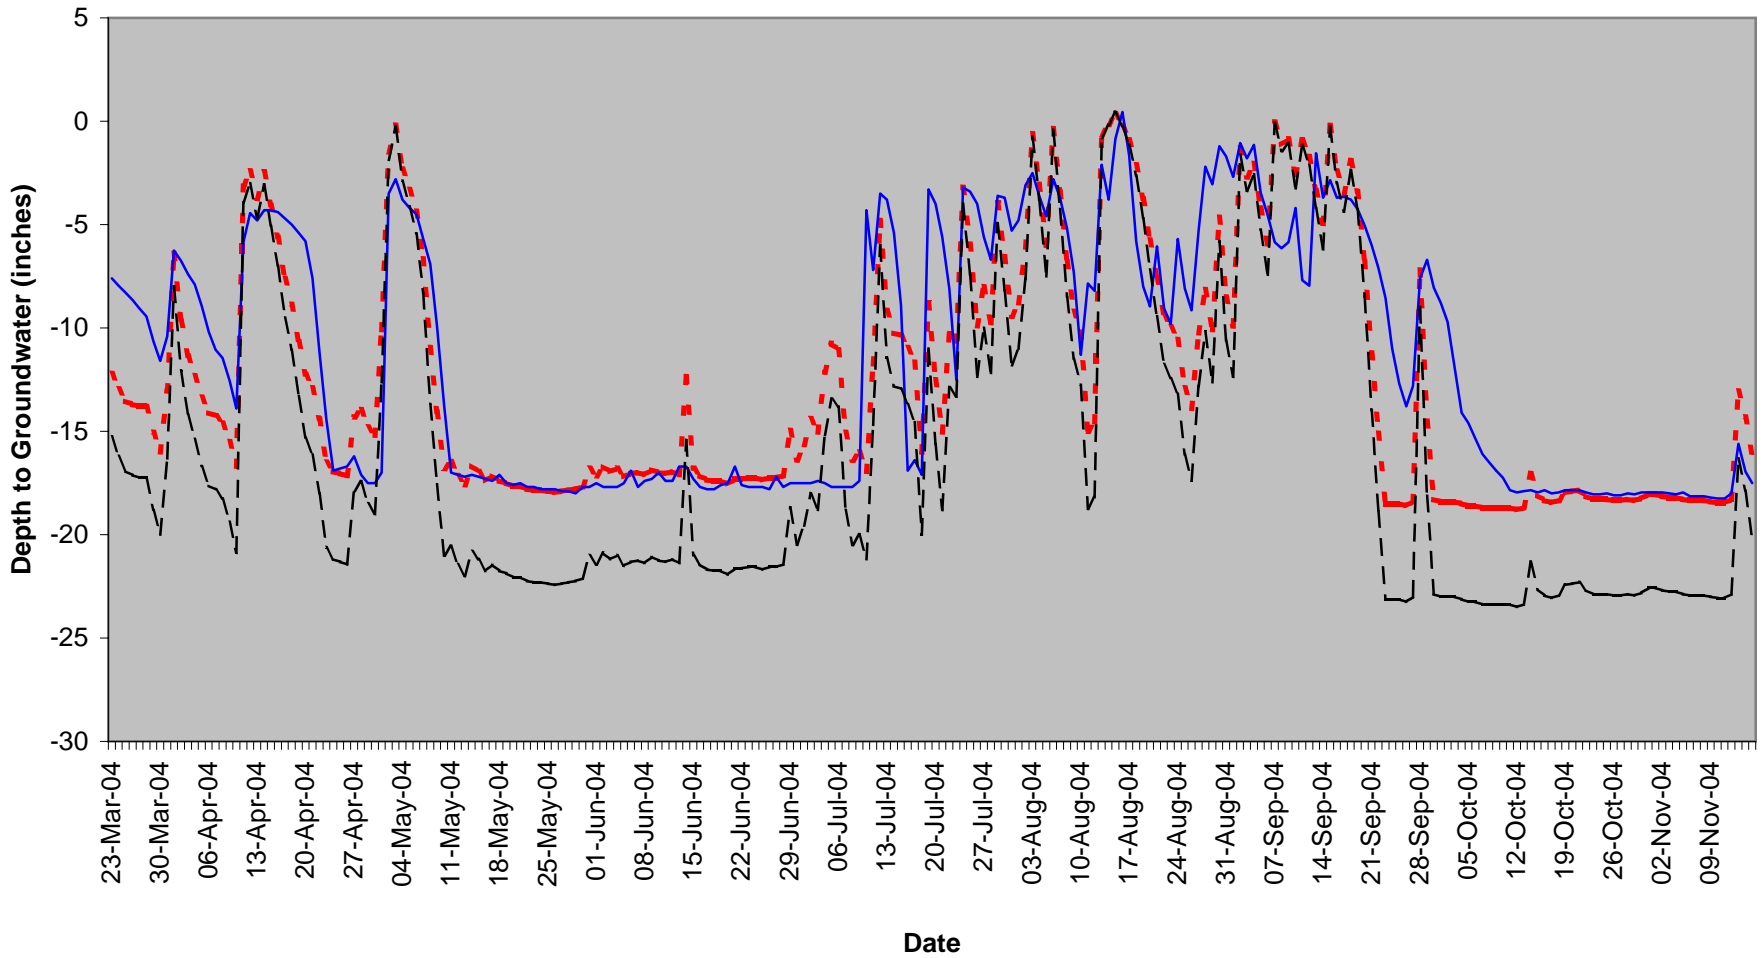
Haws Run Hauls Road (Southern Swamp) 2004 Average Reference vs. Average Restoration

The Average Haul Road (southern swamp) Restoration Area was comparable for 85.7% of days in the Average Haul Road (southern swamp) Reference Area.

The average hydrologic regime for the haul road (southern swamp) restoration area was similar to the reference area; the flooding patterns coincided well. The data illustrated the effects of removal of the haul road (southern swamp) (re-establishing the hydrologic connection of the isolated area to the southern swamp area).

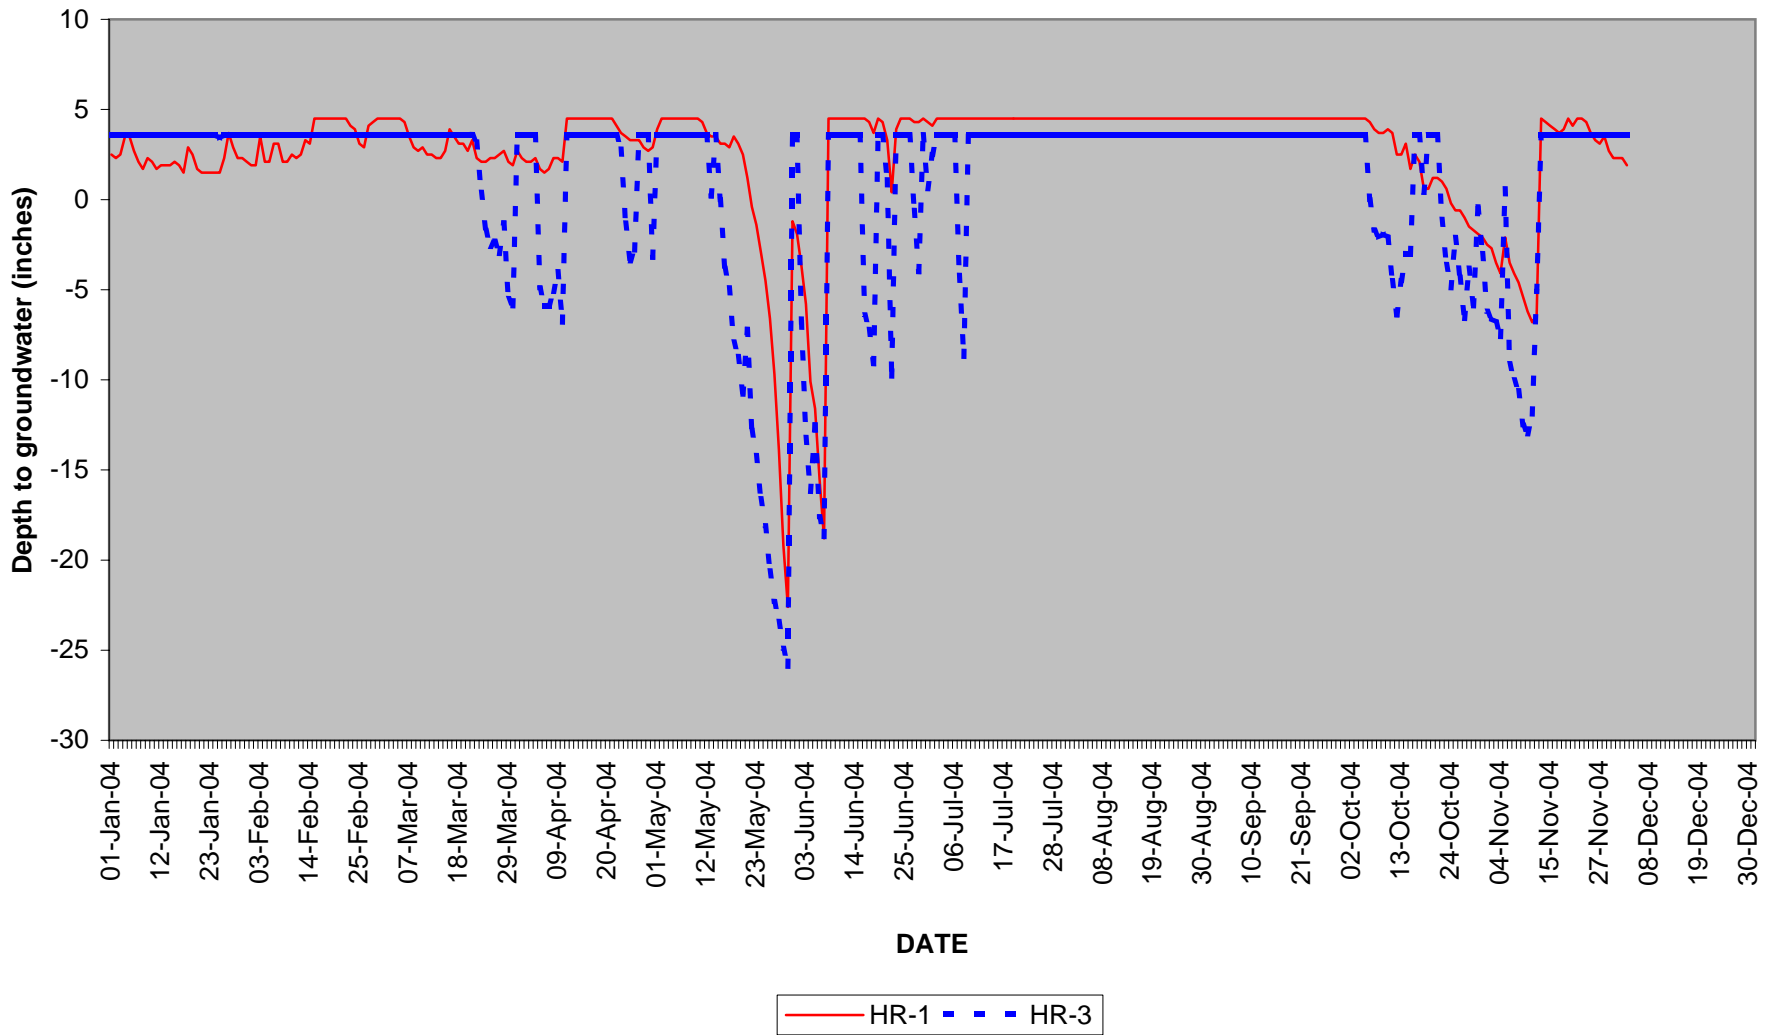
Comparison of HR-1 & HR-3 Swamp Forest

- HR-3: 95.7% of HR-1.
- HR-5: 46.2% of HR-2.
- HR-6: 78.1% of HR-4.

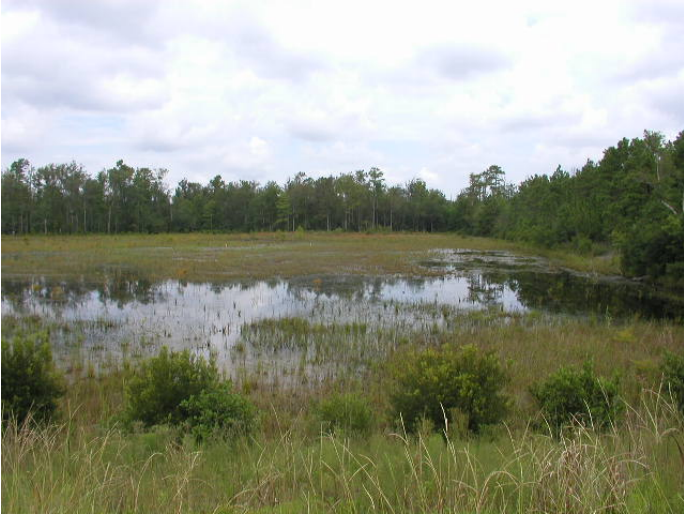
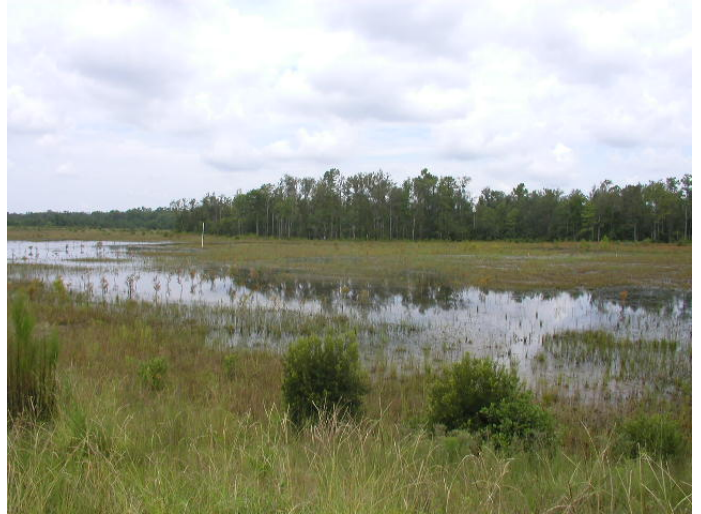
Photo 1

The area around plot one has been inundated with water at every site visit (See photos 1 and 2). The planted tree seedlings did not survive in this area. NCDOT supplemental planted this area in March 2002 with bald cypress, swamp blackgum, overcup oak, and green ash. These more wet tolerant trees have survived well in that area.

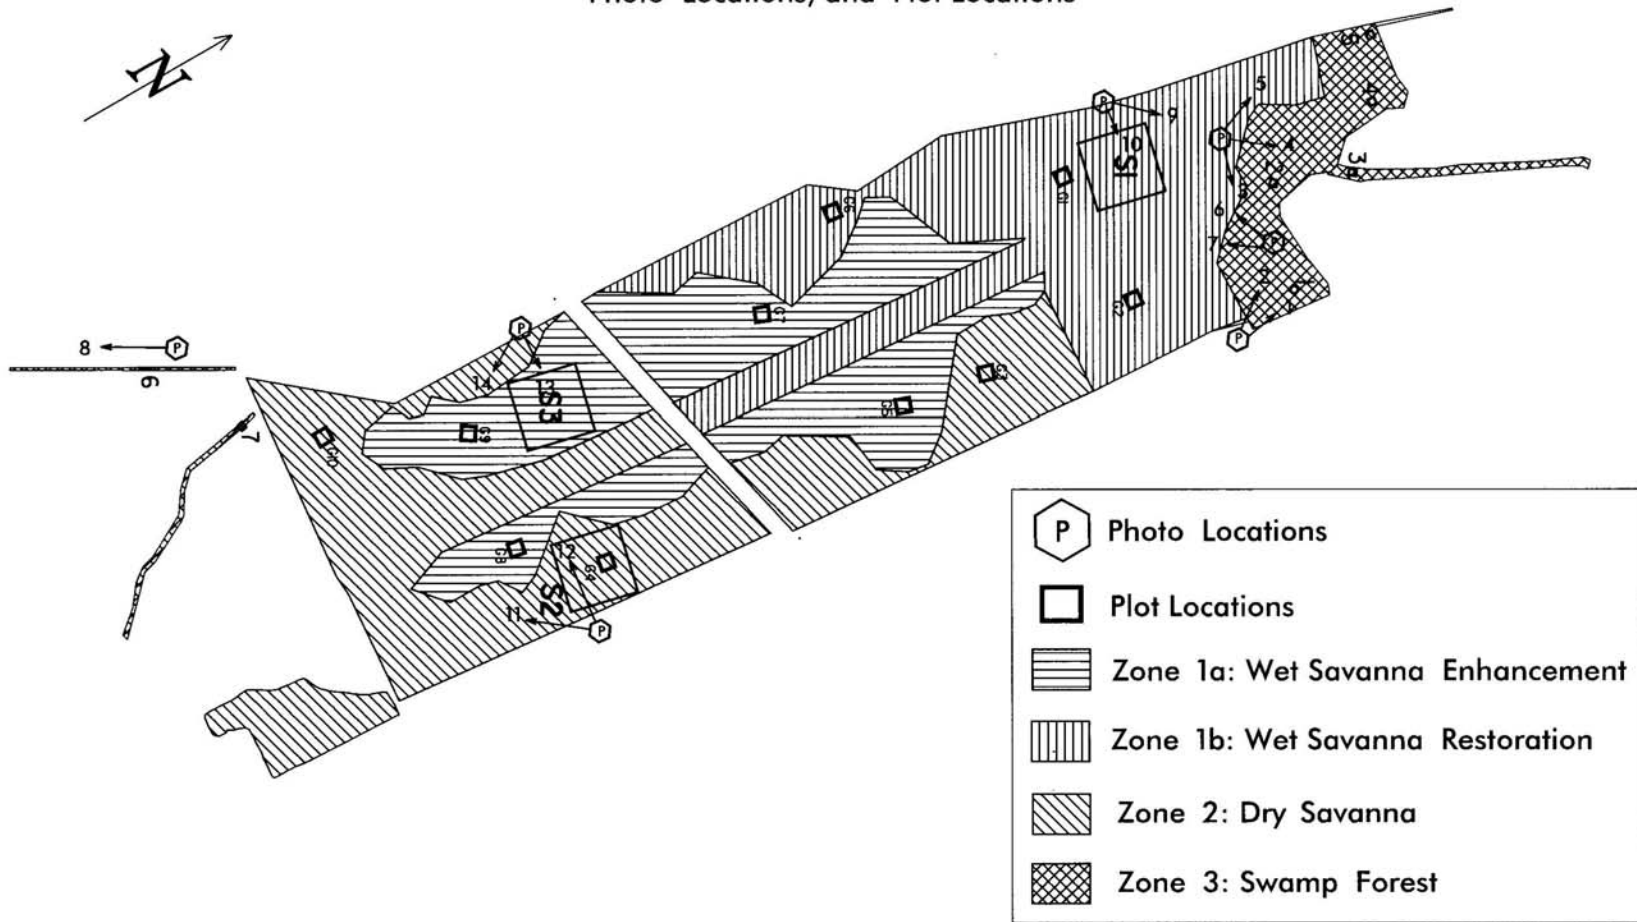
Planting Plan
Photo Locations, and Plot Locations

-   Photo Locations
-   Plot Locations
-   Zone 1a: Wet Savanna Enhancement
-   Zone 1b: Wet Savanna Restoration
-   Zone 2: Dry Savanna
-   Zone 3: Swamp Forest
