ANNUAL MONITORING REPORT
YEAR 1 (2010)
HEATH RIPARIAN BUFFER MITIGATION SITE
CRAVEN COUNTY, NORTH CAROLINA
(EEP Contract No. 002280)

**MONITORING PLAN VIEW
HEATH
RIPARIAN BUFFER MITIGATION SITE
Craven County, North Carolina**

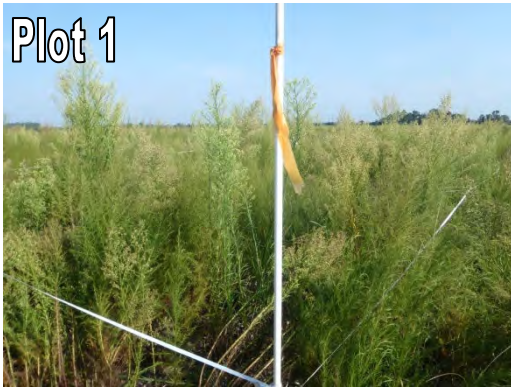
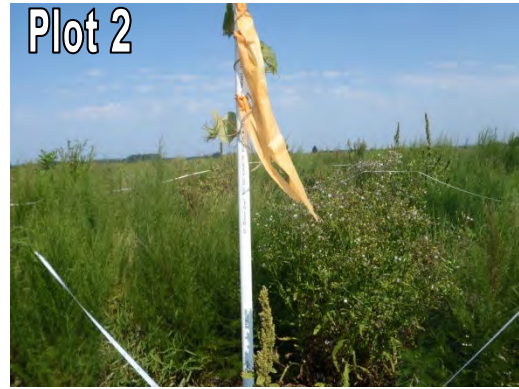
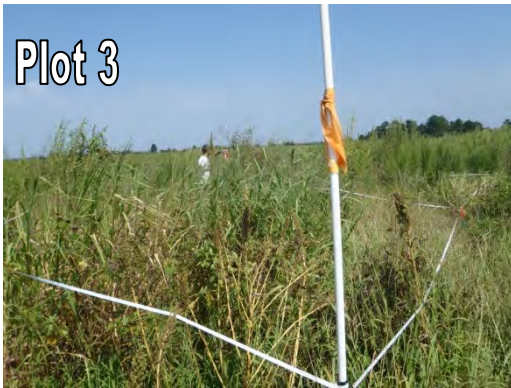
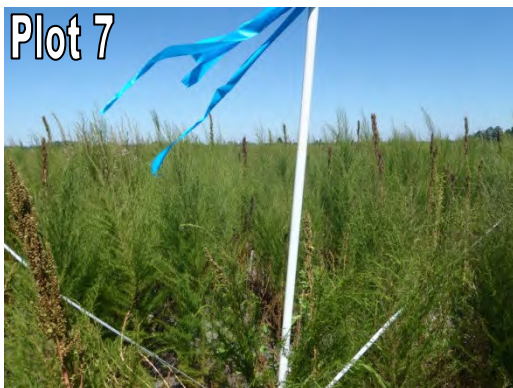
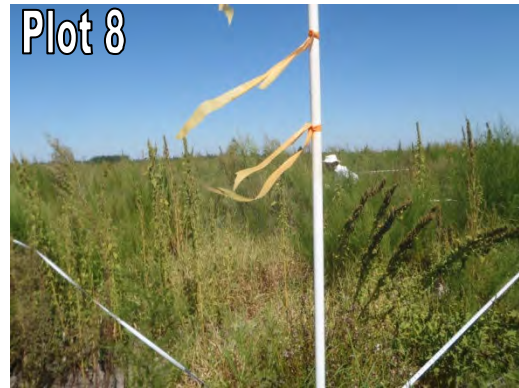
**Heath
Year 1 (2010)
Vegetation Monitoring Plot Photos
Taken September 2010**

Quantitative sampling of vegetation was conducted in September 2010. Results are provided in Appendix C. Vegetation success criteria for year 1 (320 stems per acre) were exceeded for the 2010 annual monitoring year with an average density of 826 planted stems per acre across the Site. In addition, each individual plot met success criteria based on planted stems alone.
