**ANNUAL MONITORING REPORT**  
**YEAR 4 (2013)**  
**HEATH RIPARIAN BUFFER MITIGATION SITE**  
**CRAVEN COUNTY, NORTH CAROLINA**  
**(EEP Contract No. 002280)**

**November 2013**

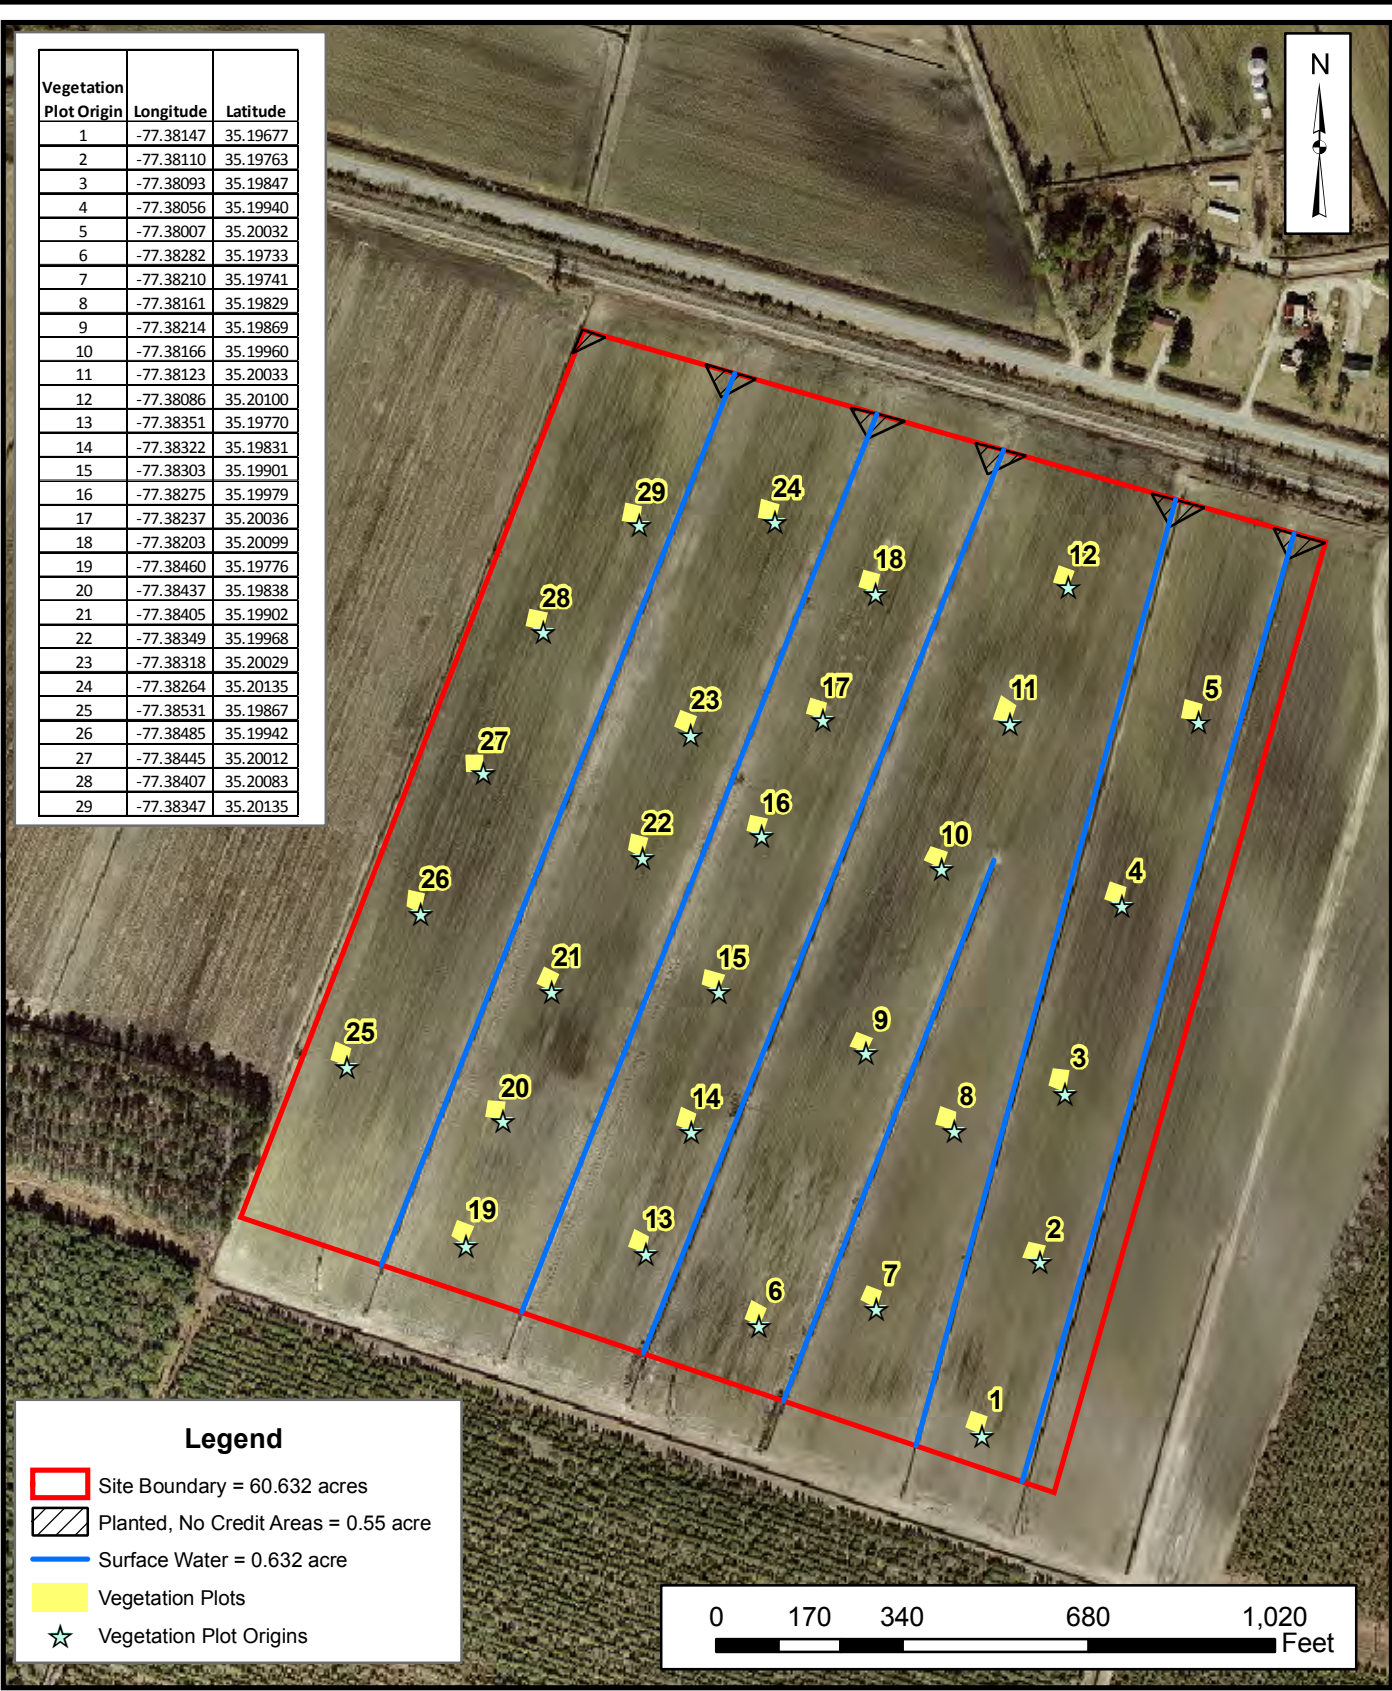
FIGURE  
**2**

- Site Boundary = 60.632 acres
- Planted, No Credit Areas = 0.55 acre
- Surface Water = 0.632 acre
- Vegetation Plots
- ☆ Vegetation Plot Origins

**MONITORING PLAN VIEW  
HEATH  
RIPARIAN BUFFER MITIGATION SITE  
Craven County, North Carolina**
