ANNUAL MONITORING REPORT
YEAR 5 (2014)
HEATH RIPARIAN BUFFER MITIGATION SITE
CRAVEN COUNTY, NORTH CAROLINA
(EEP Contract No. 002280, EEP ID No. 94014)

**MONITORING PLAN VIEW
HEATH
RIPARIAN BUFFER MITIGATION SITE
Craven County, North Carolina**

**Heath
Year 5 (2014)
Vegetation Monitoring Plot Photos
Taken October 2014**

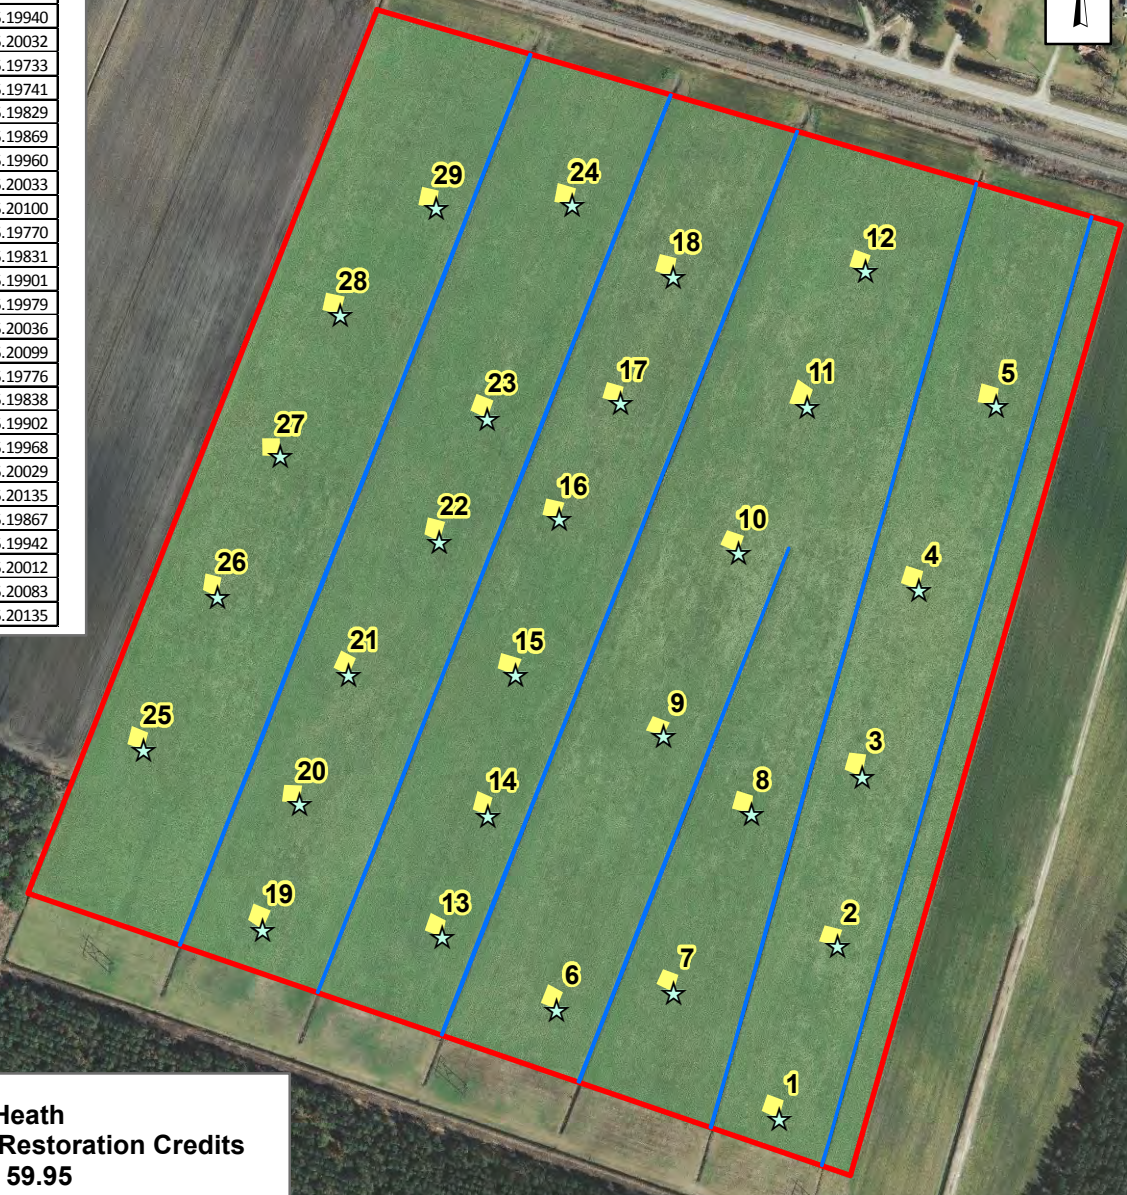
FIGURE
2

- Easement = 60.62 acres
- Vegetation Plots
- Surface Water within Easement = 0.67 acre
- Nutrient Offset Restoration Area = 59.95 acres (2,611,560 sq. ft)
- ★ Vegetation Plot Origins

As constructed, Site activities restored historic riparian buffer functions by planting the entire 60.63-acre Site with native riparian vegetation. This resulted in 59.95 units of riparian buffer restoration to be used for nutrient offset mitigation. (Table 1, Appendix B and Figure 2, Appendix A). Approximately 0.67 acres of the Site is surface water associated with Site ditches. These areas were planted; however, the area is not eligible to provide credit. The target natural community consisted of Coastal Plain Bottomland Hardwood Forest (Schafale and Weakley 1990). Table 5 (Appendix C) outlines woody species planted within the

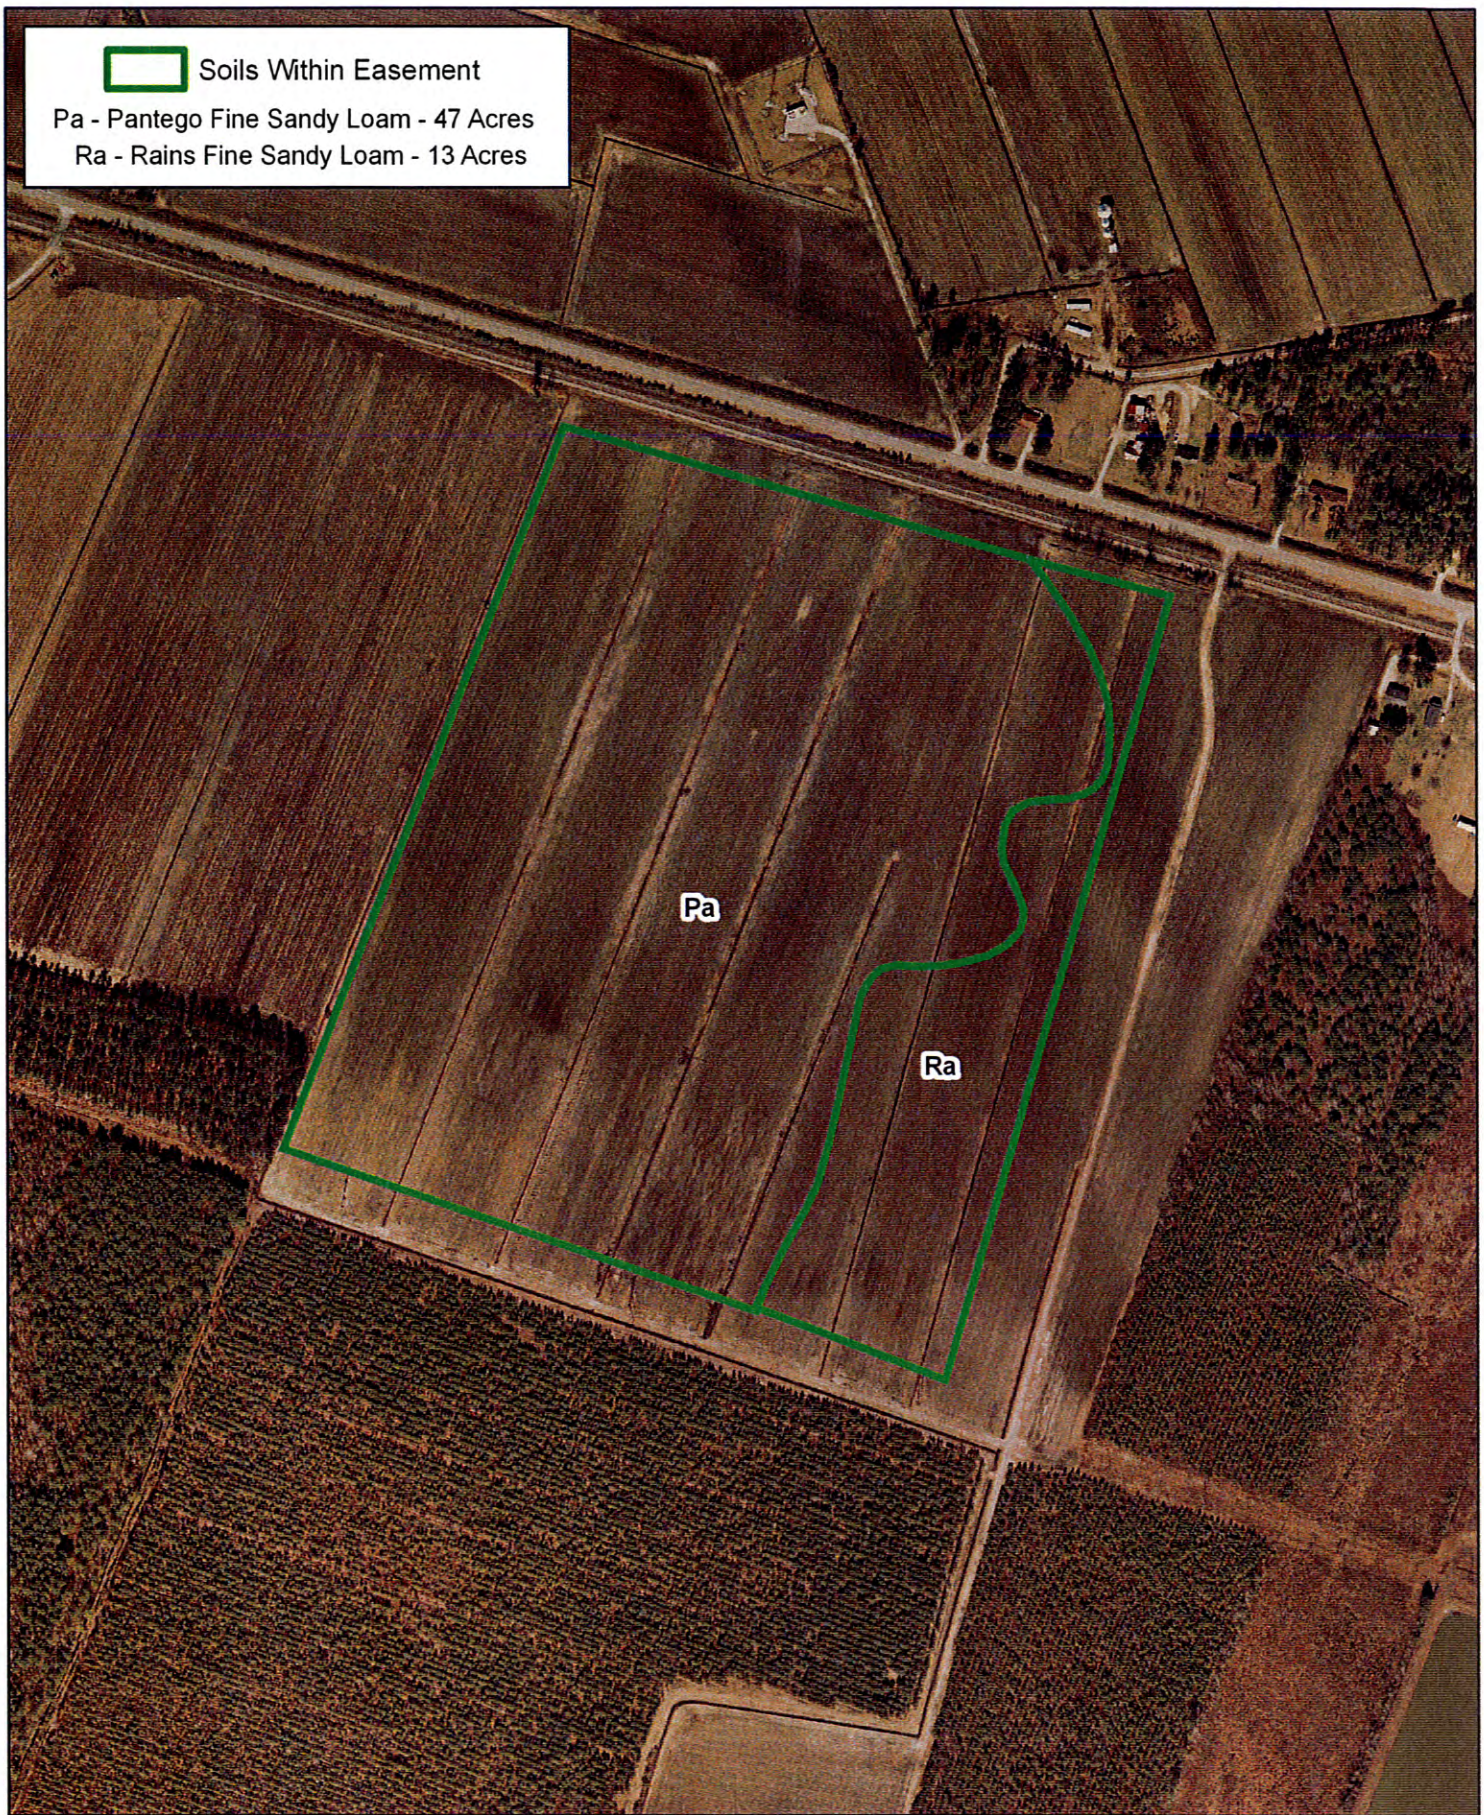
Figure 3:
Soils

Soils Within Easement

Pa - Pantego Fine Sandy Loam - 47 Acres

Ra - Rains Fine Sandy Loam - 13 Acres
