REPLY TO
ATTENTION OF:

Re: NCIRT Review and USACE Approval of the Henry Fork Draft Mitigation Plan; SAW-2014-00538;
DMS Project #96306

The Henry Fork Mitigation Site (site) is a stream and wetland project located in Catawba County approximately one mile southwest of the City of Hickory (Figure 1). The site is located in the Catawba River Basin HUC 03050102010030 and NCDWR Subbasin 03-08-35. The project’s compensatory mitigation credits will be used in accordance with the In-Lieu Fee (ILF) Program Instrument dated July 28, 2010, the expanded service area for HUC 03050103 as defined under the September 12, 2006 PACG memorandum, and/or DMS acceptance and regulatory permit conditions associated with Division of Mitigation Services ILF requirements. The site is within the Lower Henry Fork Targeted Local Watershed (TLW) identified in DMS’ 2007 Catawba River Basin Restoration Priority (RBRP) Plan which can be accessed at:

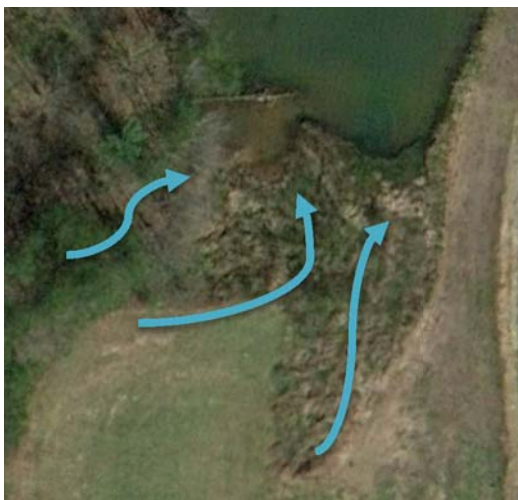
Multiple Channel Threads at Head of Pond 2 as a Result of Loss of Sediment Transport

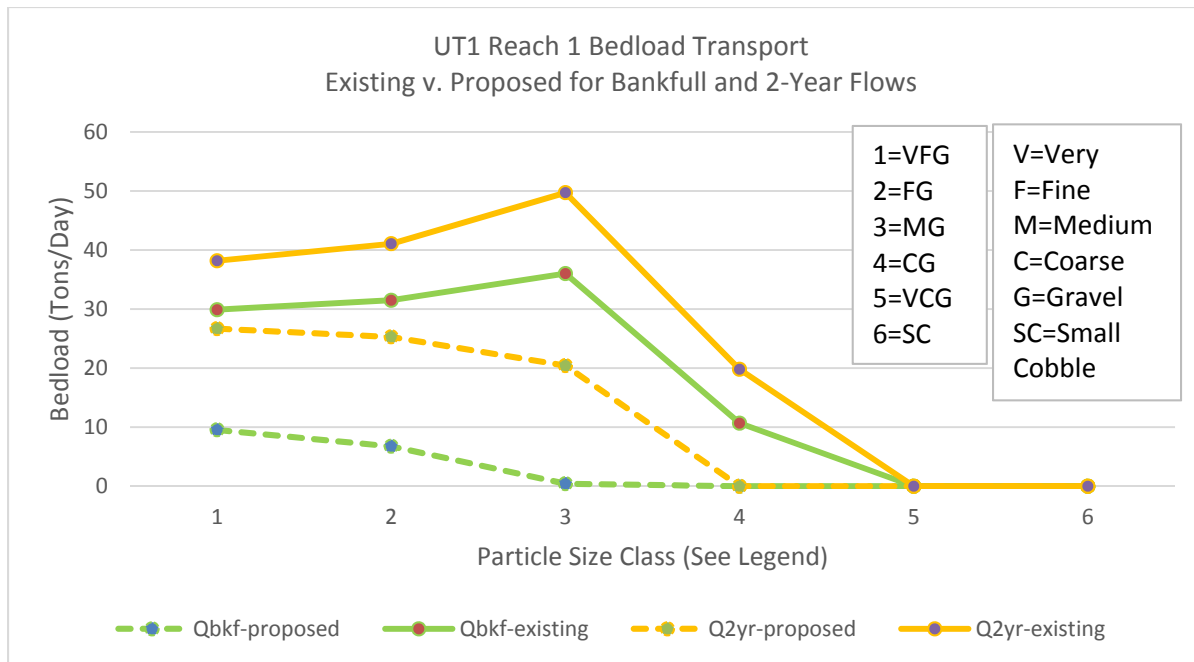
Shows that the proposed design will retain more medium and coarse gravel for the bankfull and 2-year flow events based on the MPM bedload transport function

Lastly, the steeper UT1 Reach 1 was modeled, and is a suitable analog for Reach 1 Upper and Lower, as well as for UT1B. An analysis of various flows was conducted to compare the existing and proposed sediment transport capacity in this steeper reach that has a channel slope of approximately 5%. The sediment transport rating curves and shear stress rating curves show that the proposed design will result in reductions to capacity and shear for flows exceeding the bankfull design storm which is a positive outcome in this high energy supply-limited stream. Oversized channels with excessive capacity and shear lead to increased incision and over-widening as part of channel evolution. One interesting outcome from modeling is that gravel and cobble transport capacity was reviewed and shows the expected size of material that will contribute to riffle armor layer development. The modeling predicts that medium to coarse gravel will be low mobility in the proposed stream, whereas coarse gravel and cobble is a more dominant armoring material size in the existing stream. Modeling data is supported by observation of riffles, and by pebble count data. The greater diversity of riffle particle sizes is expected to create more heterogeneous habitat niches.

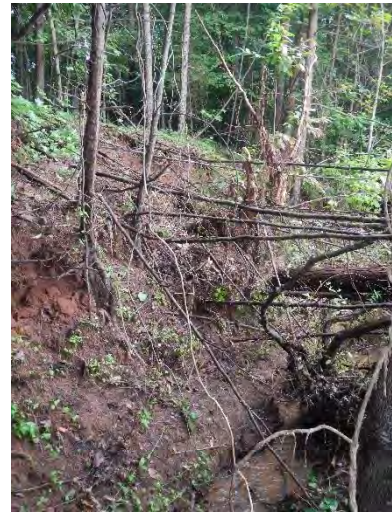
Bank failure along UT1 (8/22/2013)

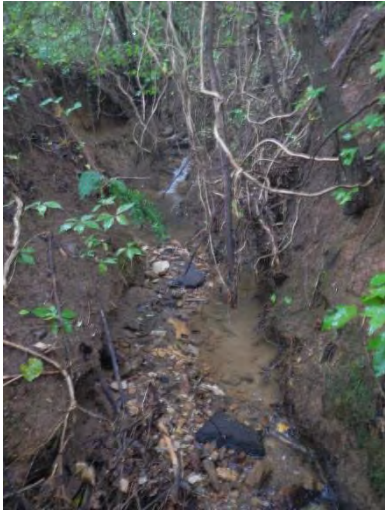
UT1 immediately above Pond 2 (8/22/2013)
