BASELINE MONITORING DOCUMENT AND AS-BUILT BASELINE REPORT

HENRY FORK MITIGATION SITE

Catawba County, NC
DEQ Contract No. 005782
DMS ID No. 96306

Baseline Monitoring Document and As-Built Baseline Report

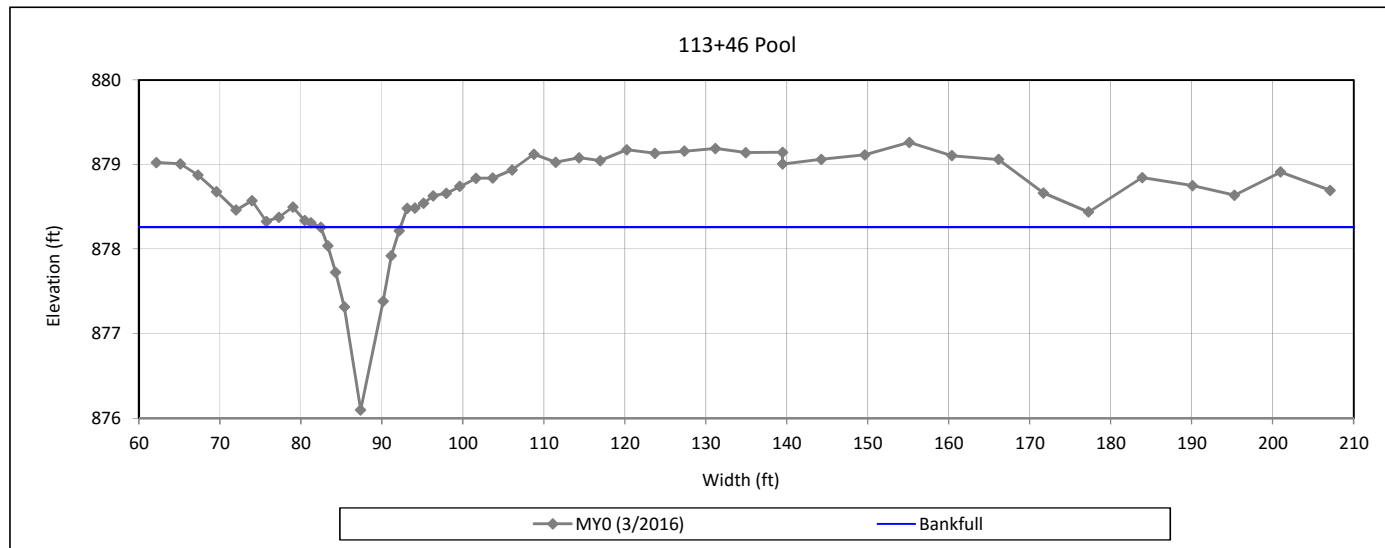
Cross Section 3-UT1 R1

9.1	x-section area (ft.sq.)
7.8	width (ft)
1.2	mean depth (ft)
2.2	max depth (ft)
8.7	wetted perimeter (ft)
1.0	hydraulic radius (ft)
6.7	width-depth ratio

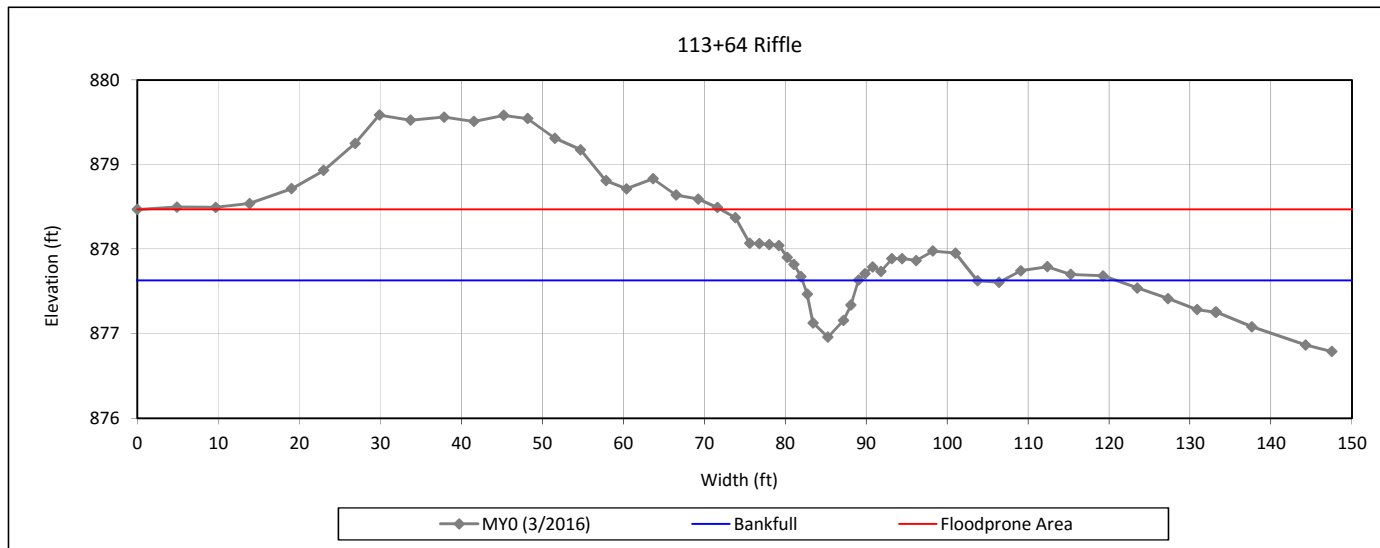
Cross Section 4-UT1 R1

2.9	x-section area (ft.sq.)
6.9	width (ft)
0.4	mean depth (ft)
0.8	max depth (ft)
7.1	wetted perimeter (ft)
0.4	hydraulic radius (ft)
16.2	width-depth ratio
118.3+	W flood prone area (ft)
17.1+	entrenchment ratio
1.0	low bank height ratio

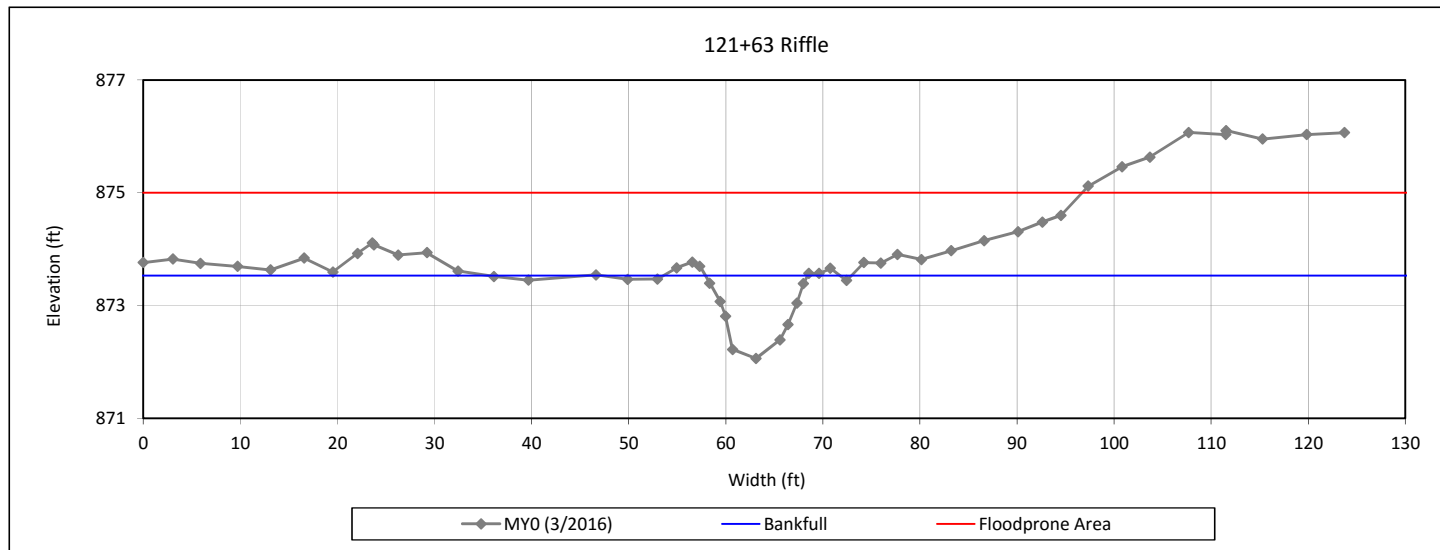
Cross Section 5-UT1 R2

9.7	x-section area (ft.sq.)
10.5	width (ft)
0.9	mean depth (ft)
1.5	max depth (ft)
11.1	wetted perimeter (ft)
0.9	hydraulic radius (ft)
11.4	width-depth ratio
96.7+	W flood prone area (ft)
9.2+	entrenchment ratio
1.0	low bank height ratio

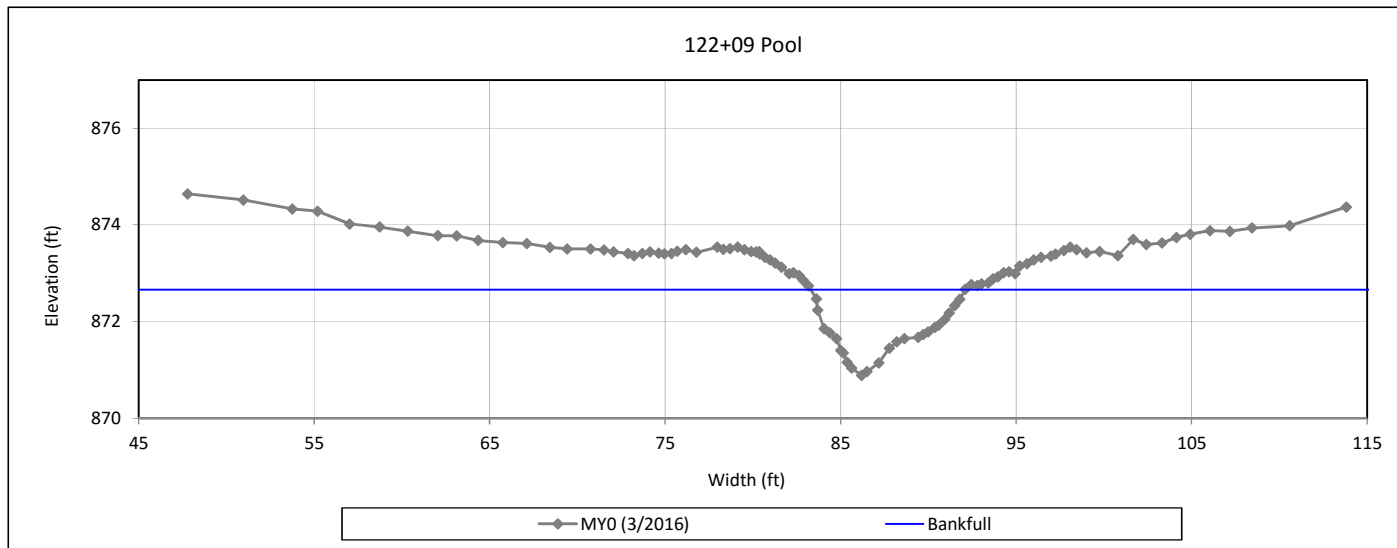
Cross Section 6-UT1 R2

8.8	x-section area (ft.sq.)
8.8	width (ft)
1.0	mean depth (ft)
1.8	max depth (ft)
9.8	wetted perimeter (ft)
0.9	hydraulic radius (ft)
8.7	width-depth ratio

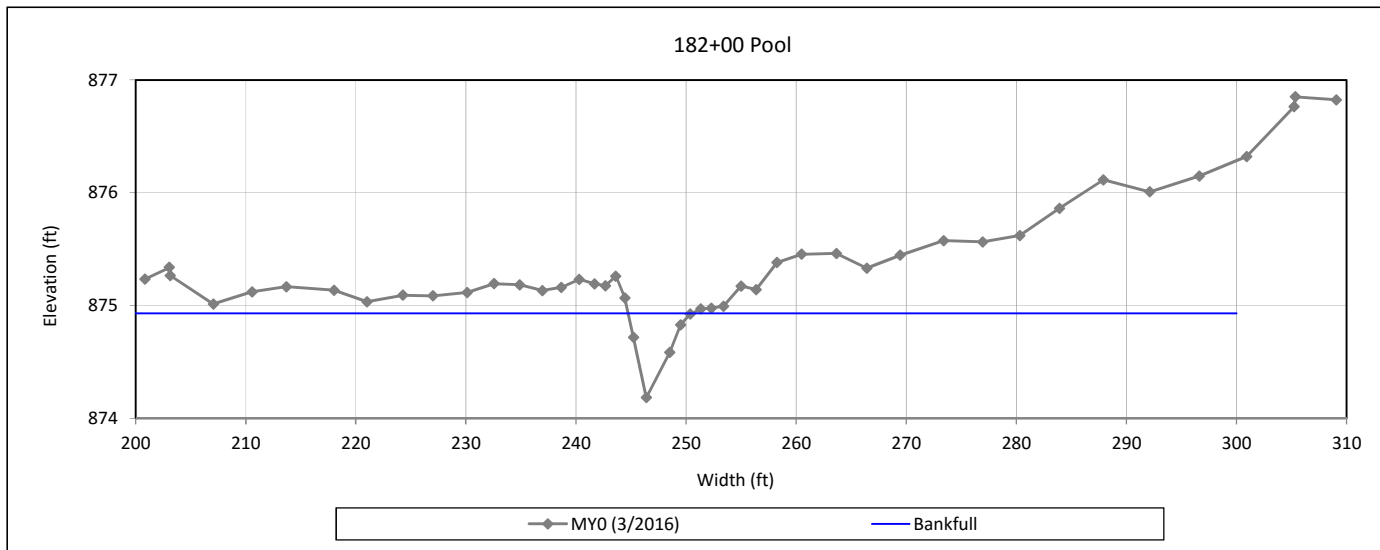
Cross Section 7-UT1A

2.0	x-section area (ft.sq.)
5.6	width (ft)
0.4	mean depth (ft)
0.7	max depth (ft)
5.9	wetted perimeter (ft)
0.3	hydraulic radius (ft)
15.6	width-depth ratio

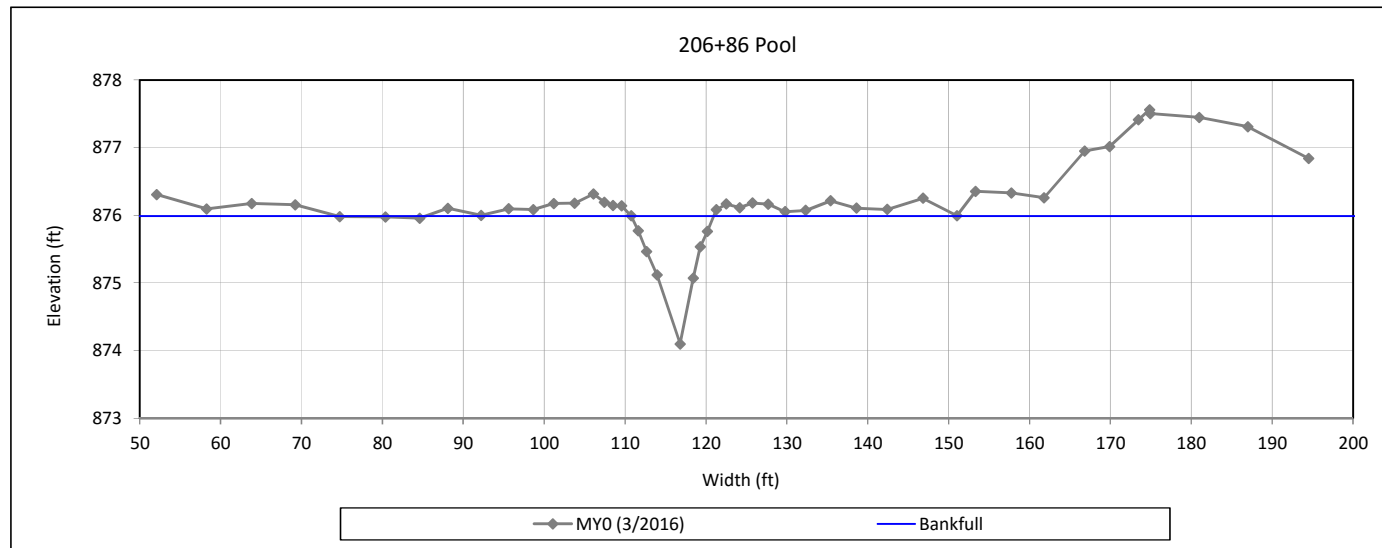
Cross Section 11-UT2

8.4	x-section area (ft.sq.)
8.5	width (ft)
1.0	mean depth (ft)
1.9	max depth (ft)
9.2	wetted perimeter (ft)
0.9	hydraulic radius (ft)
8.7	width-depth ratio

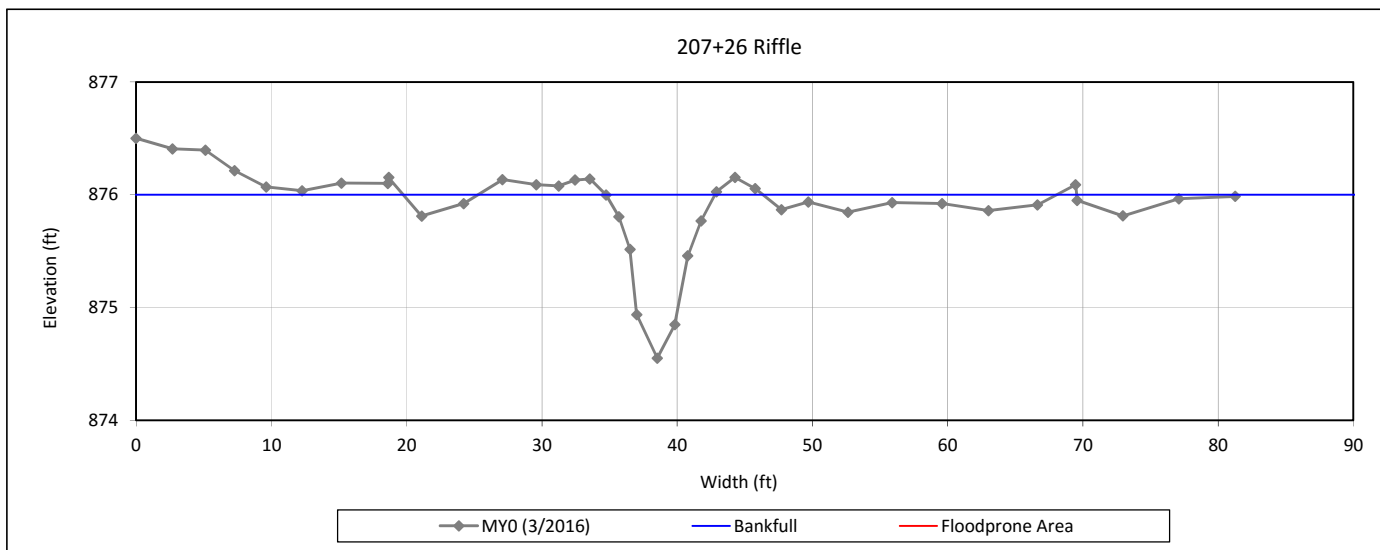
Cross Section 12-UT2

5.1	x-section area (ft.sq.)
5.1	width (ft)
1.0	mean depth (ft)
1.4	max depth (ft)
5.7	wetted perimeter (ft)
0.9	hydraulic radius (ft)
5.1	width-depth ratio
81.3	W flood prone area (ft)
15.9	entrenchment ratio
1.1	low bank height ratio

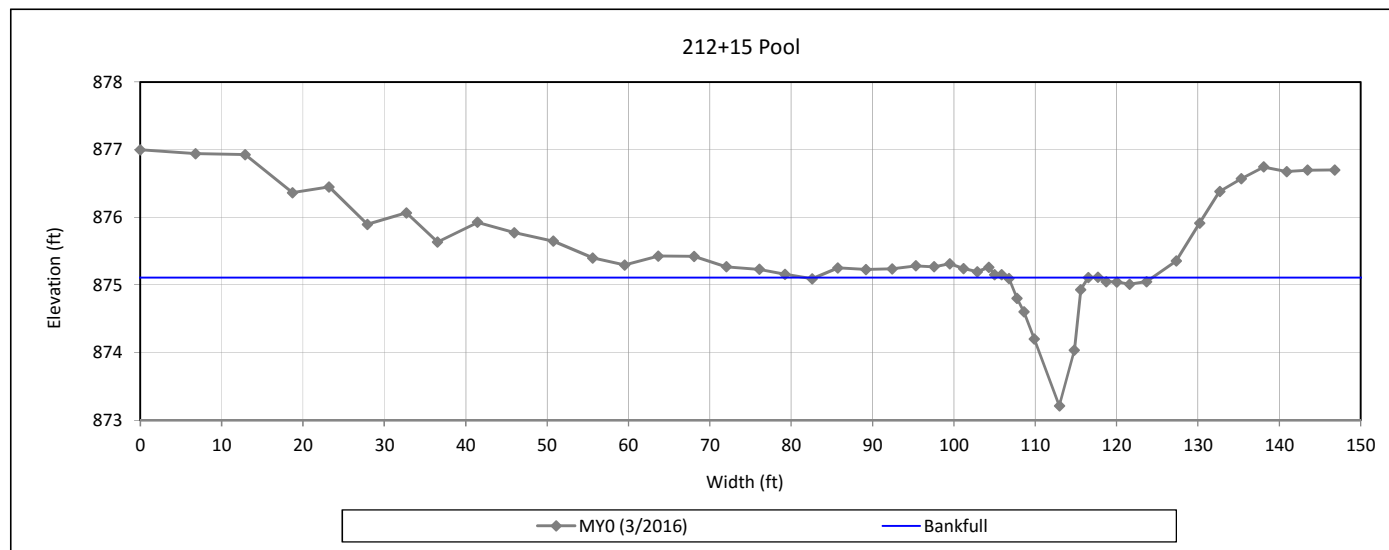
Cross Section 13-UT2

8.8	x-section area (ft.sq.)
7.8	width (ft)
1.1	mean depth (ft)
1.9	max depth (ft)
8.7	wetted perimeter (ft)
1.0	hydraulic radius (ft)
7.0	width-depth ratio

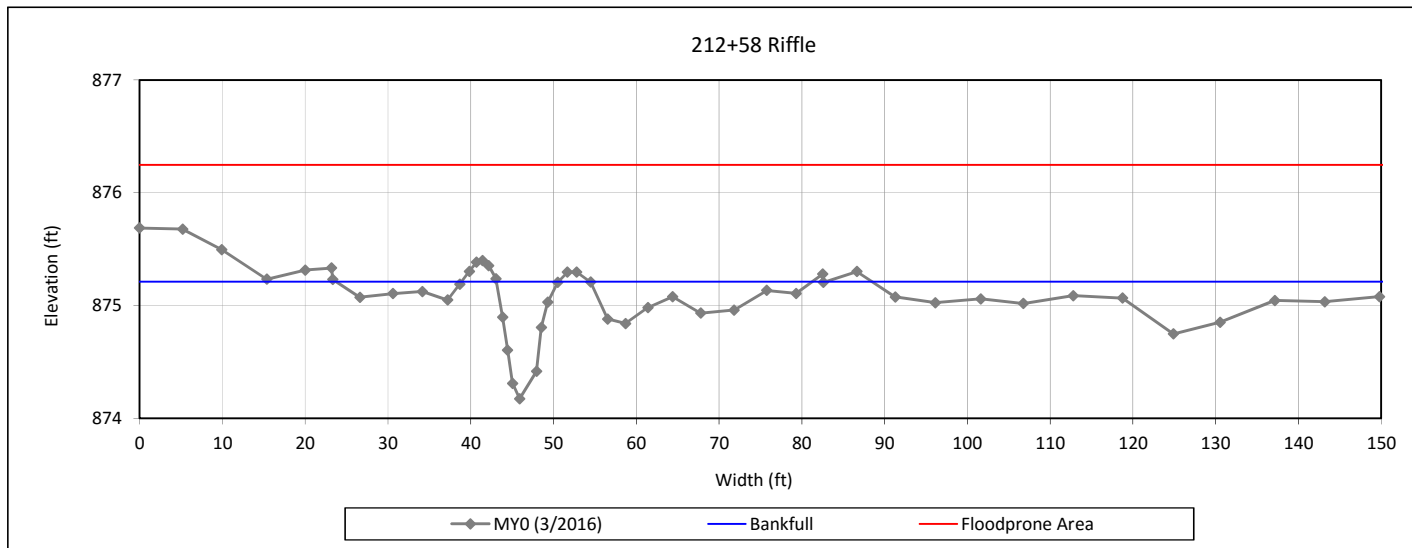
Cross Section 14-UT2

4.2	x-section area (ft.sq.)
7.4	width (ft)
0.6	mean depth (ft)
1.0	max depth (ft)
7.8	wetted perimeter (ft)
0.5	hydraulic radius (ft)
12.9	width-depth ratio
149.8+	W flood prone area (ft)
20.2	entrenchment ratio
1.09	low bank height ratio

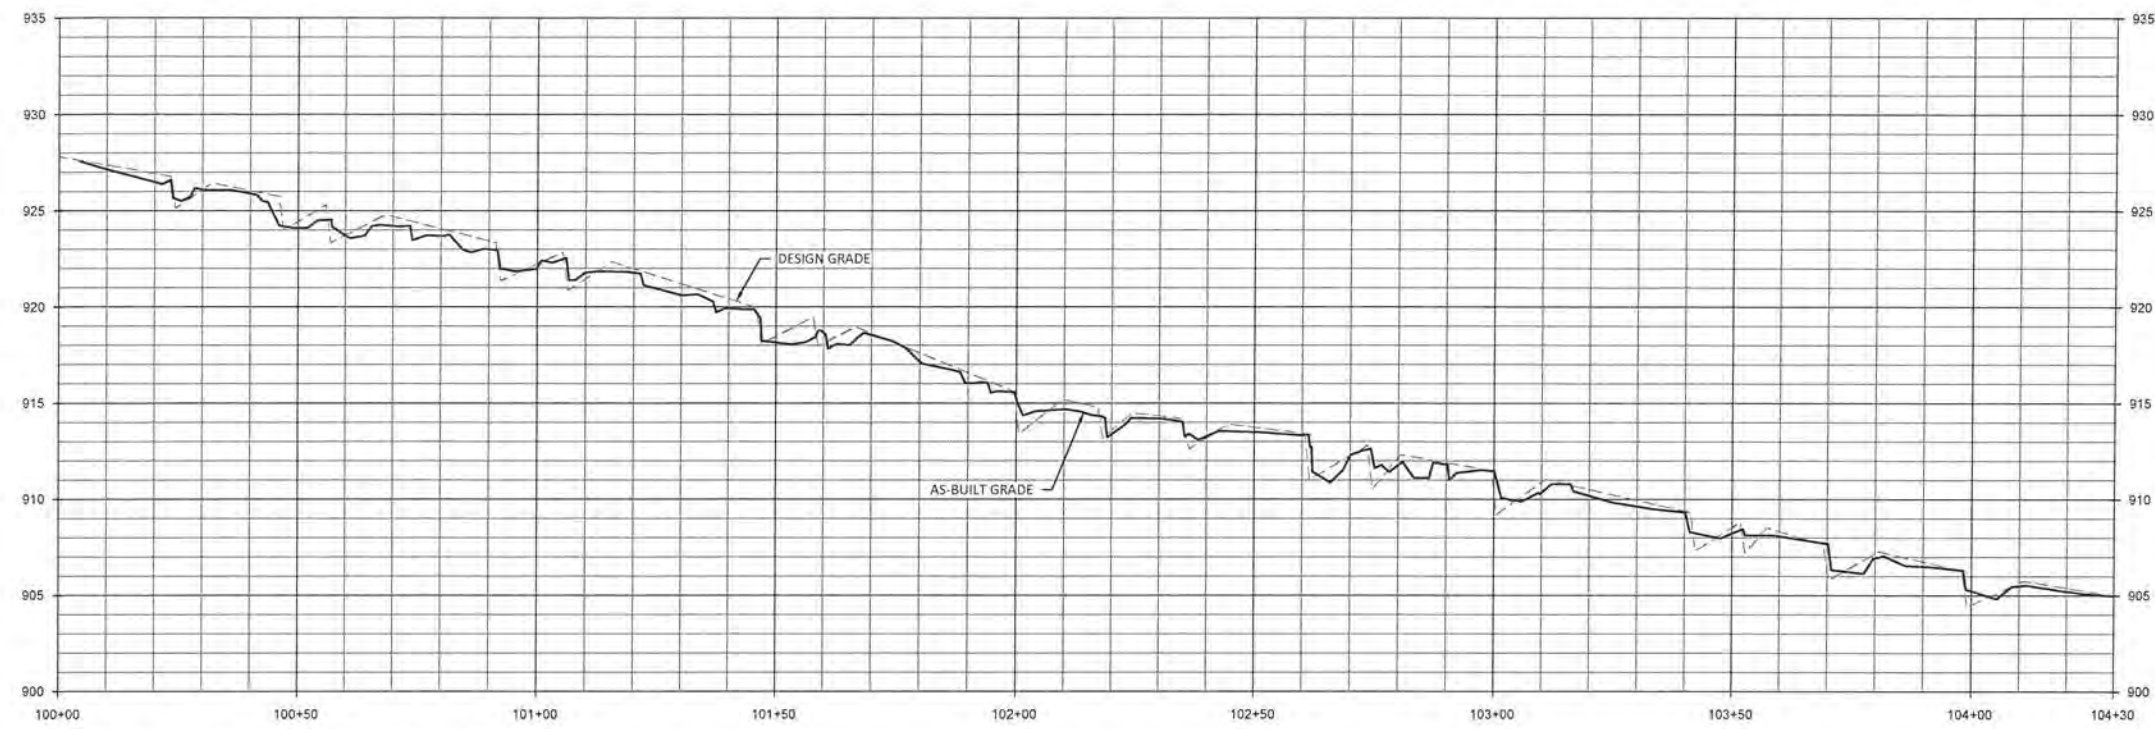
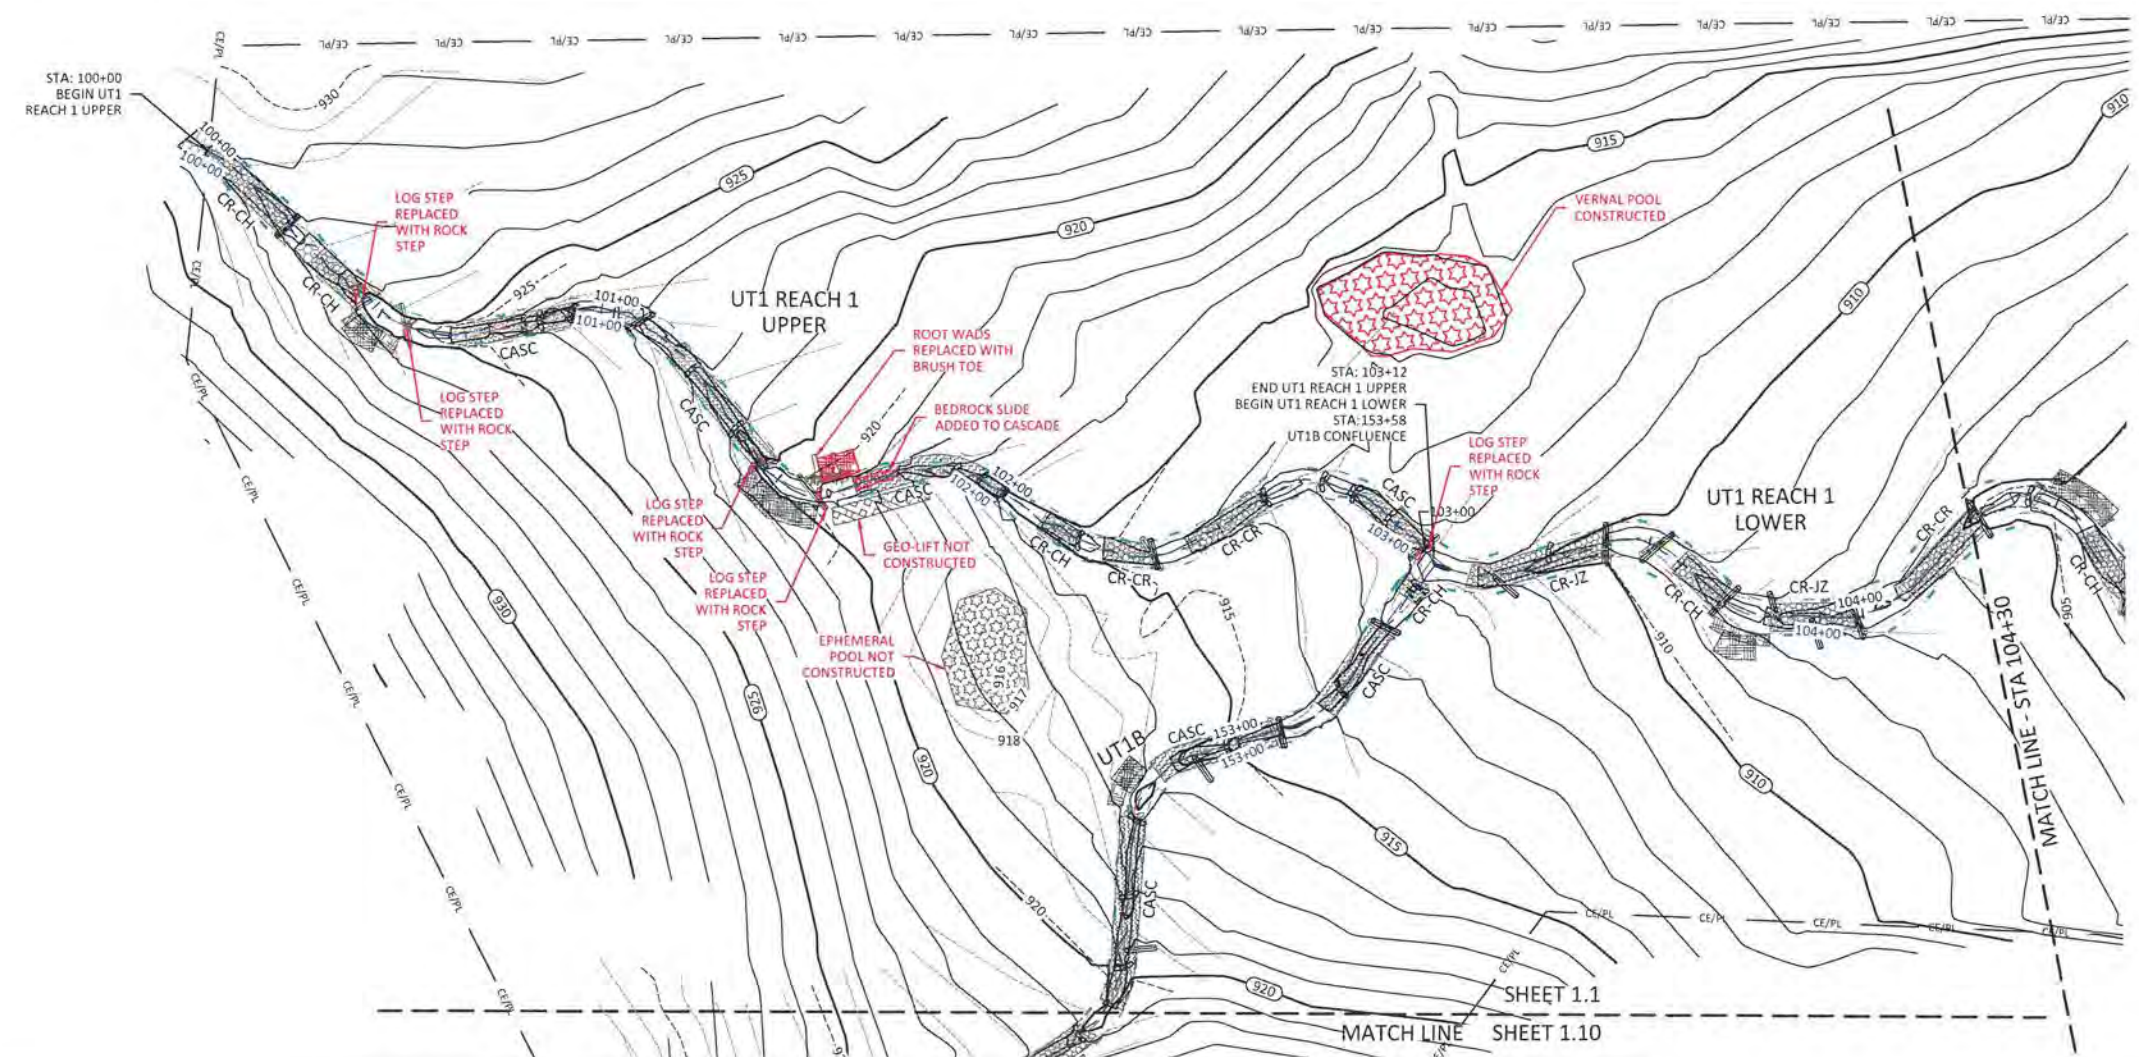
Henry Fork Mitigation Site Record Drawings
Catawba County, North Carolina
 UT1 Reach 1 Upper & Lower
 Stream Plan and Profile

Note: Profile stations and match lines based on design alignment.

- The following log steps were converted to rock steps at the following stations:
 - 100+47
 - 100+58
 - 101+50
 - 101+64
 - 101+70
 - 101+76
 - 102+20
 - 103+07;
- Root Wads at Station 101+70 were replaced with Brush Toe;
- Sourwood transplants between UT1 Reach 1 Upper and UT1B were eliminated;
- An ephemeral pool was added in the left floodplain just upstream of the confluence of UT1 Reach 1 Upper and UT1B; and
- Cascade structures were varied in the field based on available materials, a bed rock slide was installed at Station 101+64 and wrapped soil lifts on banks noted in plans were eliminated.

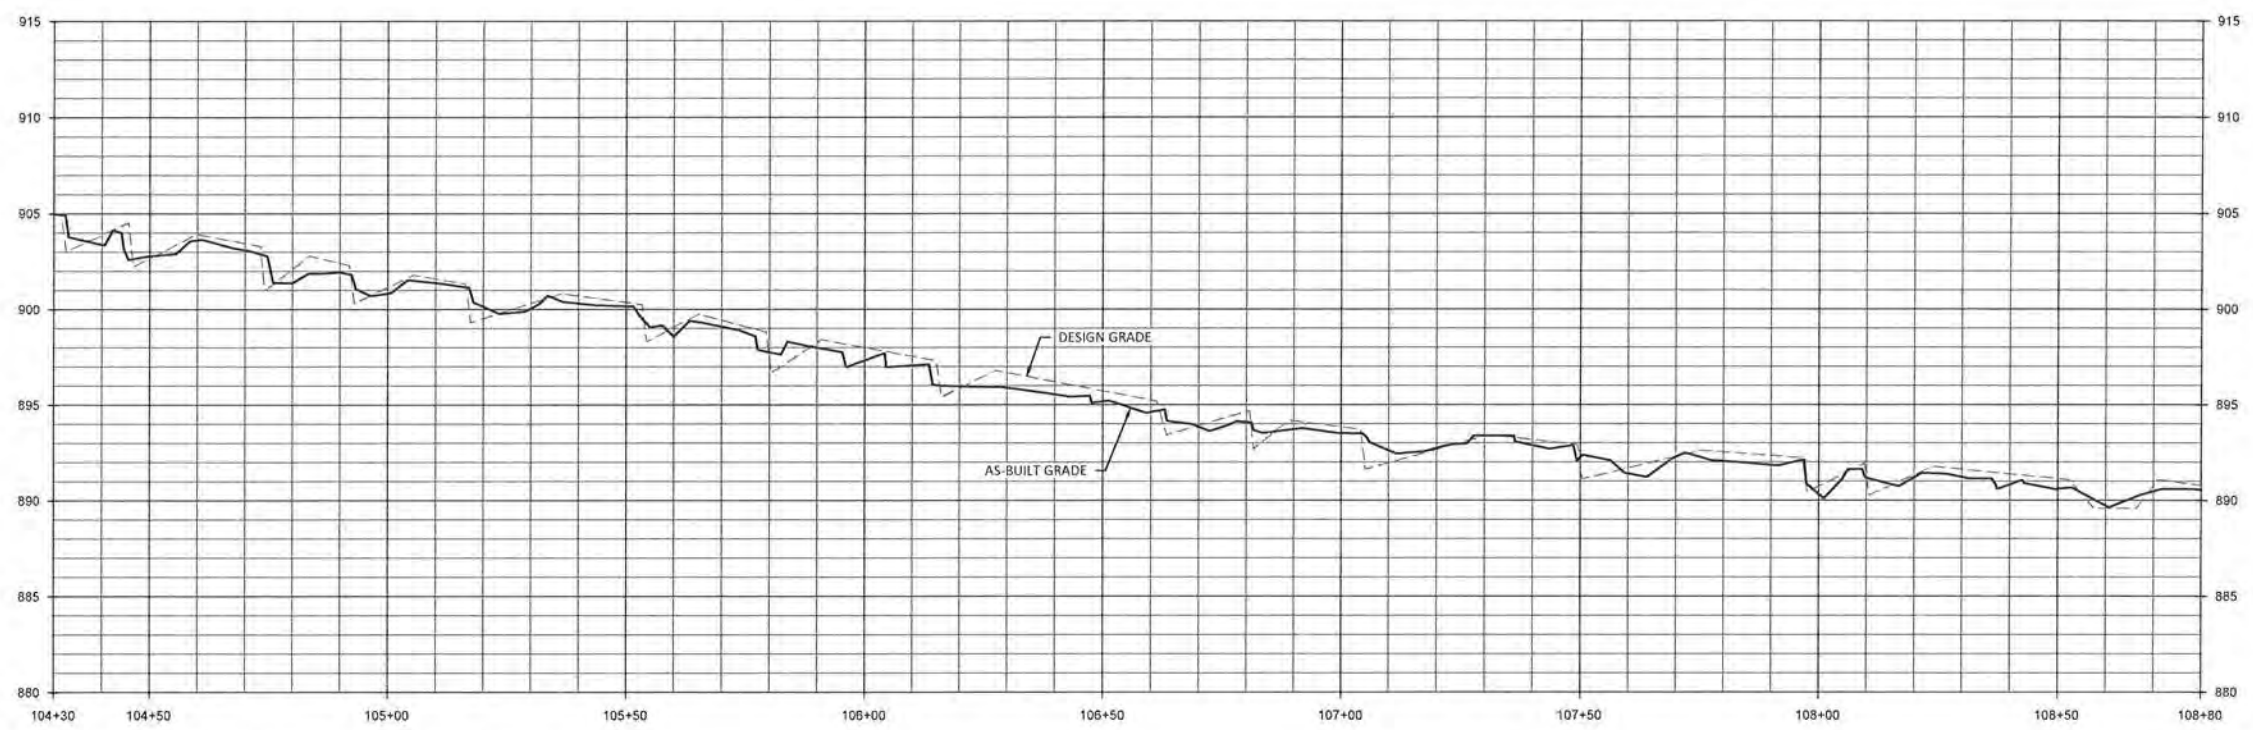
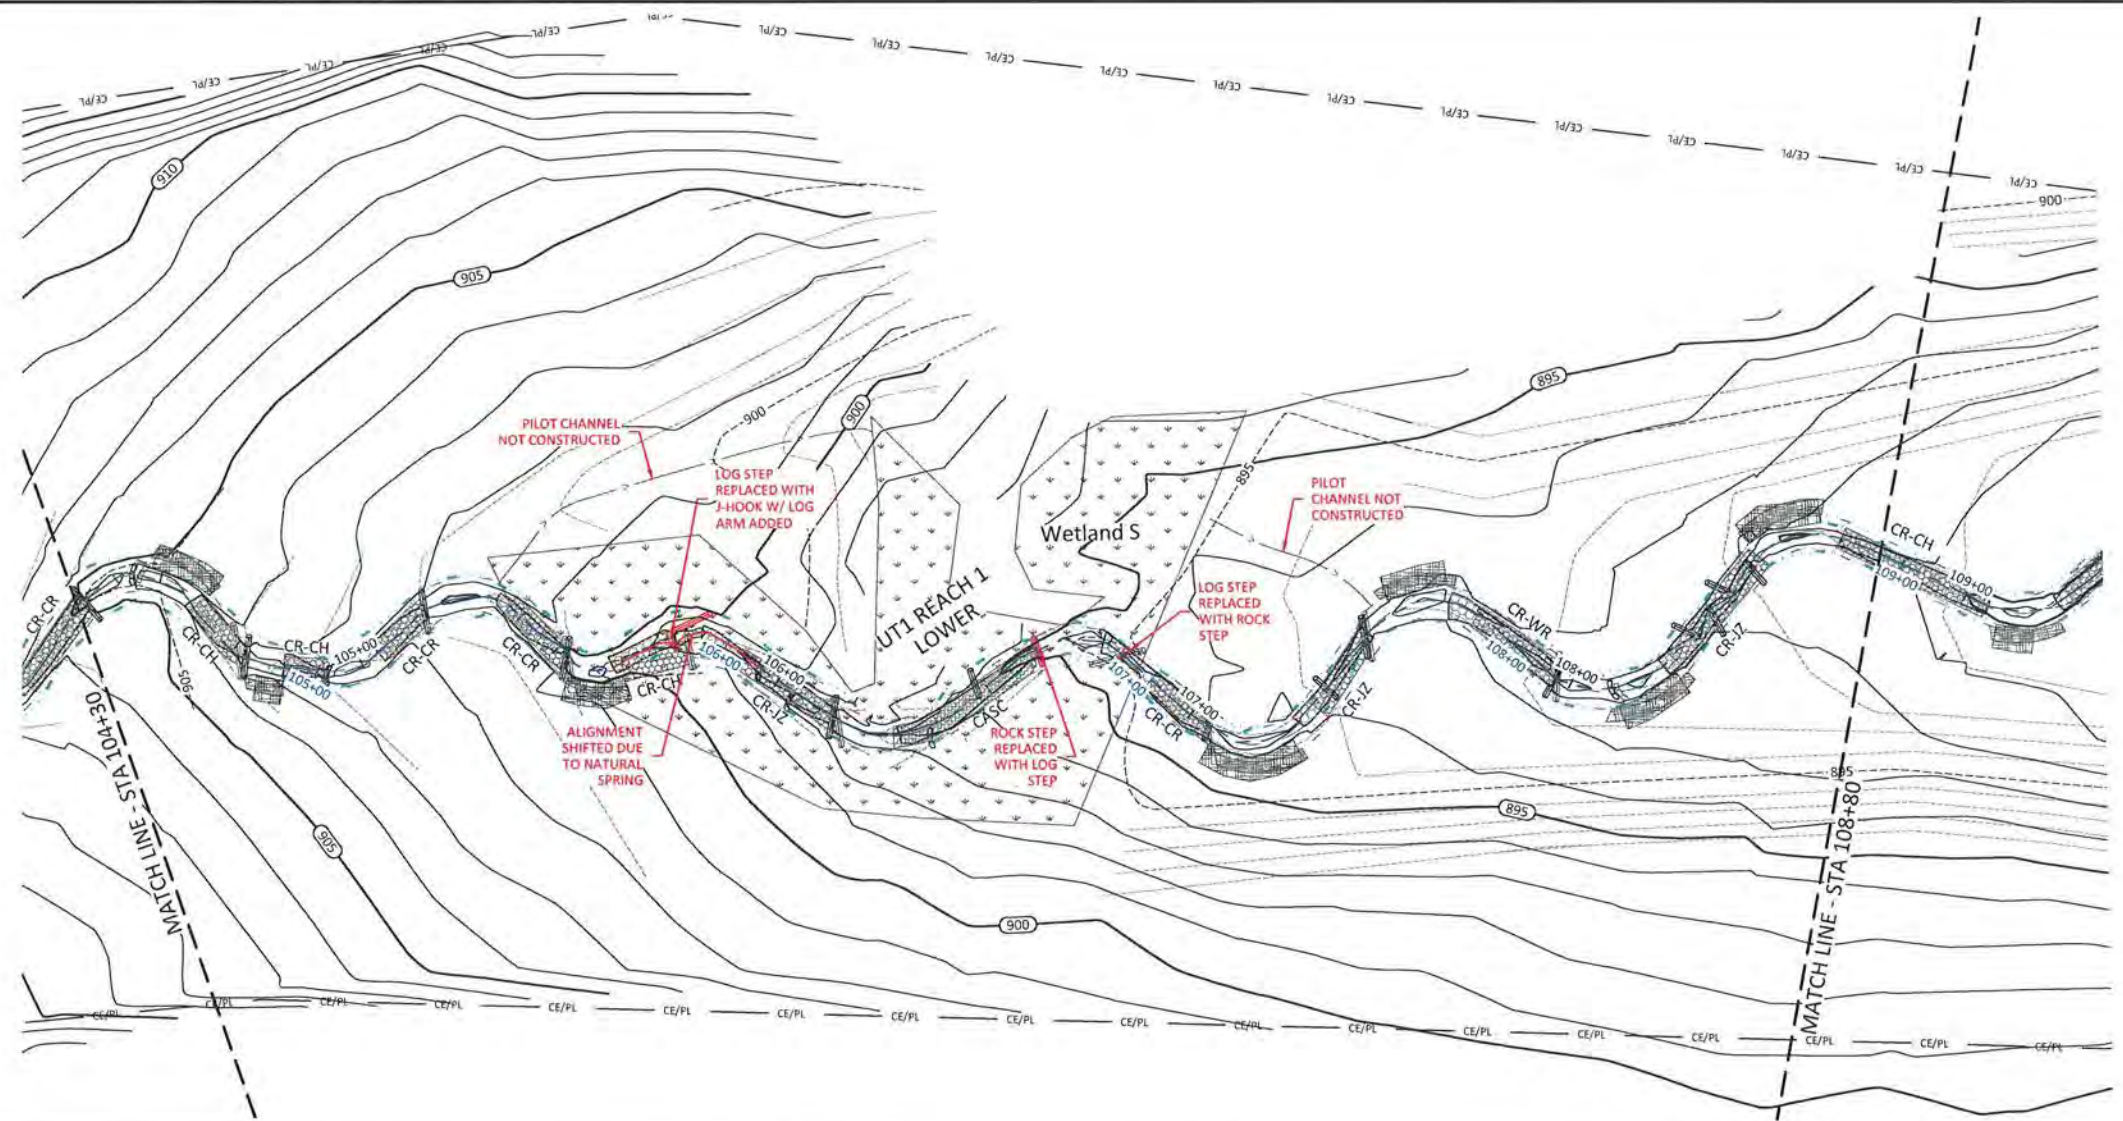
Henry Fork Mitigation Site Record Drawings
 Catawba County, North Carolina
 UT1 Reach 1 Lower
 Stream Plan and Profile

Note: Profile stations and match lines based on design alignment.

- Transplants added in the left floodplain;
- Two pilot channels were eliminated from the design in the left floodplain (see Record Drawings, Sheet 1.2);
- Near station 105+72 the alignment was adjusted because a natural spring was found. The alignment will differ from design in this location;
- Slight grade change made in field on left floodplain;
- Root wads were replaced with brush toe at station 110+88;
- Several log steps were replaced by rock steps along the reach (stations 106+96, 110+35, 111+63, 112+00, and 113+39); and
- A few structure changes were made per engineer's discretion/availability materials (stations 105+89, 106+76, and 110+40).

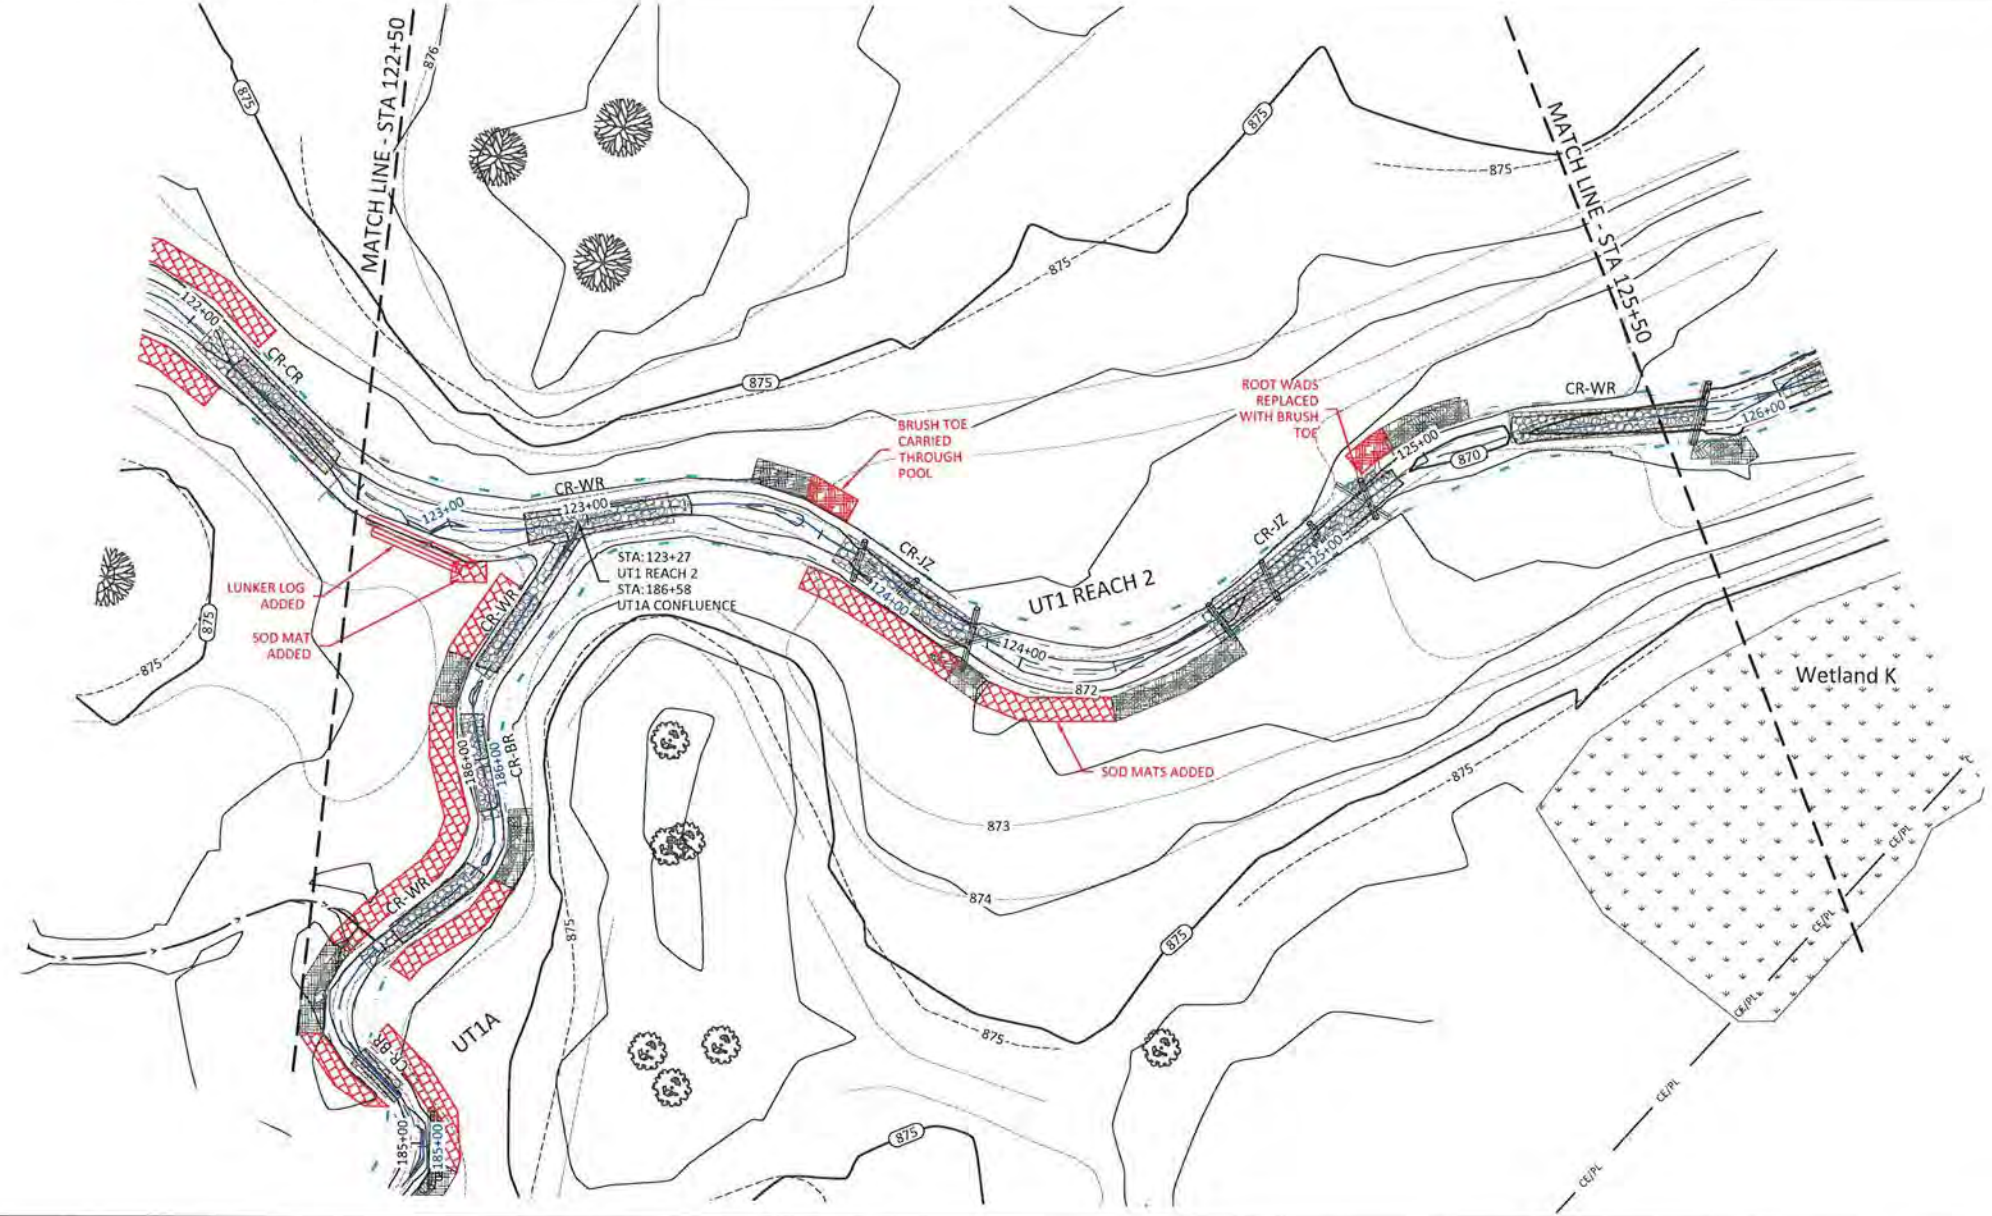
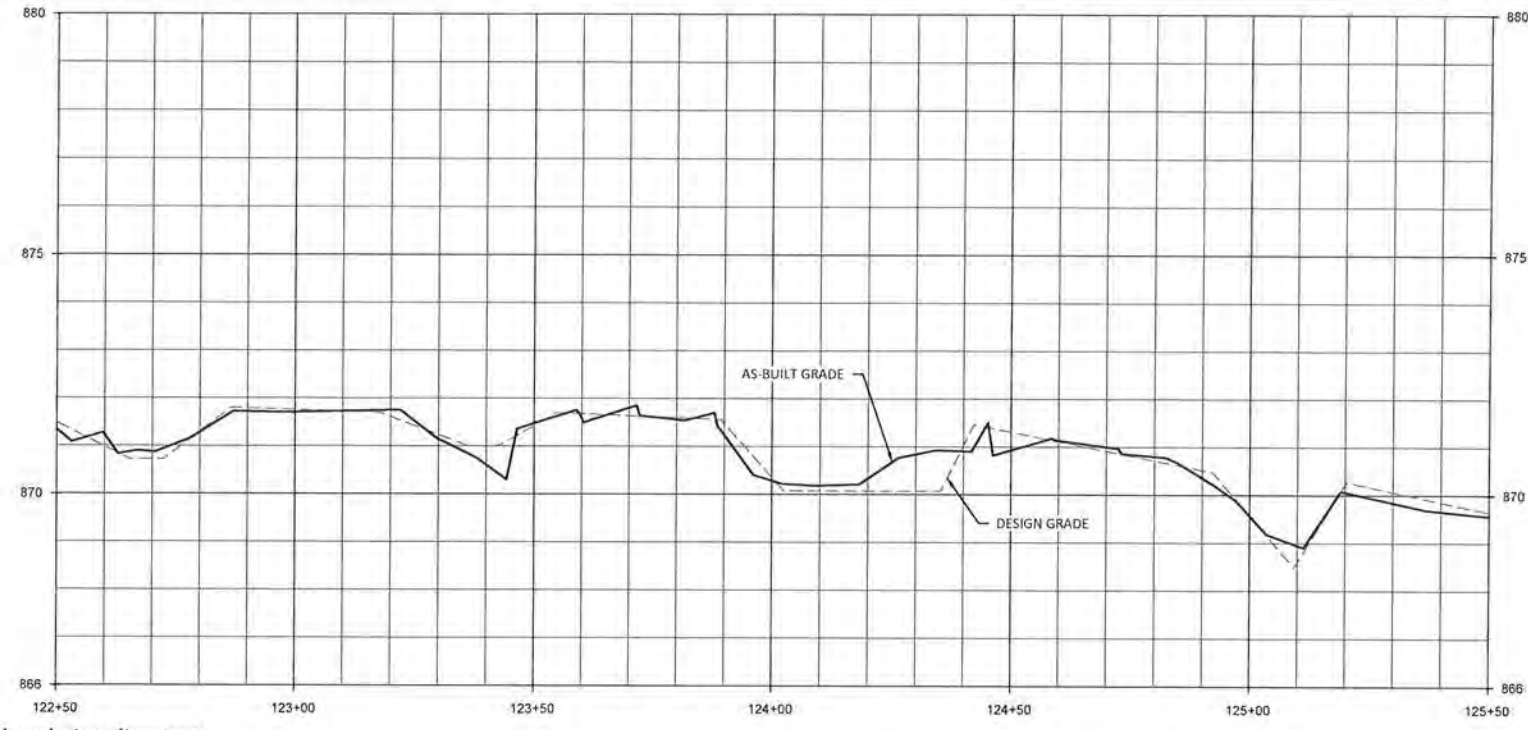
Henry Fork Mitigation Site Record Drawings
 Catawba County, North Carolina
 UT1 Reach 2
 Stream Plan and Profile

Note: Profile stations and match lines based on design alignment.

- Log step angles were modified as needed per engineer’s discretion/guidance within the reach;
- Brush toe was carried throughout pool at Station 123+77;
- Root wads at Station 125+20 were replaced with Brush Toe; and
- At the very downstream end of UT1 Reach 2 (near confluence of Henry River), the right bank was graded back. Approximately 35 to 40 LF of boulder toe was added, along with two geolifts to stabilize the bank.
