MONITORING YEAR 5 ANNUAL REPORT

HENRY FORK MITIGATION SITE

Catawba County, NC
DEQ Contract No. 005782
DMS Project No. 96306
USACE No. 2014-00538
DWR No. 20140193

Data Collection Period: January – November 2020
Draft Submission Date: November 30, 2020
Final Submission Date: January 8, 2021

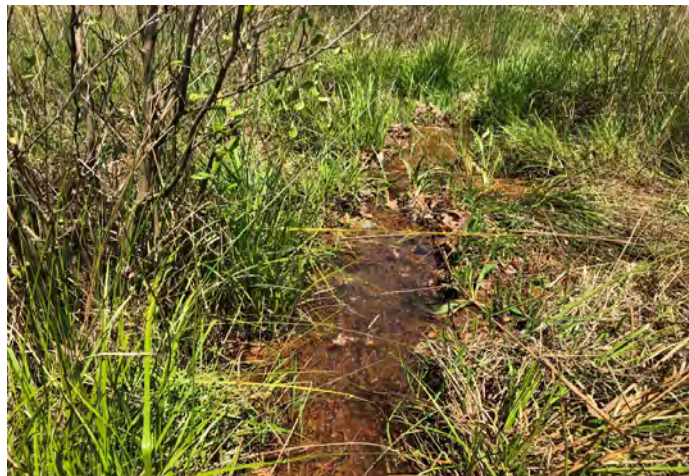
View Downstream

1.6	x-section area (ft.sq.)
5.0	width (ft)
0.3	mean depth (ft)
0.8	max depth (ft)
5.5	wetted perimeter (ft)
0.3	hydraulic radius (ft)
16.2	width-depth ratio

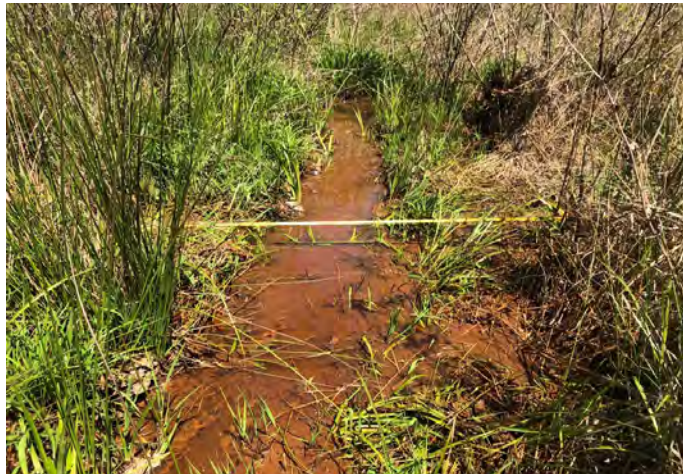
View Downstream

1.6	x-section area (ft.sq.)
4.9	width (ft)
0.3	mean depth (ft)
0.8	max depth (ft)
5.3	wetted perimeter (ft)
0.3	hydraulic radius (ft)
15.4	width-depth ratio
86.0	W flood prone area (ft)
17.5	entrenchment ratio
0.8	low bank height ratio

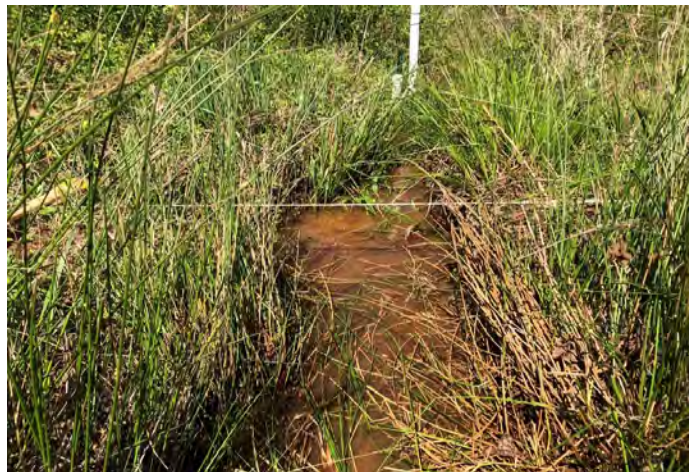
View Downstream

4.5	x-section area (ft.sq.)
6.9	width (ft)
0.7	mean depth (ft)
1.3	max depth (ft)
7.6	wetted perimeter (ft)
0.6	hydraulic radius (ft)
10.6	width-depth ratio

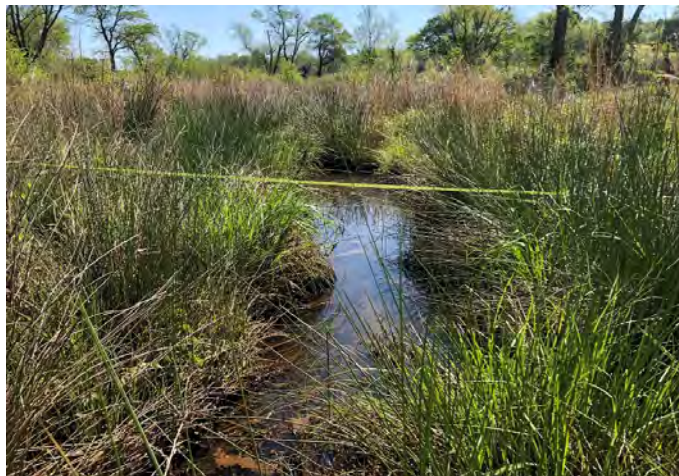
View Downstream

8.0	x-section area (ft.sq.)
10.9	width (ft)
0.7	mean depth (ft)
1.6	max depth (ft)
11.7	wetted perimeter (ft)
0.7	hydraulic radius (ft)
14.7	width-depth ratio

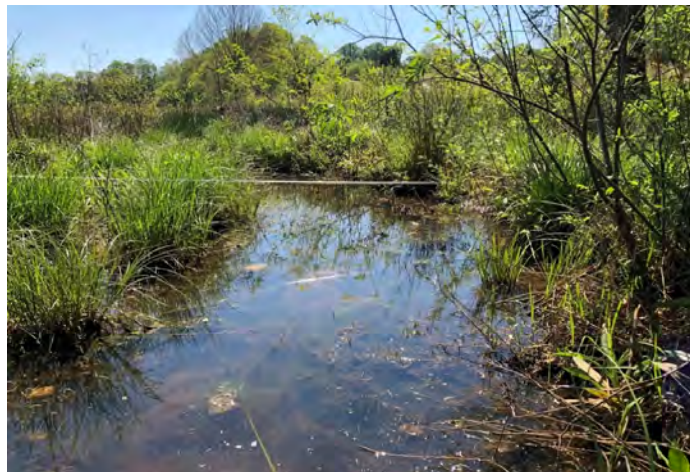
View Downstream

8.0	x-section area (ft.sq.)
10.9	width (ft)
0.7	mean depth (ft)
1.5	max depth (ft)
11.7	wetted perimeter (ft)
0.7	hydraulic radius (ft)
14.7	width-depth ratio

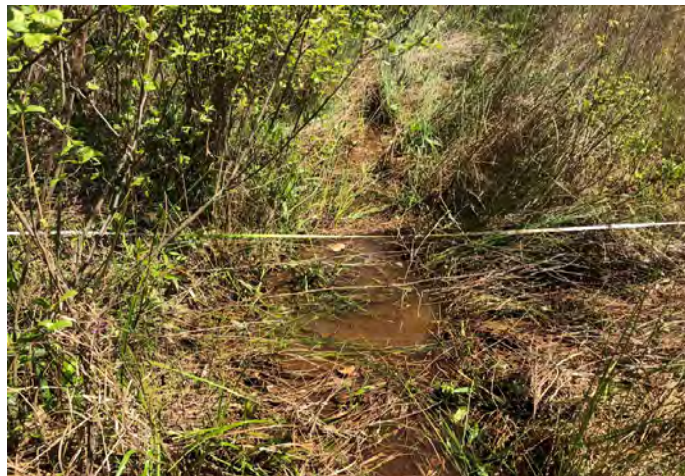
View Downstream

3.1	x-section area (ft.sq.)
8.0	width (ft)
0.4	mean depth (ft)
0.9	max depth (ft)
8.2	wetted perimeter (ft)
0.4	hydraulic radius (ft)
20.4	width-depth ratio
59.0	W flood prone area (ft)
7.4	entrenchment ratio
0.9	low bank height ratio

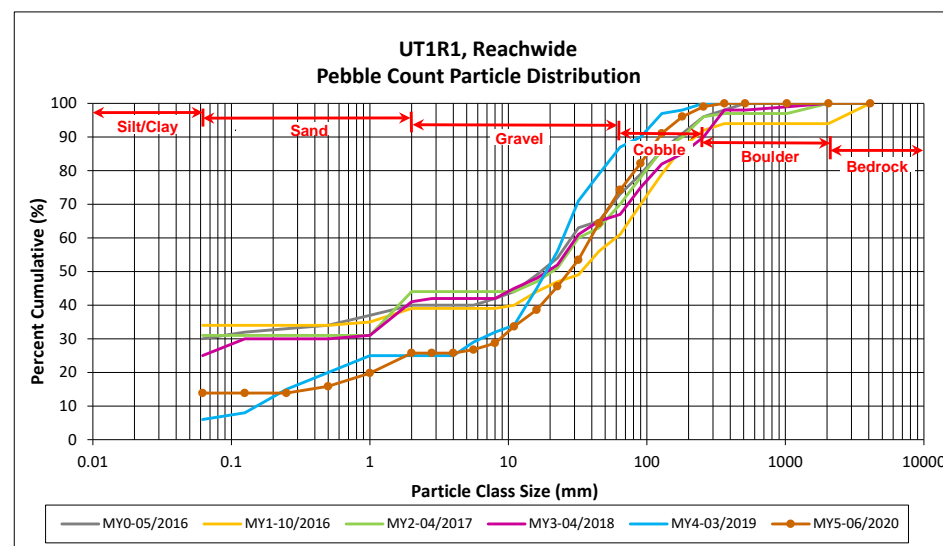
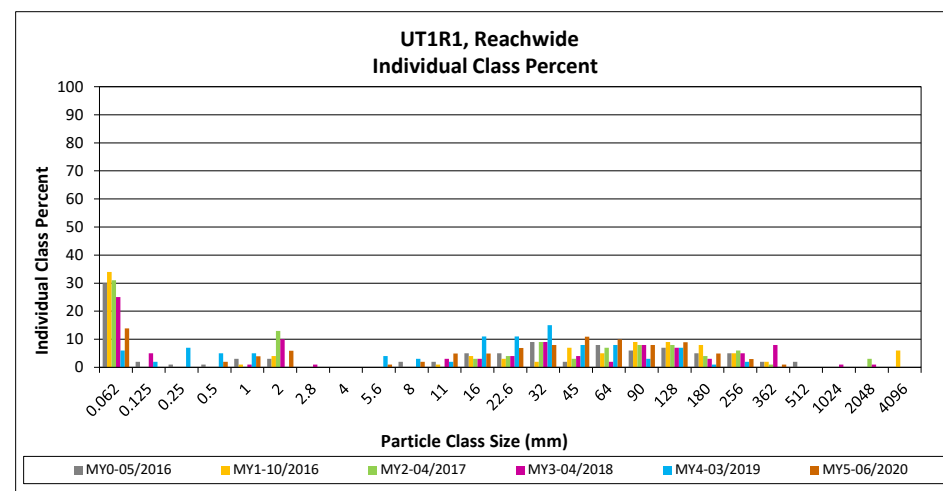
Reachwide and Cross-Section Pebble Count Plots

Reachwide Channel materials (mm)	
D ₁₆ =	0.5
D ₃₅ =	12.2
D ₅₀ =	27.5
D ₈₄ =	96.7
D ₉₅ =	167.6
D ₁₀₀ =	362.0

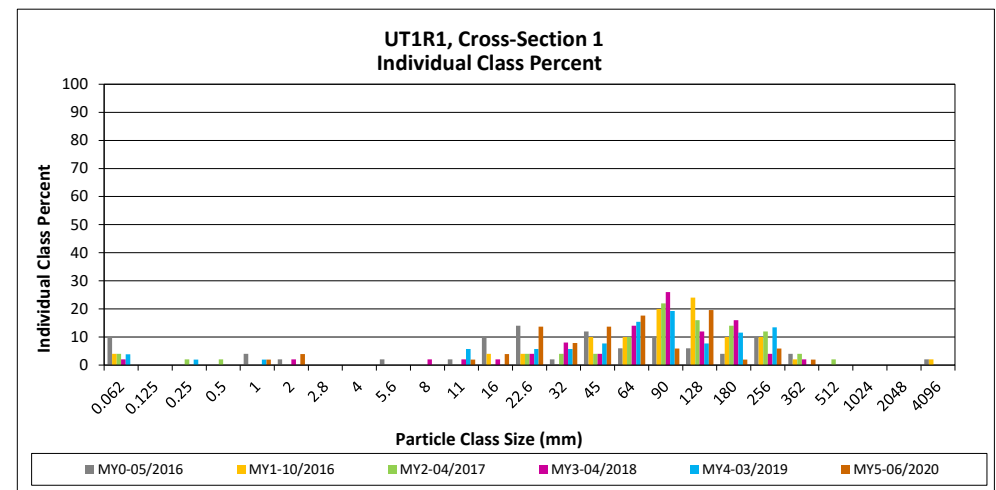
Reachwide and Cross-Section Pebble Count Plots

Cross-Section 1 Channel materials (mm)	
D ₁₆ =	17.8
D ₃₅ =	33.4
D ₅₀ =	47.7
D ₈₄ =	114.5
D ₉₅ =	213.4
D ₁₀₀ =	362.0

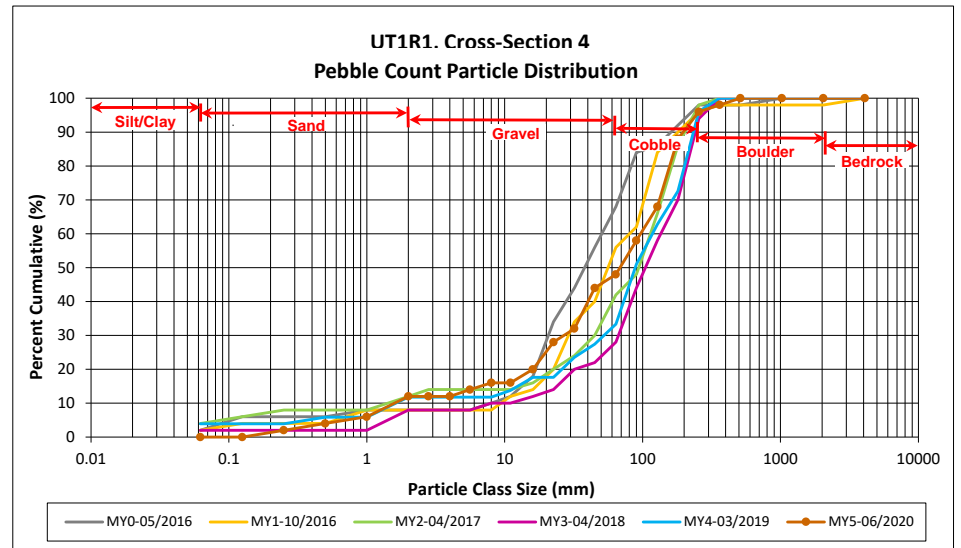
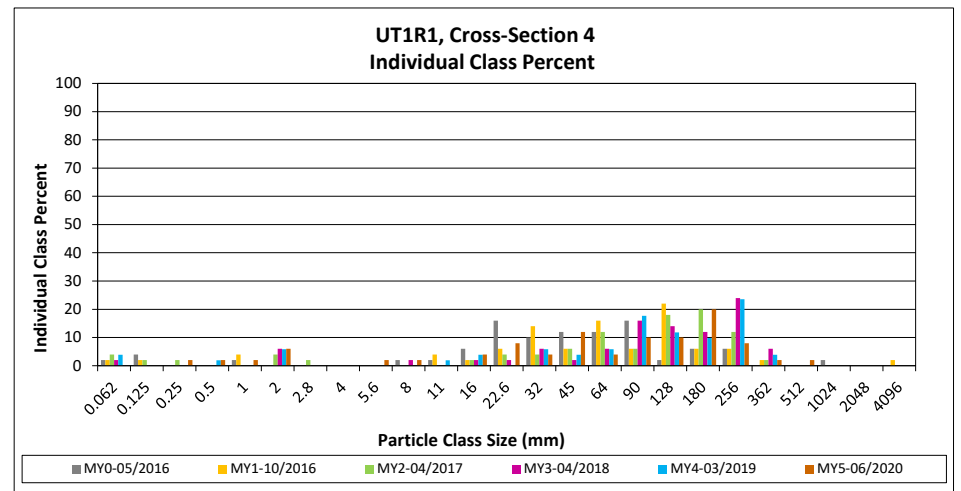
Reachwide and Cross-Section Pebble Count Plots

Cross-Section 4 Channel materials (mm)	
D ₁₆ =	8.0
D ₃₅ =	34.8
D ₅₀ =	68.5
D ₈₄ =	168.1
D ₉₅ =	245.0
D ₁₀₀ =	512.0

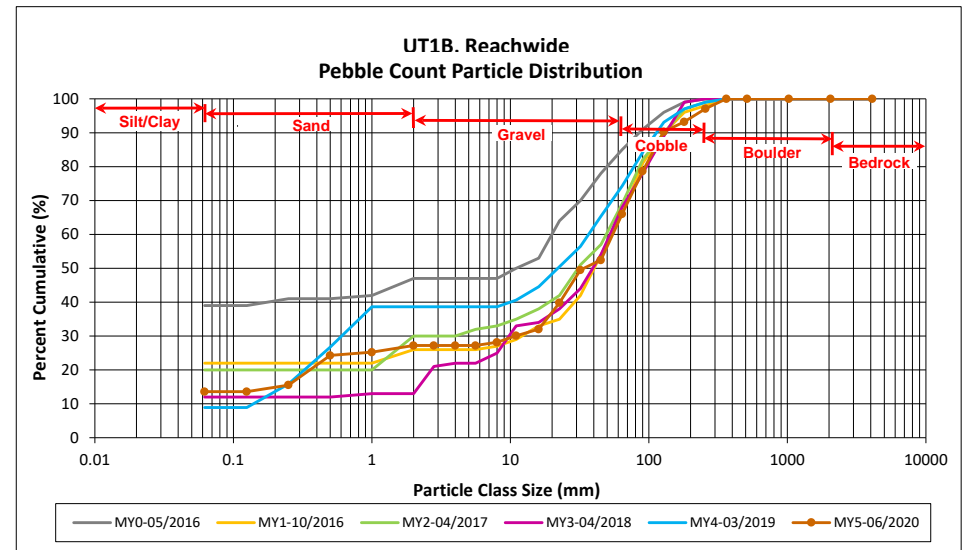
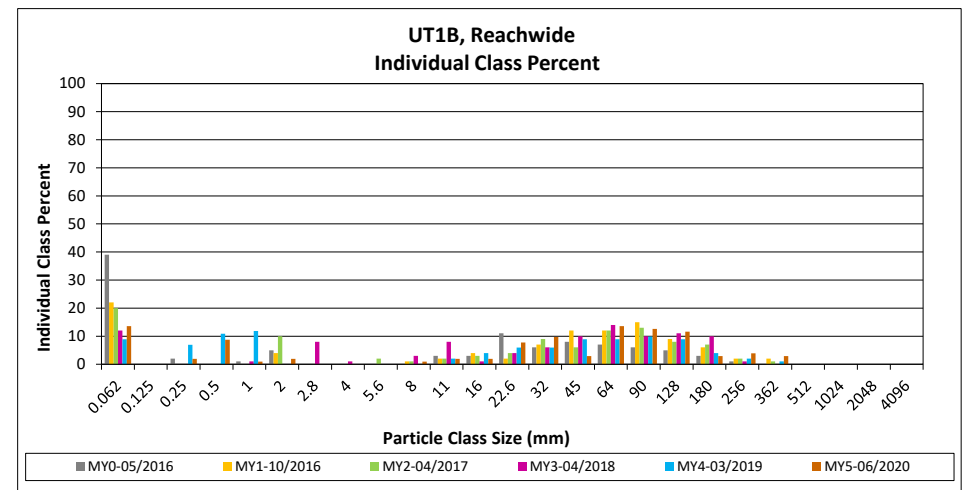
Reachwide and Cross-Section Pebble Count Plots

Reachwide Channel materials (mm)	
D ₁₆ =	0.3
D ₃₅ =	18.3
D ₅₀ =	33.9
D ₈₄ =	105.8
D ₉₅ =	211.8
D ₁₀₀ =	362.0

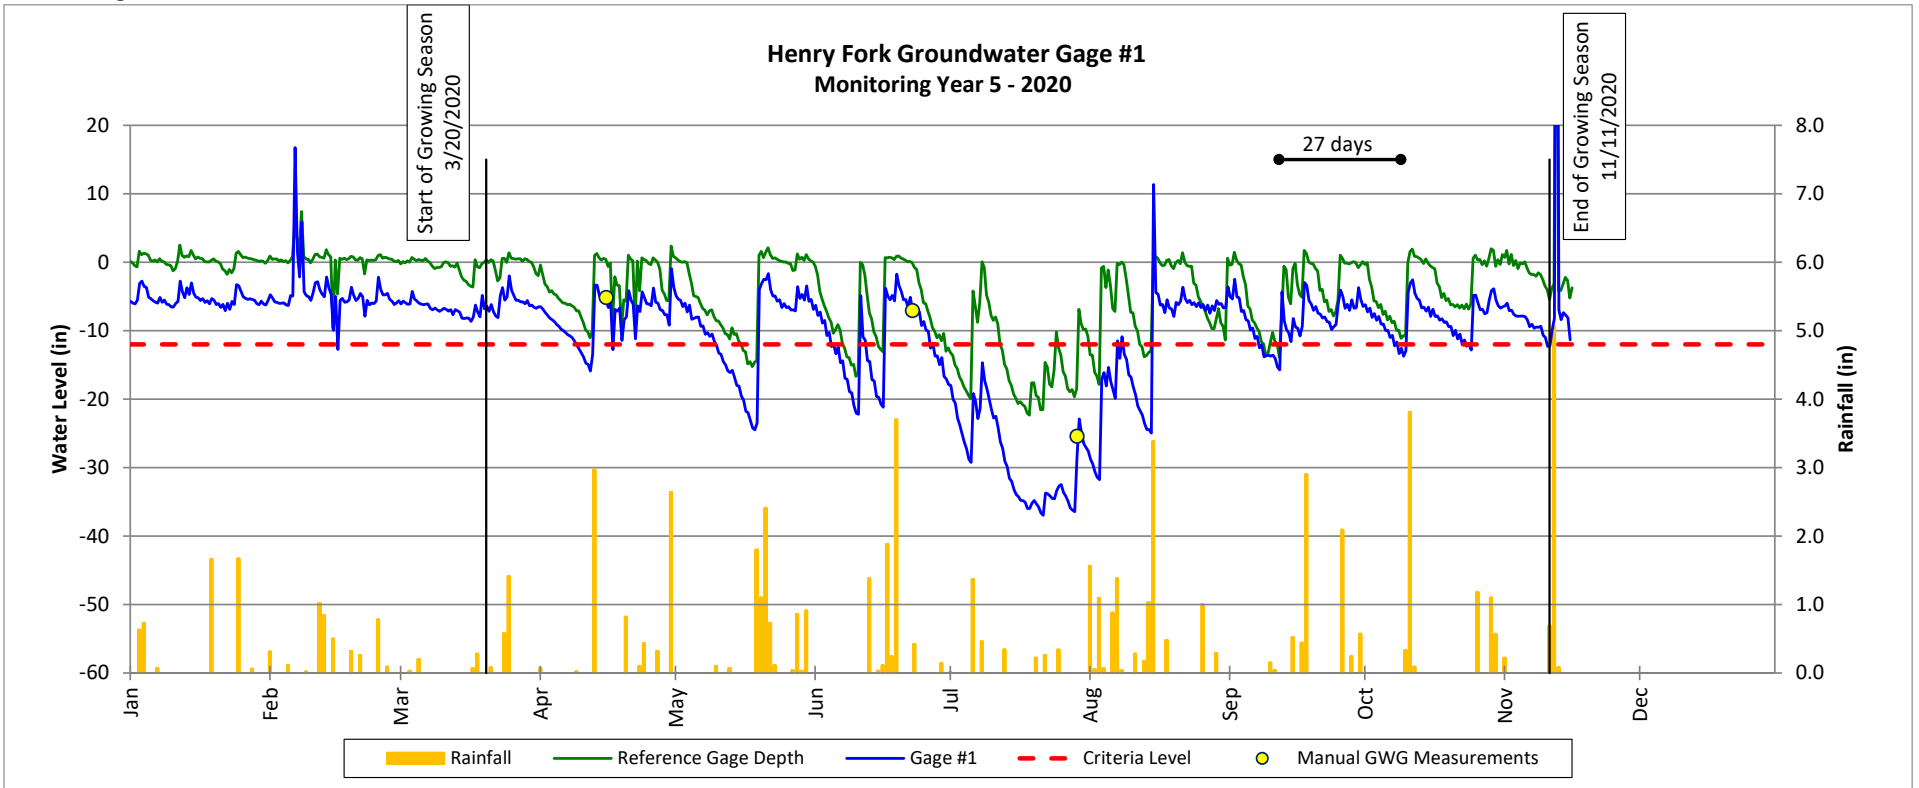
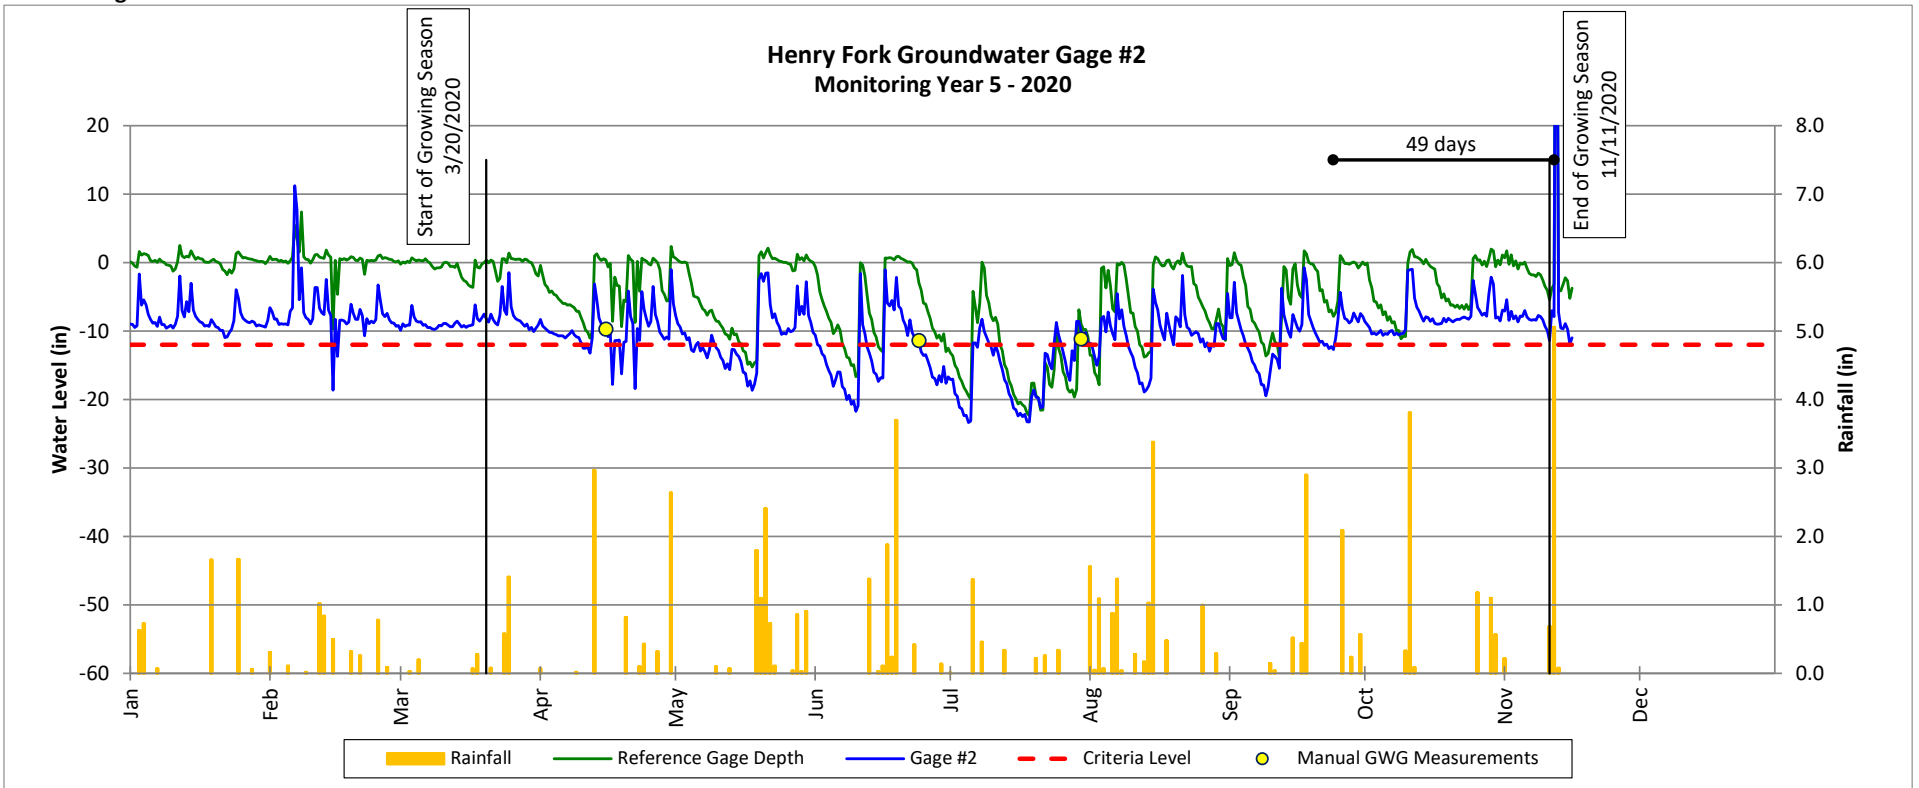
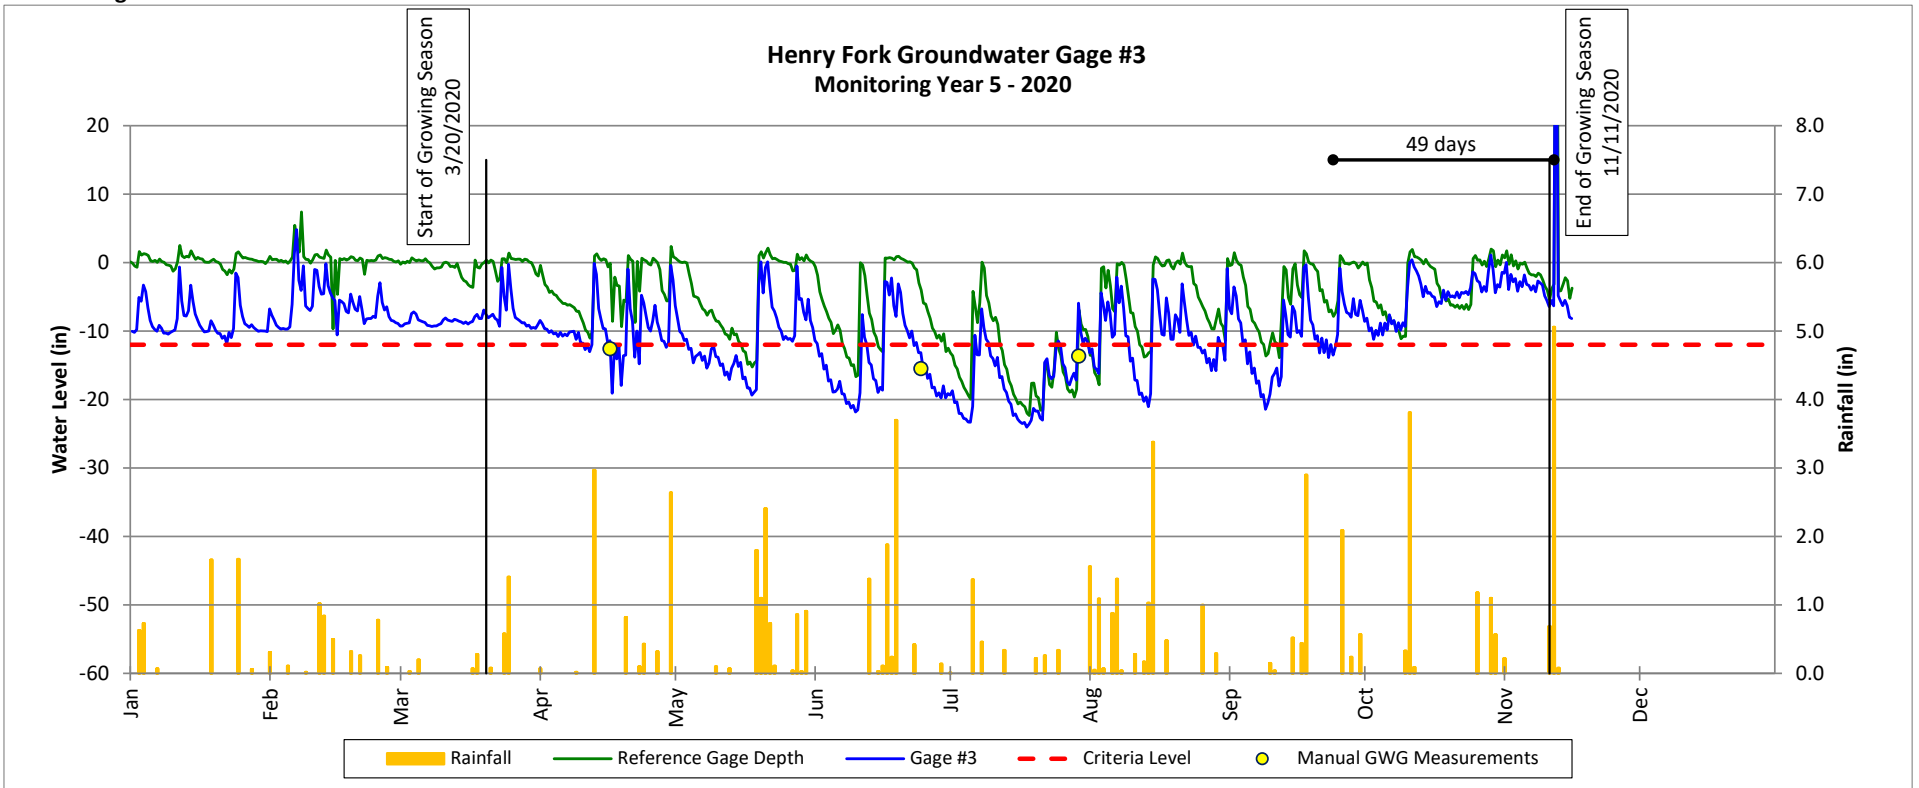
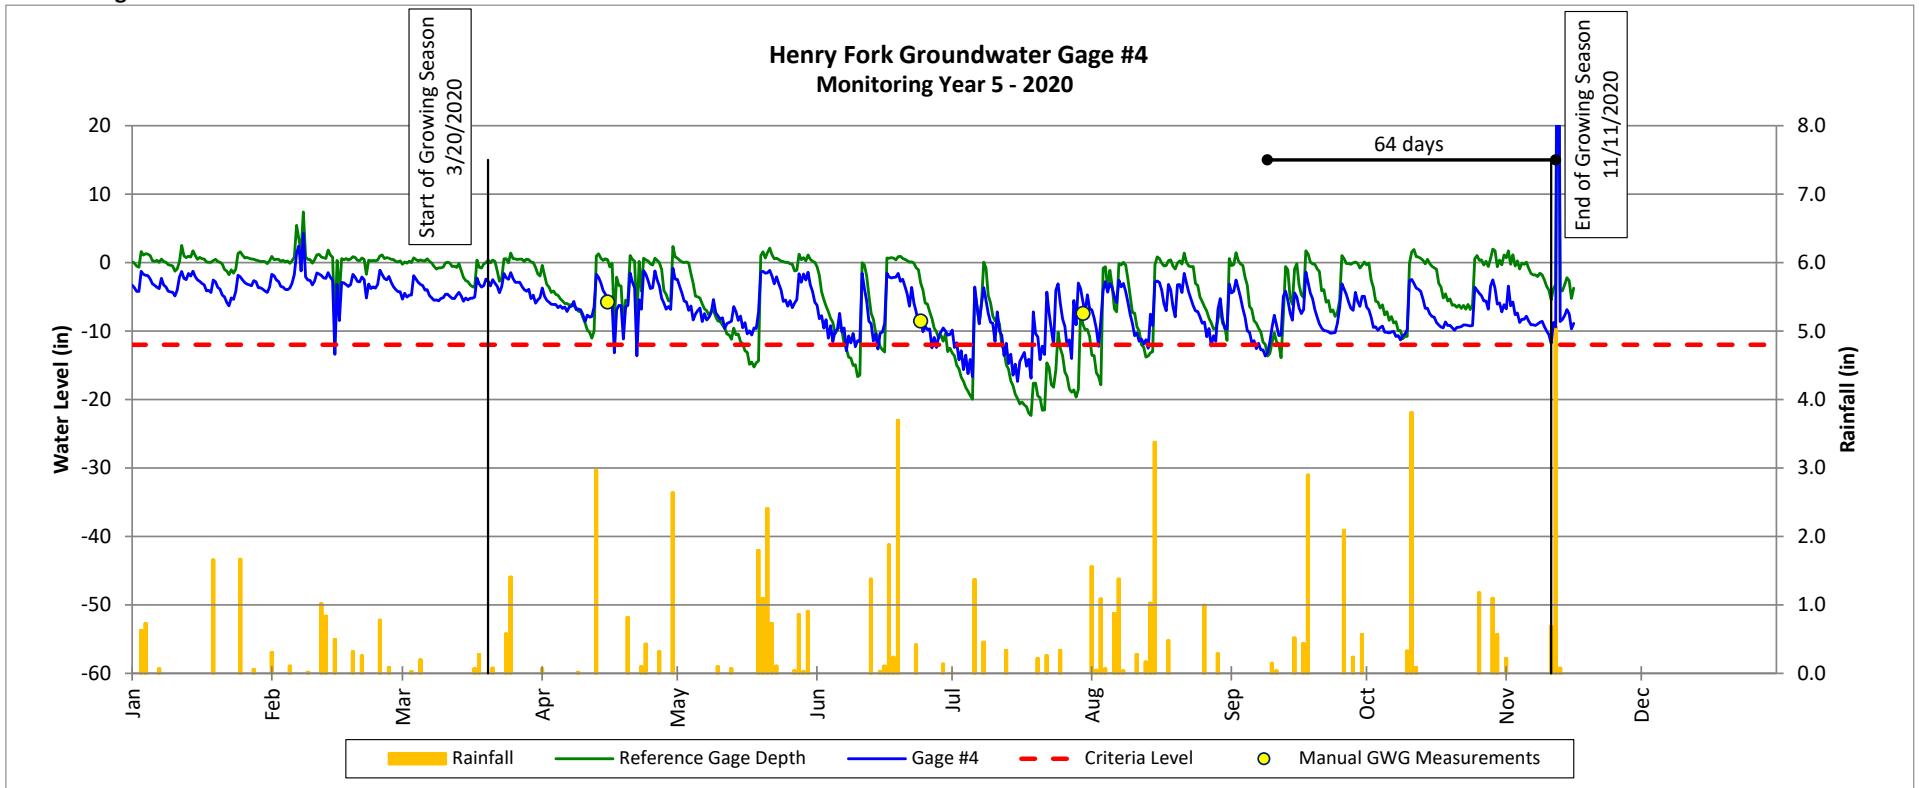
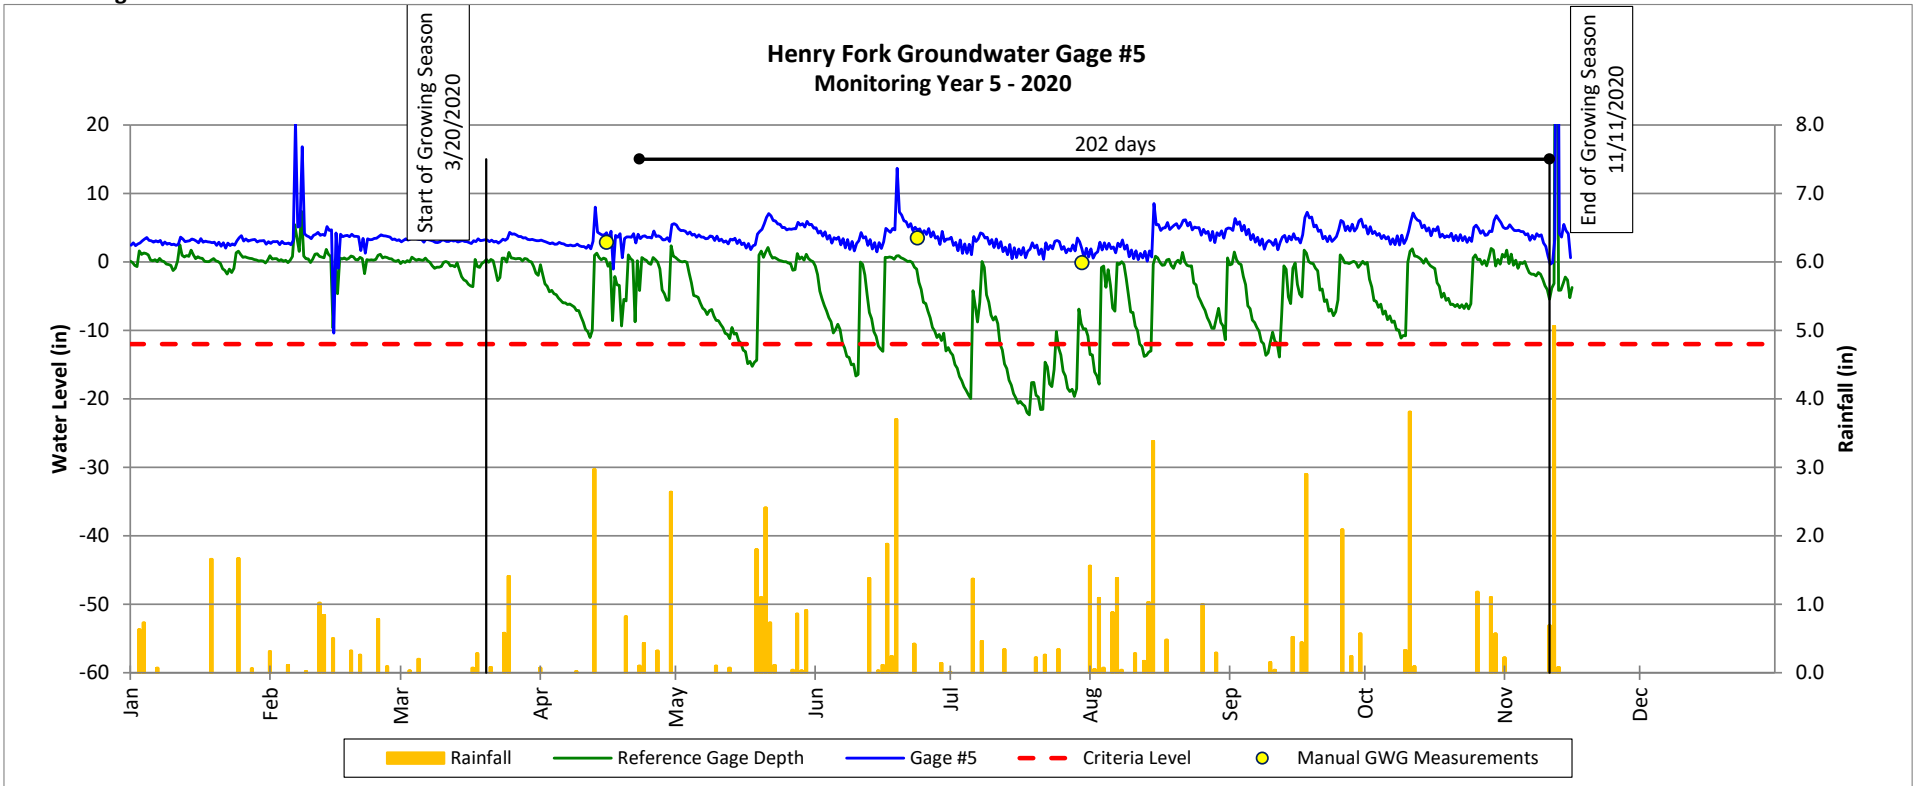
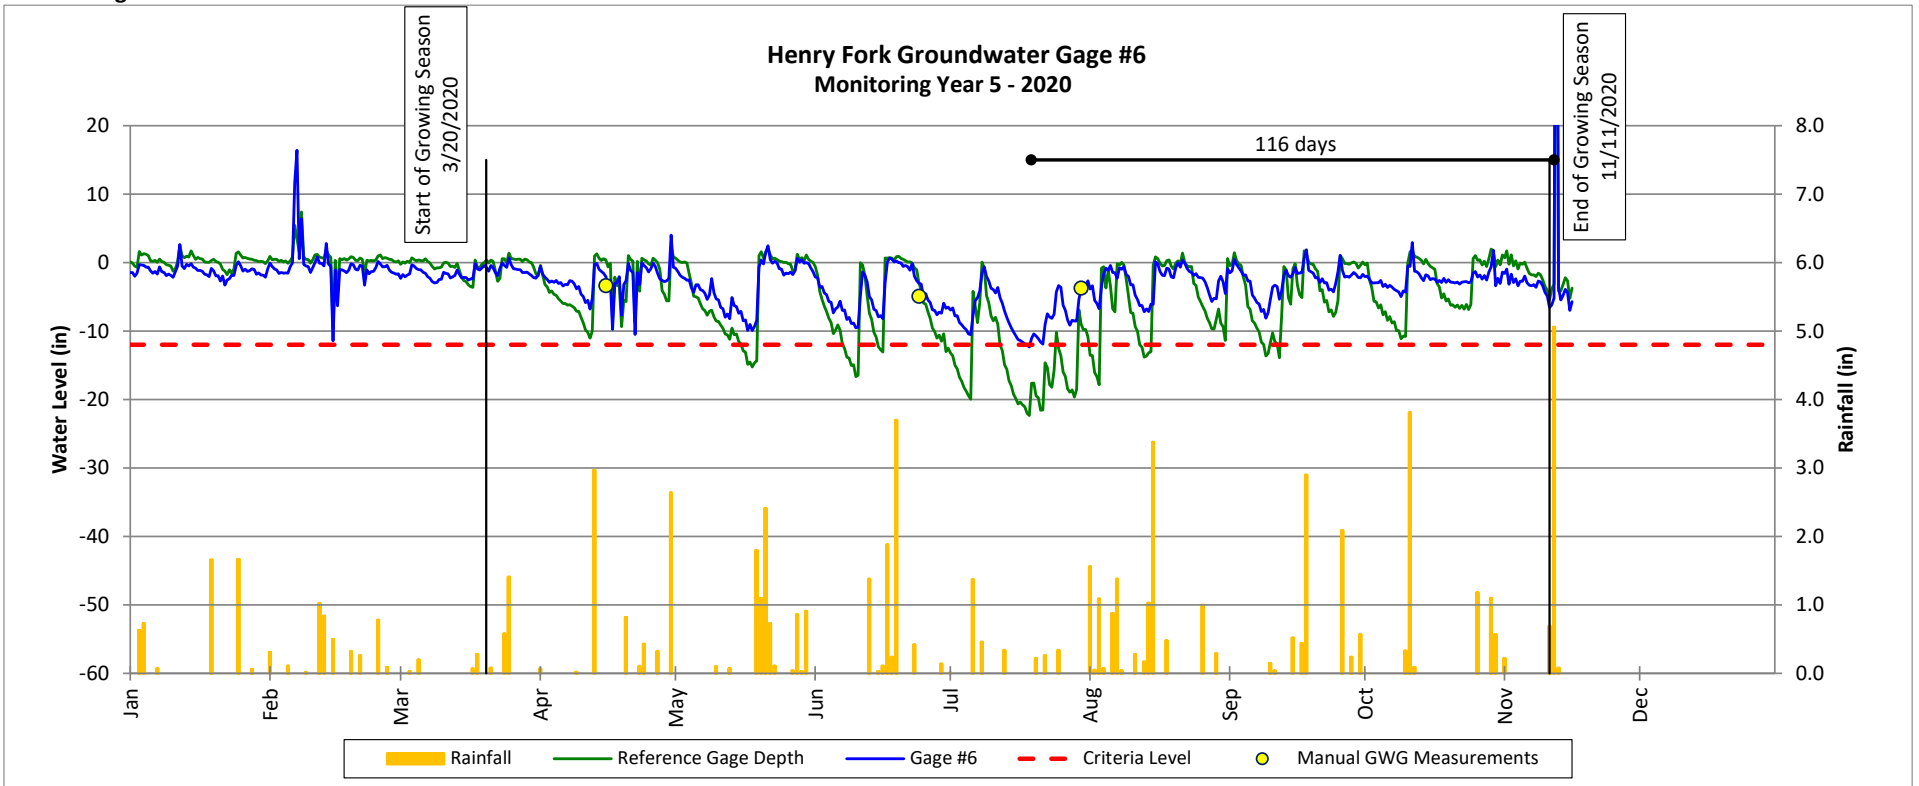
Note: The barotroll at Henry Fork experienced minor malfunctions in February (2/6 and 2/14 - 2/17) and during April (4/16 - 4/17 and 4/21-4/22); therefore, data collected during the February and April malfunctions was omitted from the reported data. In addition, the barotroll quit working on 8/1/2020 so the remaining data was calibrated using the barotroll from the Owl's Den Mitigation Site which is located in Lincoln, County approximately 15 miles from the Henry Fork Mitigation Site.

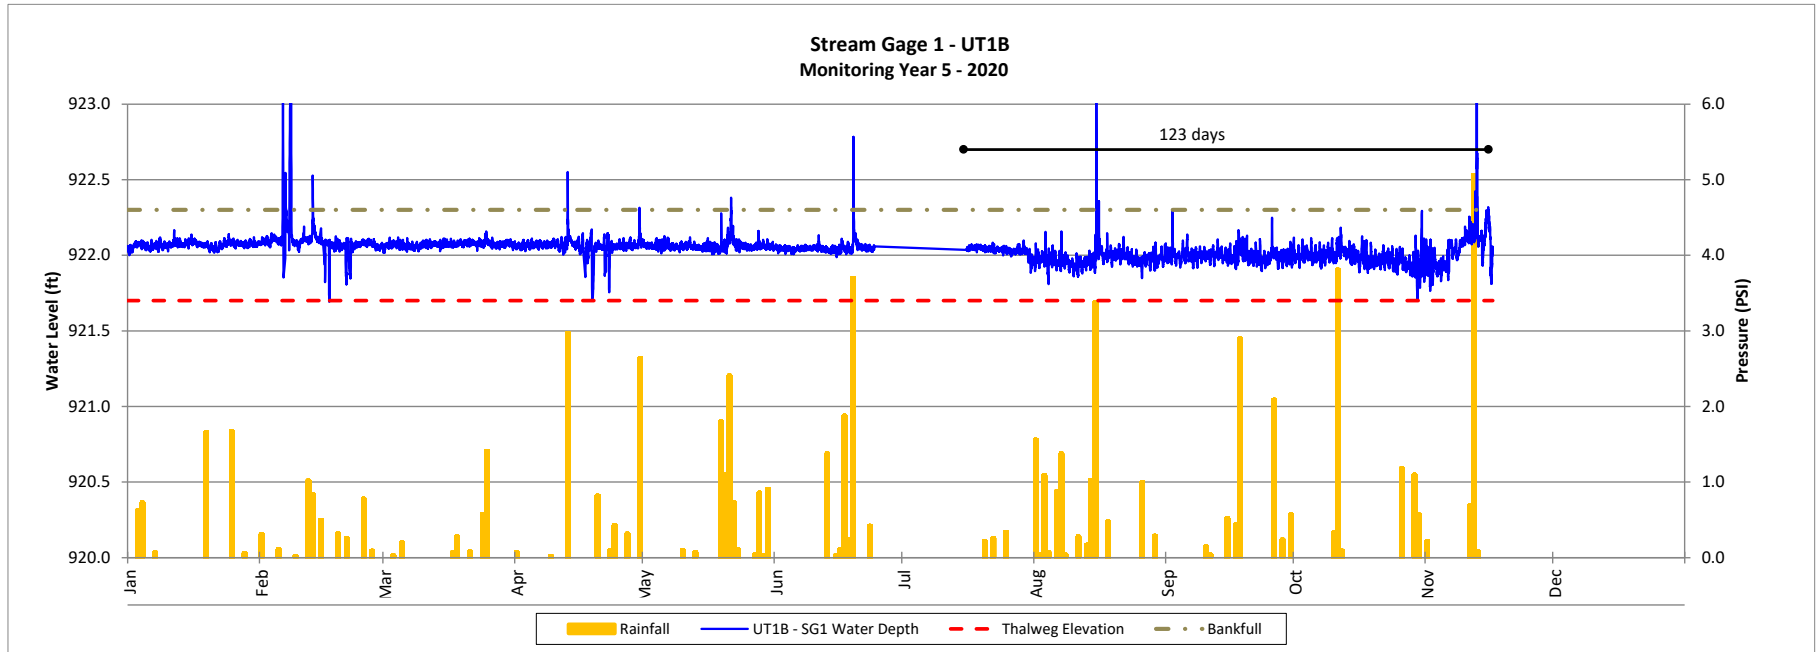
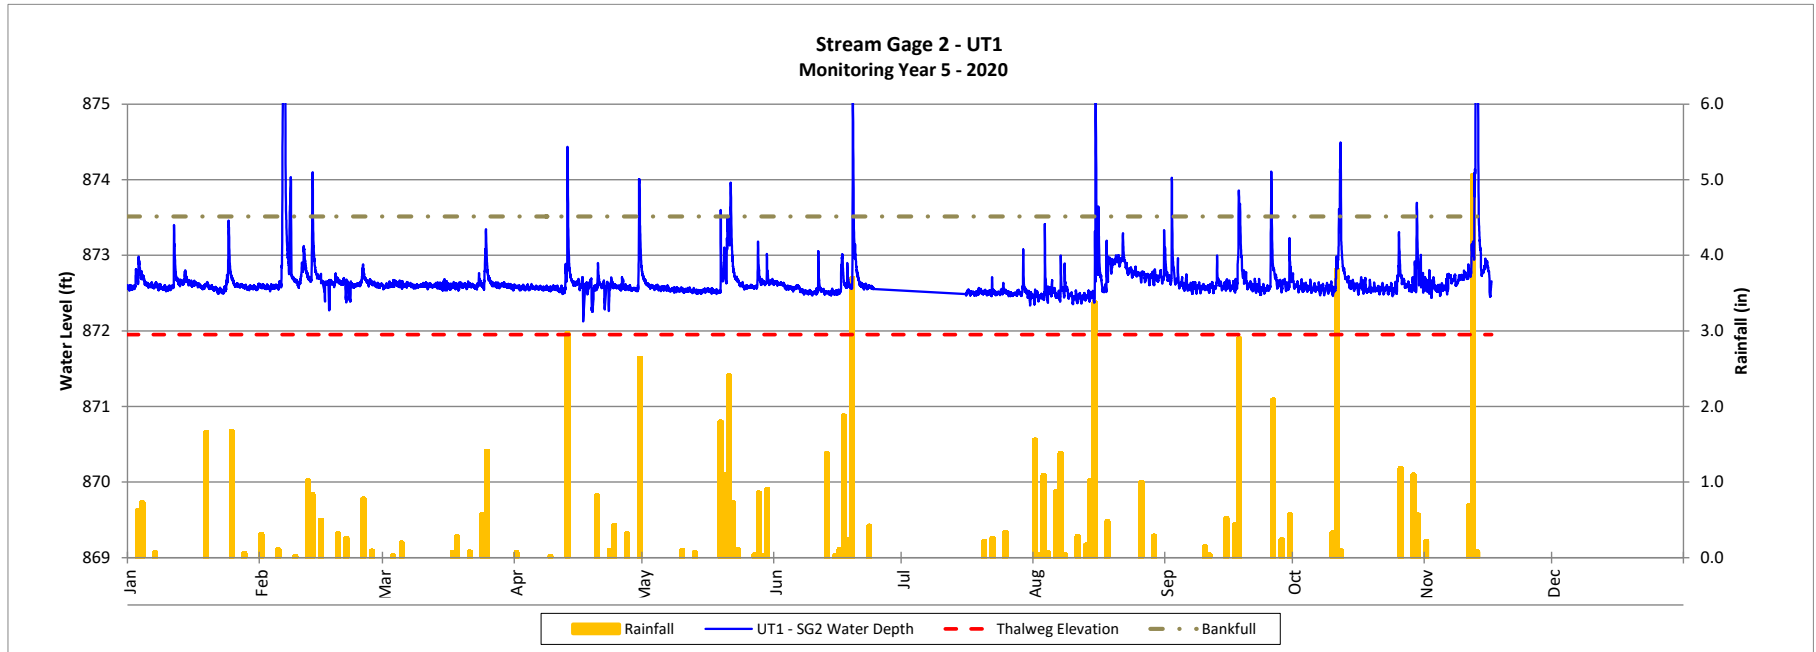
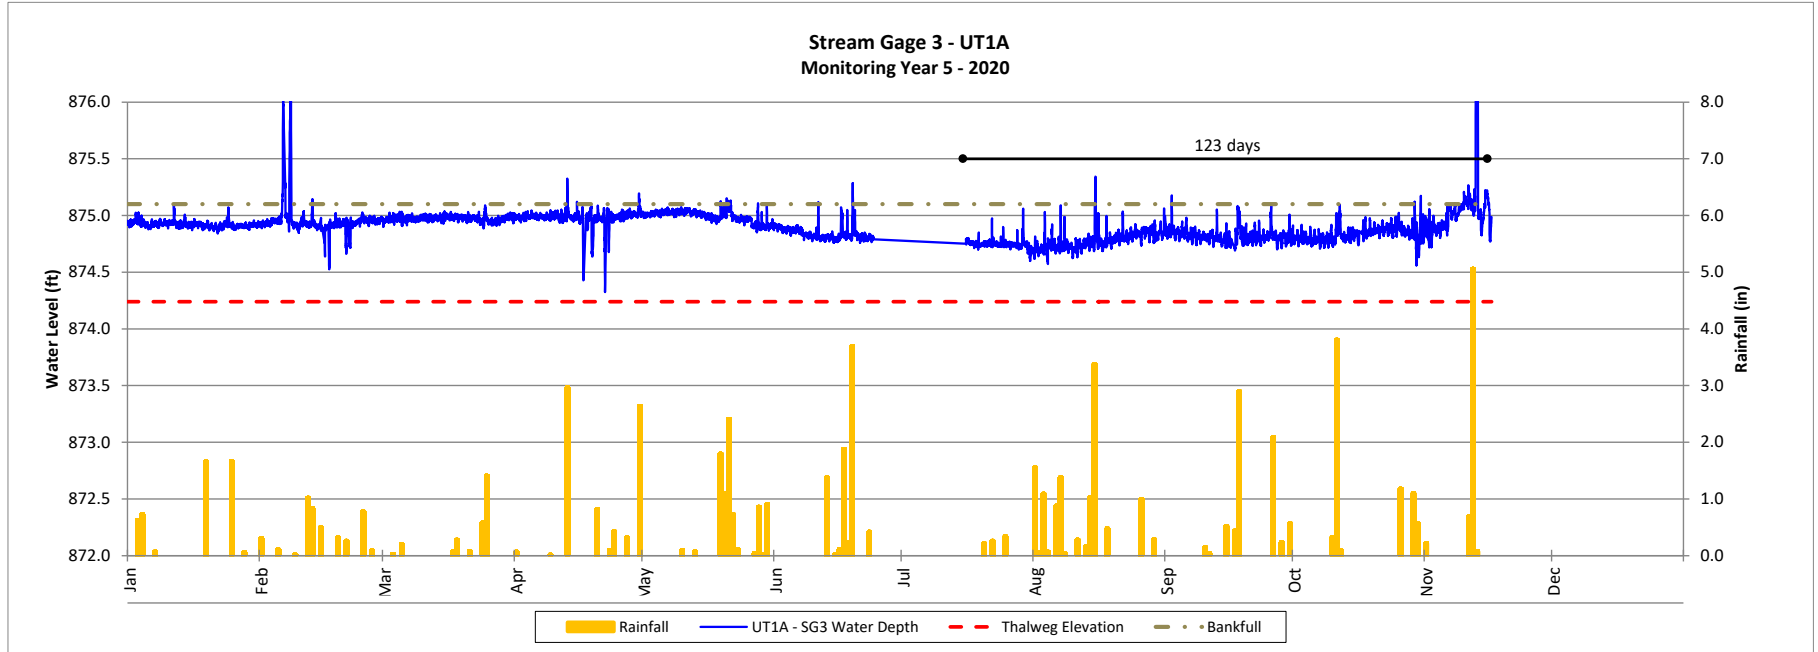
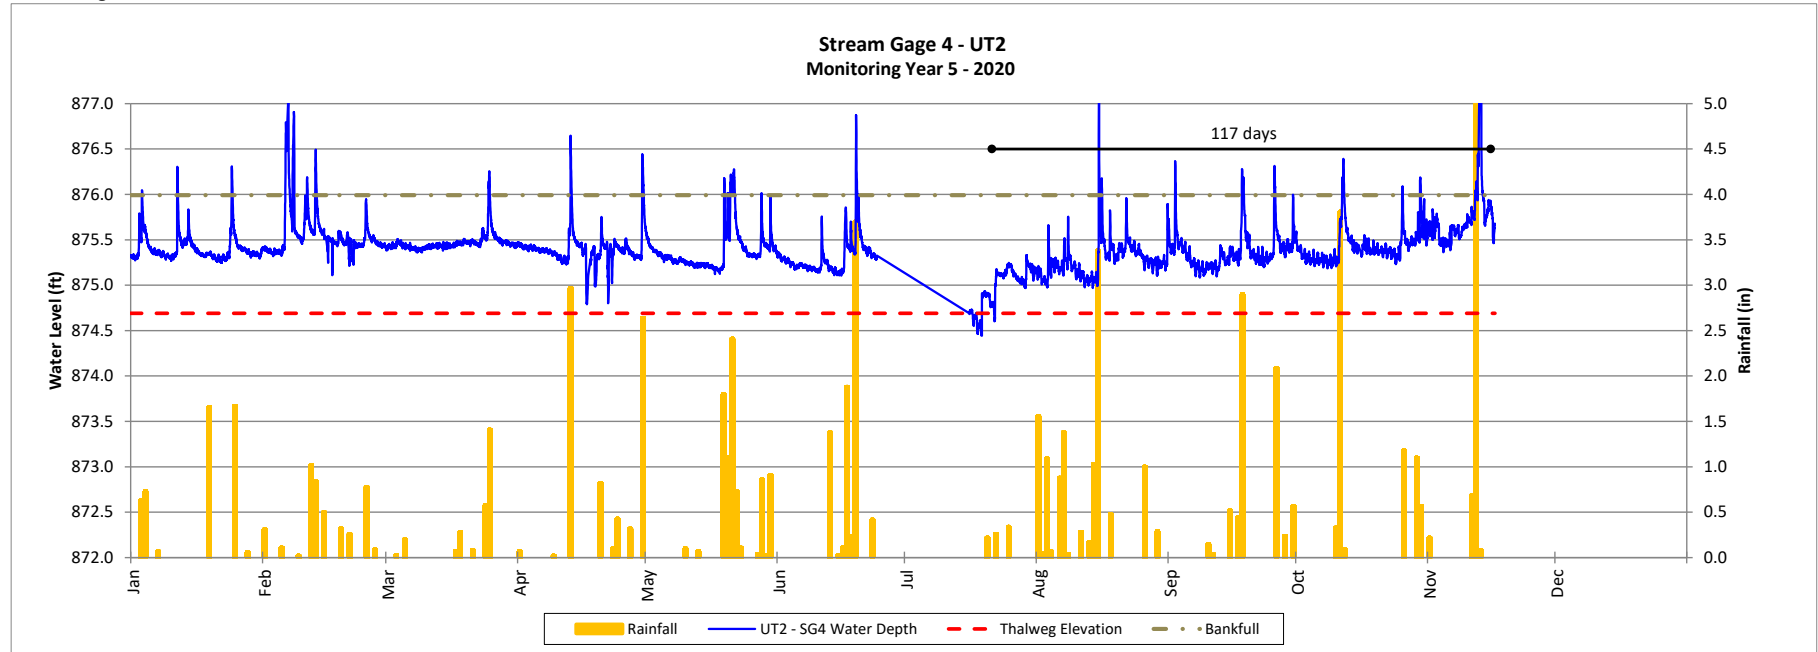
The barotroll at Henry Fork experienced minor malfunctions in February (2/6 and 2/14 - 2/17) and during April (4/16 - 4/17 and 4/21-4/22); therefore, data collected during those dates were omitted from the reported data. In addition, the barotroll quit working on 8/1/2020 so the remaining data was calibrated using the barotroll from the Owl's Den Mitigation Site which is located in Lincoln, County approximately 15 miles from the Henry Fork Mitigation Site.

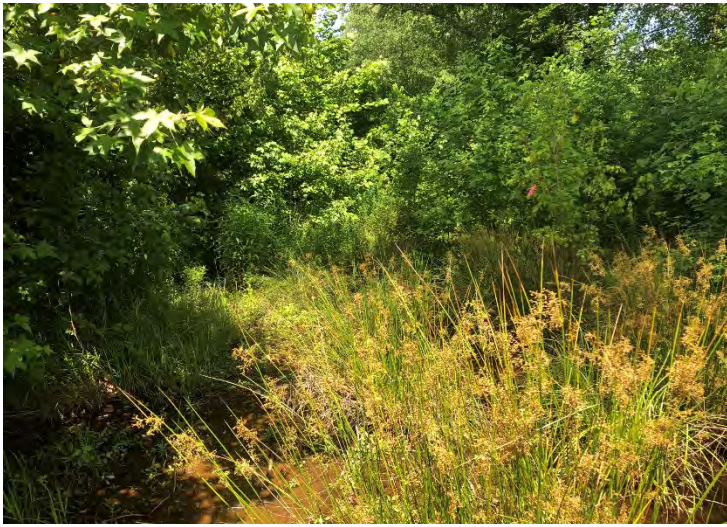
Potential Wetland AA – northern view (6/23/2020)

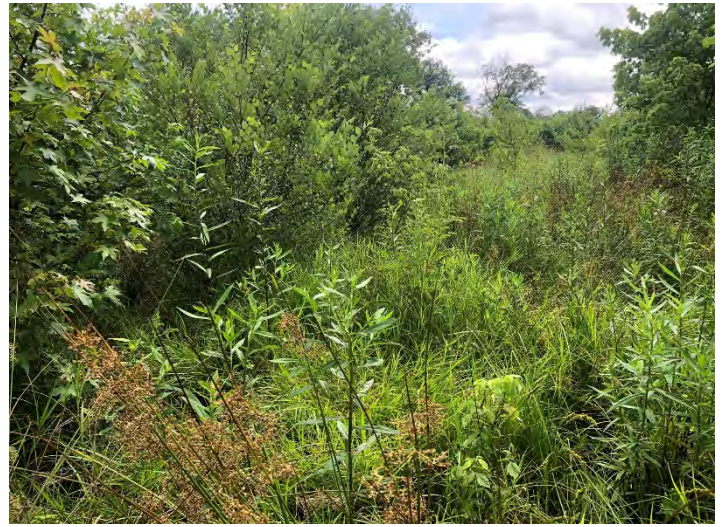
DP1/Potential Wetland BB – eastern view (6/23/2020)

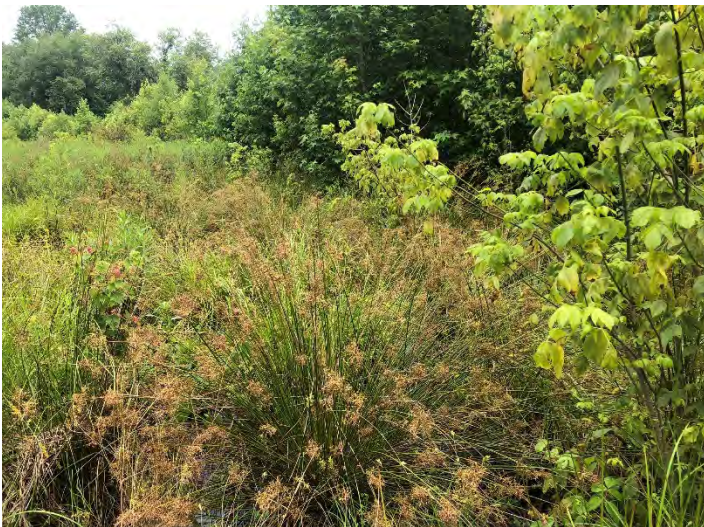
Potential Wetland CC – western view (6/23/2020)

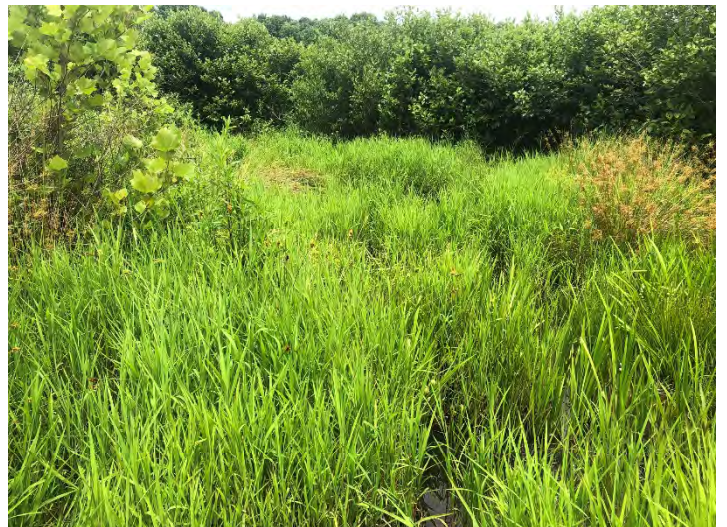
DP2/Potential Wetland DD – northern view (6/23/2020)

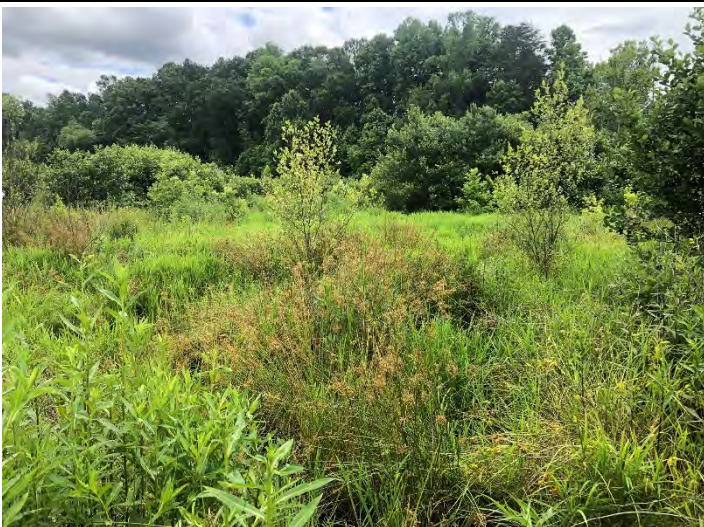
Potential Wetland DD – southern view (6/23/2020)

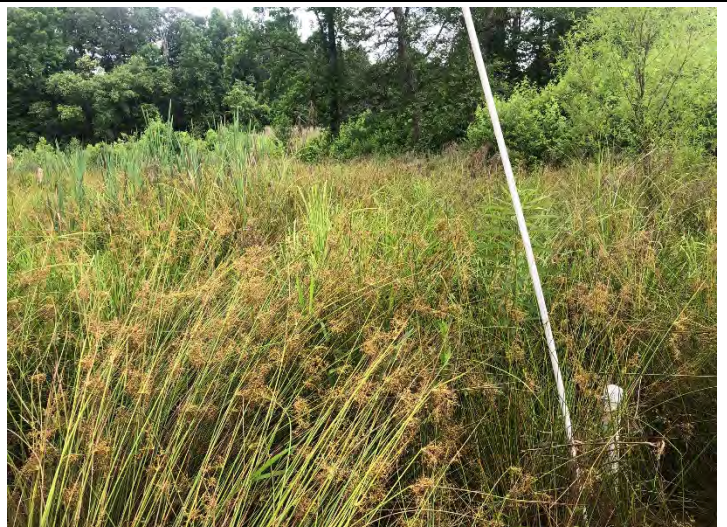
DP3/GWG 13/Potential Wetland EE – southwest view

Wetland EE is located in and around the pre-construction footprint of UT1 near the previous UT1A confluence, adjacent to Wetlands J and K enhancement areas. The restoration of UT1A has increased the floodplain access from overbank flooding and resulted in a gain in wetland function well beyond the mapped wetland re-establishment area (Wetland 1). GWG 13 was installed in MY4 and has achieved wetland hydrologic success criteria for the past two years. Wetland data point 3 (DP3) was collected near GWG 13 and details the conditions of Wetland EE.

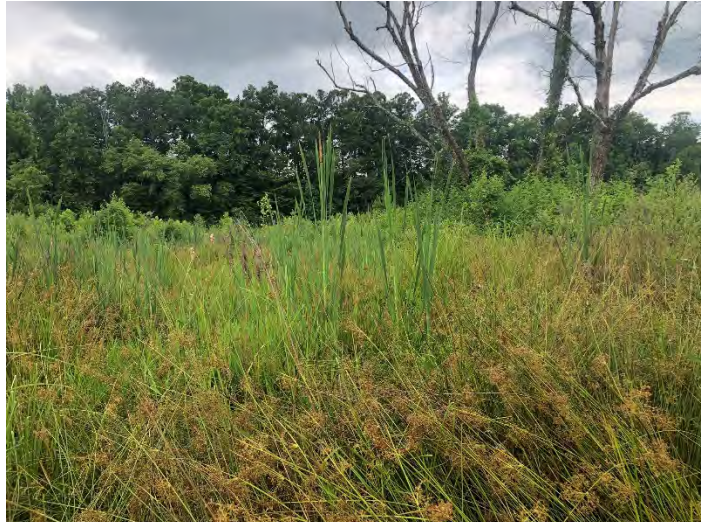
Potential Wetland EE – southern view (6/23/2020)
