MITIGATION PLAN
HERMAN DAIRY
STREAM AND WETLAND RESTORATION SITE
Alexander County, North Carolina
Full Delivery Contract No. 003271

Catawba River Basin
Cataloging Unit and Targeted Local Watershed
03050101120030

February 2011

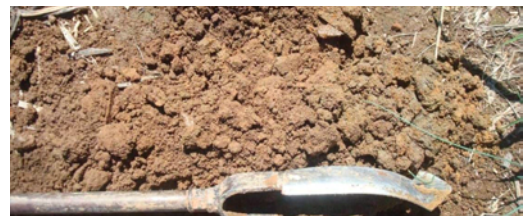
Profile 1

0-8 inches: 10YR 4/3 clay loam
8-10 inches: 10YR 5/3 clay loam with
common/fine/distinct mottles 5YR 5/8
10-13+ inches: 10YR 5/2 sandy clay loam with
common/fine /distinct mottles 7.5YR 5/6

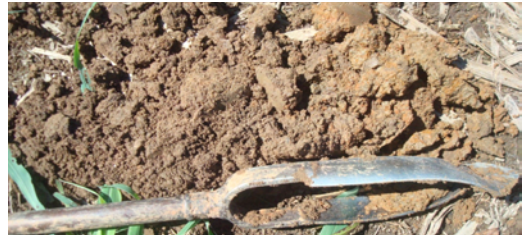
Profile 2

0-6 inches 10YR 4/3 clay loam
6-8 inches 10YR 5/3 clay loam with few/fine/faint mottles 7.5YR 5/8
8-12+ inches 10YR 6/2 clay loam with common/fine/distinct mottles 7.5YR 5/8

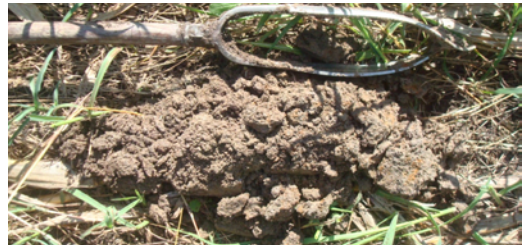
Profile 3

0-4 inches: 10YR 5/4 clay loam
4-12 inches: 10YR 5/2 clay loam with many/medium/distinct mottles 7.5YR 5/6
12-14+ inches: 10YR 6/1 clay loam with common/medium/prominent mottles 7.5YR 5/8

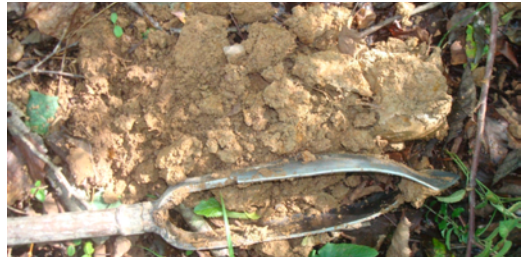
Profile 4

0-4 inches: 10YR 5/4 clay loam
4-10 inches: 2.5Y 5/2 clay loam with many/fine/prominent mottles 7.5YR 5/6
10-14+ inches: 2.5Y 6/2 clay loam with many/medium/distinct mottles 7.5YR 5/6

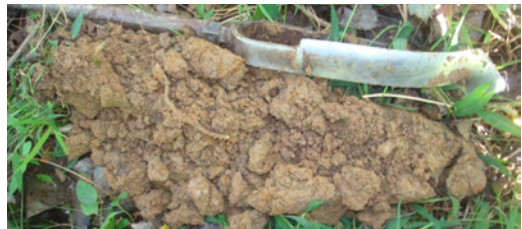
Profile 5

0-6 inches: 10YR 5/3 clay loam with many/medium/distinct mottles 7.5YR 5/6
6-12 inches: 10YR 5/2 clay loam with many/medium/distinct mottles 7.5YR 5/8
12-14+ inches: 10YR 6/2 clay loam with many/medium/prominent mottles 7.5YR 5/8 few/fine/faint mottles 7.5YR 5/6

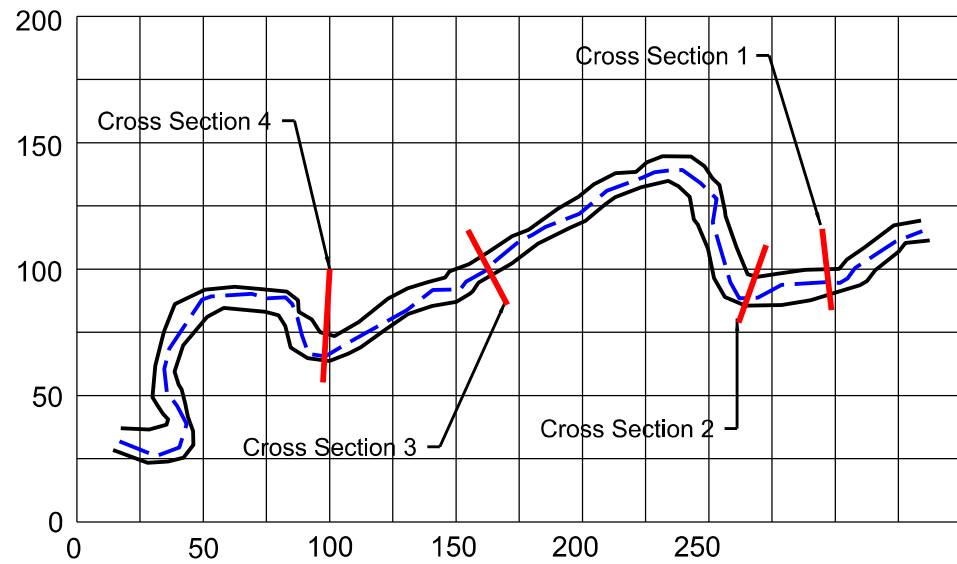
Reference Pattern
 Lp-p = 60 (29 - 103) ft
 Lm = 80.5 (65 - 128) ft
 Wbelt = 45 (35 - 58) ft
 Rc = 16 (10 - 32) ft
 Lp-p/Wbkf = 6.3 (3.1 - 10.8)
 Lm/Wbkf = 8.5 (6.8 - 13.5)
 Wbelt/Wbkf = 4.7 (3.7 - 6.1)
 Rc/Wbkf = 1.7 (1.1 - 3.4)
 SIN = 1.40

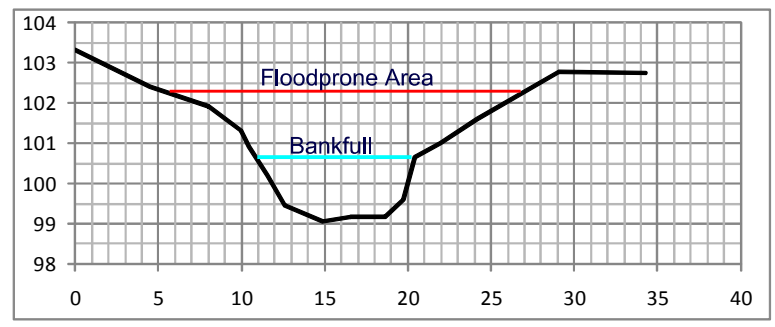
Cross Section 3 - Riffle
 Abkf = 11.8 ft
 Dave = 1.2 ft
 Wbkf = 9.6 ft
 Dmax = 1.6 ft
 Bank Height = 1.6 ft
 Bank Height Ratio = 1.0
 W/D = 7.9
 FPA = 22
 ENT = 2.3
 Stream Type = E

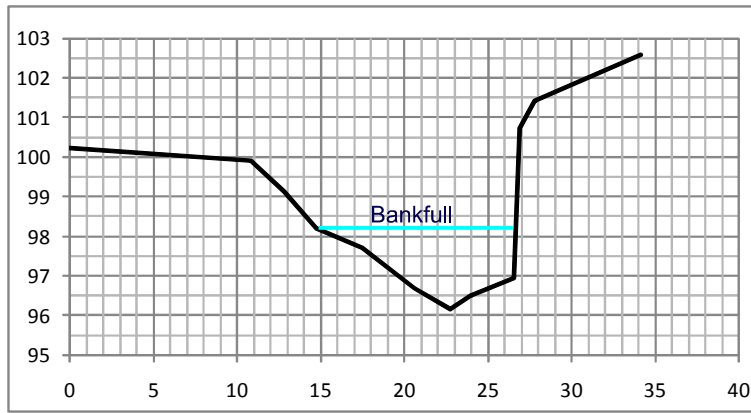
Cross Section 2 - Pool
 Abkf = 13.8 ft
 Wbkf = 11.9 ft
 Dmax = 2.1 ft

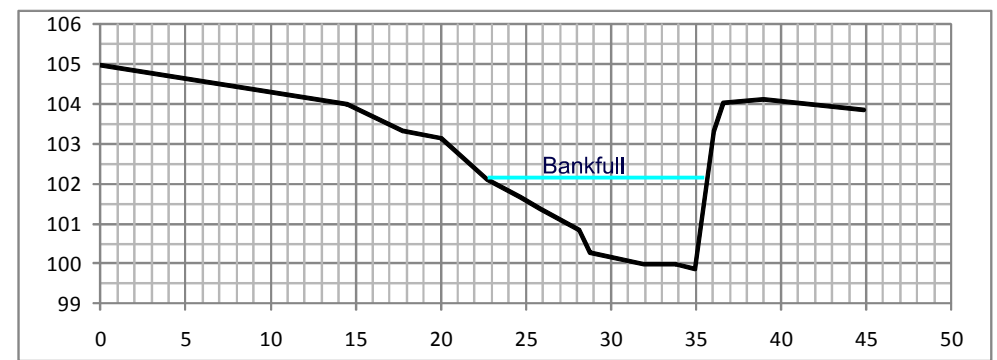
Cross Section 4 - Pool
 Abkf = 18.1 ft
 Wbkf = 13.0 ft
 Dmax = 2.3 ft

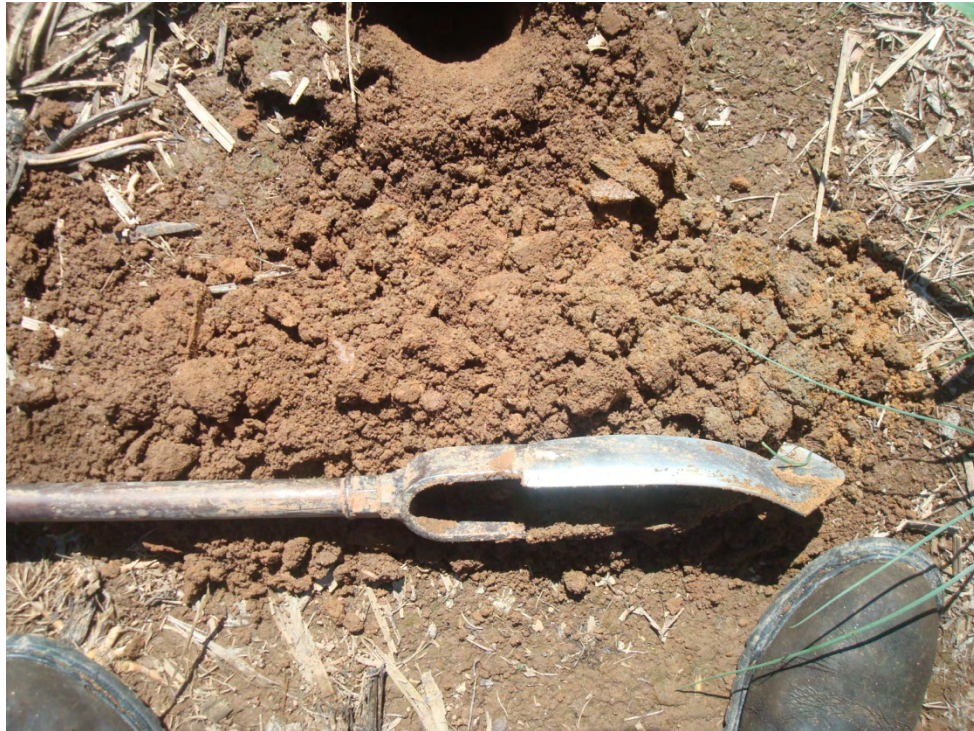
Soil Sample #1

0 – 8”	brown	10YR 4/3	CL
8” – 10”	brown	10YR 5/3	CL
	yellowish red	5YR 5/8 (common/fine/distinct)	
10” – 13”+	grayish brown	10YR 5/2	SCL
	strong brown	7.5YR 5/6 (common/Fine/distinct)

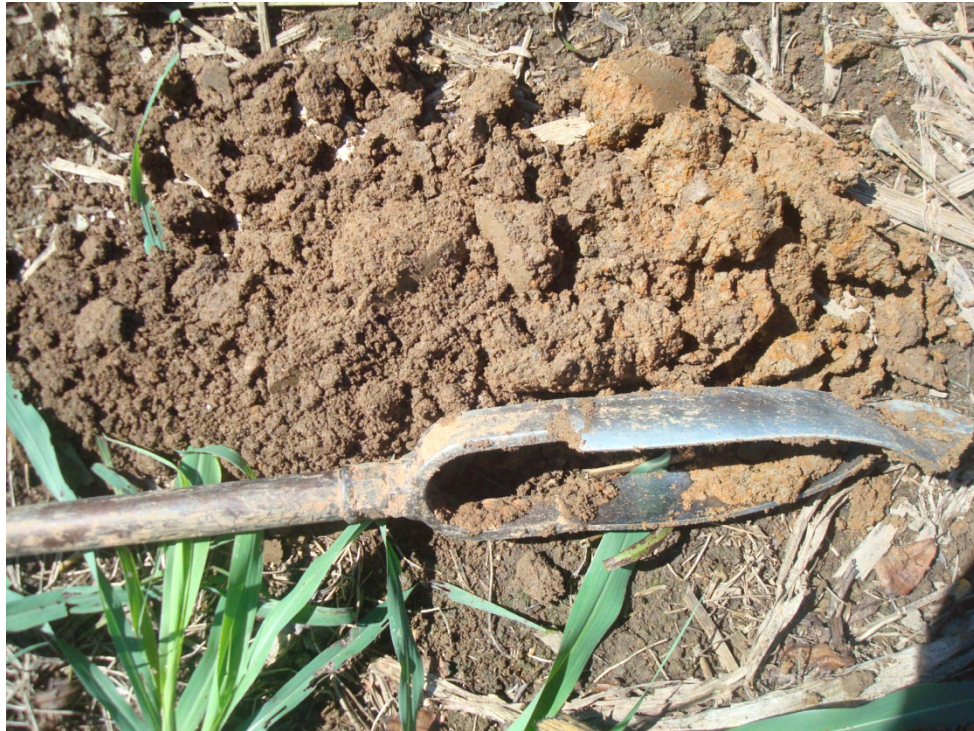
Soil Profile #2

0 – 6"	brown	10YR 4/3	CL
6" – 8"	brown	10YR 5/3	CL
	strong brown	7.5YR 5/8 (few/fine/faint)	
8" – 12"+	light brownish gray	10YR 6/2	CL
	strong brown	7.5YR 5/8 (common/fine/distinct)

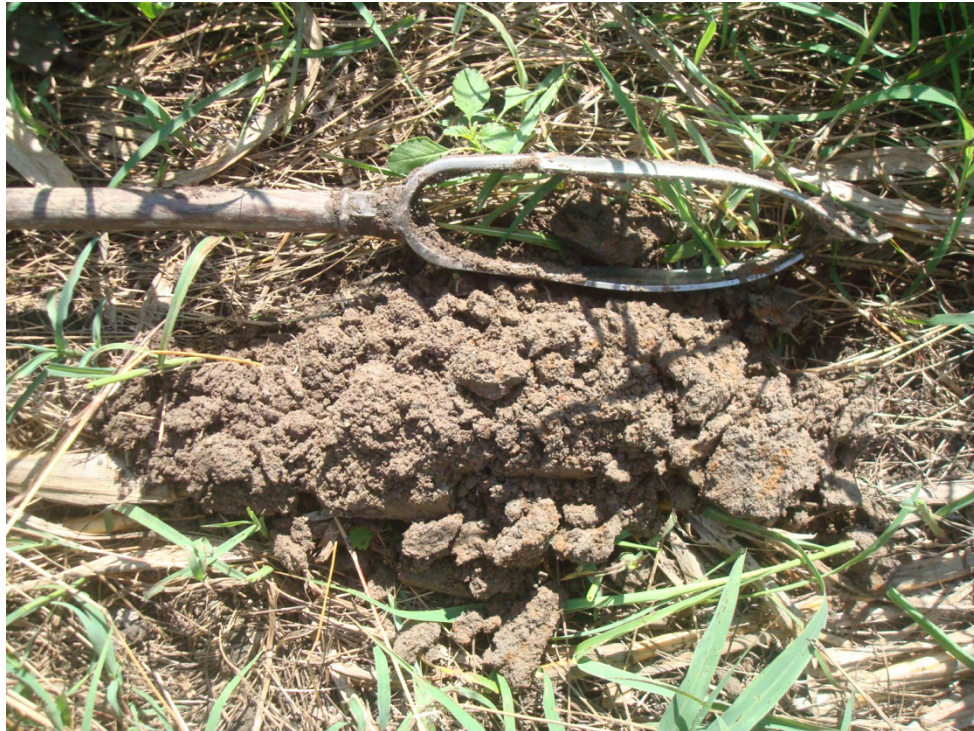
Soil Profile #3

0 – 4"	yellowish brown	10YR 5/4	CL
4" – 12"	grayish brown	10YR 5/2	CL
	strong brown	7.5YR 5/6 (many/medium/distinct)	
12" – 14"+	gray	10YR 6/1	CL
	strong brown	7.5YR 5/8 (common/medium/prominent)

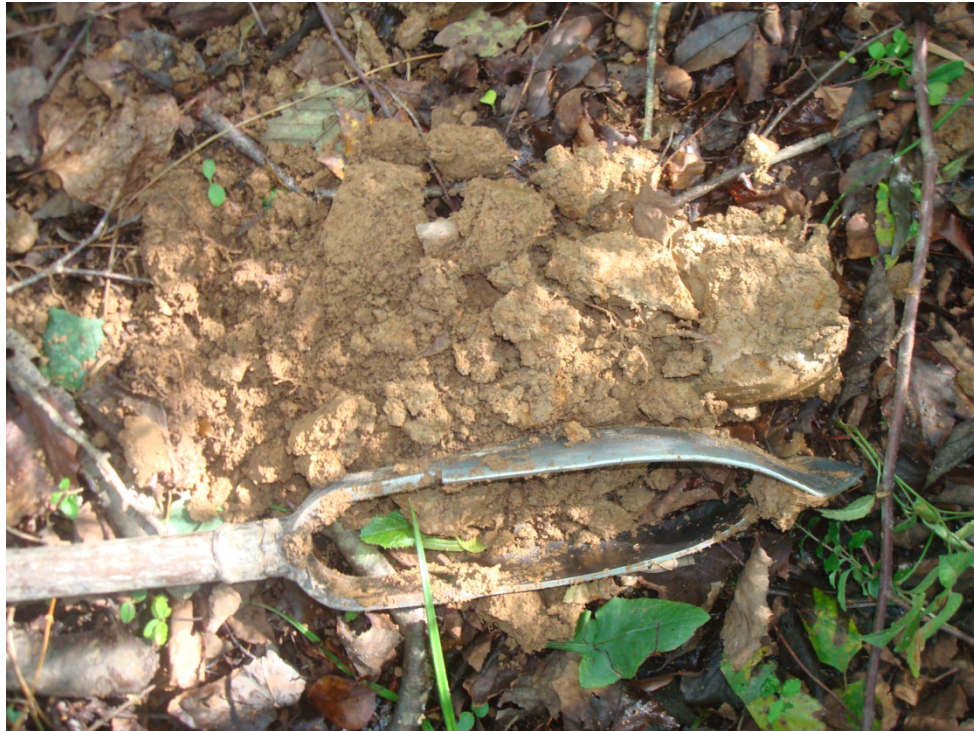
Soil Profile #4

0 – 4”	yellowish brown	10YR 5/4	CL
4” – 10”	grayish brown	2.5Y 5/2	CL
	light olive brown	7.5YR 5/6 (many/fine/prominent)	
10” – 14”+	light brownish gray	2.5Y 6/2	CL
	strong brown	7.5YR 5/6 (many/medium/distinct)

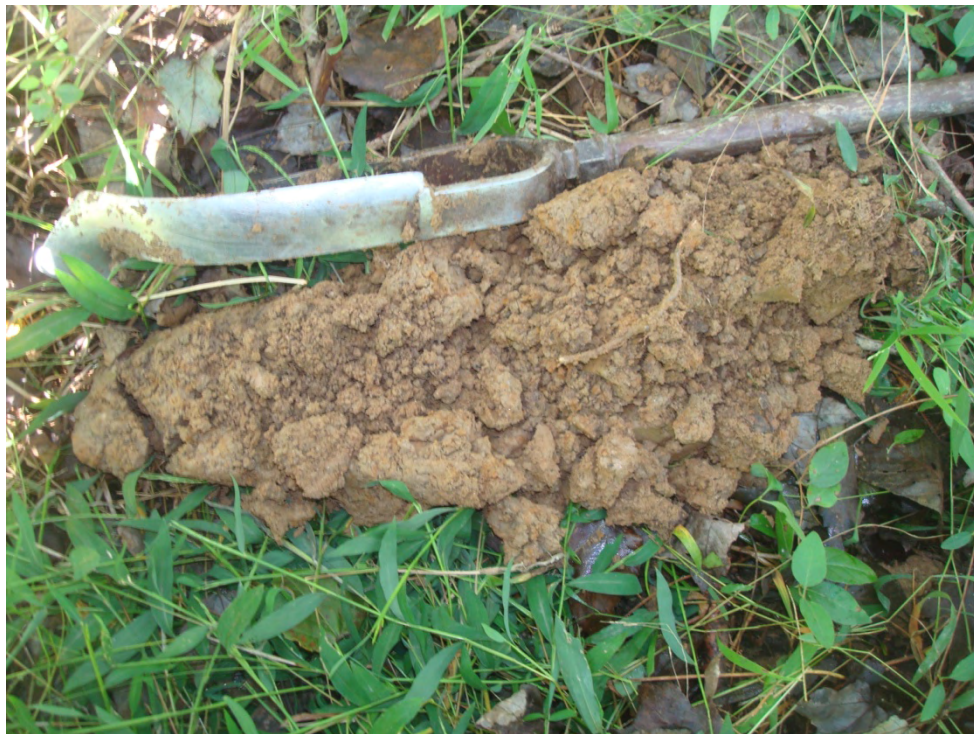
Soil Profile #5

0 – 6”	brown	10YR 5/3	CL
	strong brown	7.5 YR 5/6 (many/medium/distinct)	
6” – 12”	grayish brown	10YR 5/2	CL
	strong brown	7.5YR 5/8 (many/medium/distinct)	
12” – 14”+	light brownish gray	10YR 6/2	CL
	strong brown	7.5YR 5/8 (many/medium/distinct)	
	strong brown	7.5YR 5/6 (few/fine/faint)
