**HILLCREST BAY WETLAND RESTORATION SITE
(Contract # D04013-2)**

**MONITORING YEAR 3
2007**

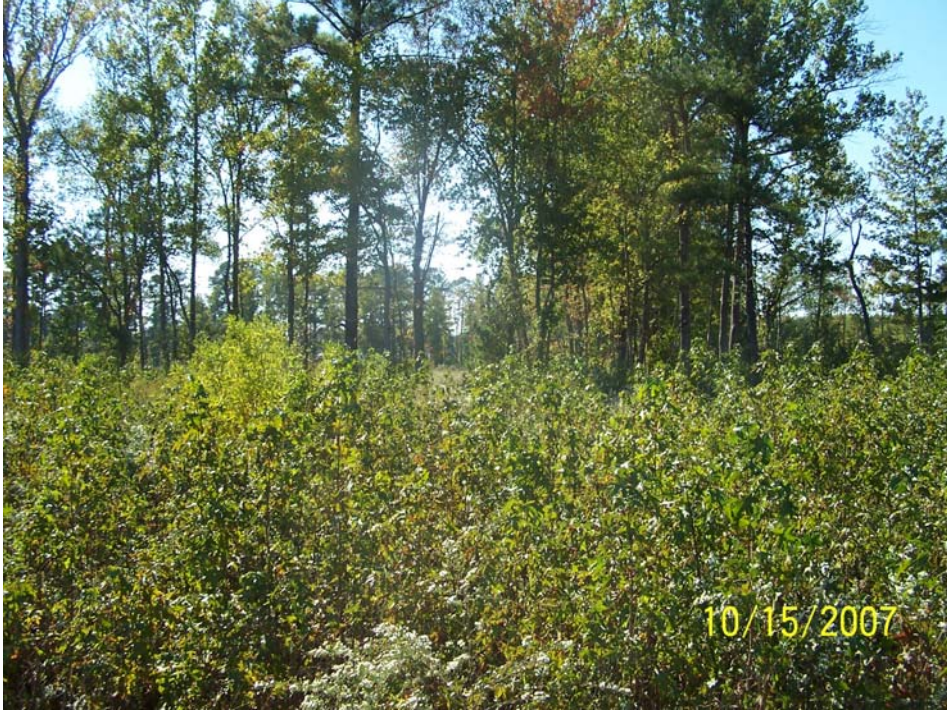
Exhibit Table X. Vegetative Problem Areas		
Feature/Issue	Station # / Range	Probable Cause
Invasive Vegetation	Throughout the bay	Scattered sweet gum , large stand around Gage 7
	Bay entrance	Mimosa

Sweet Gum patch around Gage 7

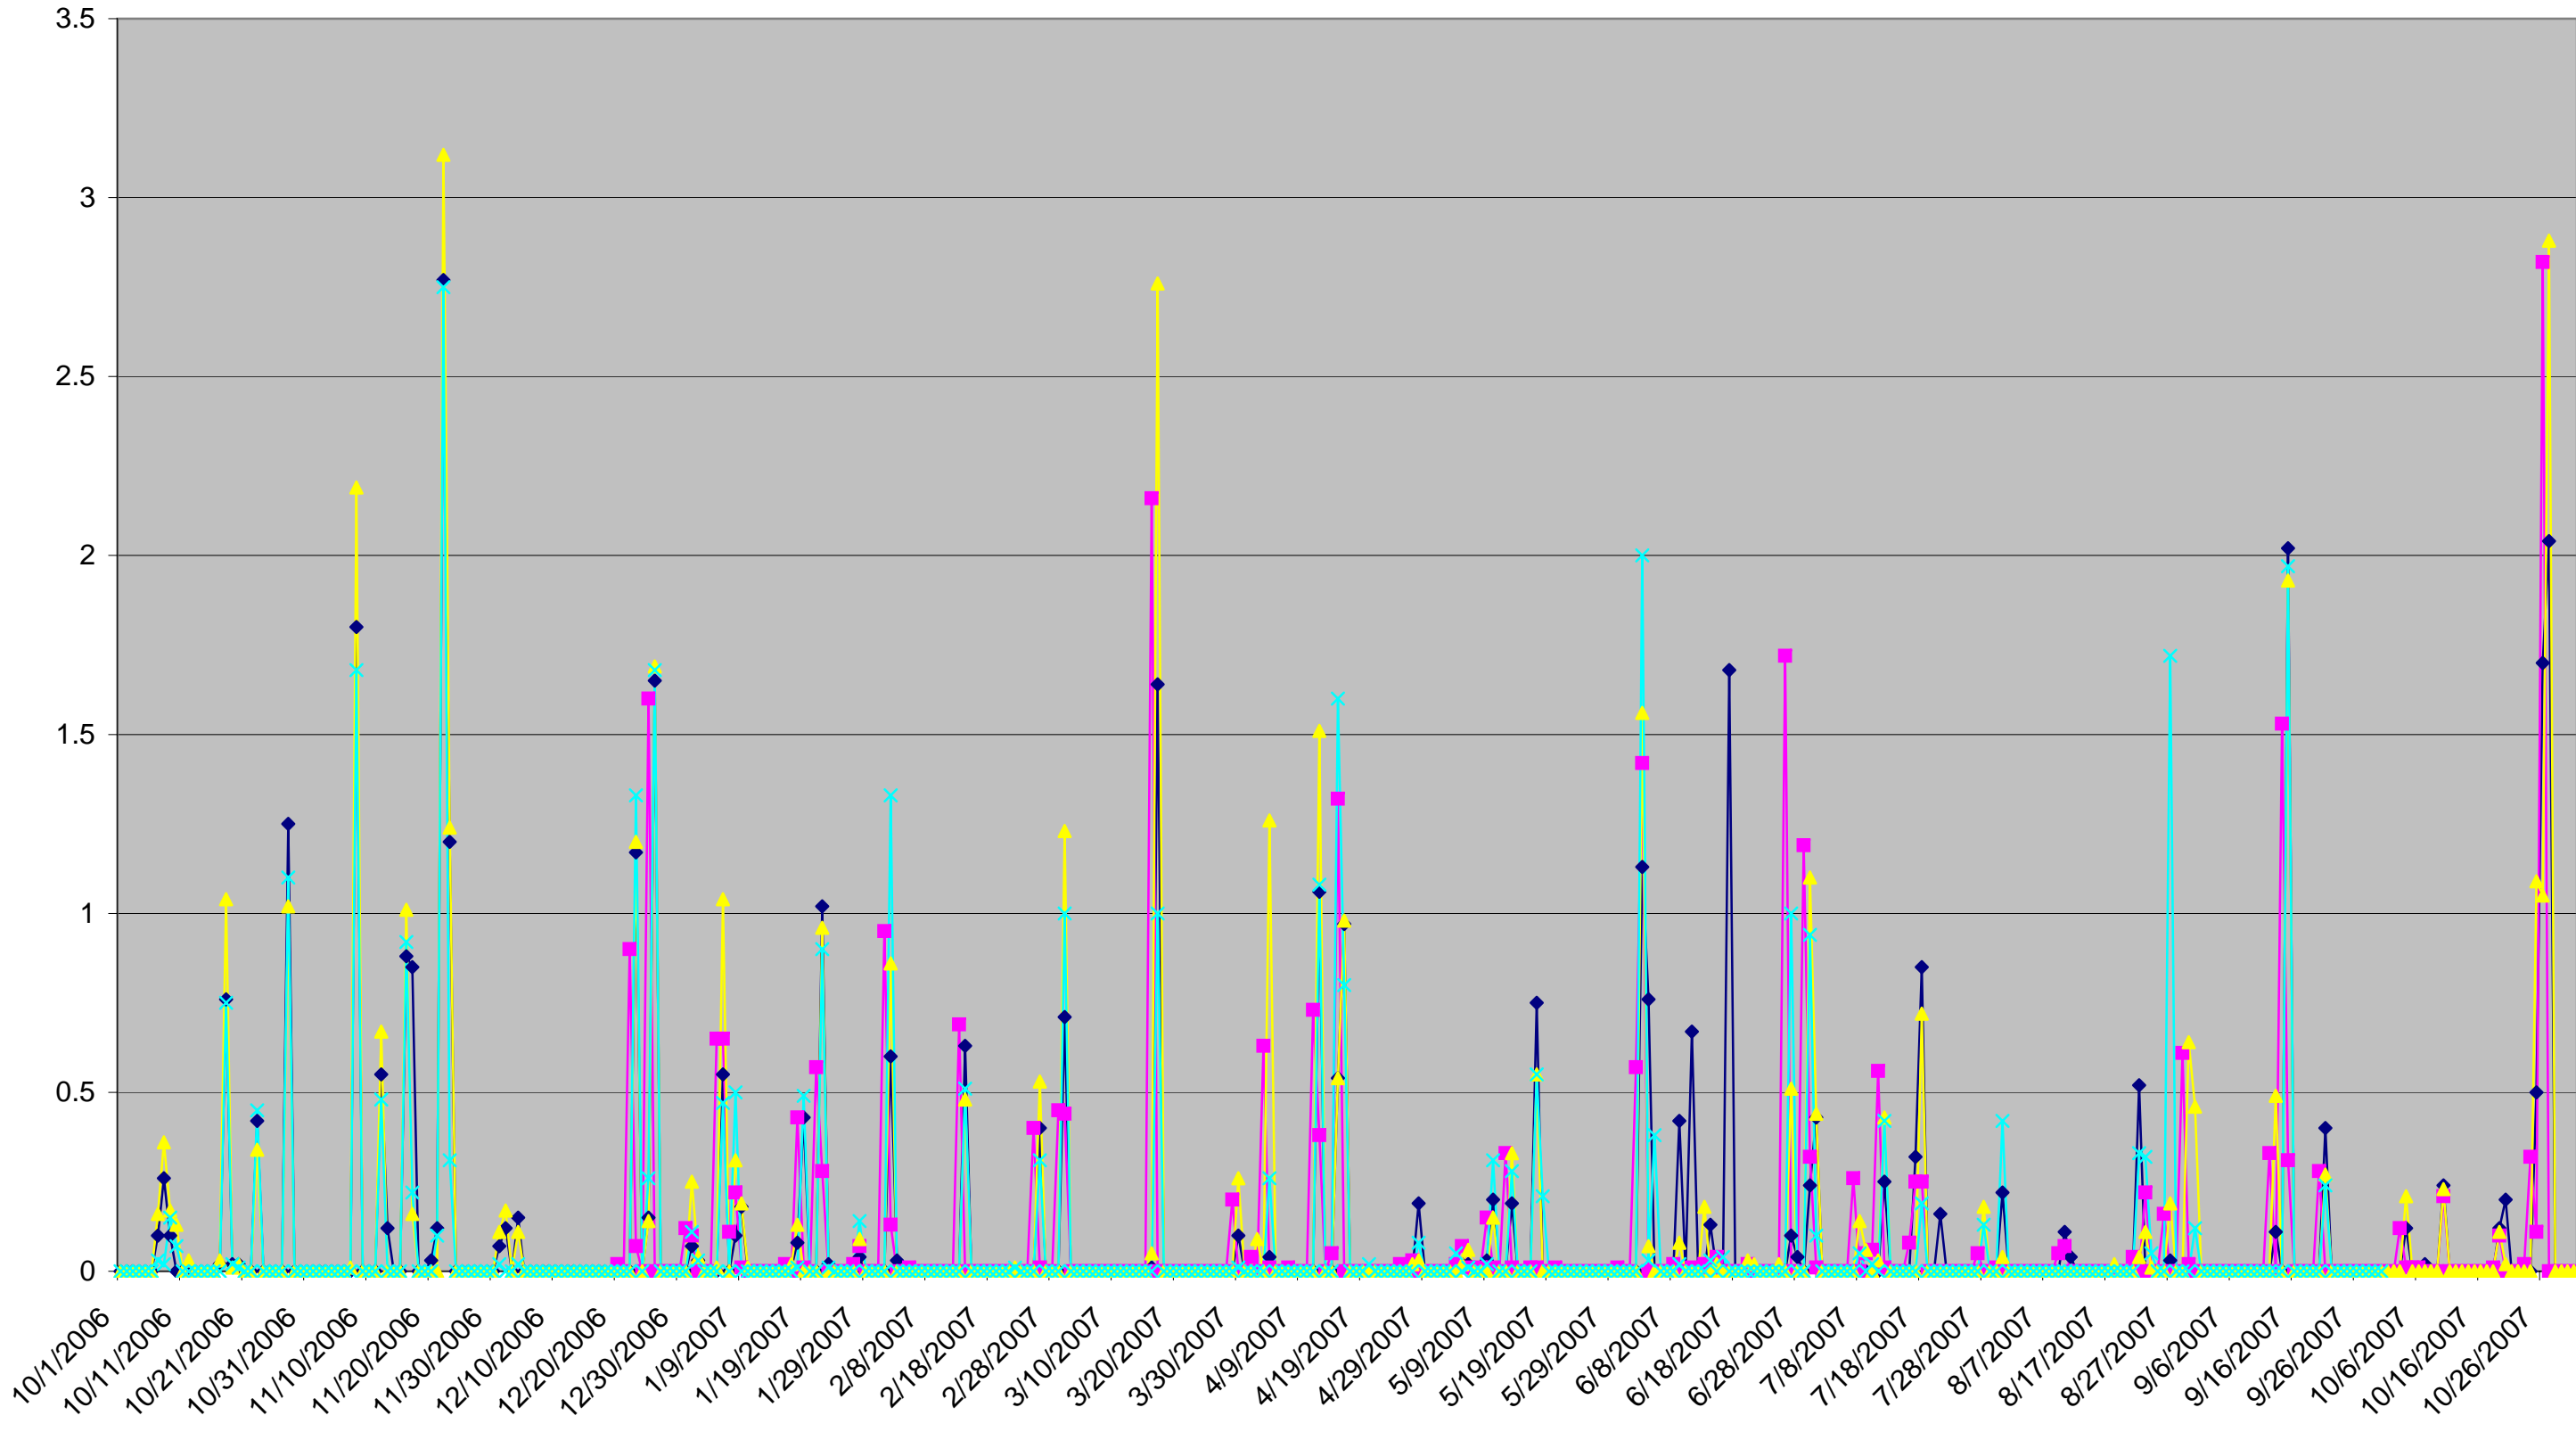
The onsite rain gage was compared to two CRONOS gages for quality check purposes, see Rainfall Data in Appendix B. No malfunctions or clogs were noted this year at the onsite raingage, and the onsite data is believed to be accurate. A local CRONOS gage in Red Springs was also used to compare potential differences between rainfall at the project site and rainfall further south in Robeson County near the reference gages.

Fayetteville Rain Onsite - Hillcrest Rain Raeford Rain Red Springs Rain

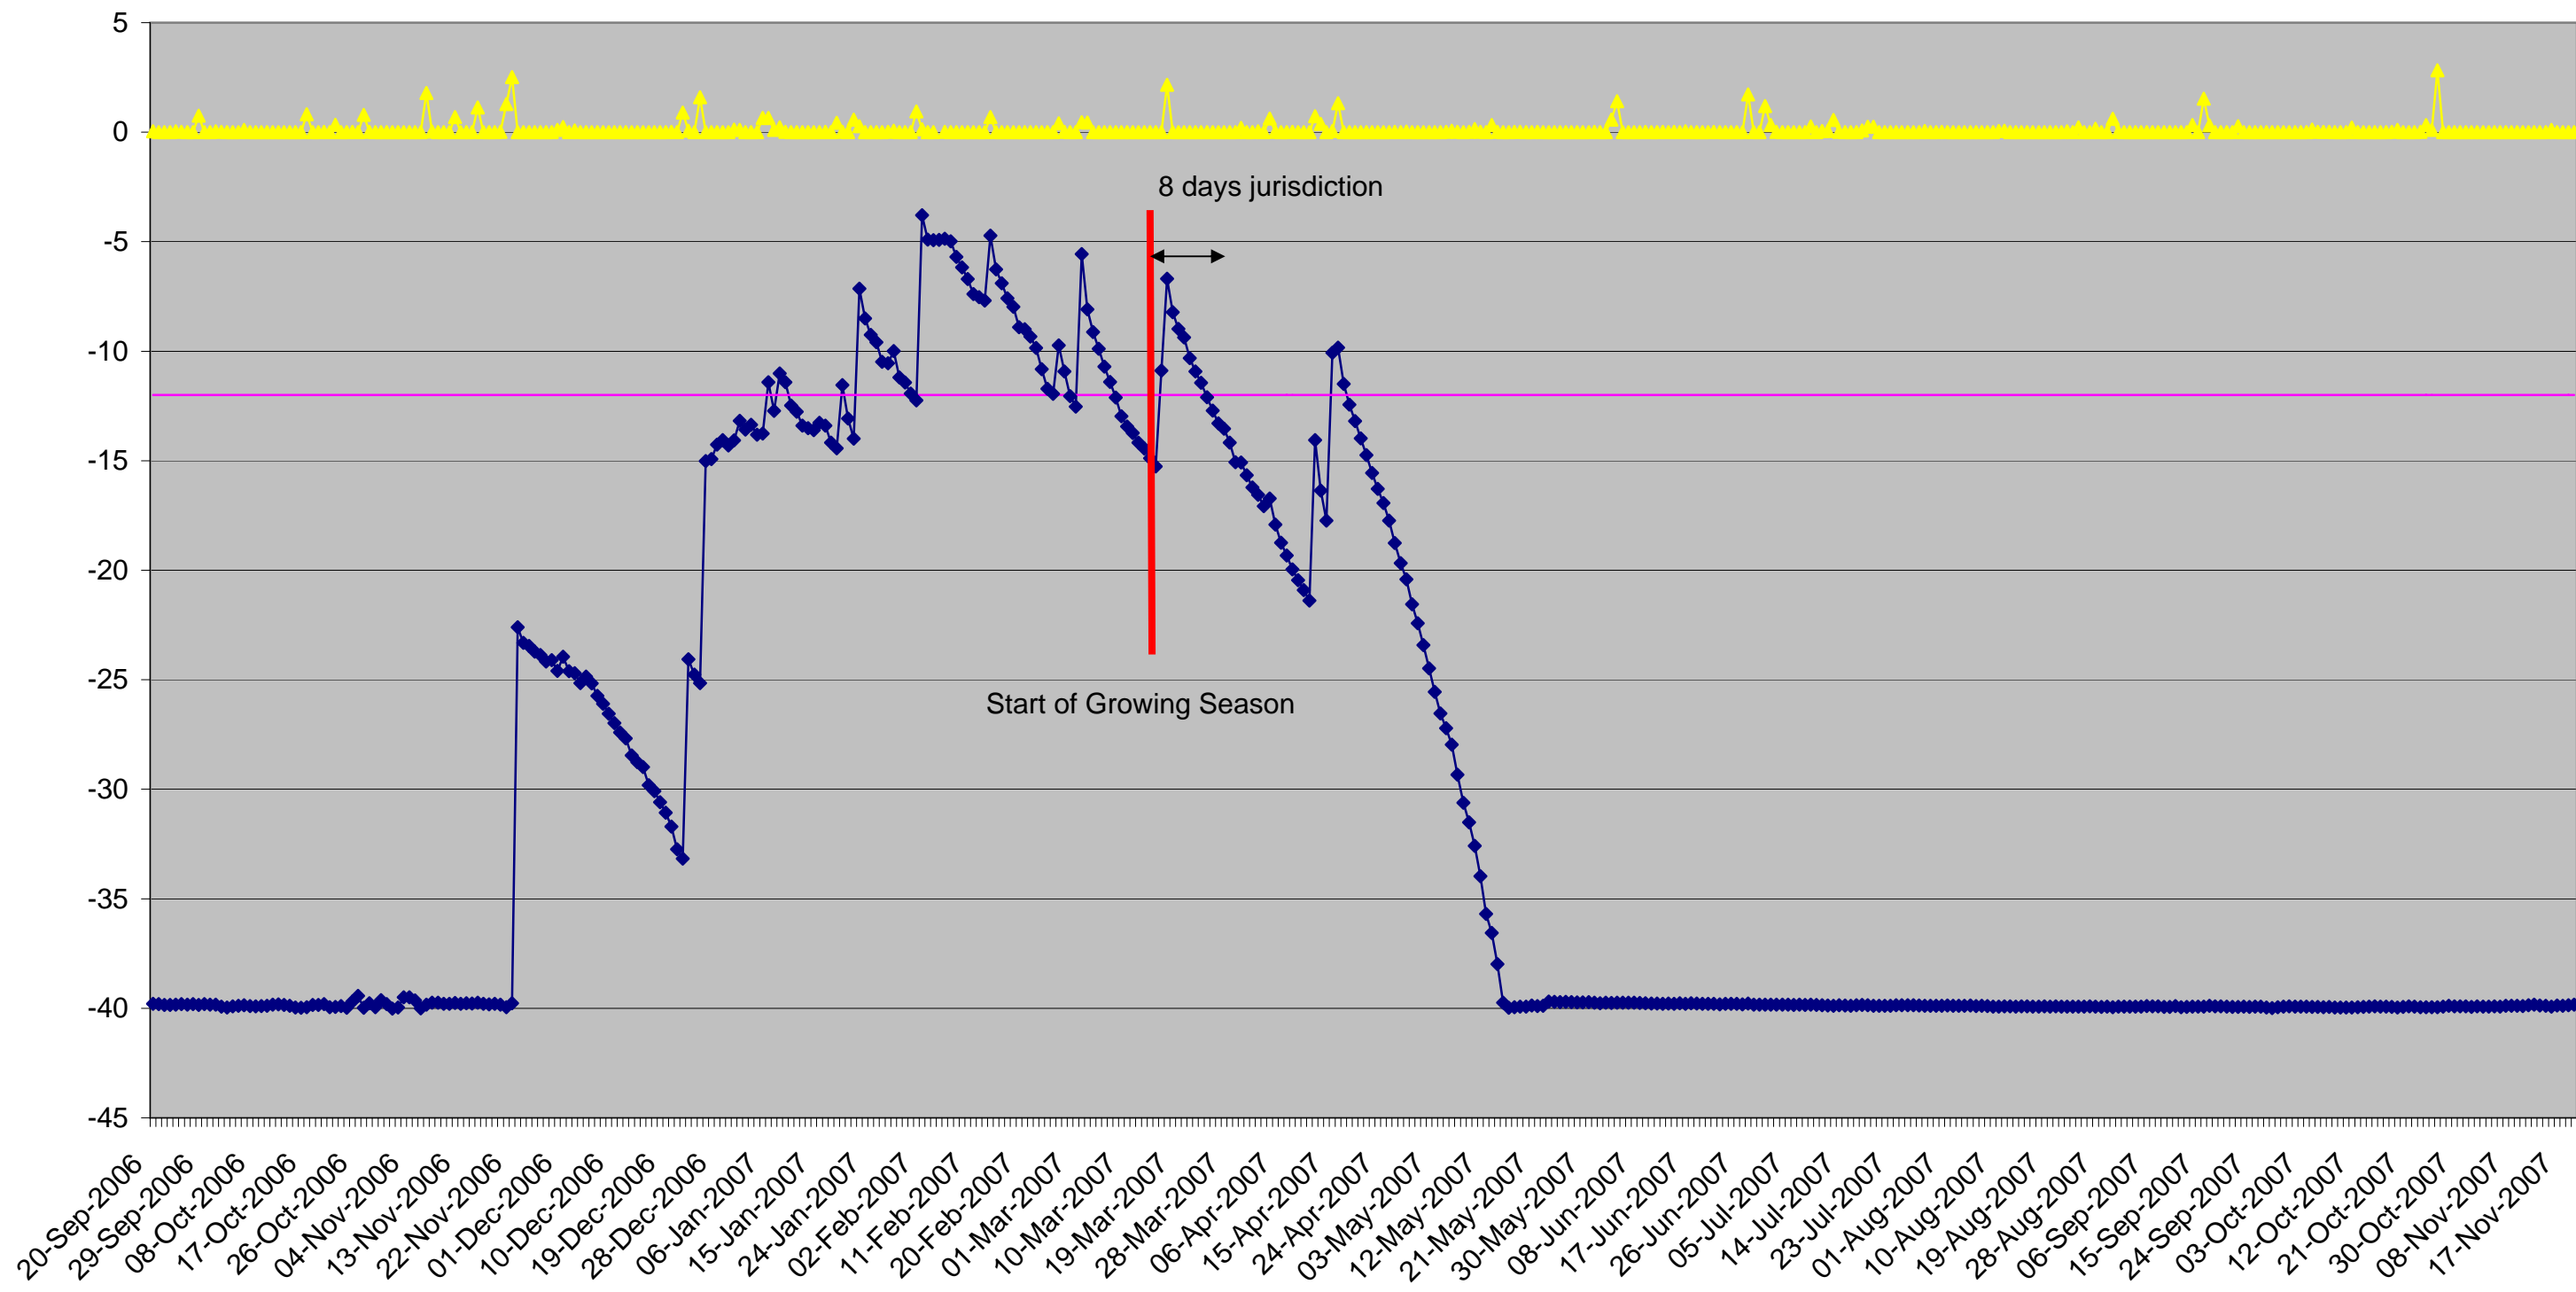
Goose Pond Reference Bay

Despite the regional drought conditions, the majority of the gages have met jurisdictional hydrology which indicates a positive trend for meeting hydrological success criteria. In fact, the reference bay gage did not meet jurisdictional hydrology while the majority of the Site gages did. Over the next few years the hydrology will be monitored in comparison to the reference bays to determine if the success criteria has been achieved. As the water table slowly recovers from the extended drought over the last several years, we expect continued hydrologic improvements. Additional monitoring years may be required to allow the site to develop jurisdictional hydrology. The Mitigation Plan defined Hydrologic Success as jurisdictional hydrology for 5% of the growing season, which for this area is approximately 219 days beginning March 17th and ending October 12th. Therefore, successful hydrology will be indicated by 11 or more days meeting jurisdiction during that time period. More detailed explanation is discussed in Section 3.2.

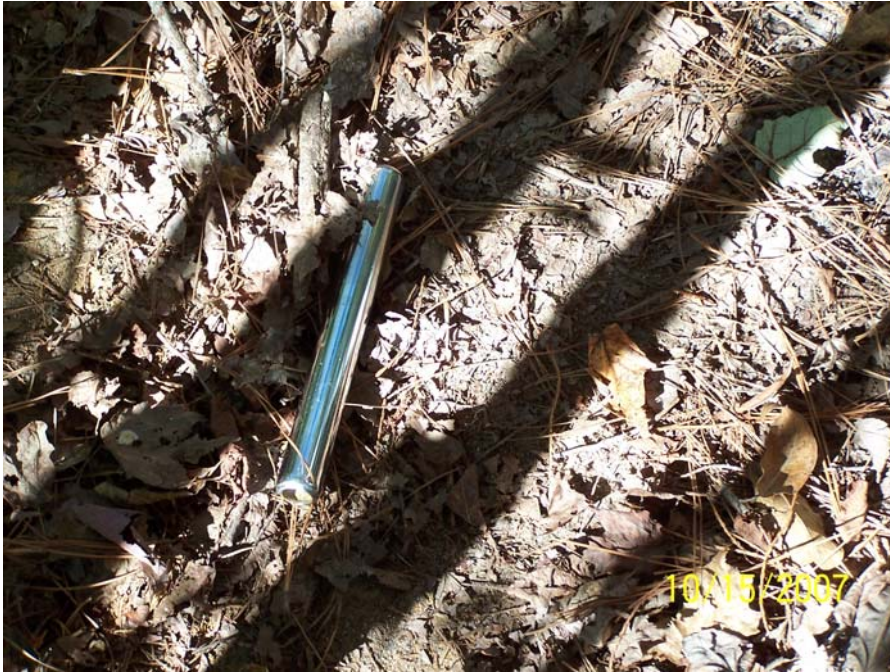
Reference bays were examined in conjunction with monitoring of the site. A field visit was made to Goose Pond Bay and Antioch Bay. Hydrology data was downloaded from the gauge that was installed in Goose Pond Bay. MAM personnel augered to a depth of 36" to examine soil moisture in each reference bay. No ground water was identified in the auger hole. Soil was dry and hard at 30" in both reference bays.

Goose Pond Bay Test Hole, approximately 36" deep

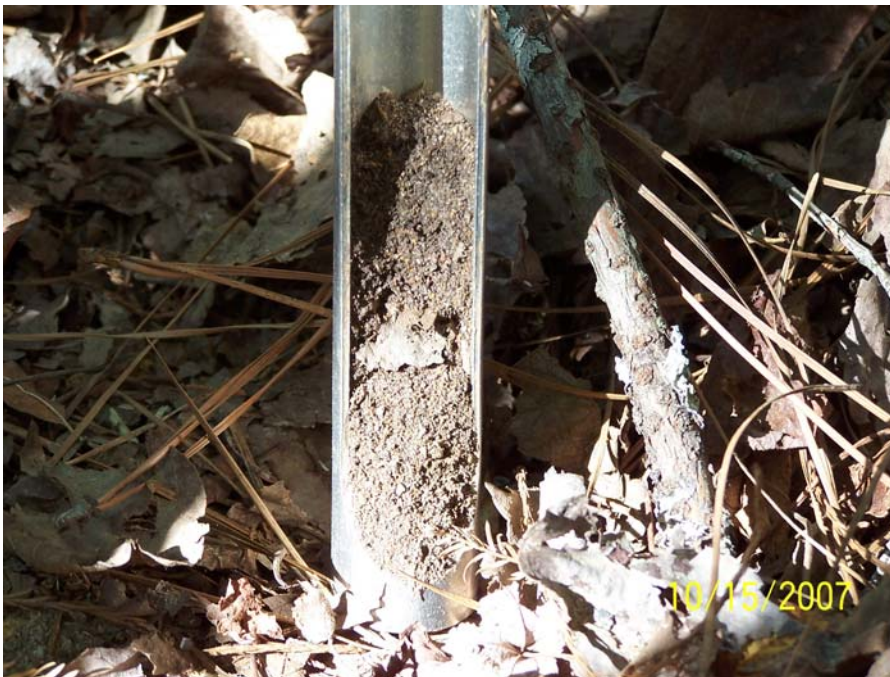
Contents of test hole, dry and hard packed

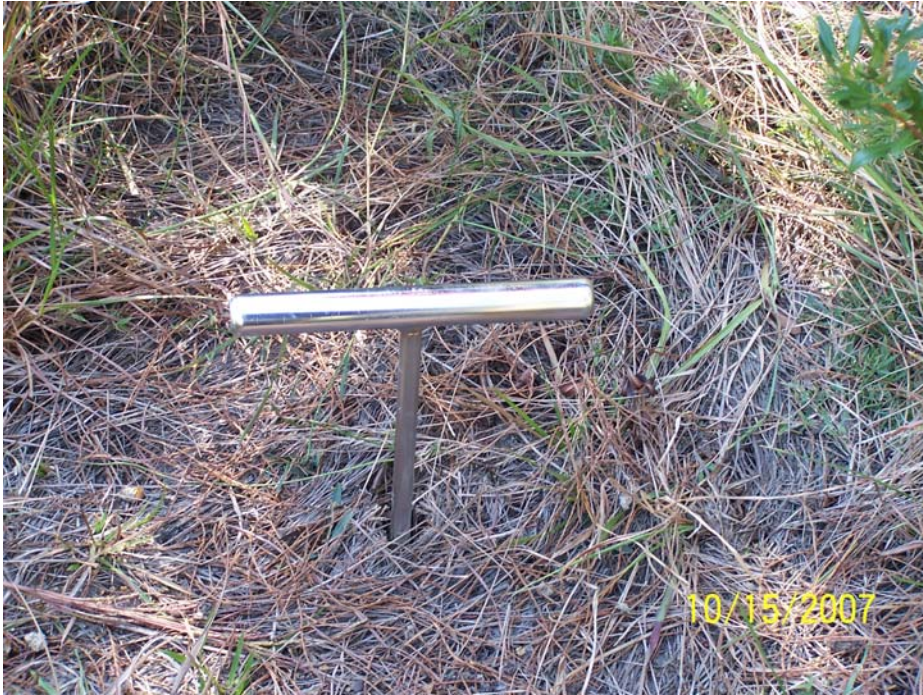
Dry conditions identified at the Site since construction were also noted this year although they were not as severe. The reference sites also demonstrated dry conditions, the soils within the bays were inspected to at least 36”. No ground water was identified to this depth. Soil within 30” was dry and hard.

Antioch Bay Test Hole, approximately 30" deep

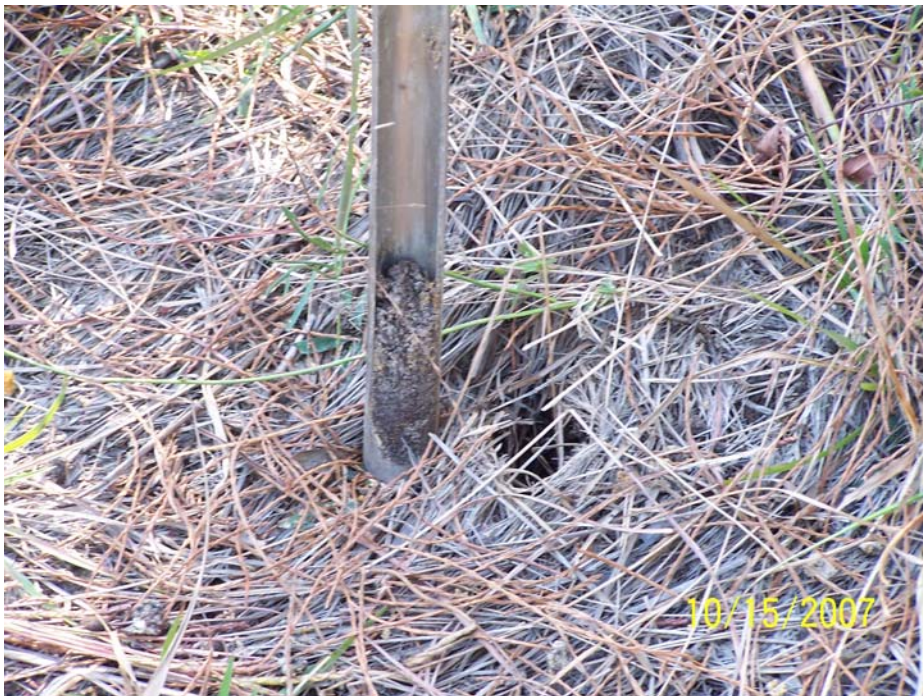
Contents of test hole, dry and hard packed
