MITIGATION PLAN

**Hip Bone Creek Restoration Site
Chatham County, North Carolina
DMS Project Number 100059
DMS Contract 7528
USACE AID #: SAW 2018-01160
DWR #: 2018-0785**

**Cape Fear River Basin
Cataloging Unit 03030003**

NC Department of Environmental Quality
Division of Mitigation Services
1652 Mail Service Center
Raleigh, NC 27699
March 17, 2020

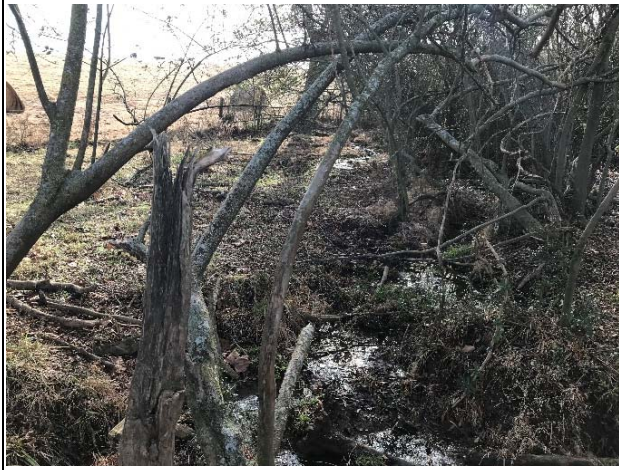
Photo 1: Degraded stream along beginning of T1.

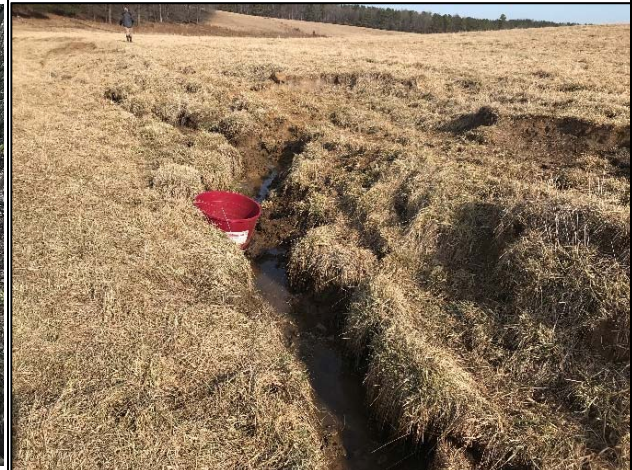
Photo 2: Eroded and cattle impacted channel T1.

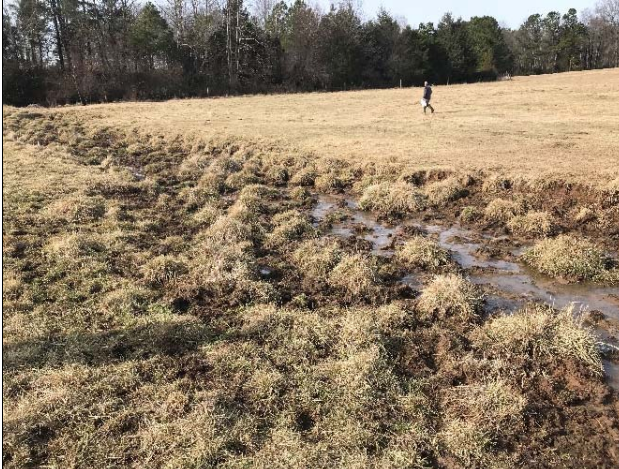
Photo 3: Drained wetland along T2.

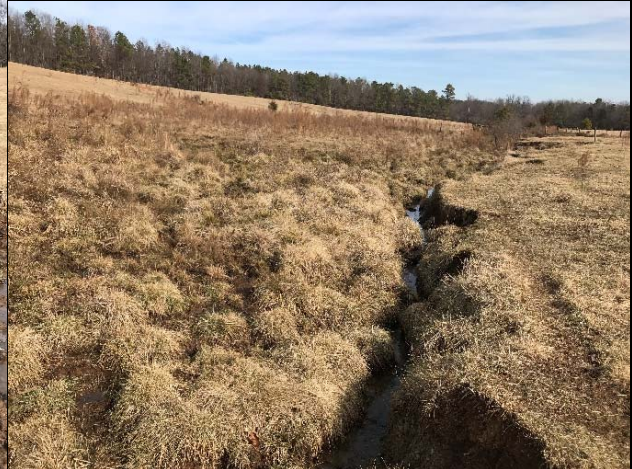
Photo 4: Wetland restoration area along T1.

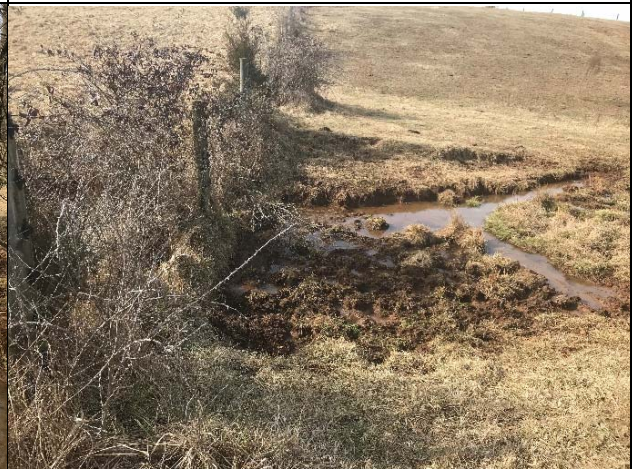
Photo 6: Channel just downstream of spring box on T3.

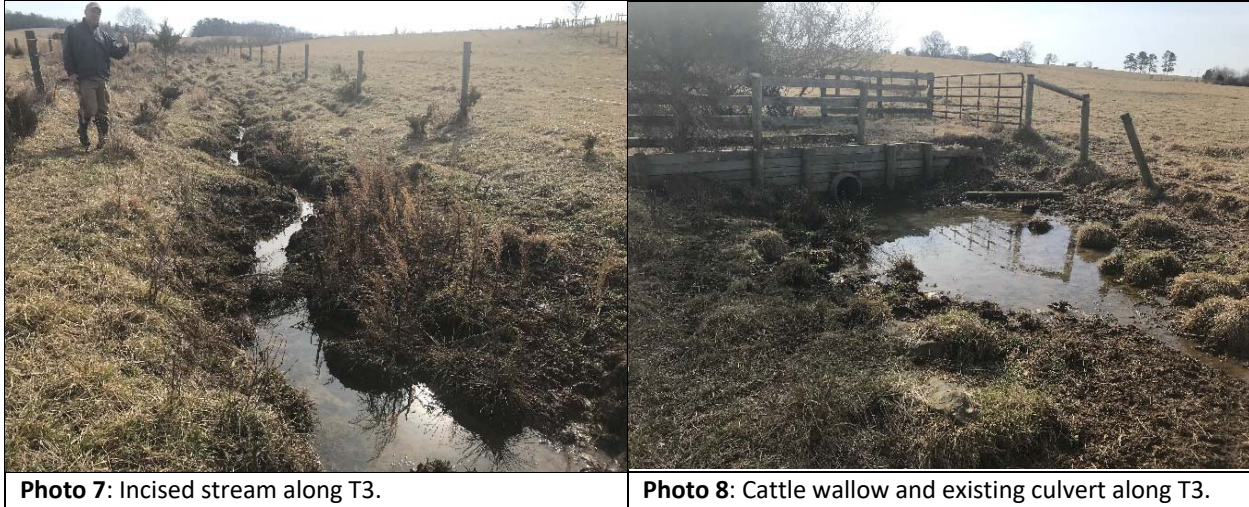
Photo 7: Incised stream along T3.

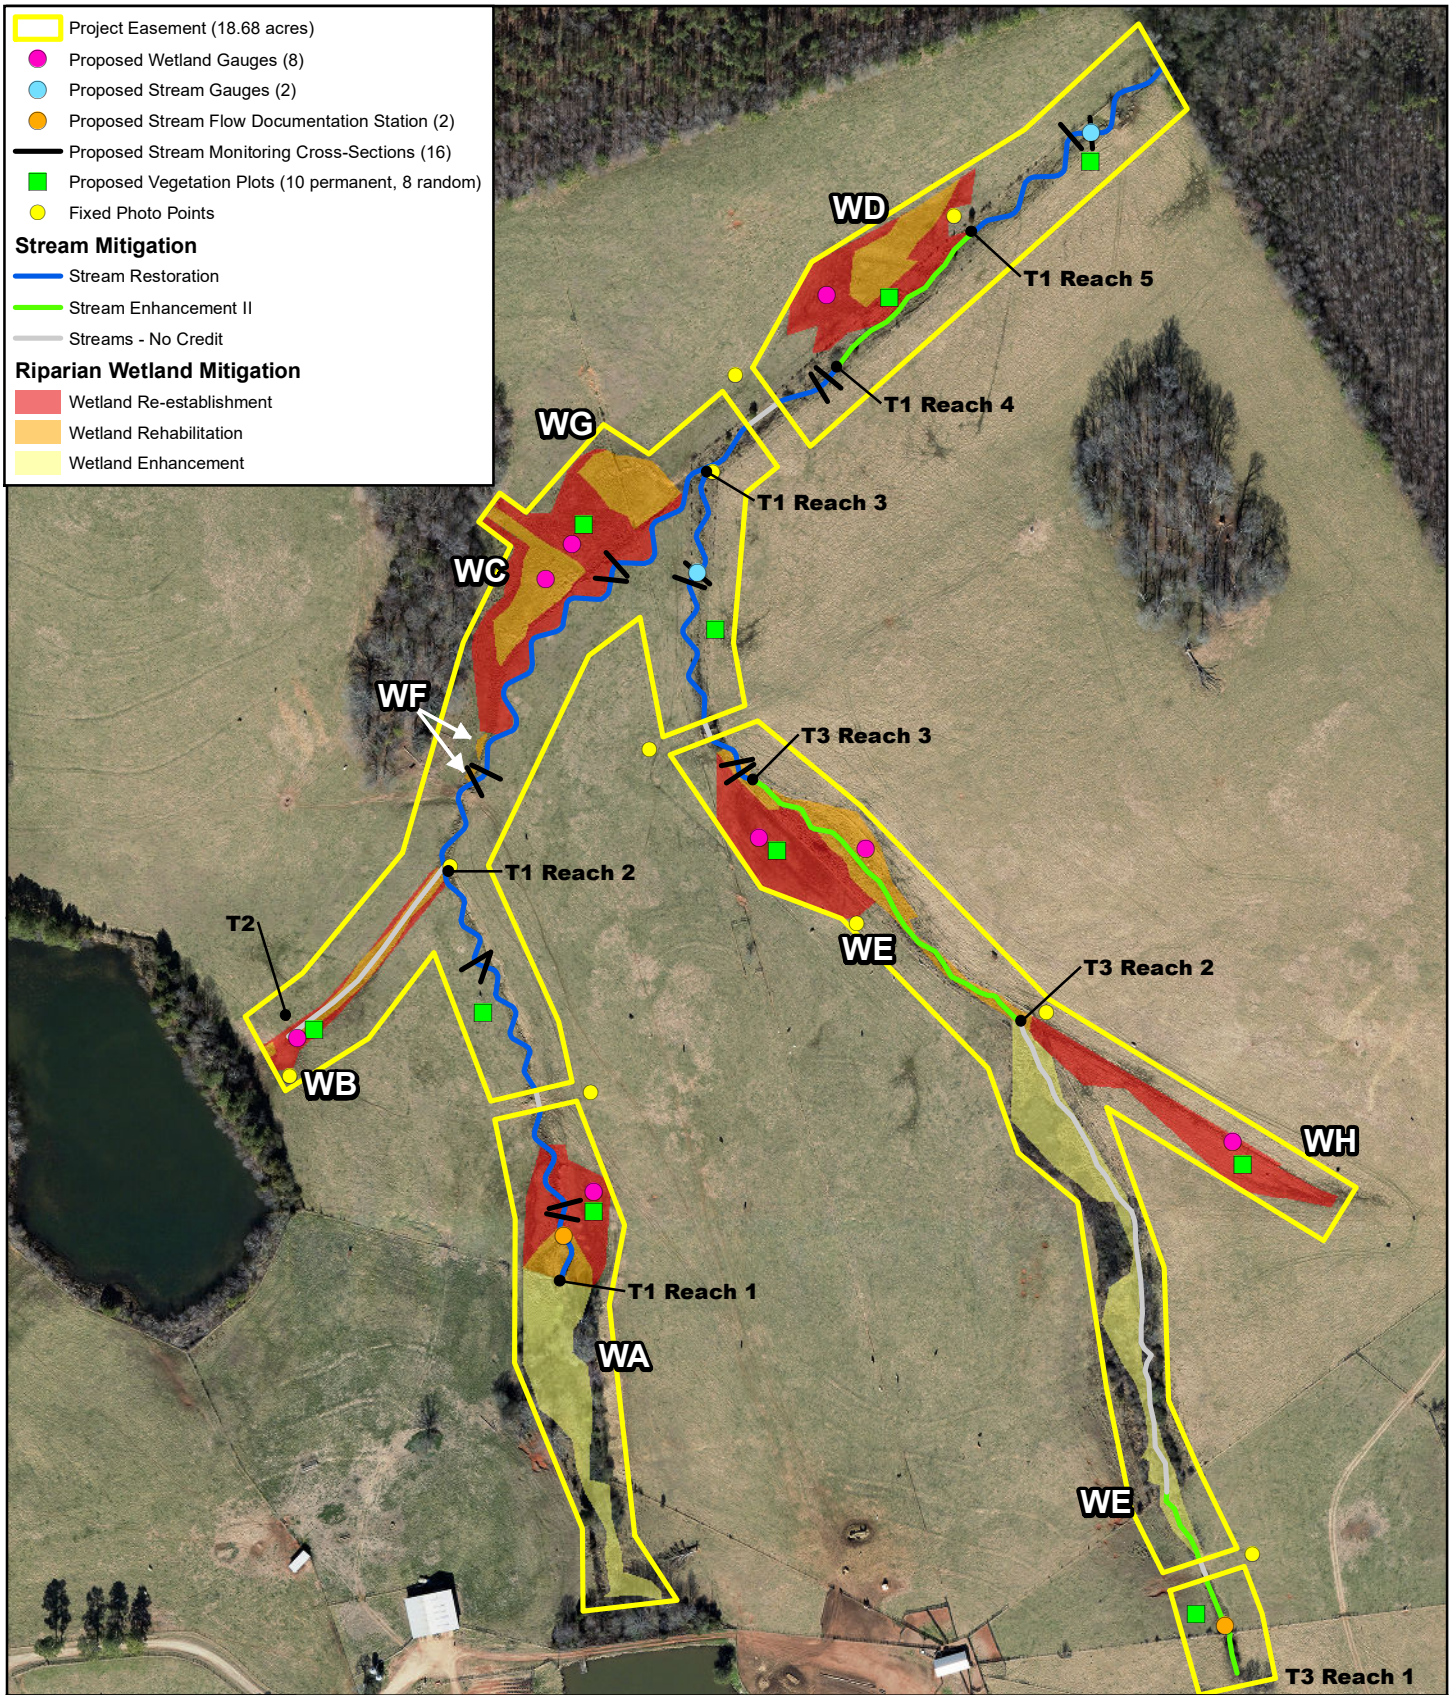
**FIGURE 9. PROPOSED MONITORING
HIP BONE CREEK RESTORATION SITE
CHATHAM COUNTY, NC**

The site’s geomorphology for all reaches will be monitored per the NCIRT 2016 monitoring guidelines. The bank height ratio (BHR) should not exceed 1.2 and the entrenchment ratio (ER) must not fall below 2.2 for C and E channels. BHR and ER at any measured riffle cross-section should not change by more than 10% from the baseline condition during any given monitoring interval (e.g., no more than 10% between years 1 and 2, 2 and 3, 3 and 5, or 5 and 7). There will be an overall assessment for each reach to distinguish localized versus systemic concerns for that stream. Adjustment and lateral movement following construction and as the channel settles over the monitoring period are to be expected. Geomorphological measurements of cross-sections will be used to determine if any adjustments that occur are out of the range typically expected for this type of stream.

Wetland hydrology monitoring will be conducted to determine if the restored wetland areas meet the proposed performance criteria for wetland hydrology. The growing season for the project monitoring period will be April 2 through November 5 (217 days) based on the WETS table for Siler City 2 N Station in Siler City, NC. The site must present continuous saturated or inundated hydrologic conditions for at least 12% of the growing season (26 consecutive days) in the riparian wetlands during normal weather conditions. A “normal” year will be based on NRCS climatological data for Chatham County, and using the 30th to 70th percentile thresholds as the range of normal, as documented in the USACE Technical Report “Accessing and Using Meteorological Data to Evaluate Wetland Hydrology, April 2000.”

Vegetation monitoring will take place between July 1st and leaf drop. Monitoring should occur later in the growing season to capture any effects of climatic or other conditions that may adversely affect vegetation survival. The success of the riparian and wetland plantings will be evaluated using eighteen 0.02-acre square or rectangular plots within the planted stream buffer. Ten plots will be permanently installed, while the remaining eight will be randomly placed at the time of each monitoring visit. Vegetation must be planted and plots established at least 180 days prior to the start of the first year of monitoring. The first monitoring event may take place no sooner than 180 days (6 months) after planting during the first growing season.

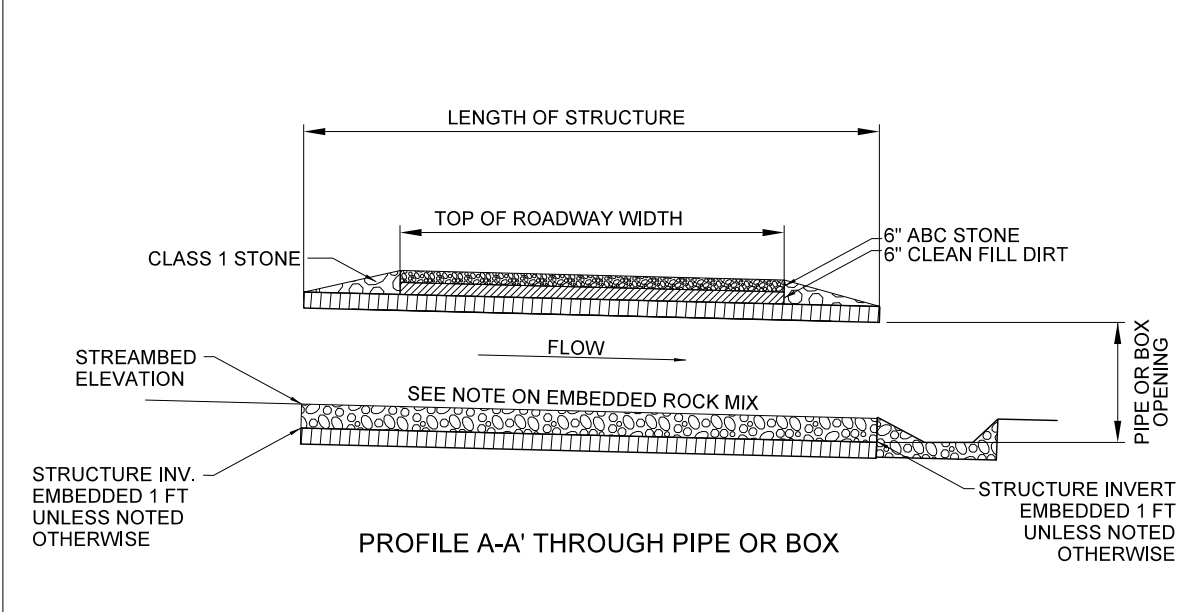
TYPICAL CROSSING - PROFILE VIEW

PROPOSED CROSSING SIZING

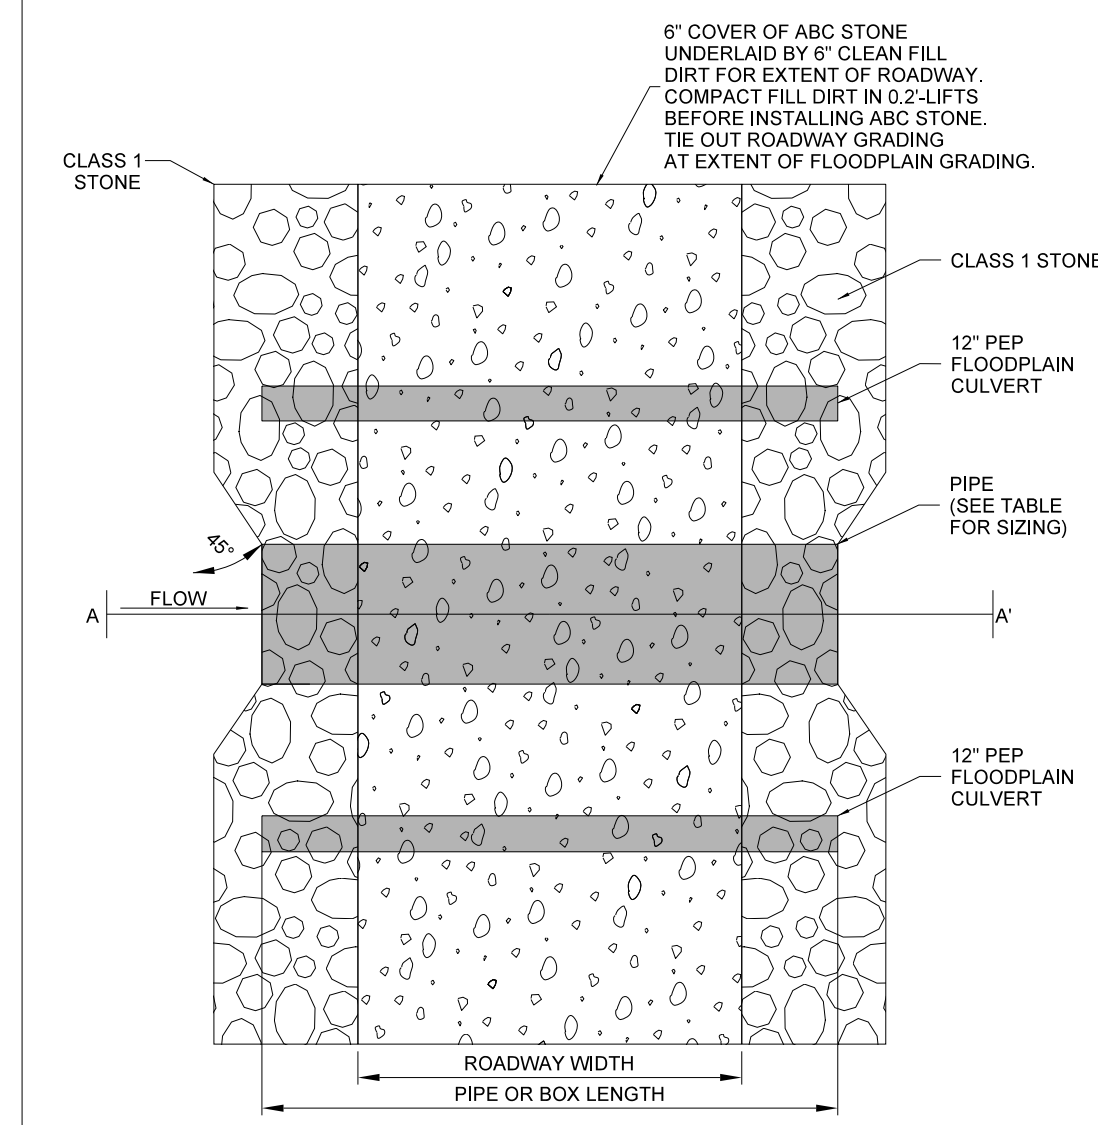
TYPICAL CROSSING - PLANVIEW

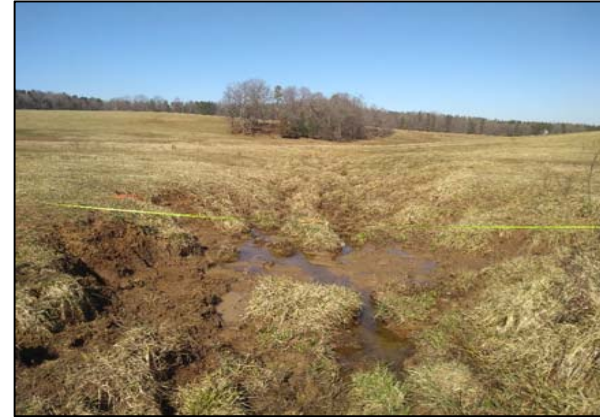
Station	Elevation
0.00	567.89
6.16	568.07
11.45	568.26
14.37	568.14
15.50	567.67
17.28	565.91
18.54	565.80
19.81	565.21
20.29	565.23
20.48	565.45
21.28	565.01
22.34	565.29
23.51	564.74
24.63	564.56
25.02	565.46
25.73	565.24
26.32	565.20
26.95	565.57
28.45	565.62
28.94	566.54
31.28	567.48
33.79	568.43
40.18	568.45
48.85	568.35

SUMMARY DATA	
Current Bankfull Elevation:	565.44
Bankfull Cross-Sectional Area:	2.5
Bankfull Width:	7.3
Flood Prone Area Elevation:	566.3
Flood Prone Width:	12.0
Max Depth at Bankfull:	0.9
Mean Depth at Bankfull:	0.3
W / D Ratio:	21.8
Entrenchment Ratio:	1.6
Bank Height Ratio:	1.2

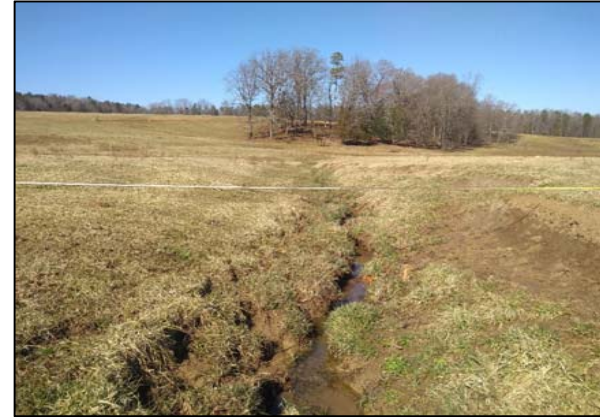
River Basin:	Cape Fear
Site:	Hip Bone Creek
XS ID	T1 XSb
Drainage Area (sq mi):	0.06
Date:	2/5/2019
Field Crew:	T. Seelinger, J. Sullivan

Station	Elevation
0.00	559.69
5.57	559.28
12.57	558.95
17.48	558.48
21.88	557.83
24.83	557.08
26.96	556.72
27.15	556.44
28.53	556.11
30.08	556.03
30.68	555.21
31.08	554.95
31.44	554.90
31.88	555.21
32.52	556.00
33.67	556.28
35.57	556.56
37.54	557.01
39.46	559.11
46.18	559.49
53.58	559.43
57.80	559.58

SUMMARY DATA	
Current Bankfull Elevation:	556.20
Bankfull Cross-Sectional Area:	2.4
Bankfull Width:	5.2
Flood Prone Area Elevation:	557.5
Flood Prone Width:	14.8
Max Depth at Bankfull:	1.3
Mean Depth at Bankfull:	0.5
W / D Ratio:	11.0
Entrenchment Ratio:	2.9
Bank Height Ratio:	1.0

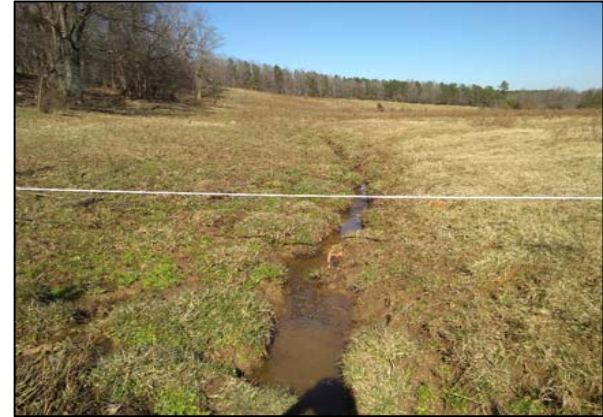
River Basin:	Cape Fear
Site:	Hip Bone Creek
XS ID	T1 XSc
Drainage Area (sq mi):	0.13
Date:	2/5/2019
Field Crew:	T. Seelinger, J. Sullivan

Station	Elevation
0.00	550.99
3.73	550.53
6.64	550.42
8.24	550.21
11.61	549.63
15.23	548.97
18.61	548.60
21.28	548.29
23.67	548.28
24.61	548.62
25.23	548.12
25.94	548.01
26.46	547.18
26.92	547.10
27.51	547.25
28.14	547.44
28.78	548.24
30.13	548.30
32.52	549.22
33.67	549.44
37.68	549.76
44.14	550.28
51.51	550.81
60.27	551.21

SUMMARY DATA	
Current Bankfull Elevation:	548.47
Bankfull Cross-Sectional Area:	4.2
Bankfull Width:	10.2
Flood Prone Area Elevation:	549.8
Flood Prone Width:	28.2
Max Depth at Bankfull:	1.4
Mean Depth at Bankfull:	0.4
W / D Ratio:	24.8
Entrenchment Ratio:	2.8
Bank Height Ratio:	1.0

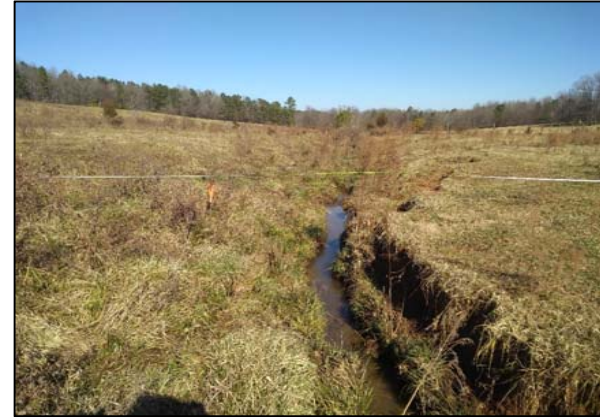
River Basin:	Cape Fear
Site:	Hip Bone Creek
XS ID	T1 XSd
Drainage Area (sq mi):	0.13
Date:	2/5/2019
Field Crew:	T. Seelinger, J. Sullivan

Station	Elevation
0.00	546.17
4.15	546.12
10.10	545.73
11.78	545.50
16.88	545.09
21.94	544.65
24.08	544.20
26.61	543.75
29.13	543.37
29.51	542.74
30.44	542.60
30.83	541.83
31.74	541.69
32.56	541.63
33.35	542.40
33.95	543.85
34.54	544.16
34.87	544.95
35.91	545.15
37.88	545.34
42.87	545.98
48.05	546.26
52.32	546.52
58.30	546.61

SUMMARY DATA	
Current Bankfull Elevation:	543.12
Bankfull Cross-Sectional Area:	4.2
Bankfull Width:	4.4
Flood Prone Area Elevation:	544.6
Flood Prone Width:	12.6
Max Depth at Bankfull:	1.5
Mean Depth at Bankfull:	1.0
W / D Ratio:	4.5
Entrenchment Ratio:	2.9
Bank Height Ratio:	1.0

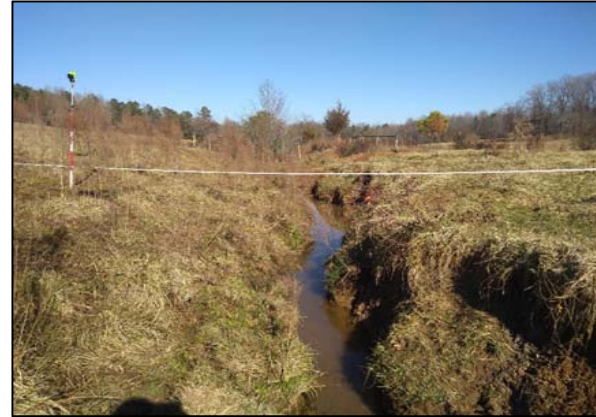
River Basin:	Cape Fear
Site:	Hip Bone Creek
XS ID	T1 XSe
Drainage Area (sq mi):	0.14
Date:	2/5/2019
Field Crew:	T. Seelinger, J. Sullivan

Station	Elevation
0.00	545.10
6.66	544.83
11.57	544.38
16.35	543.36
22.87	542.64
25.35	542.13
25.51	542.20
28.44	541.58
29.22	539.84
29.96	539.93
30.16	539.36
31.08	539.05
31.80	538.91
32.57	539.14
33.03	539.53
33.51	540.94
35.06	542.02
35.87	542.69
37.94	543.48
41.06	543.76
44.47	544.29
48.48	544.63
57.73	544.86

SUMMARY DATA	
Current Bankfull Elevation:	540.74
Bankfull Cross-Sectional Area:	5.9
Bankfull Width:	4.6
Flood Prone Area Elevation:	542.6
Flood Prone Width:	12.5
Max Depth at Bankfull:	1.8
Mean Depth at Bankfull:	1.3
W / D Ratio:	3.6
Entrenchment Ratio:	2.7
Bank Height Ratio:	1.5

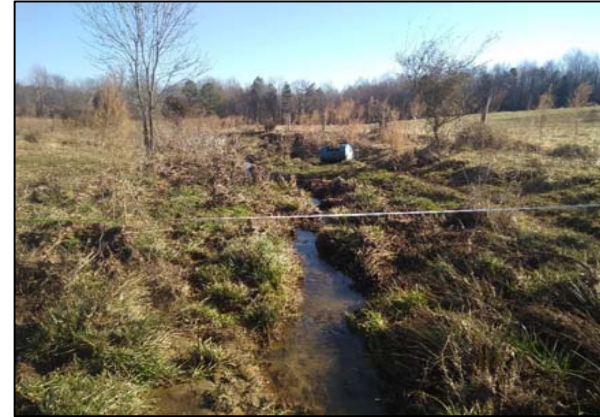
River Basin:	Cape Fear
Site:	Hip Bone Creek
XS ID	T1 XSg
Drainage Area (sq mi):	0.23
Date:	2/5/2019
Field Crew:	T. Seelinger, J. Sullivan

Station	Elevation
0.00	537.30
5.73	537.20
9.46	537.14
12.40	536.79
15.91	536.03
17.48	535.64
19.09	535.58
22.11	535.52
24.95	535.35
27.08	535.20
27.32	534.88
27.82	534.63
28.72	534.72
29.18	534.94
29.64	535.17
30.74	535.42
31.67	535.59
32.72	536.03
33.27	535.91
33.88	535.68
34.90	535.83
36.42	536.06
38.29	536.10
40.57	536.49
43.27	537.07
45.12	537.59
48.14	538.04
50.99	537.89

SUMMARY DATA	
Current Bankfull Elevation:	535.75
Bankfull Cross-Sectional Area:	6.0
Bankfull Width:	15.7
Flood Prone Area Elevation:	536.9
Flood Prone Width:	30.7
Max Depth at Bankfull:	1.1
Mean Depth at Bankfull:	0.4
W / D Ratio:	41.4
Entrenchment Ratio:	2.0
Bank Height Ratio:	1.0

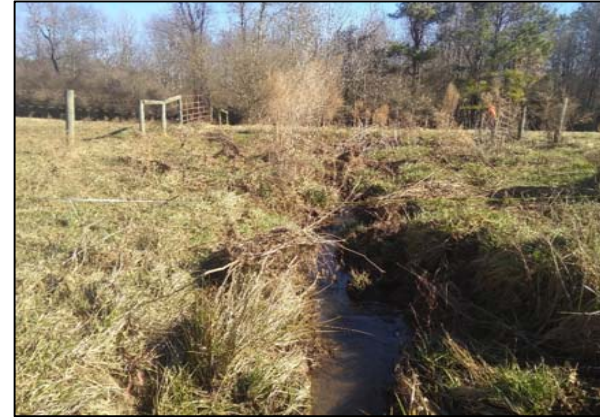
River Basin:	Cape Fear
Site:	Hip Bone Creek
XS ID	T1 XSh
Drainage Area (sq mi):	0.24
Date:	2/5/2019
Field Crew:	T. Seelinger, J. Sullivan

Station	Elevation
0.00	531.92
7.86	531.29
9.66	531.07
12.22	530.83
16.61	530.92
21.41	530.92
23.29	530.81
23.88	530.40
24.85	530.41
25.09	529.80
25.33	529.61
25.81	529.23
26.56	529.20
27.15	529.48
27.66	529.66
28.65	531.06
29.10	531.22
30.47	531.36
32.22	531.48
33.67	531.78
35.26	532.25
37.44	532.03
40.03	532.22
43.53	532.27
46.01	532.25
49.93	532.27

SUMMARY DATA	
Current Bankfull Elevation:	531.09
Bankfull Cross-Sectional Area:	8.8
Bankfull Width:	19.3
Flood Prone Area Elevation:	533.0
Flood Prone Width:	49.9
Max Depth at Bankfull:	1.9
Mean Depth at Bankfull:	0.5
W / D Ratio:	42.1
Entrenchment Ratio:	2.6
Bank Height Ratio:	1.0

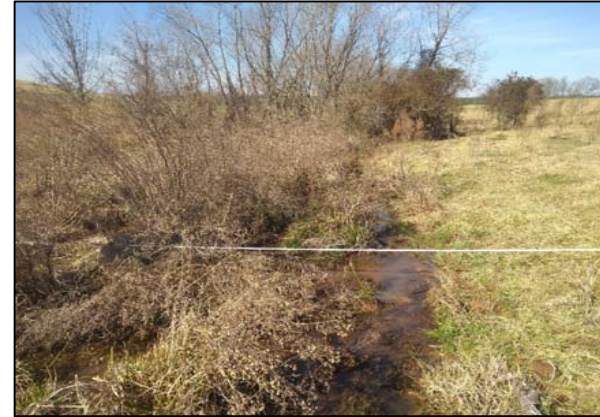
River Basin:	Cape Fear
Site:	Hip Bone Creek
XS ID	T3 XSa
Drainage Area (sq mi):	0.01
Date:	2/5/2019
Field Crew:	T. Seelinger, J. Sullivan

Station	Elevation
0.00	589.77
7.26	588.19
12.62	587.74
17.29	587.35
19.53	587.16
21.18	587.15
23.35	587.21
26.04	587.02
27.41	586.89
29.61	586.78
31.22	587.05
33.59	587.09
35.60	587.21
38.28	586.78
41.08	587.18
43.55	587.24
44.75	587.17
45.05	587.20
45.66	587.31
46.63	587.49
47.72	587.71
50.75	588.30
53.86	588.60
58.49	589.02
65.77	589.62
71.21	590.00

SUMMARY DATA	
Current Bankfull Elevation:	586.99
Bankfull Cross-Sectional Area:	0.8
Bankfull Width:	7.2
Flood Prone Area Elevation:	587.2
Flood Prone Width:	21.8
Max Depth at Bankfull:	0.2
Mean Depth at Bankfull:	0.1
W / D Ratio:	65.0
Entrenchment Ratio:	3.0
Bank Height Ratio:	2.1

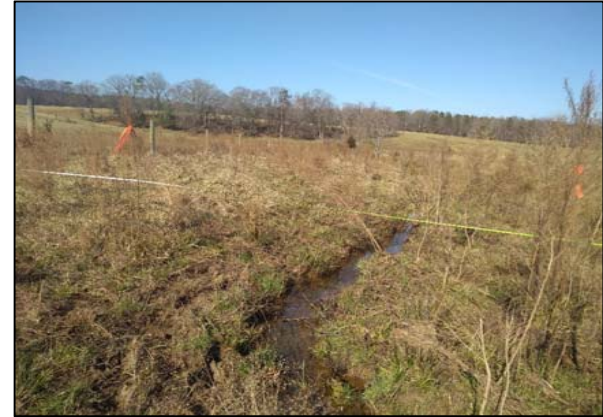
River Basin:	Cape Fear
Site:	Hip Bone Creek
XS ID	T3 XSb
Drainage Area (sq mi):	0.05
Date:	2/5/2019
Field Crew:	T. Seelinger, J. Sullivan

Station	Elevation
0.00	558.26
4.65	558.23
6.36	557.99
8.80	557.86
10.89	557.53
13.19	557.07
14.46	556.68
16.50	556.38
18.60	556.38
20.18	556.20
20.48	555.80
21.06	555.79
21.29	556.08
21.46	556.12
21.60	555.73
21.86	555.75
22.12	556.15
22.63	556.56
24.02	556.48
27.28	556.48
31.05	556.44
34.92	556.38
37.93	556.84
40.68	557.05
42.34	556.93
45.74	557.05
48.56	557.27
49.89	557.44
52.32	557.70

SUMMARY DATA	
Current Bankfull Elevation:	556.50
Bankfull Cross-Sectional Area:	2.4
Bankfull Width:	18.7
Flood Prone Area Elevation:	557.3
Flood Prone Width:	36.2
Max Depth at Bankfull:	0.8
Mean Depth at Bankfull:	0.1
W / D Ratio:	146.8
Entrenchment Ratio:	1.9
Bank Height Ratio:	1.0

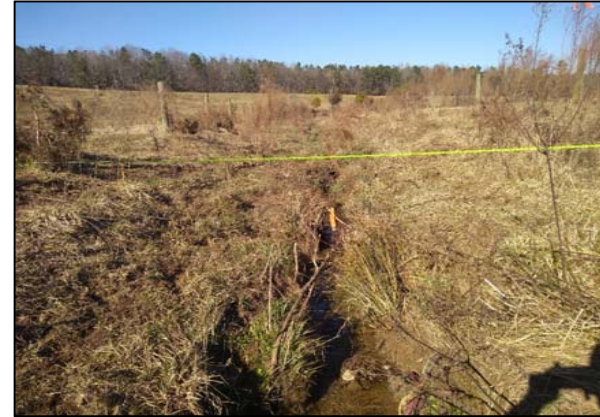
River Basin:	Cape Fear
Site:	Hip Bone Creek
XS ID	T3 XSc
Drainage Area (sq mi):	0.06
Date:	2/5/2019
Field Crew:	T. Seelinger, J. Sullivan

Station	Elevation
0.00	545.63
7.57	545.62
11.23	545.93
13.90	545.36
15.40	545.10
17.23	544.12
19.22	543.71
19.78	543.72
20.71	542.51
21.08	542.32
21.41	542.34
22.12	542.47
22.66	543.16
23.57	543.81
24.97	544.29
28.07	544.80
31.58	545.27
36.04	545.80
38.78	546.17
41.37	546.25

SUMMARY DATA	
Current Bankfull Elevation:	543.42
Bankfull Cross-Sectional Area:	2.1
Bankfull Width:	3.0
Flood Prone Area Elevation:	544.5
Flood Prone Width:	9.8
Max Depth at Bankfull:	1.1
Mean Depth at Bankfull:	0.7
W / D Ratio:	4.2
Entrenchment Ratio:	3.2
Bank Height Ratio:	1.3

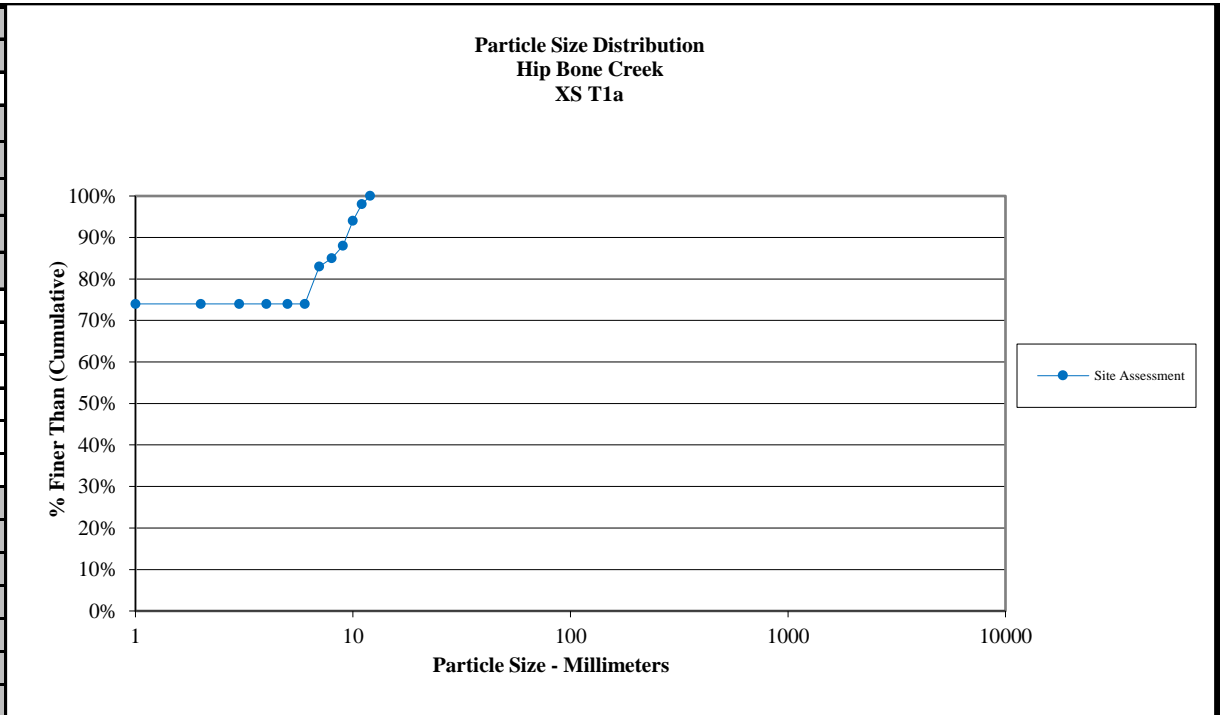
Tributary 1 Cross-Section A			
Particle	Millimeter		Count
Silt/Clay	< 0.062	S/C	74
Very Fine	.062 - .125	S	
Fine	.125 - .25	A	
Medium	.25 - .50	N	
Coarse	.50 - 1	D	
Very Coarse	1 - 2	S	
Very Fine	2 - 4		9
Fine	4 - 5.7	G	2
Fine	5.7 - 8	R	3
Medium	8 - 11.3	A	6
Medium	11.3 - 16	V	4
Coarse	16 - 22.6	E	2
Coarse	22.6 - 32	L	
Very Coarse	32 - 45	S	
Very Coarse	45 - 64		
Small	64 - 90	C	
Small	90 - 128	O	
Large	128 - 180	B	
Large	180 - 256	L	
Small	256 - 362	B	
Small	362 - 512	L	
Medium	512 - 1024	D	
Lrg- Very Lrg	1024 - 2048	R	
Bedrock	>2048	BDRK	
		Total	100
Note:

Size (mm)	
D16	0.062
D35	0.062
D50	0.062
D65	0.062
D84	4.9
D95	12
