**MITIGATION PLAN**

**Hockett Dairy Site  
Riparian Buffer Restoration  
Randolph County, North Carolina  
EEP Project ID Number 003993 – EEP Site 95013**

**Cape Fear River Basin  
HUC 03030003010070**

**June 2012**

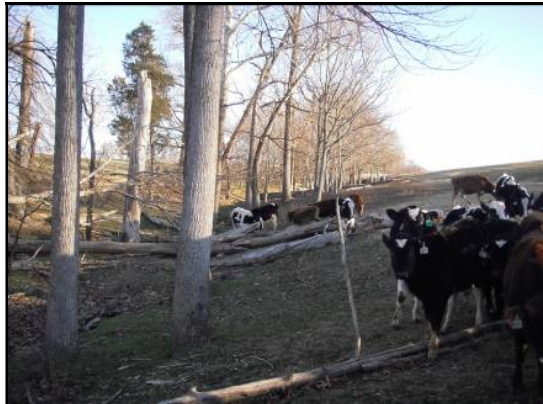
UT-2: Facing upstream showing cattle within the riparian buffer.

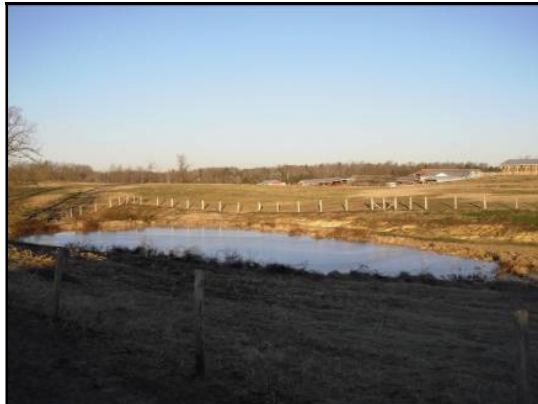
Pond 2: Farm pond at head of UT-2.

Located upstream of UT-2 is Farm Pond 2. This 0.28-acre pond is fenced and not regularly used as a water source for cattle. The buffer around this pond has limited vegetation that consists mainly of grasses and a few herbaceous weeds. Because of limited vegetation and regular maintenance, active surface erosion is present in areas around this pond, but no significant concentrated flows were observed. The dam has areas of erosion and a sub-standard outlet structure.

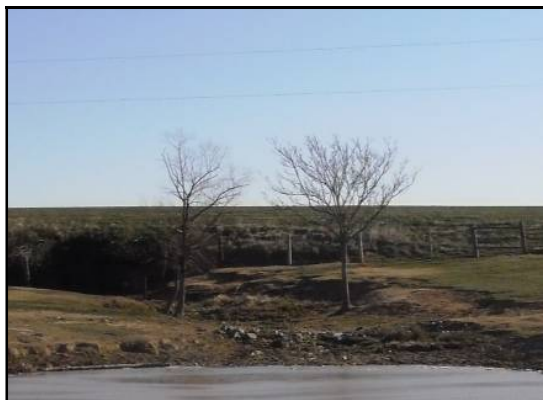
UT-3B: Above Pond 3.

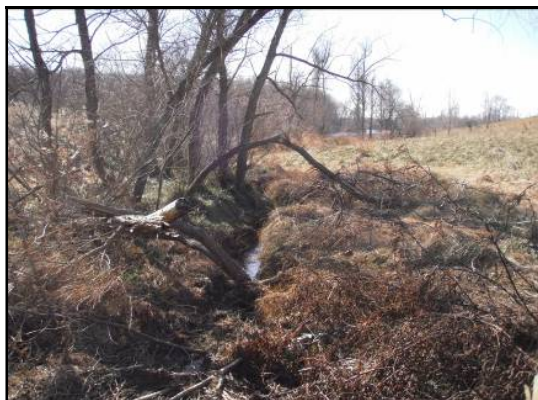
UT-4C: Facing downstream.

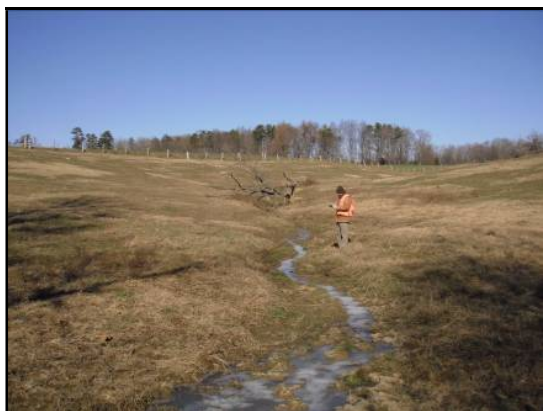
UT-5A: Facing upstream.

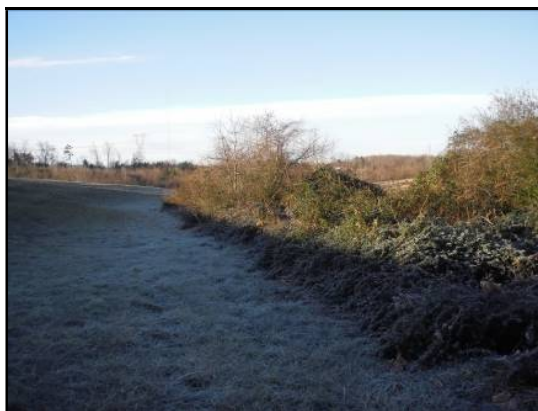
UT-6: Facing downslope.

UT-6 will be planted with a proposed buffer of 1.84 acres. This channel is stable, but to ensure grade control, a log grade-control structure will be installed at a nick point at the upper limit of the channel. No livestock fencing is required around UT-6.
