**FINAL MONITORING REPORT
YEAR 1 of 5**

**Hockett Dairy Site
Riparian Buffer Restoration
EEP Project ID Number 003993 – EEP Site 95013**

**Randolph County, North Carolina
Cape Fear River Basin
HUC 03030003010070**

**Construction Completed: October 2012
Data Collection Period: October 2013
Submission Date: December 2013**

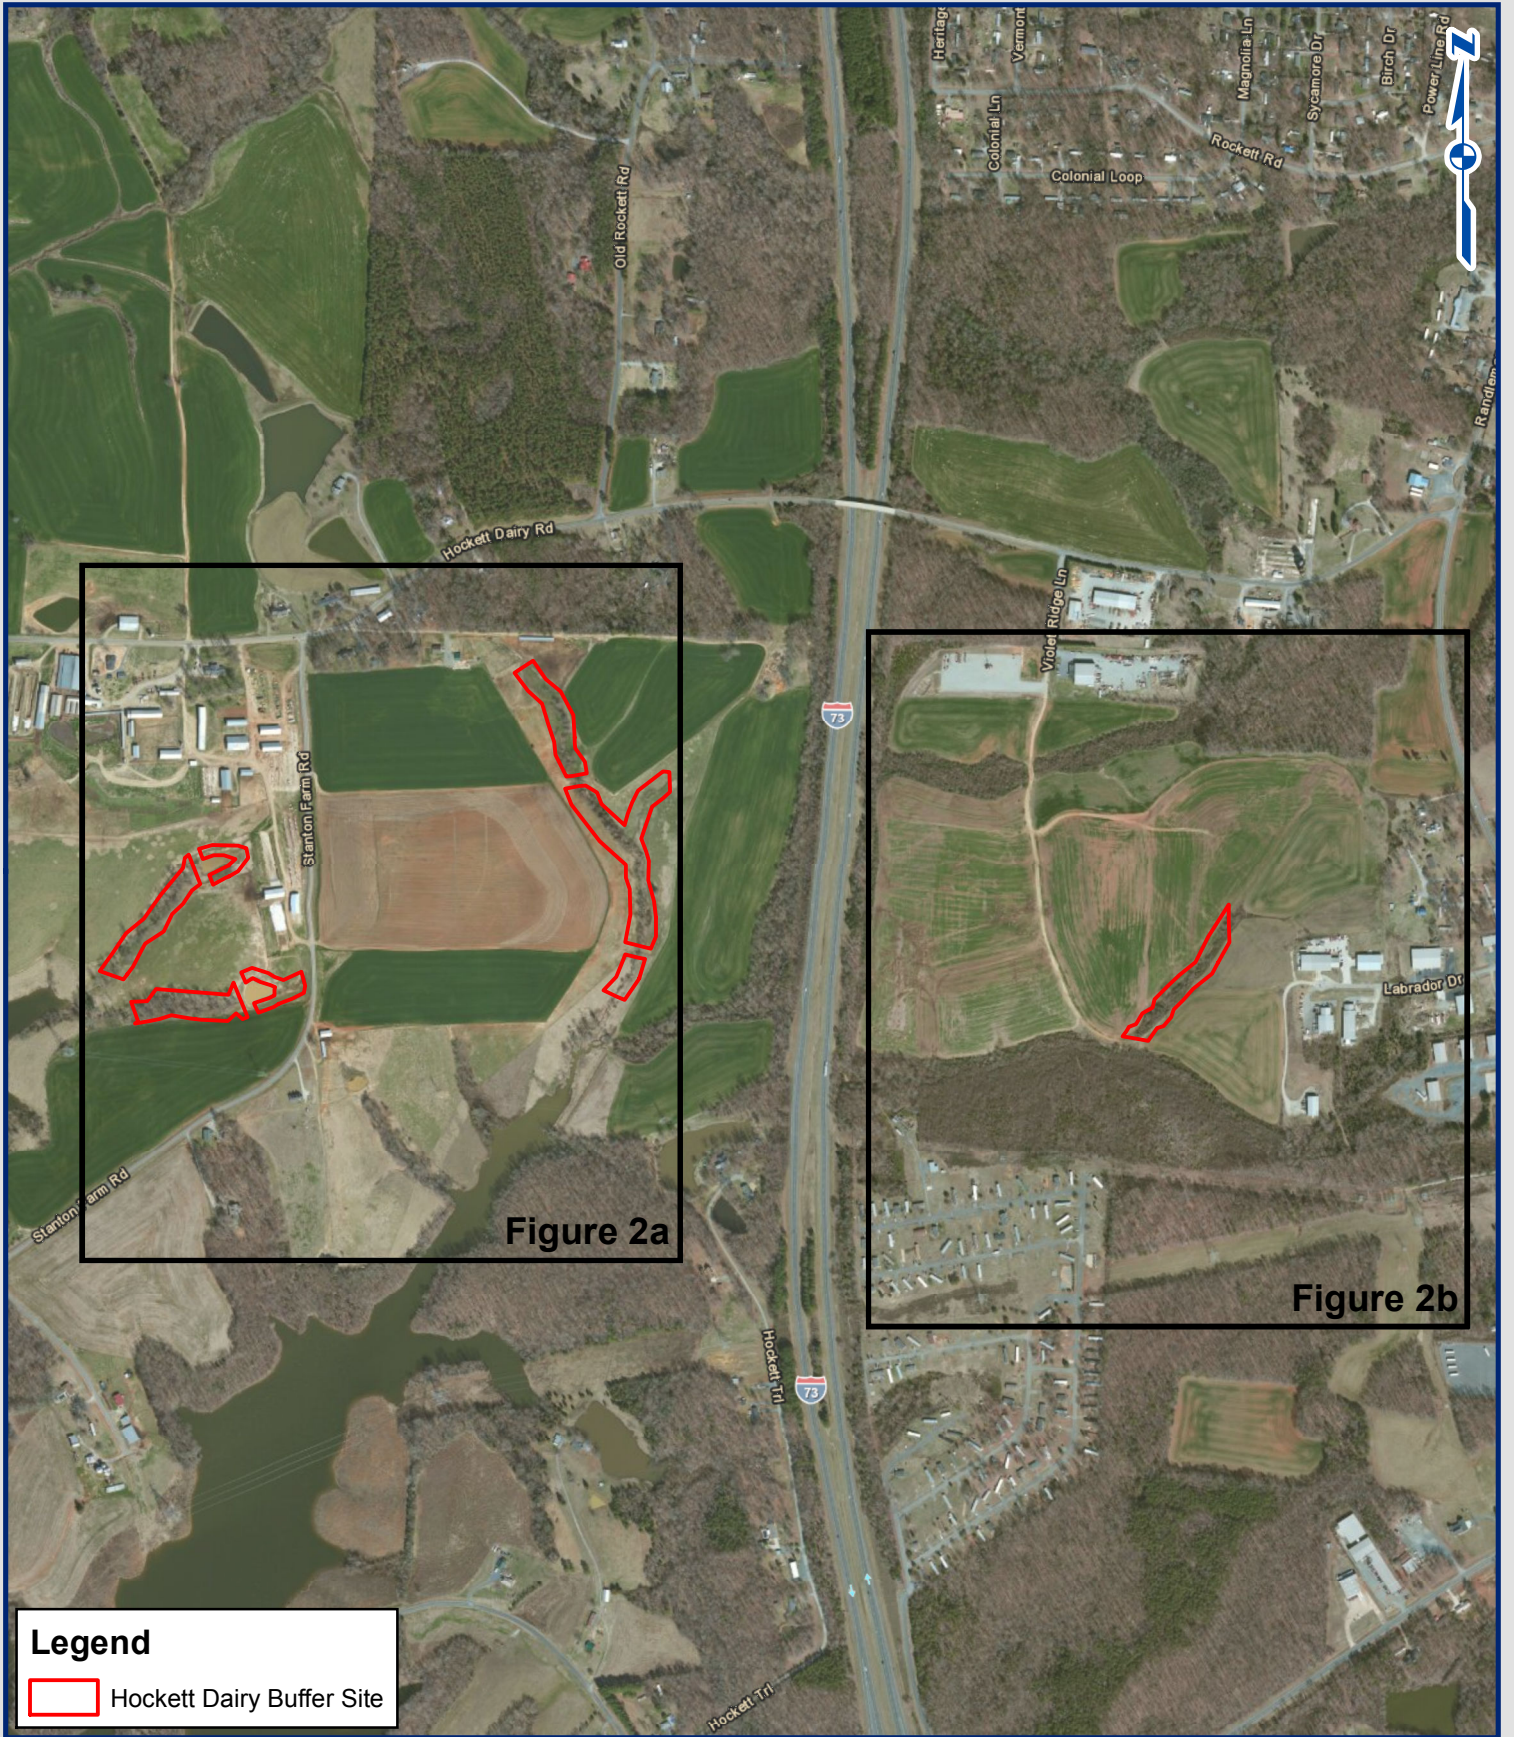
Figure 2-KEY. Current Condition Plan View

The measure of vegetative success for the site is the survival of at least 320 five-year old planted trees per acre at the end of year five of the monitoring period. Year 1 monitoring recorded an average of 597 stems per acre across all vegetation plots. Plots 2 and 7 each had less than 300 stems per acre. All other plots achieved the success criteria in Year 1. Vegetation issues included invasive species along much of UT 4 and vegetation trampled by cattle near Plot 2 on UT 2. The cattle gained access to the easement when a tree fell onto the fence near Plot 2. This fence has been repaired, and the plot may need to be replanted. No volunteer stems were observed during Year 1 monitoring activities. CVS Level 2 will be performed in monitoring Year 2 to document any volunteer generation. Overall, vegetation across the site is in good condition. The Current Condition Plan View is provided in **Appendix B, Figure 2**.

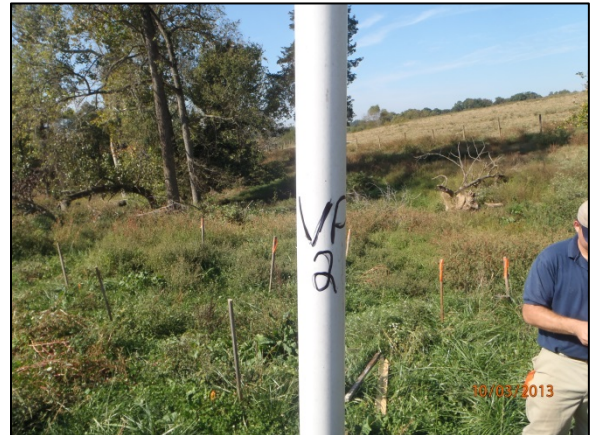
Vegetation Plot 2

Table 6. Riparian Buffer Vegetation Totals Hockett Dairy, Randolph County EEP Project ID Number 003993 EEP Site 95013		
Plot #	Riparian Buffer Stems¹ (per acre)	Success Criteria Met?
1	890	Yes
2	162	No
3	647	Yes
4	809	Yes
5	688	Yes
6	526	Yes
7	283	No
8	526	Yes
9	526	Yes
10	769	Yes
11	607	Yes
12	728	Yes
Project Avg	597	Yes
