**FINAL MONITORING REPORT  
YEAR 5 of 5**

**Hockett Dairy Site  
Riparian Buffer Restoration  
DMS Contract Number 003993 – DMS Site 95013  
DWR Project Number 2016-0402**

**Randolph County, North Carolina  
Cape Fear River Basin  
HUC 03030003010070**

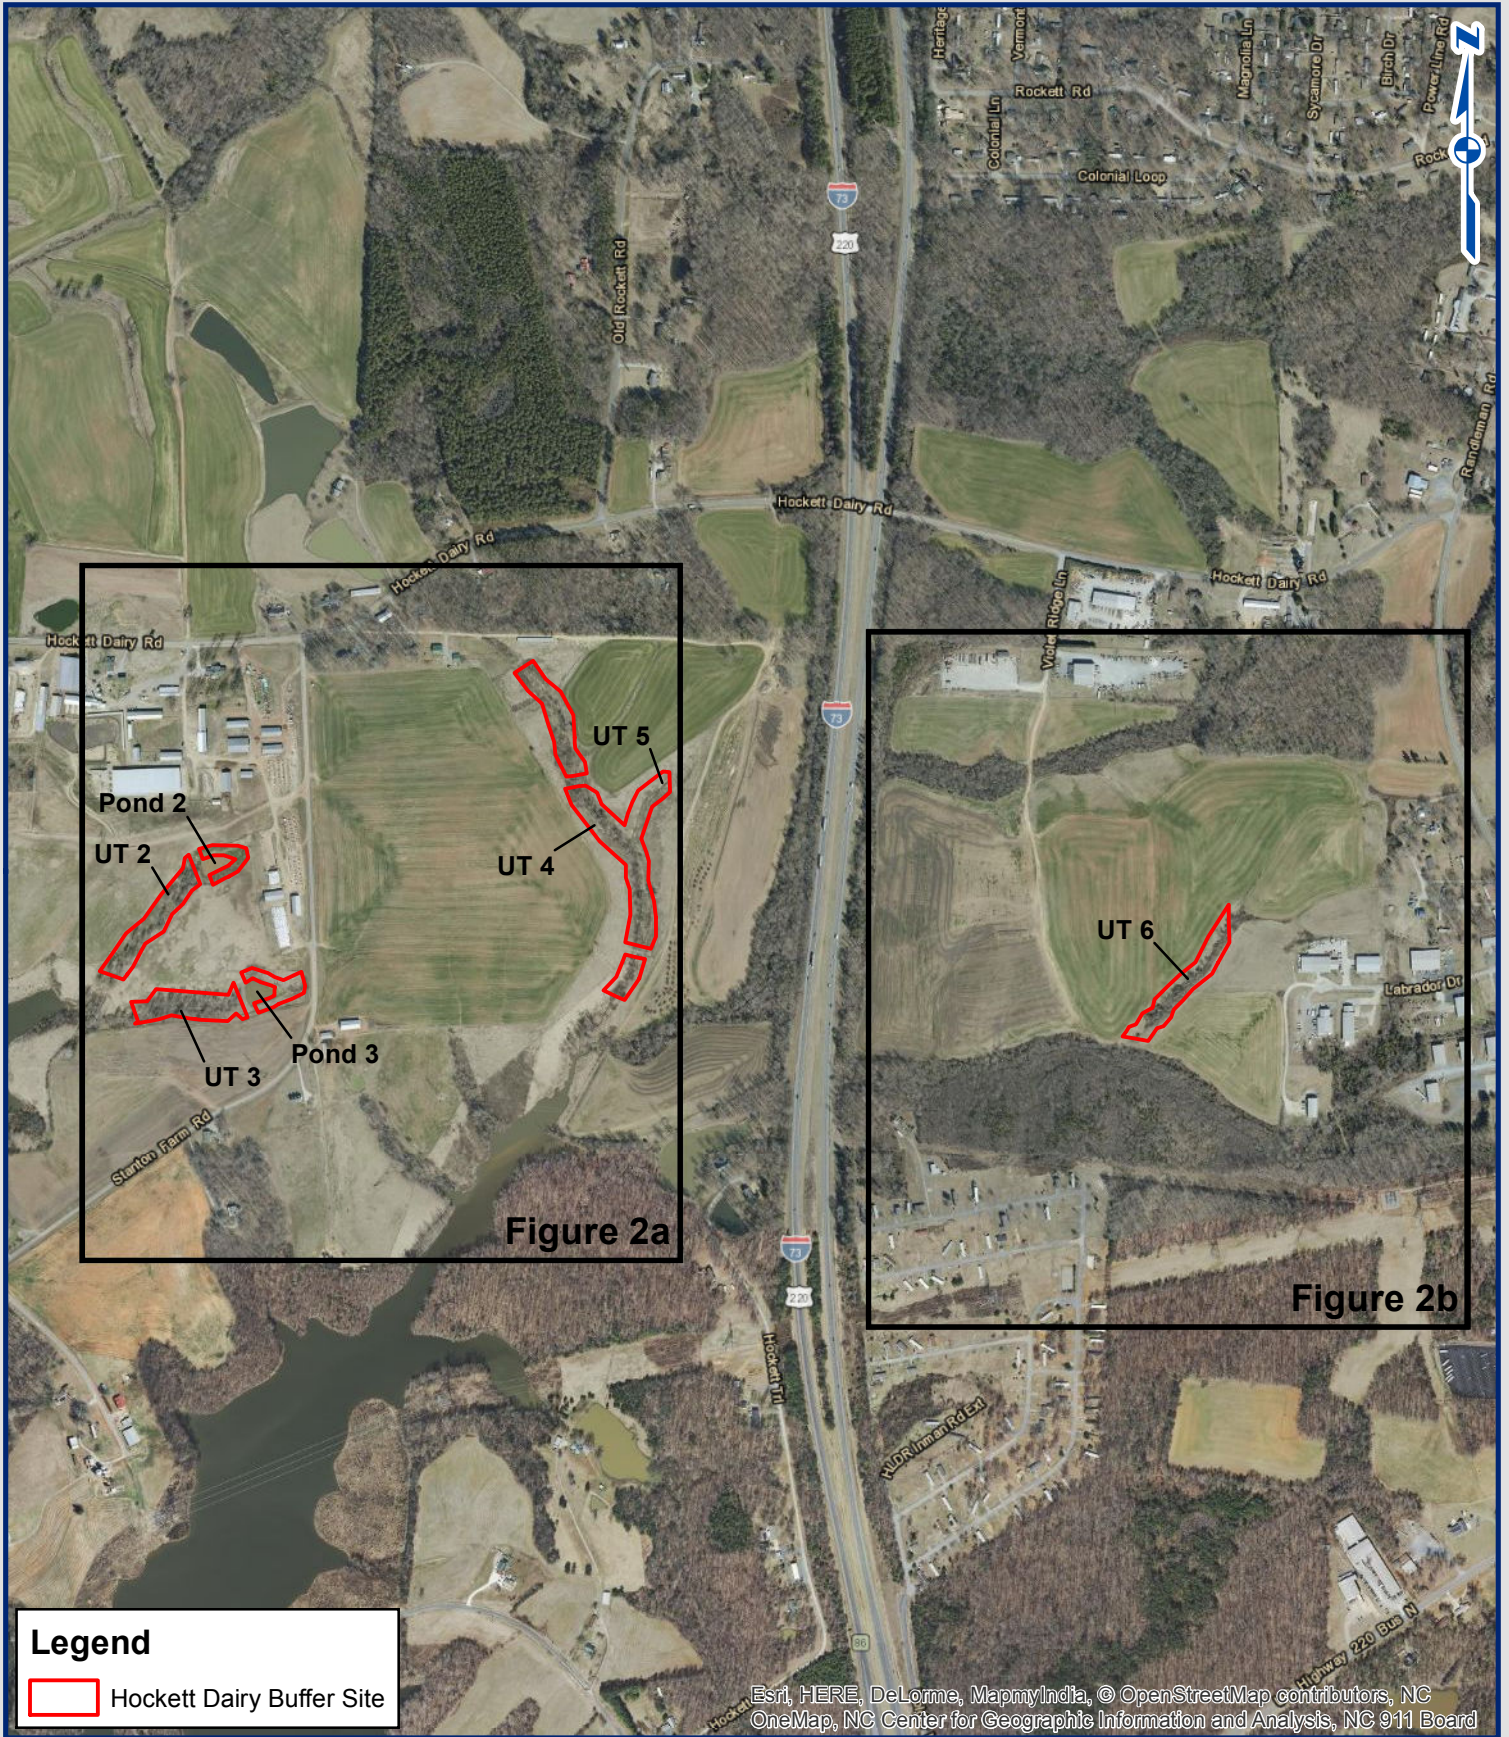
**Figure 2-KEY. Current Condition Plan View**  
 Hockett Dairy Riparian Buffer Restoration Site

Randleman Lake. The mitigation design divides the site into five distinct reaches (**Figure 2**). Buffer restoration was performed along five channels. Two undersized and failing channel crossings were replaced with appropriately sized culverts to prevent erosion. Two small dams on small farm ponds have been stabilized.
