Re: NCIRT Review and USACE Approval of the Hogan Creek Mitigation Plan (SAW-2011-02268)

**Hogan Creek Stream Mitigation Project
Surry County, North Carolina
EEP Project No. 94708**

Upper Yadkin River Basin
Cataloging Unit 03040101

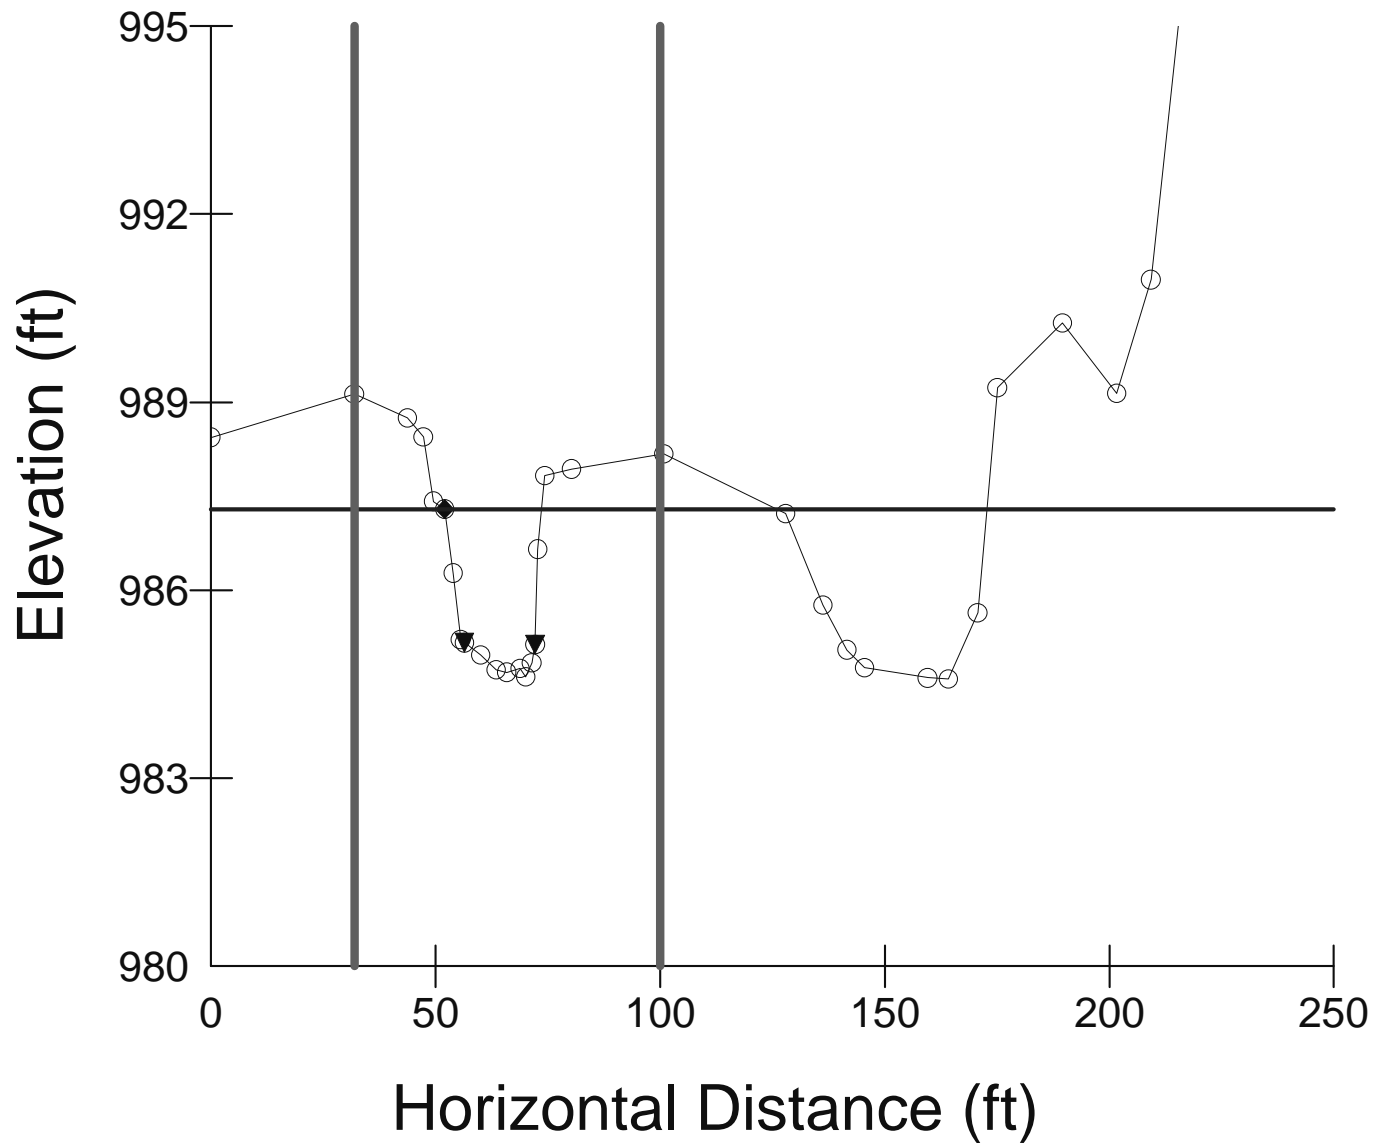
Hogan XS8 (riffle)

Wbkf = 21.5 Dbkf = 2.09 Abkf = 45.1

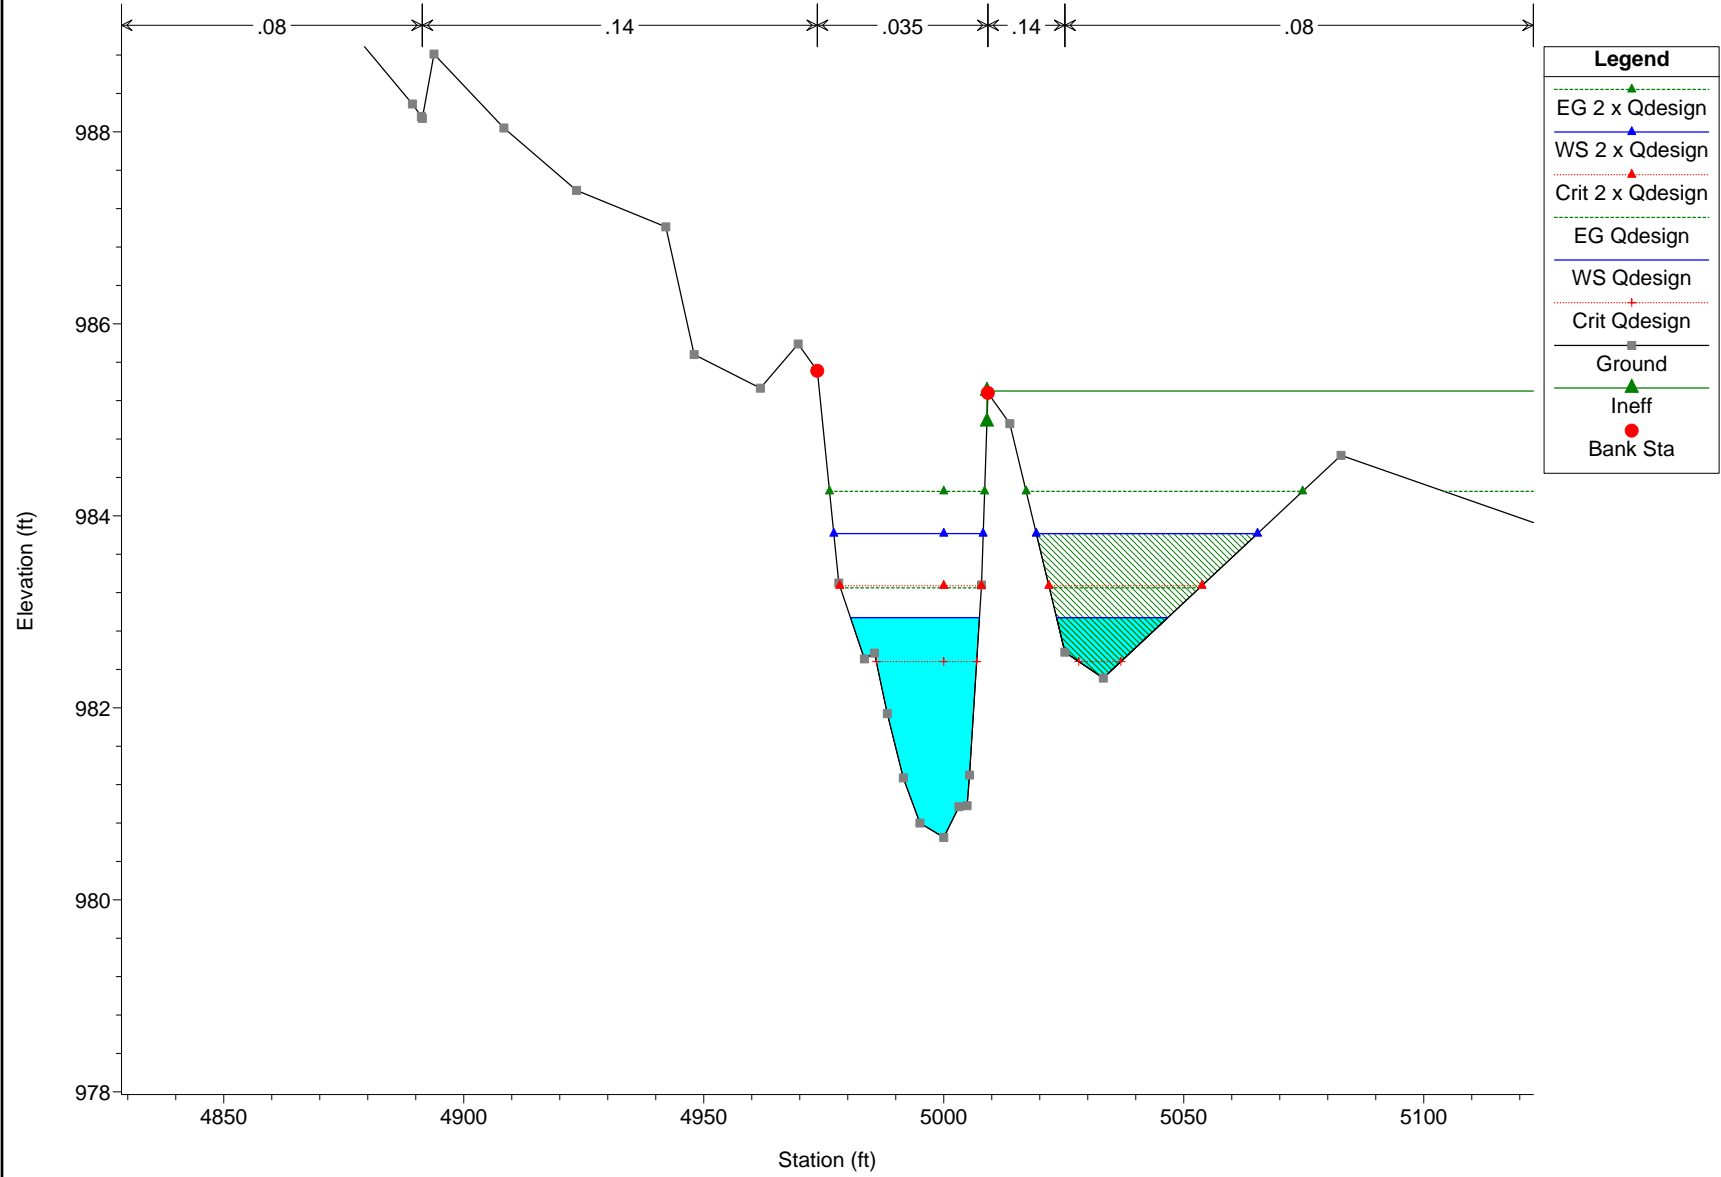
Hogan Creek Limited Detail Study Plan: range of flows existing 10/10/2011

int. floodplain with channel topo

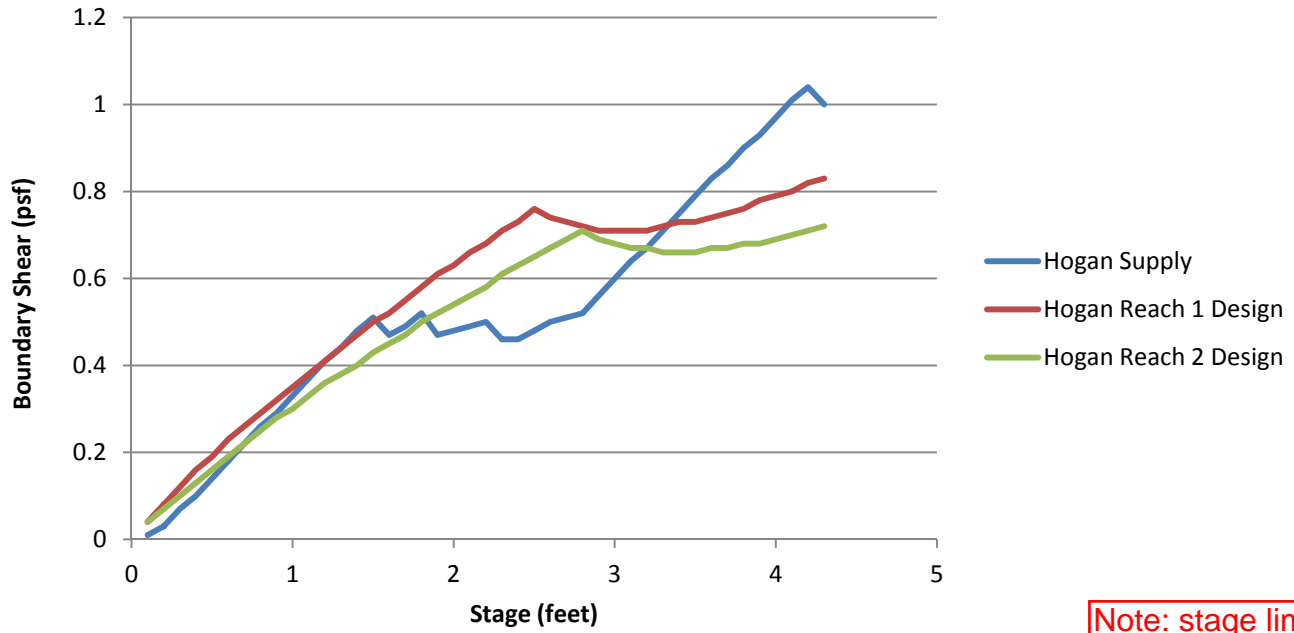
Hogan Creek - Stage vs. Shear

Note: stage limits on both graphs correspond to top of terrace slope at existing floodplain, beyond which shear and power changes with stage are minor; $Q_{max} \sim 4 \cdot Q_{bkf}$

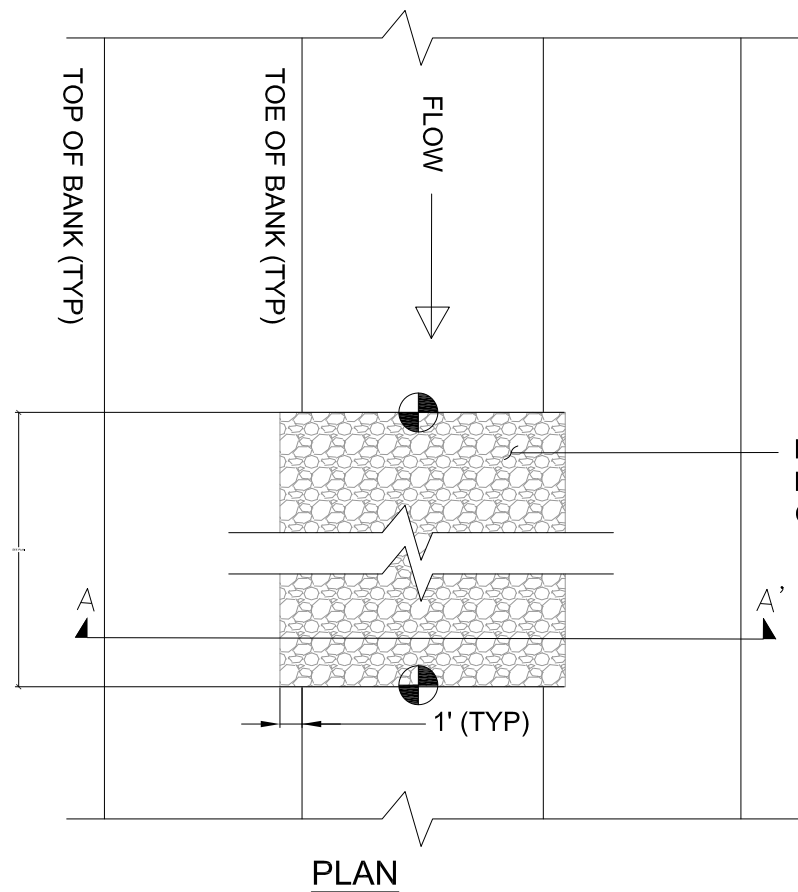
2 CONSTRUCTED RIFFLE
D1 NTS

MIXTURE OF CLASS B RIPRAP AND ON-SITE GRAVEL AND COBBLE

3. Proposed riffles should be constructed utilizing local material salvaged from the abandoned stream reaches. Confirmation was provided by Julie Cahill with NCEEP that local material from abandoned reaches will be utilized in the constructed riffles.
