Mitigation Plan

Holman Mill Mitigation Project

Alamance County, NC
DENR Contract No. 005795
EEP ID No. 96316

Cape Fear River Basin
HUC 03030002

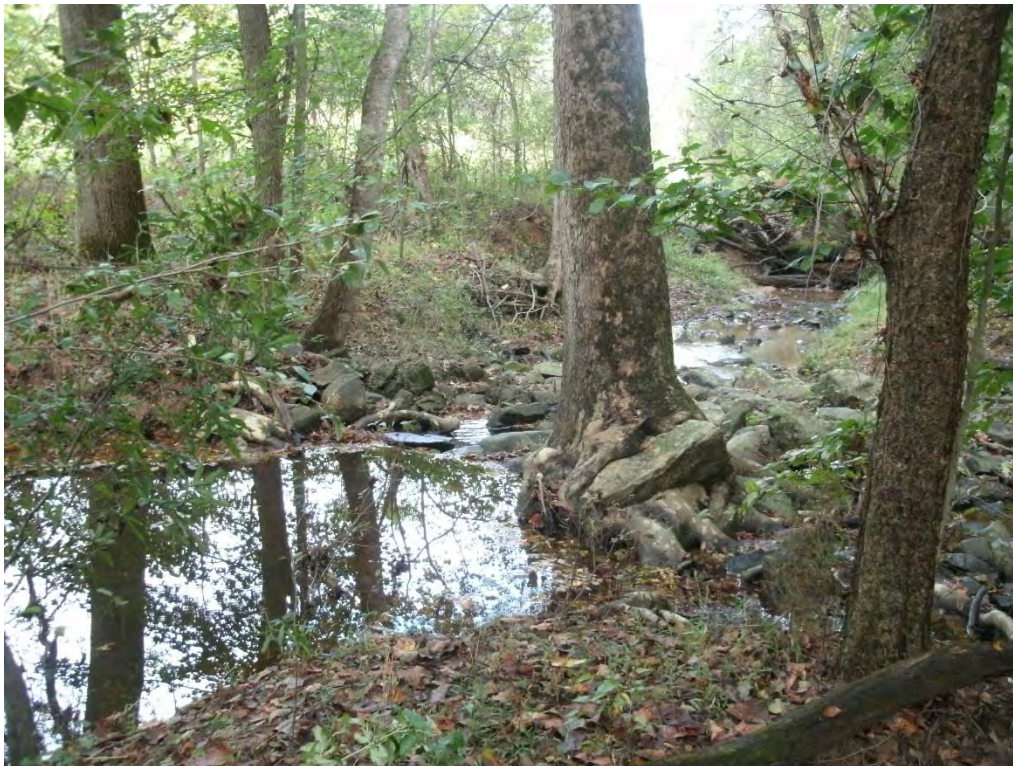
Photo 2. Old Mill Dam facing downstream (UT to Pine Hill Branch)

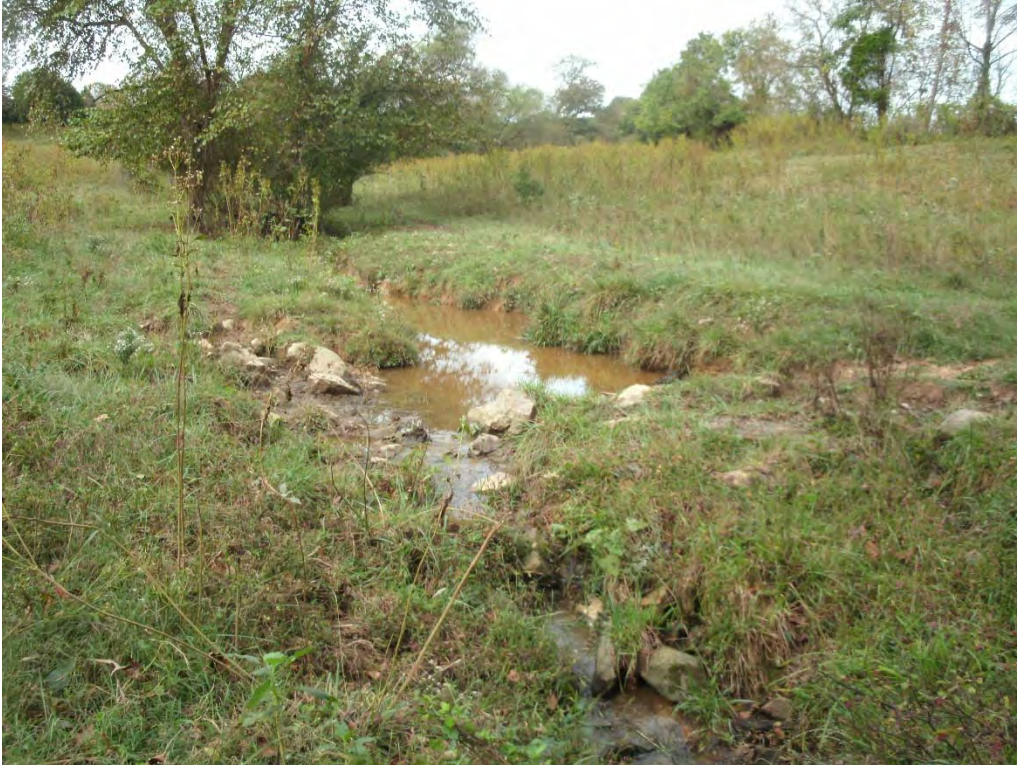
Photo 4. Damage on UT1 due to cattle

The drainage area to UT1 is currently used for livestock production. Livestock have direct access to the stream, which has resulted in heavily trampled banks and an actively eroding channel. The active scour zones and wallow areas are contributing to the fining of bed material as evidenced by the reach-wide pebble-count, which indicates that UT1 has a median particle size classified as sand. Channel incision ranges from slight to moderate throughout the reach. UT1 classifies as a Rosgen modified E5 channel type. Results of the existing conditions morphologic survey of UT1 are summarized in Table 5 and the survey data is included in Appendix 5.

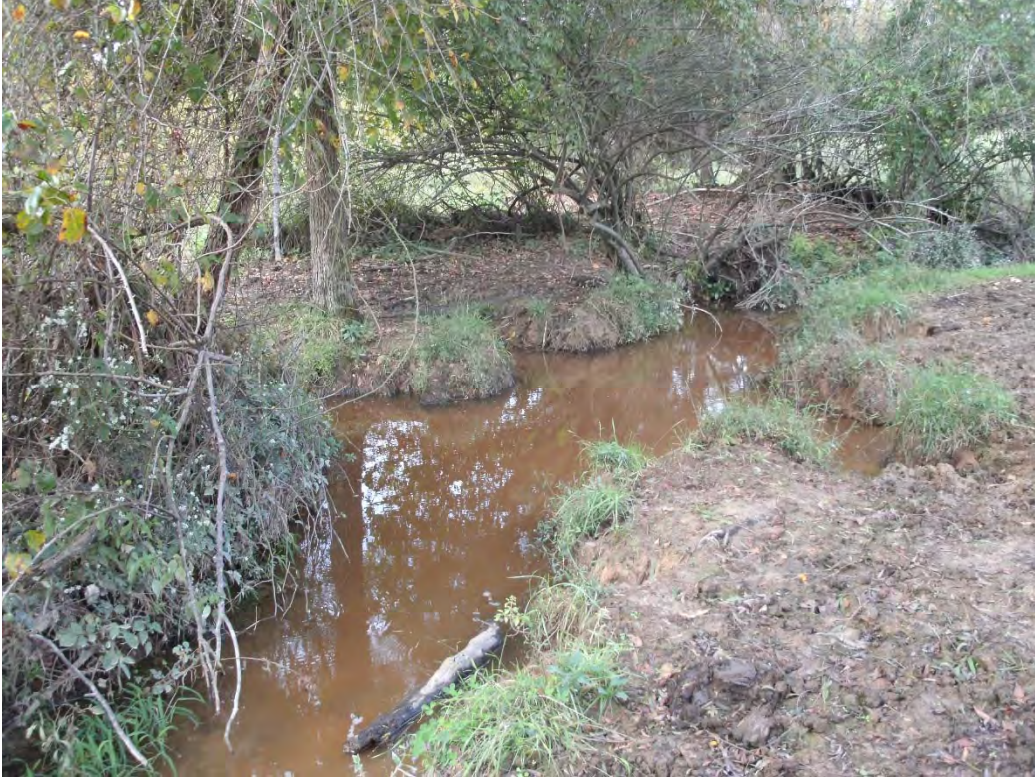
Photo 5. Damage to UT1 due to cattle

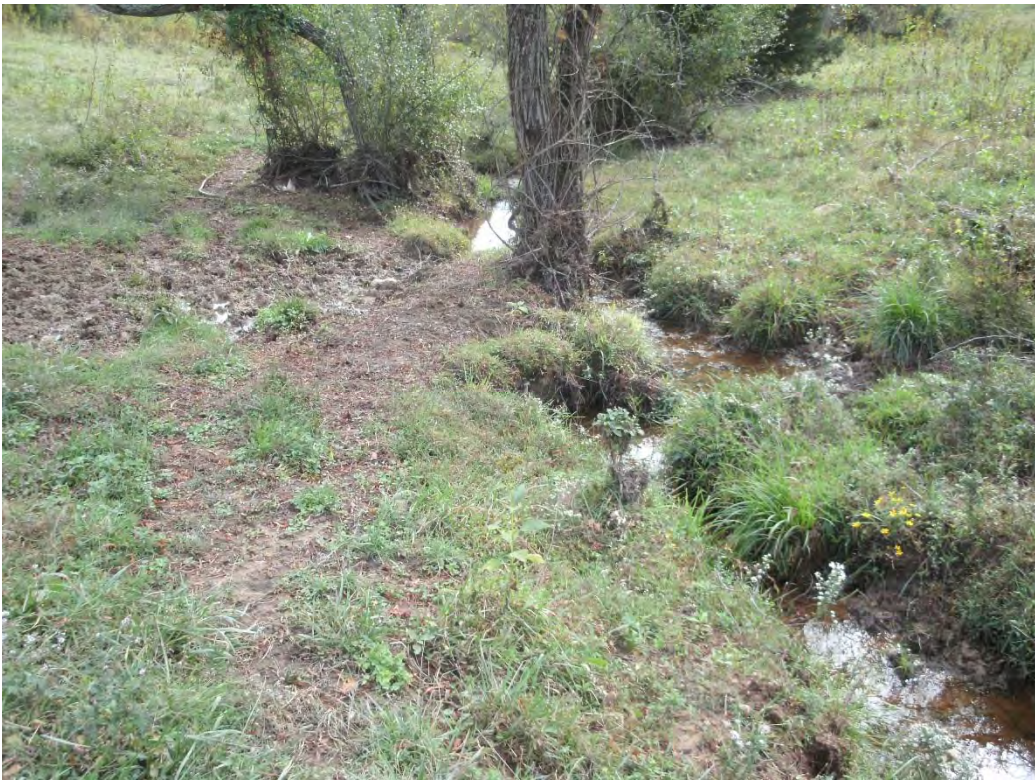
Photo 6. Damage to UT1 due to cattle

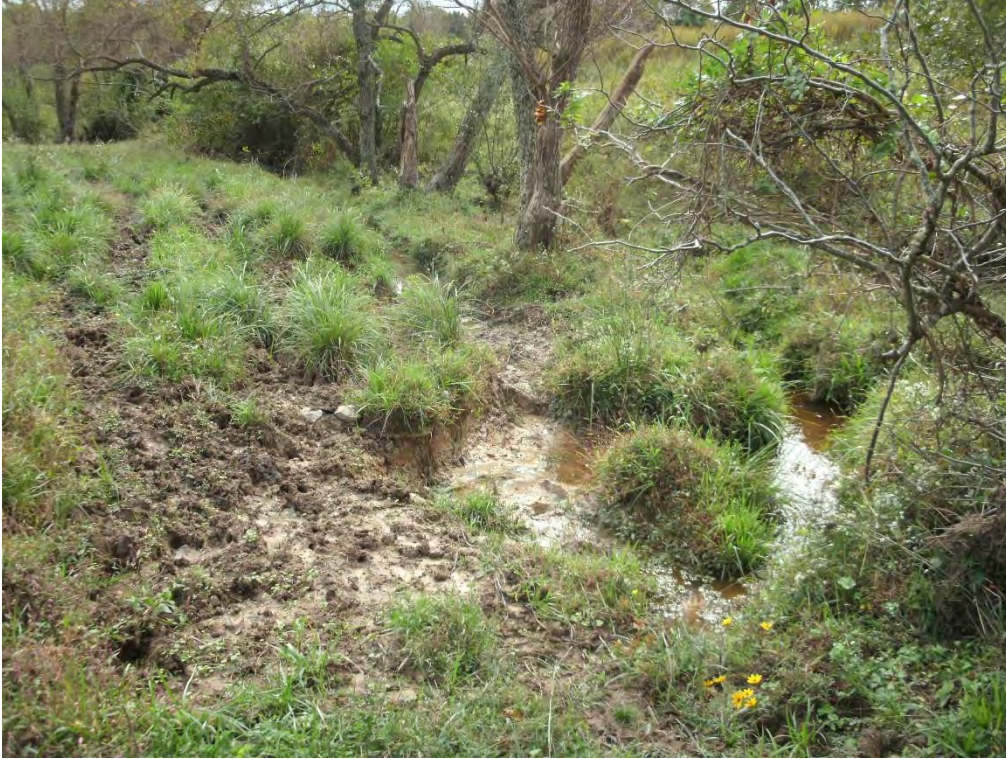
Photo 7. Damage to UT1 due to cattle

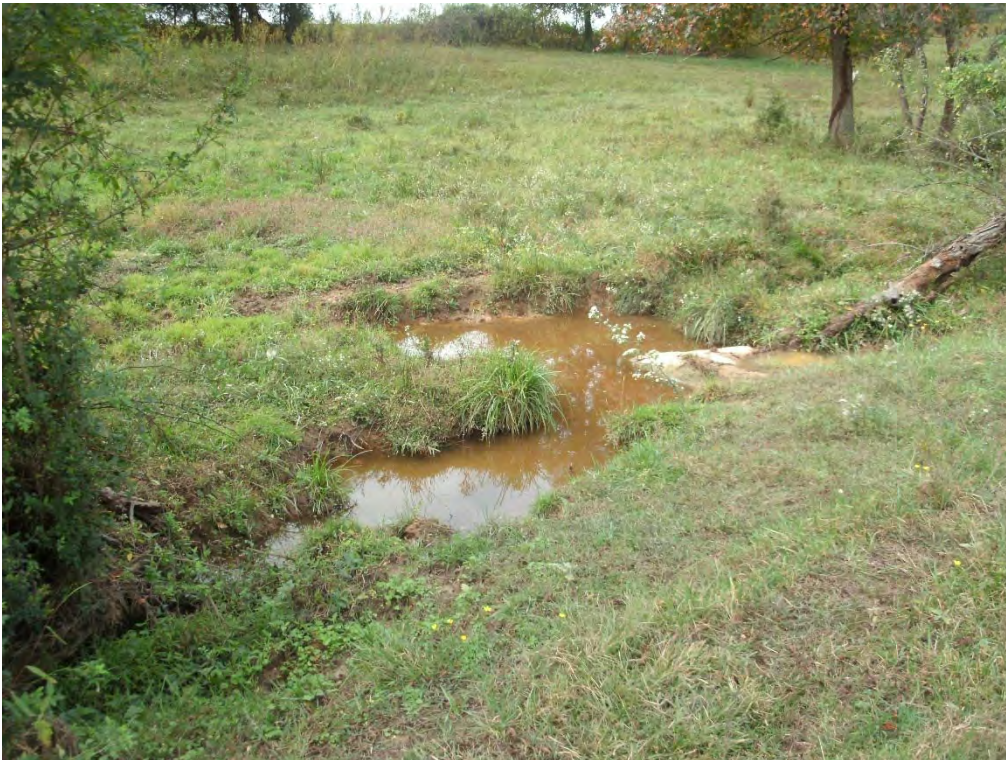
Photo 8. Damage to UT1 due to cattle

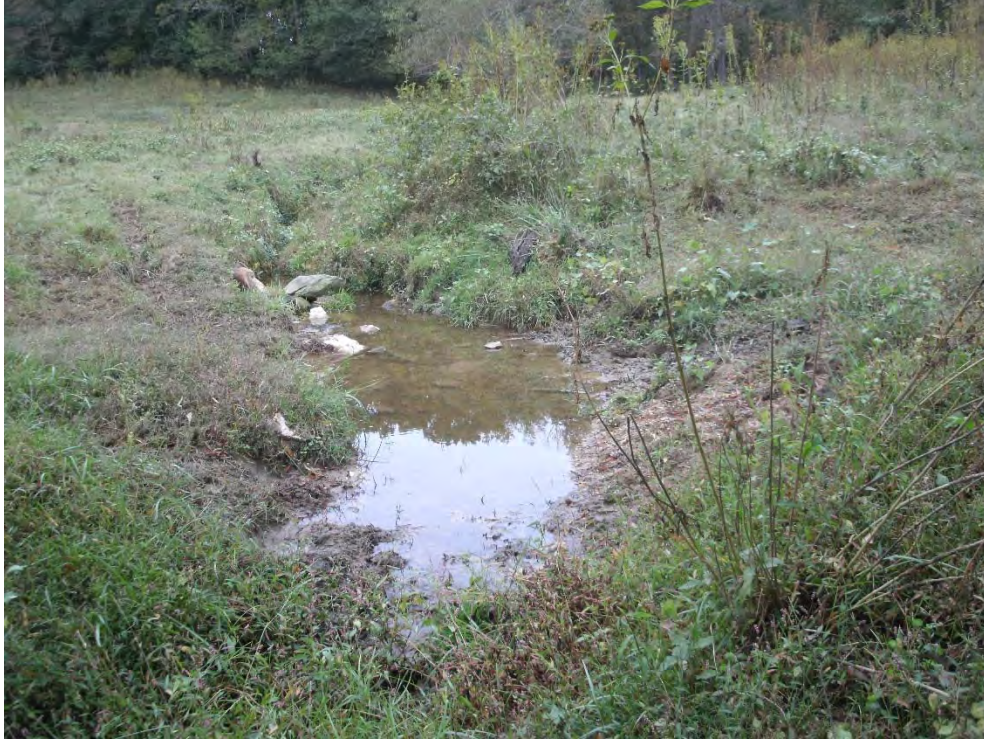
Photo 9. Cattle wading area on UT2A

UT2A has the steepest valley slope and channel slope of any reach on the Site, with the greatest degree of incision (BHR = 3.4) and the lowest entrenchment ratio (ER = 2.3). It serves as a water source for livestock and trampled banks and cattle crossings are frequent along the length of the stream. An existing conditions survey showed that the entire length of UT2A is incised and 34% of the length has scoured banks. The incision and trampled banks have led to a fining of bed material and median particle size classified as very fine gravel. The channel classifies as an incised Rosgen C4b transitioning to a G4. Results of the existing conditions morphologic survey of UT2A are summarized in Table 5 and the survey data is included in Appendix 5.

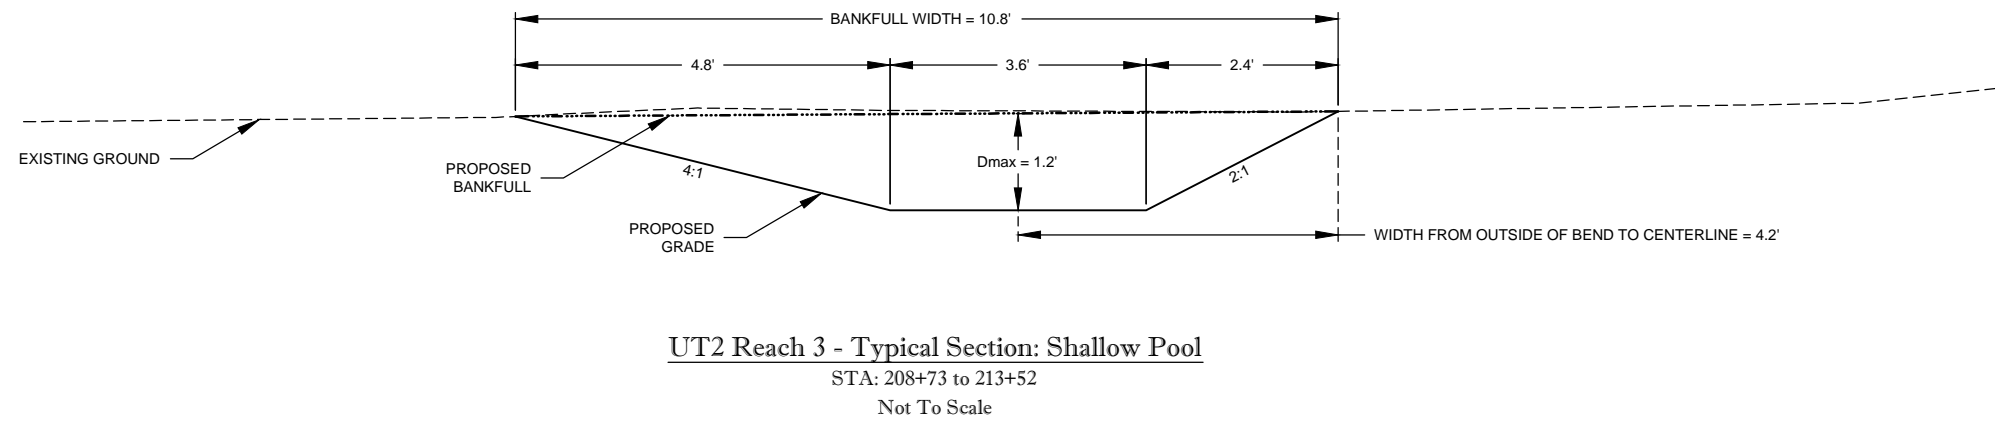
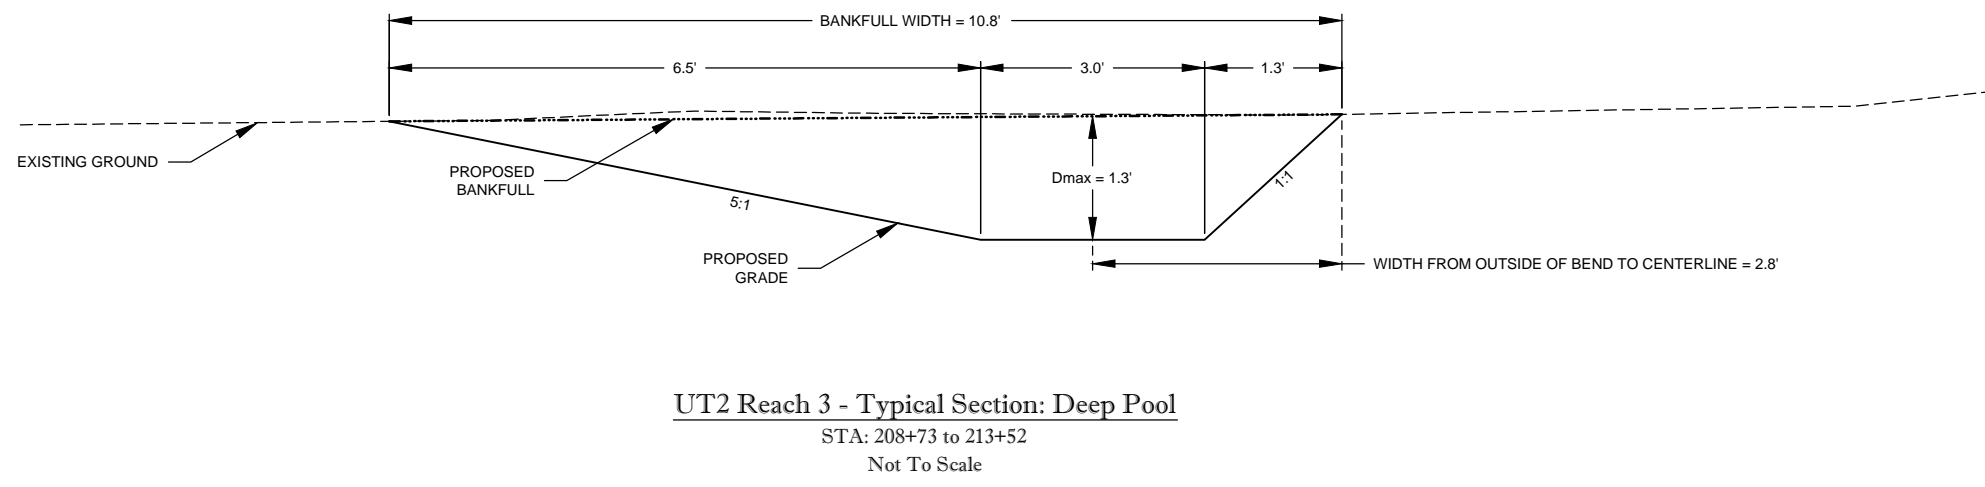
1. Typical sections are provided as a reference for in channel grading only.
For floodplain grading and connection to existing ground elevations refer to Sheets 2.1 - 2.12.
2. Pool depth will vary per profile.
3. All deep pools shall have bank revetments on outside of bend.
4. Typical pool sections are shown as right meander bends only. The flatter side slope is on the inside of the meander bend and for left meander bends should be on the opposite side than shown on the typical sections.

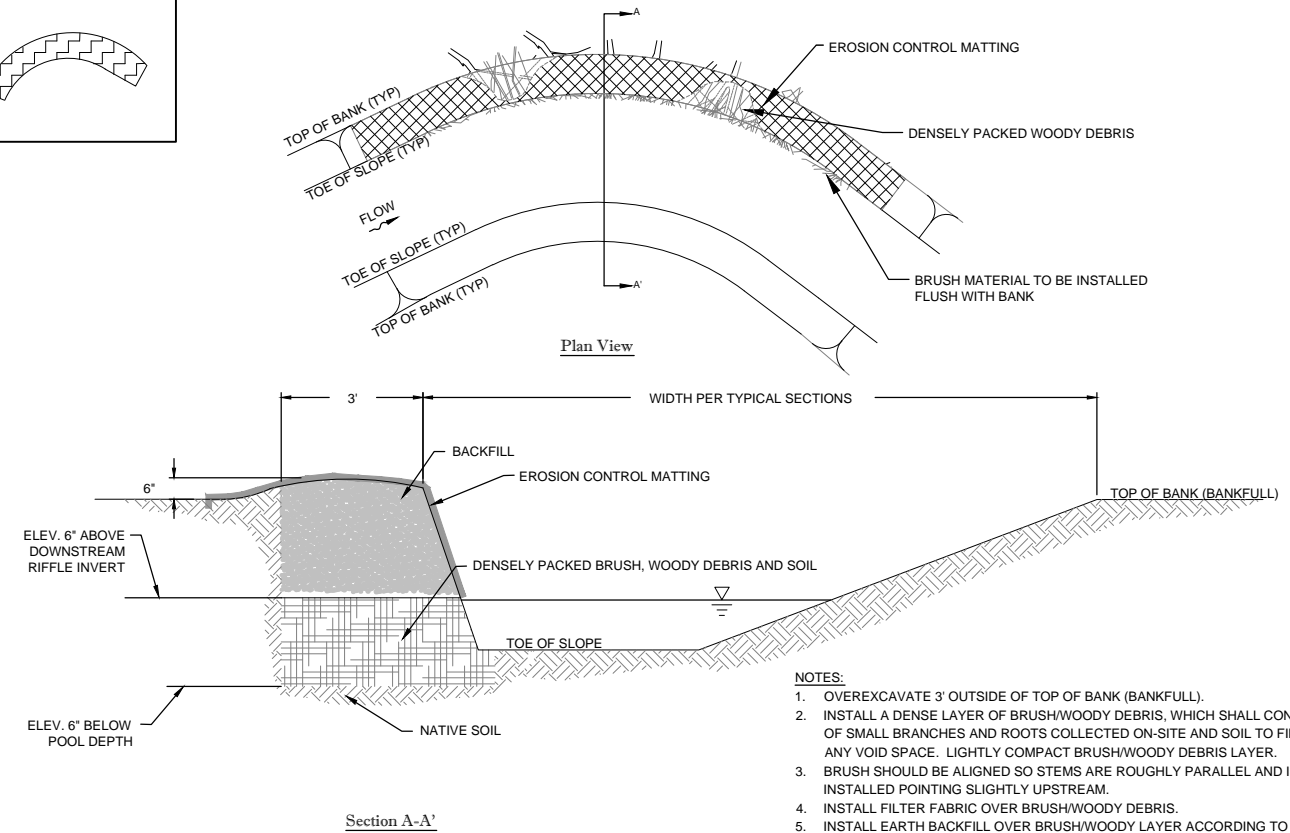
4
6.2 Brush Toe
Not to Scale

- NOTES:
- OVEREXCAVATE 3' OUTSIDE OF TOP OF BANK (BANKFULL).
 - INSTALL A DENSE LAYER OF BRUSH/WOODY DEBRIS, WHICH SHALL CONSIST OF SMALL BRANCHES AND ROOTS COLLECTED ON-SITE AND SOIL TO FILL ANY VOID SPACE. LIGHTLY COMPACT BRUSH/WOODY DEBRIS LAYER.
 - BRUSH SHOULD BE ALIGNED SO STEMS ARE ROUGHLY PARALLEL AND IS INSTALLED POINTING SLIGHTLY UPSTREAM.
 - INSTALL FILTER FABRIC OVER BRUSH/WOODY DEBRIS.
 - INSTALL EARTH BACKFILL OVER BRUSH/WOODY LAYER ACCORDING TO TYPICAL SECTION DIMENSIONS.
 - SEED, MULCH AND INSTALL EROSION CONTROL MATTING AND BANK STABILIZATION PER PLANS.
