Mitigation Plan

**Hominy Swamp Creek, City Recreation Park
Wilson, North Carolina**

N.C. Wetlands Restoration Program
NCDENR

January 2003

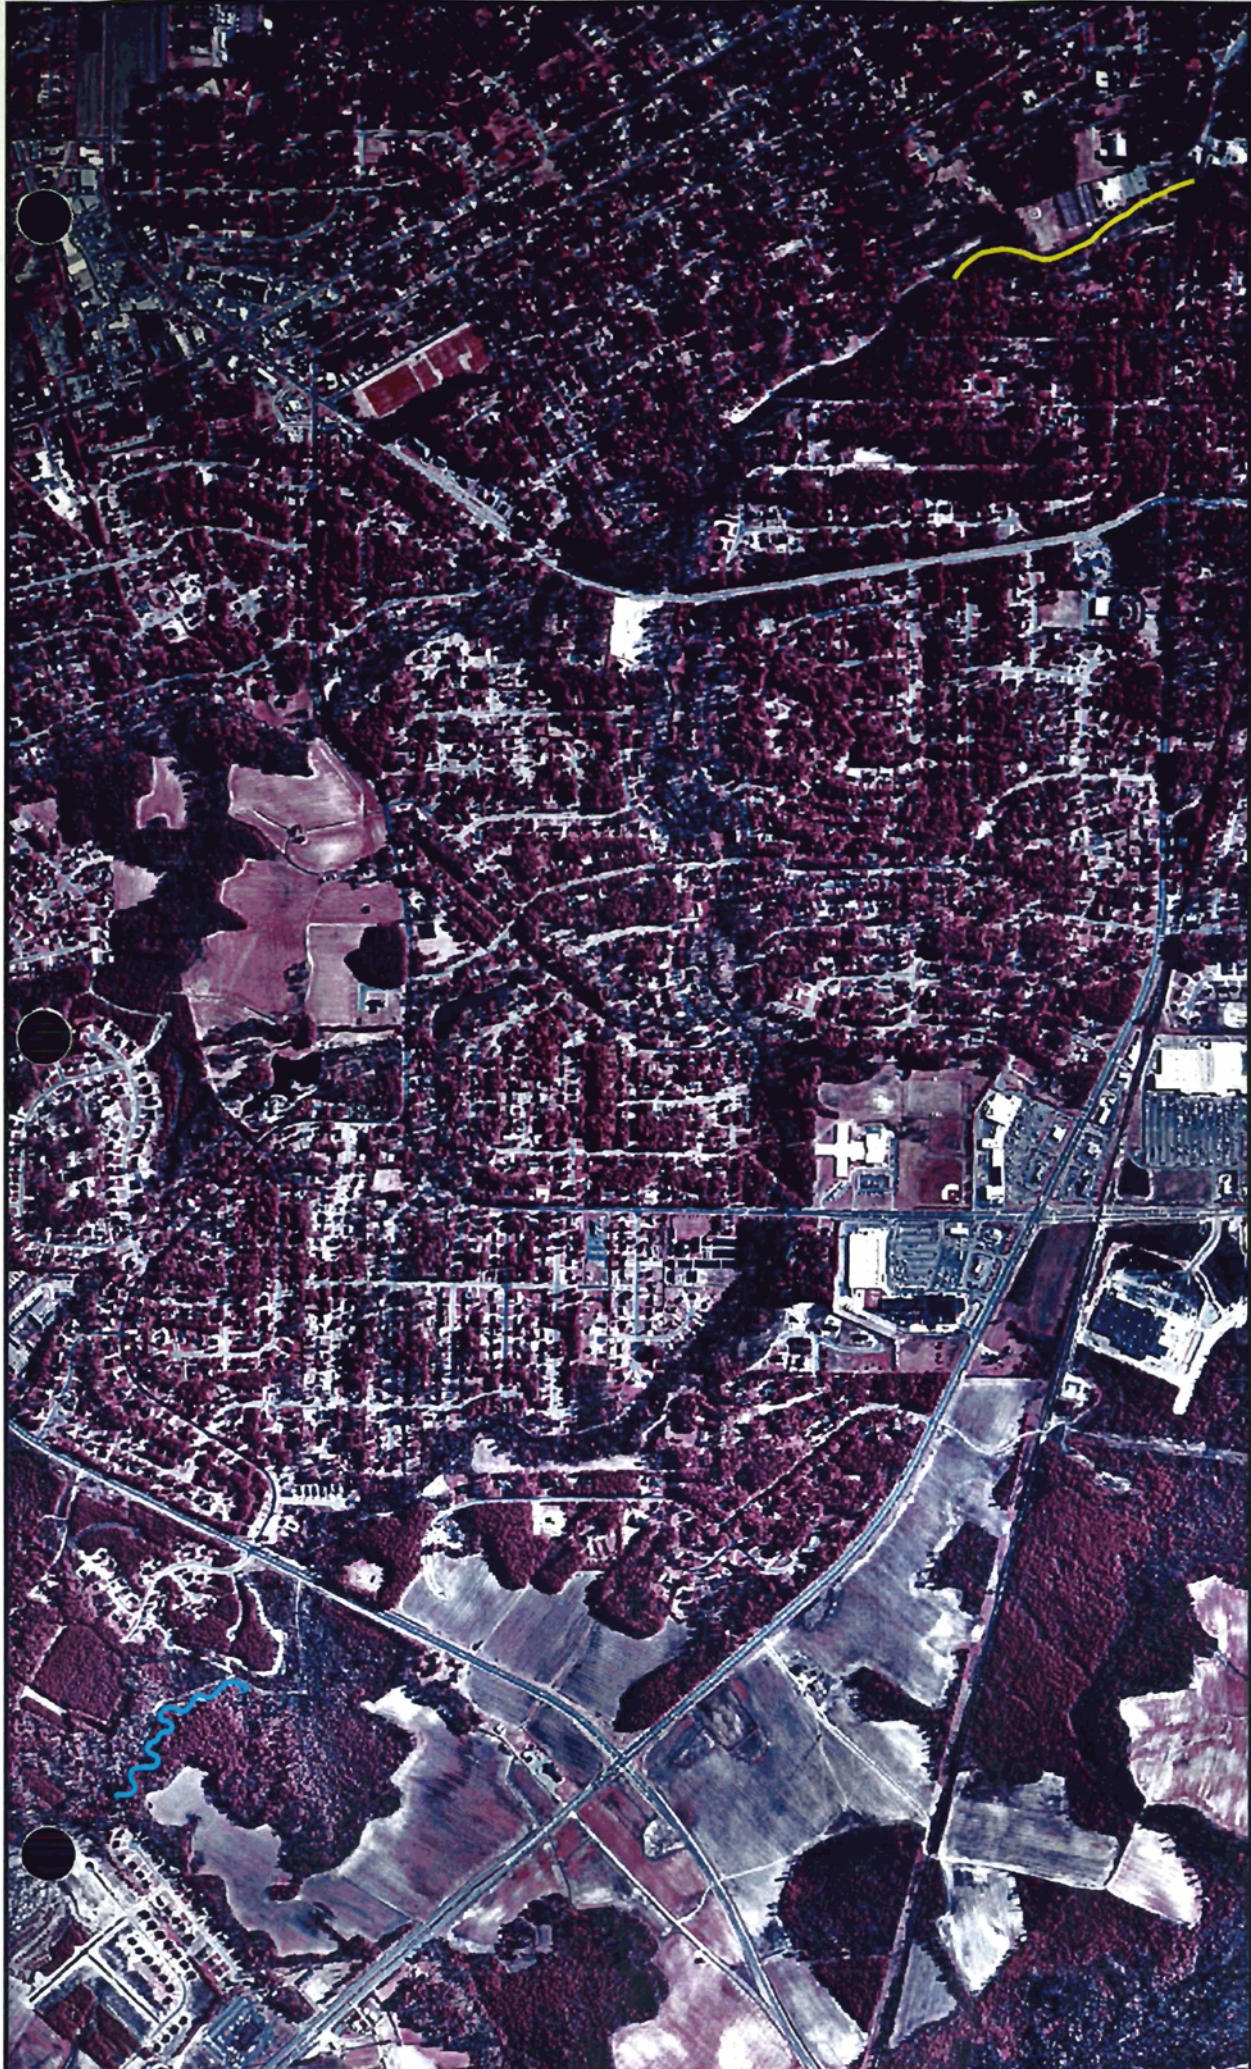
Figure 3.
Reference
Site
Location

The restoration of the project reach was based upon the use of an analog design or reference reach methodology. A Rosgen Level II Morphological Assessment and Classification was completed of the selected reference reach – a portion of Hominy Swamp Creek located northwest of Airport Road and south of the Wilson Airport (Figure 3).

Selection of this site was appropriate due to its close proximity to the subject site, location within the same watershed as the project site, and similarity of physiographic characteristics (i.e., geology, landscape position, topographic relief, and watershed land use/land cover) to the project site. Channel dimensions, pattern and profile were measured at the stable reference site and used to develop quantitative dimensionless ratios on which the restoration design was based (Table 2).

— Project Reach — Reference Reach
