Mitigation Plan  
Hornpipe Branch Tributaries  
Mitigation Project  
Lenoir County, North Carolina  
FINAL VERSION

NCDEQ DMS Project Identification # 100076  
NCDEQ DMS Contract # 7605  
Neuse River Basin (Cataloging Unit 03020202)  
USACE Action ID Number: SAW-2018-01762  
DWR Project #20-0048  
Contracted Under RFP # 16-007401

**RE: WLS Responses to NCIRT 30-day Review Comments Regarding Task 3 Submittal, Final Mitigation Plan Approval for the Hornpipe Branch Tributaries Mitigation Project, USACE AID# SAW-2018-01762, NCDEQ DMS Full-Delivery Project ID #100076, Contract #7605, Neuse River Basin, Cataloging Unit 03020202, Johnston County, NC**

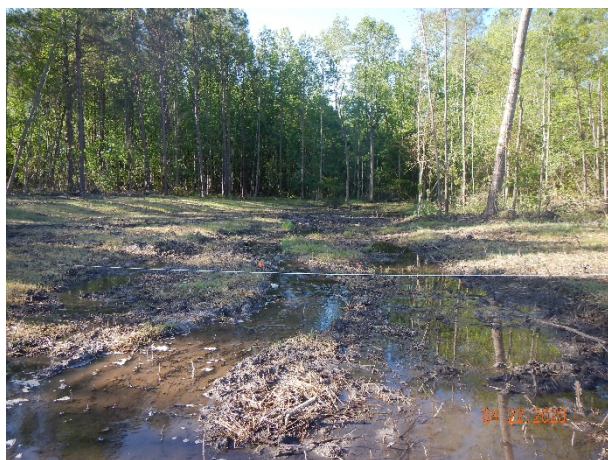
*Headwater Valley Restoration – As-built Condition*

channel morphology to vary between a poorly defined and moderately defined channel as shown on design plan sheet 3 and supported by the adjacent reference reach data. The representative photos below illustrate as-built conditions of a recently constructed HW stream and wetland complex with similar design parameters and characteristics as compared to the nearby 'South Reference Reach' system visited by Mac Haupt with DWR.

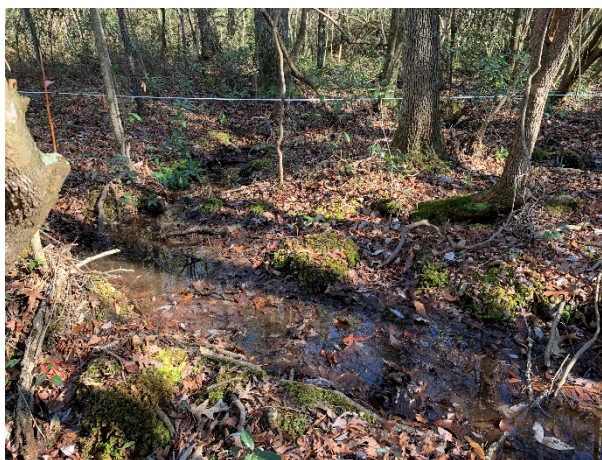
*Nearby South Reference Reach – Existing Condition*

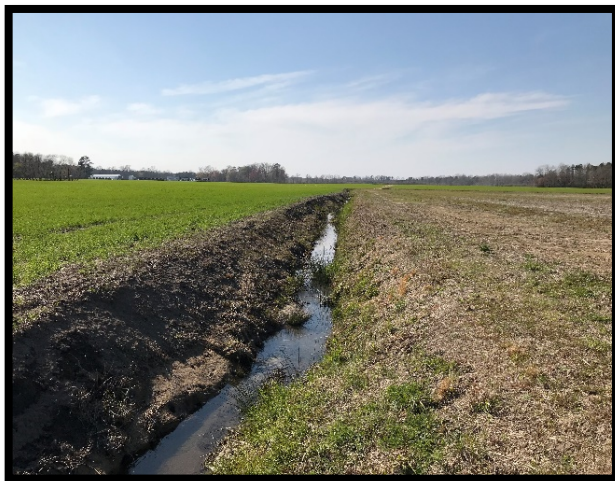
*Photo of MS1 showing lack of riparian buffer and straightening for agricultural purposes.*

**MS1:** MS1 is a headwater tributary that has been channelized and straightened along its entire length. The upstream end of MS1 drains a ditch network that appears to have been dug through historic non-riparian wetlands. The valley slope is approximately 0.6 percent and the drainage area is 183 acres. The majority of the drainage area for MS1 is within active agricultural fields.

The riparian buffer along the entire length of MS1 consists of active agricultural fields, with no woody vegetation, as the streambanks are regularly mowed and maintained. The landowner has consistent problems with streambank collapse and associated soil loss along this reach. Based on the poor channel conditions and historic anthropogenic disturbances, including channelization and straightening, MS1 was not classified.

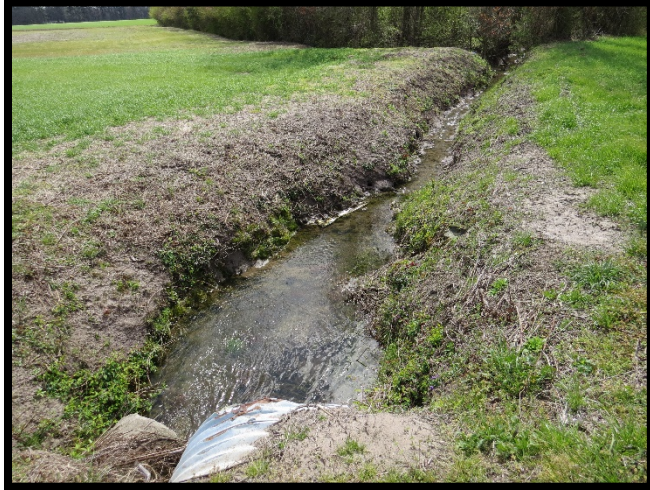
*Looking downstream to the confluence of MS2 and UT2 from existing culvert crossing.*

**MS2:** MS2 continues as an unnamed tributary that has been channelized although appears to generally be at the historic valley centerline/low point along most of its length. The valley slope is approximately 0.4 percent and the drainage area is 222 acres. The majority of the drainage area for MS2 is active agricultural fields. Near the downstream end of MS2, there is a historic in-line agricultural BMP that was constructed decades ago as stormwater wetland. The landowner noted that this was implemented by the Lenoir County Soil and Water Conservation District and that it was the first such BMP installed in the County. MS2 drains to its confluence with UT2 to begin MS3.

Because the system has been channelized, the sinuosity is very low ( $k=1.01$ ). The dimension of MS2 currently is a trapezoidal channel with a top width of approximately 10.5 feet, a depth of approximately 2.8 feet, and 1.5:1 side slopes. The typical BHR for MS2 was measured to be 2.2. The riparian buffer along the entire length of MS2 consists of active agricultural fields, with no woody vegetation, as the streambanks are regularly mowed and maintained, except at the described in-line BMP. Based on the poor channel conditions and historic anthropogenic disturbances, including channelization and straightening, MS2 was not classified.

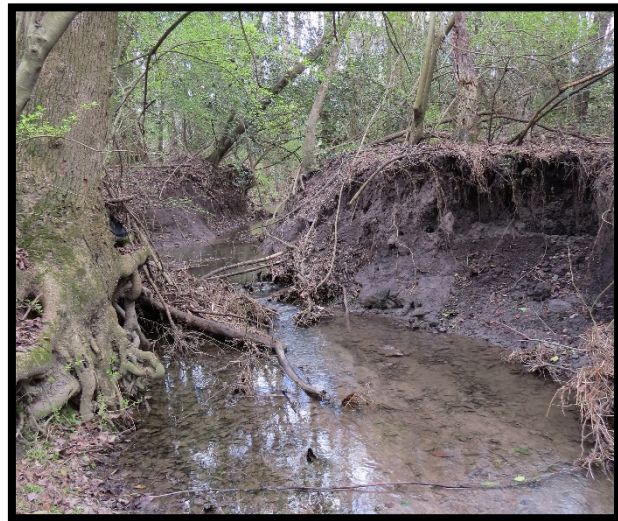
*Looking upstream at an incised channel and the unstable bed and bank conditions of MS3.*

**MS3:** MS3 continues from MS2 to the downstream end of the project boundary at a culvert under Sandy Foundation Road. MS3 has been channelized and straightened along much of its length, as evidenced by the spoil piles and levees along the floodplain. MS3 entrenchment ratio (ER) is 1.1 and lacks natural stream bed features. This reach exhibits active streambank erosion and associated soil loss. The valley slope is approximately 0.4 percent and the drainage area is 331 acres. The majority of the drainage area for MS3 is active agricultural fields with an adjacent forested area. Because the stream system has been channelized, the sinuosity is very low ( $k=1.02$ ). The typical BHR for MS3 was measured to be 4.8. The riparian buffer along the entire length of MS3 is mostly wooded. Based on the existing conditions and sand and clay bed materials, MS3 is classified as a Rosgen 'F5' stream type.

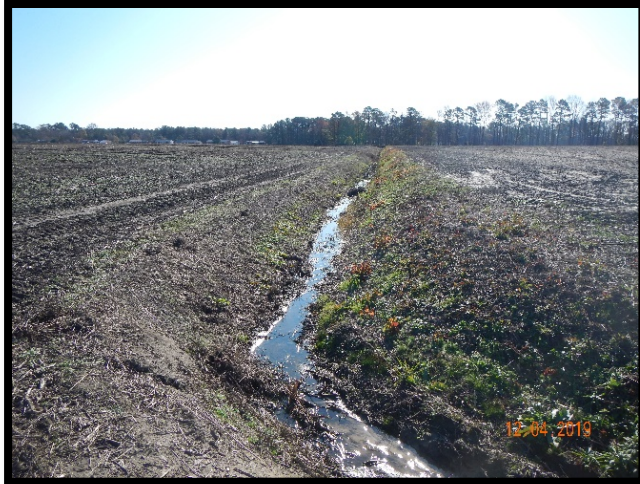
*Looking at channel straightening and lack of riparian buffer on UT1.*

**UT1:** UT1 is a small headwater tributary that has been channelized and straightened along its entire length, such that it is not at the historic valley centerline/low point. The valley slope is approximately 0.8 percent and the drainage area is approximately 46 acres. The entire drainage area for UT1 is within active agricultural fields. The channel is the main stem of a ditch network and is fed by two other ditches at its upstream end.

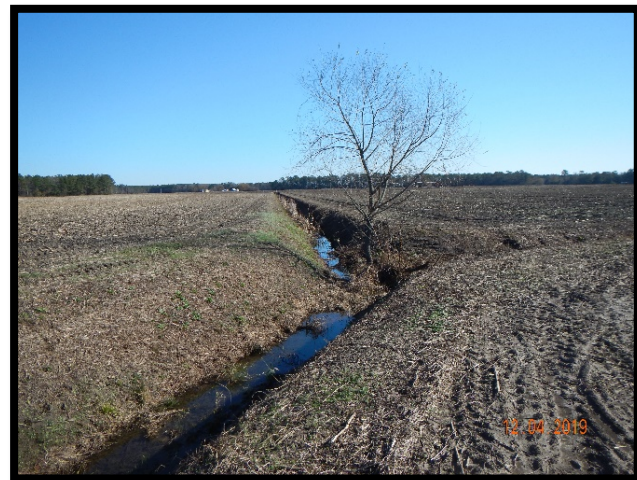
*Photo of UT2 showing channel modification and lack of riparian buffer.*

**UT2:** Similar to UT1, UT2 is a small headwater tributary that has been channelized and straightened along its entire length, such that it is not at the historic valley centerline/low point. The valley slope is approximately 0.6 percent and the drainage area is 32 acres. The entire drainage area for UT2 is active agricultural fields. The channel is fed by two other ditches at its upstream end. UT2 drains together with MS2 to begin MS3. Because the system has been channelized, the sinuosity is very low ( $k=1.06$ ). The dimension of UT2 currently is a trapezoidal channel with a top width of approximately 11.0 feet, a depth of approximately 2.7 feet, and 1.5:1 side slopes. The typical BHR for UT2 was measured to be 4.7.

The riparian buffer along the entire length of UT2 consists of active agricultural fields, with no woody vegetation, as the streambanks are regularly mowed and maintained. Based on the poor channel conditions and historic anthropogenic disturbances, including channelization and straightening, UT2 was not classified.

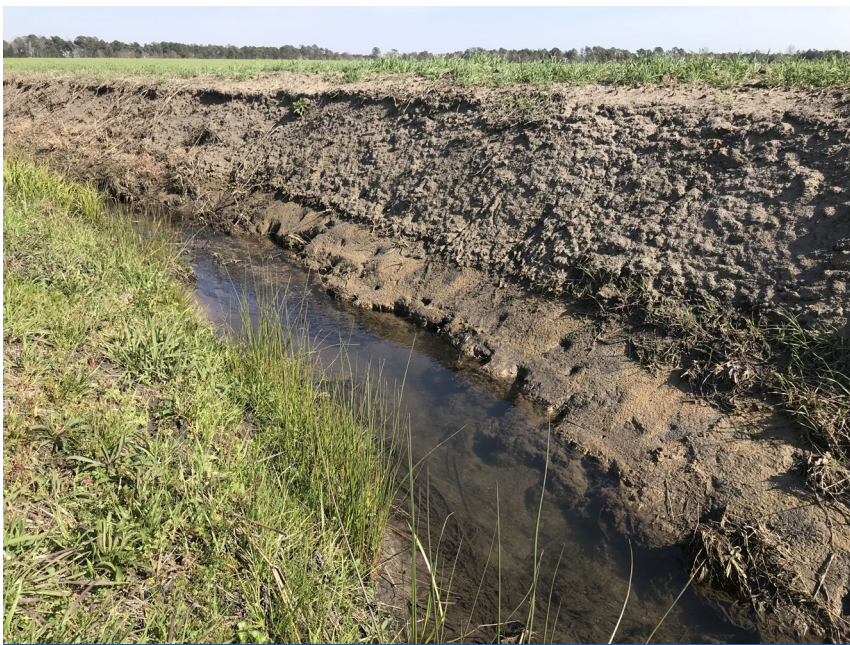
MS1– Straightened channel with bare banks 3/14/2018
