Howell Woods
Wetland Restoration Site
Johnston County, North Carolina
Year 4 Annual Monitoring Report
2005

December 2005

**Howell Woods Wetland Restoration Site
Fall 2005 Monitoring Summary**

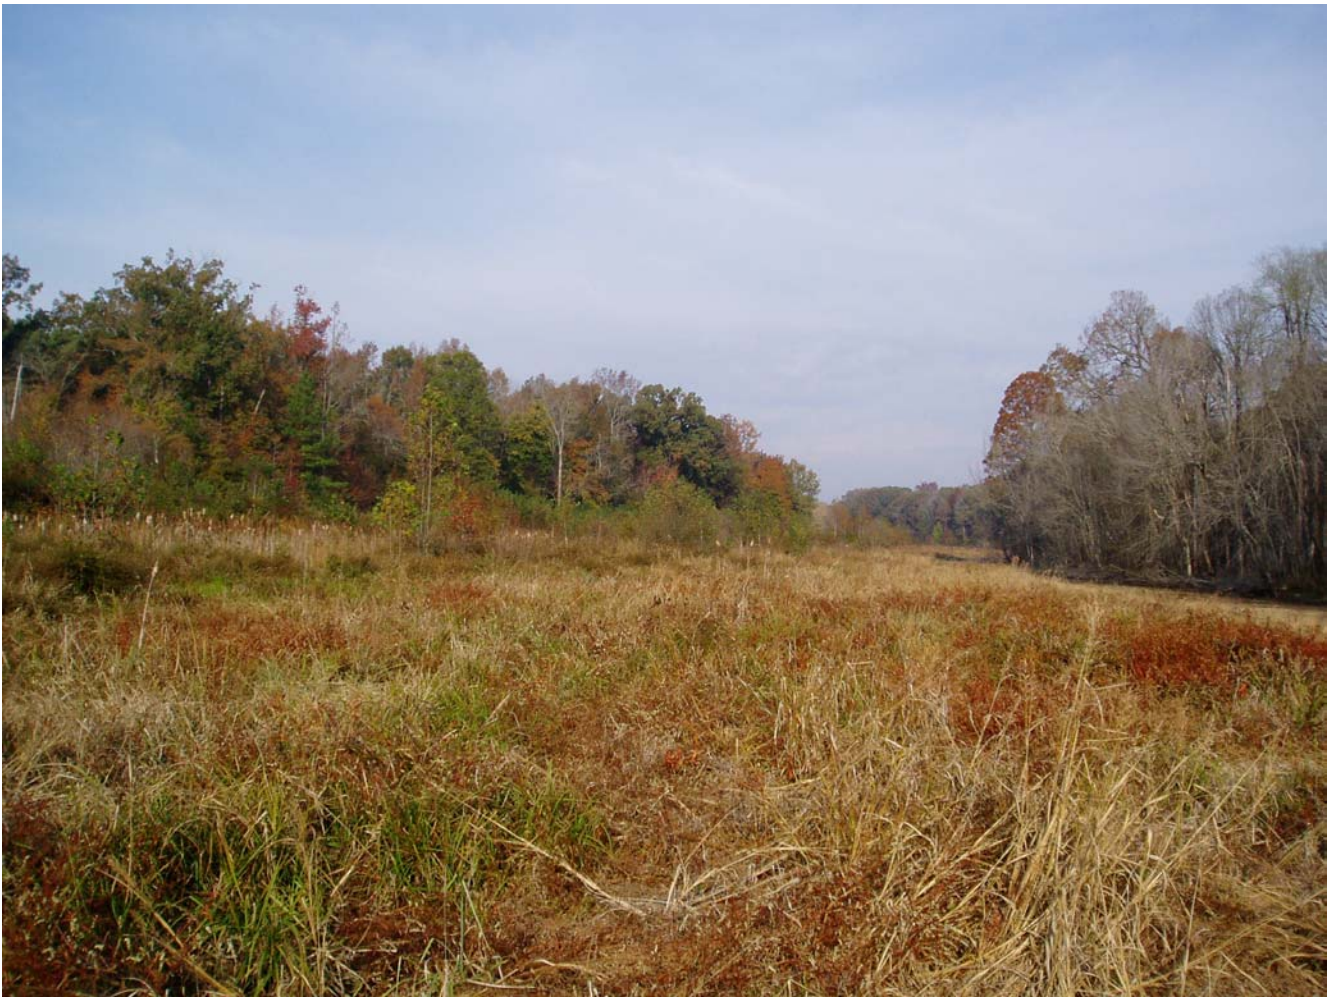
Photo 1. Fall 2005. Wetland Restoration Area.

Location/Issue	Location	Probable Causes	Photo #
Low Tree Stem Counts in Stream Side Zones	See Plan View	Compacted soil	1,2,3,5
		Lower planted quantities	
		Proximity of surface water	
Littoral Shelf	See Plan View	Compacted soil	5
		Improper hydrologic conditions	
Mature trees stressed in enhancement area	See Photos	Proximity of surface waters	4,5

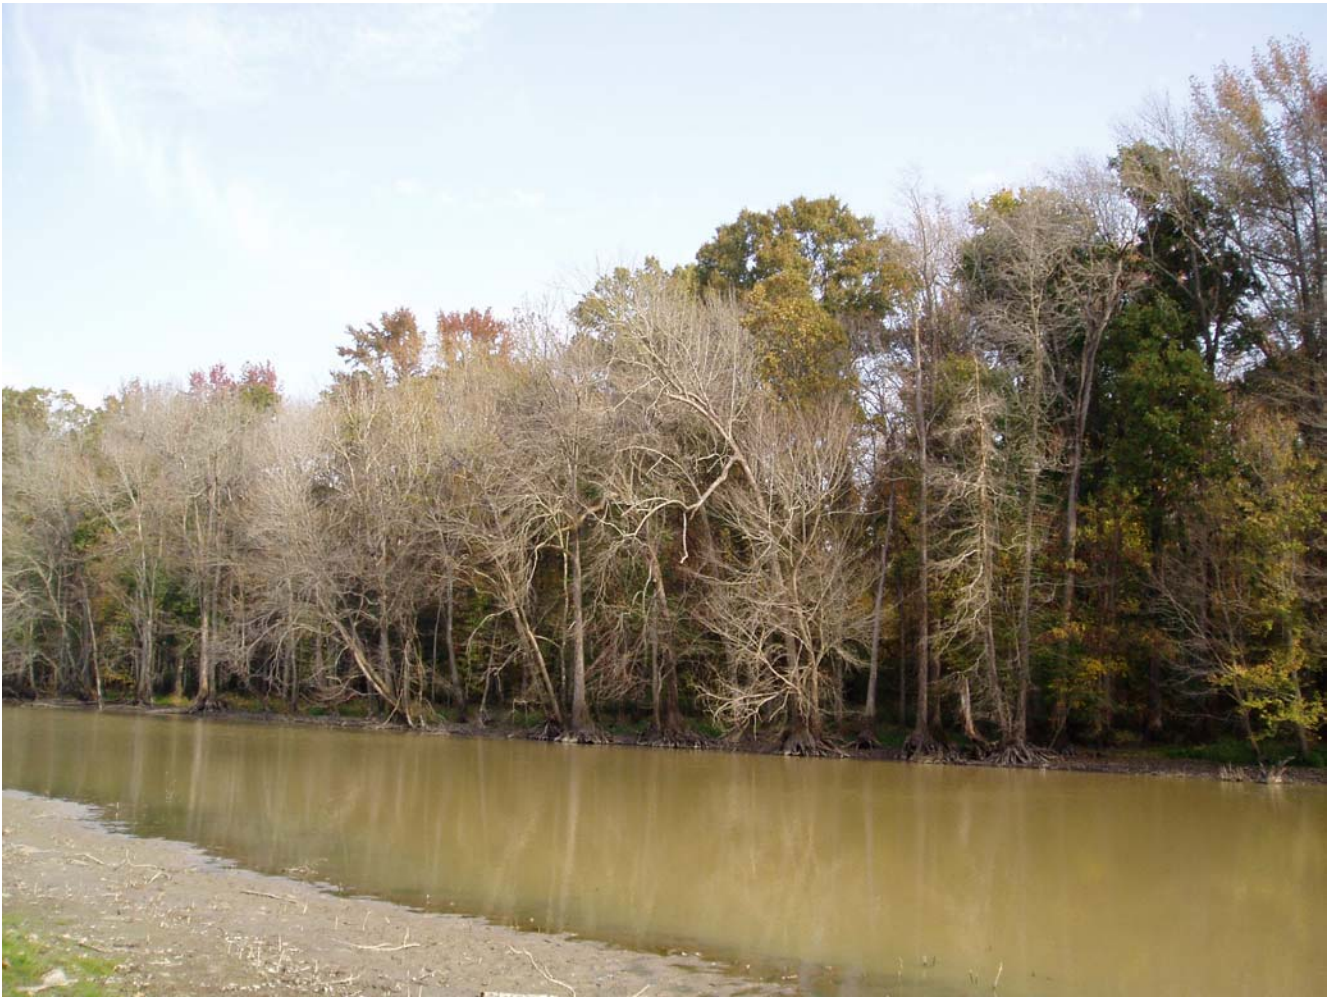
Photo 4. Fall 2005. Stressed trees along plugged channel.

It appears, based on the As-Built Construction Report, that a large portion of the project site where no construction activities took place was planned as the enhancement area. However, it is unknown how the extent of this enhancement was determined and is unclear how this might be assessed. During our visit, it appeared that a large portion of the areas likely designated for enhancement had been actively flooded during the growing season. It is clear that the site work has decreased drainage and restored a more natural hydrologic regime to most of the area. Trees in the enhancement area, that used to be near the banks of the newly plugged channel, are now in almost constant contact with surface waters. It appears that these trees have been adversely effected and that an increasing number will likely die due to excessive saturation.

It has also been difficult to assess enhancement areas with the current monitoring protocol. Data collected near the channel has shown high water tables and frequent flooding. This may be the intended effect, but it also appears to be causing stress on some of the mature trees along the channel banks. Gages installed farther from the channels have been prone to errors and water tables have been mostly below the reading limits of the equipment.

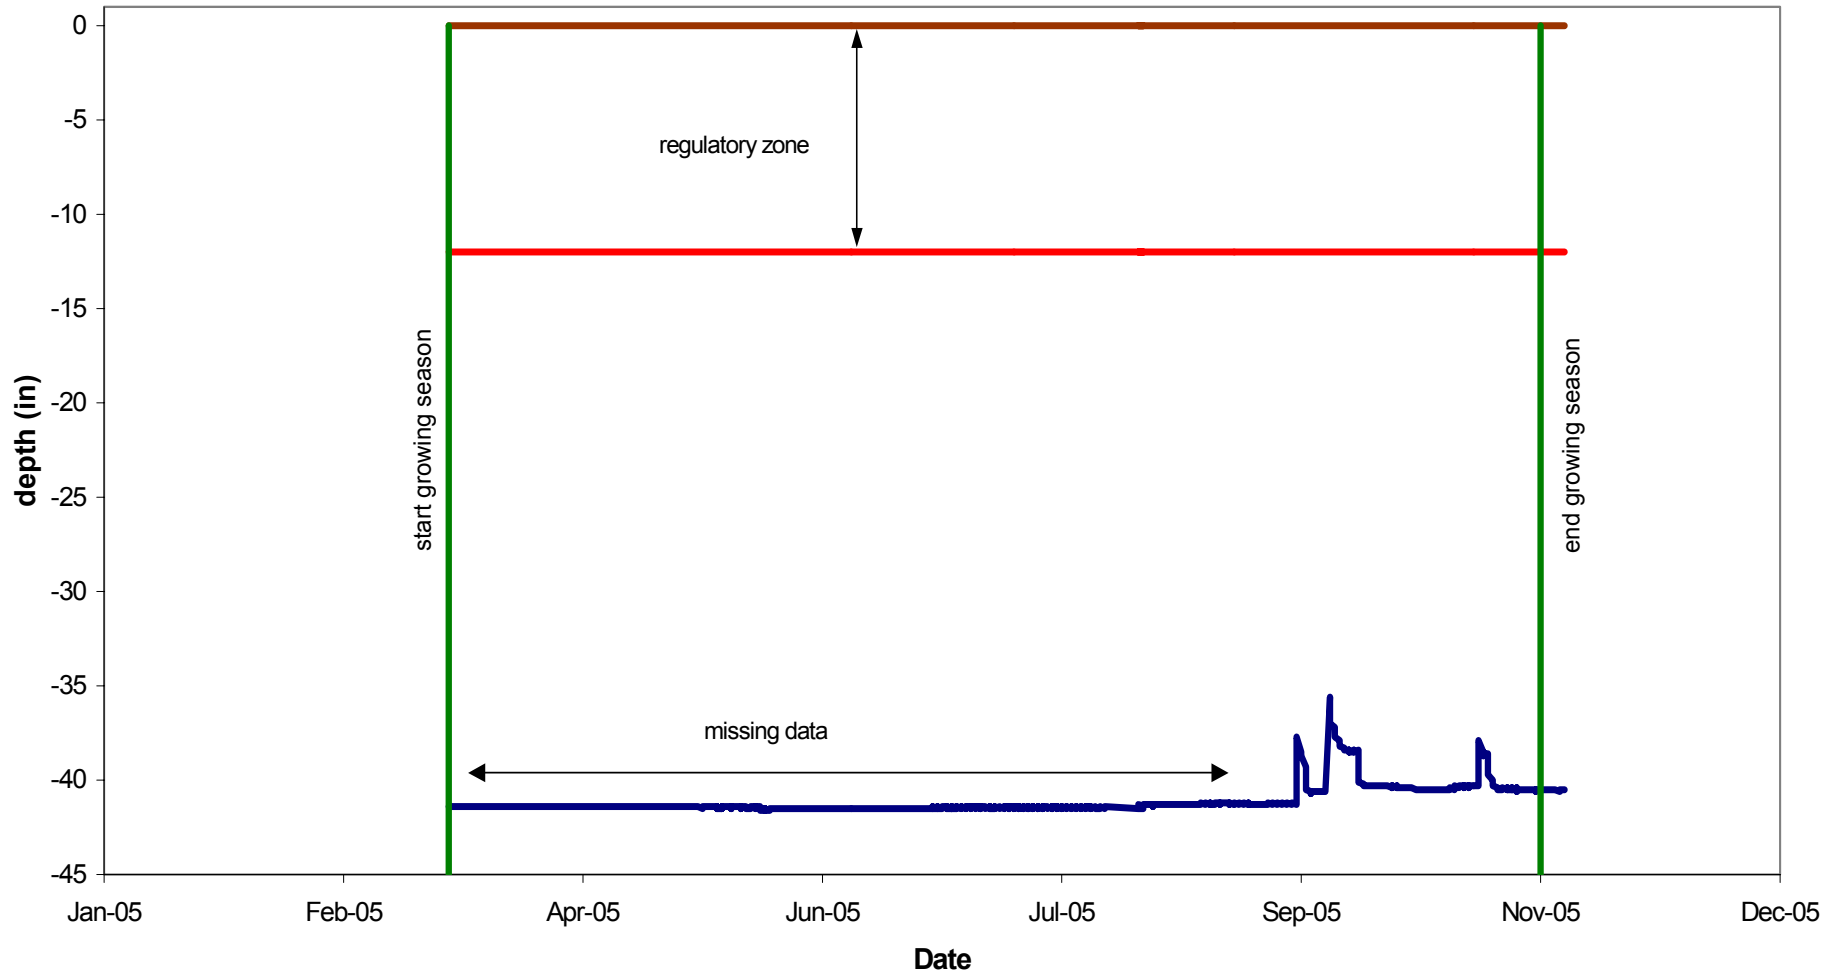
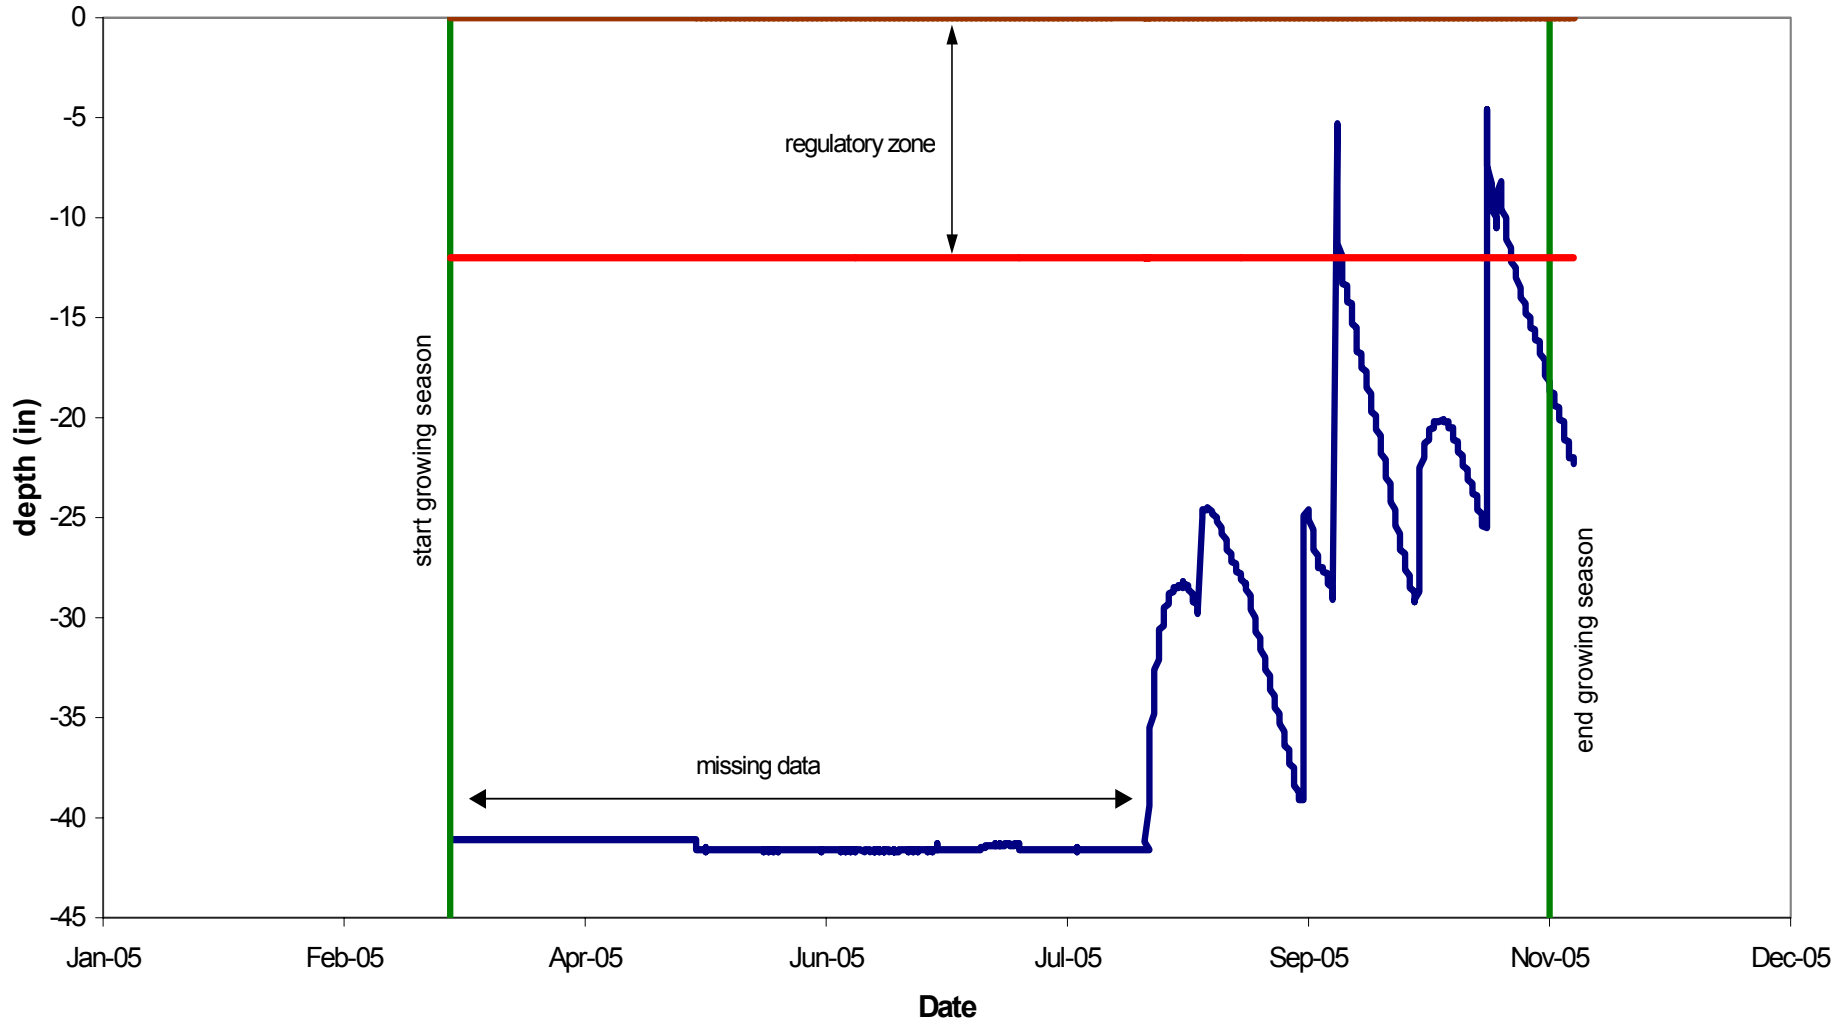
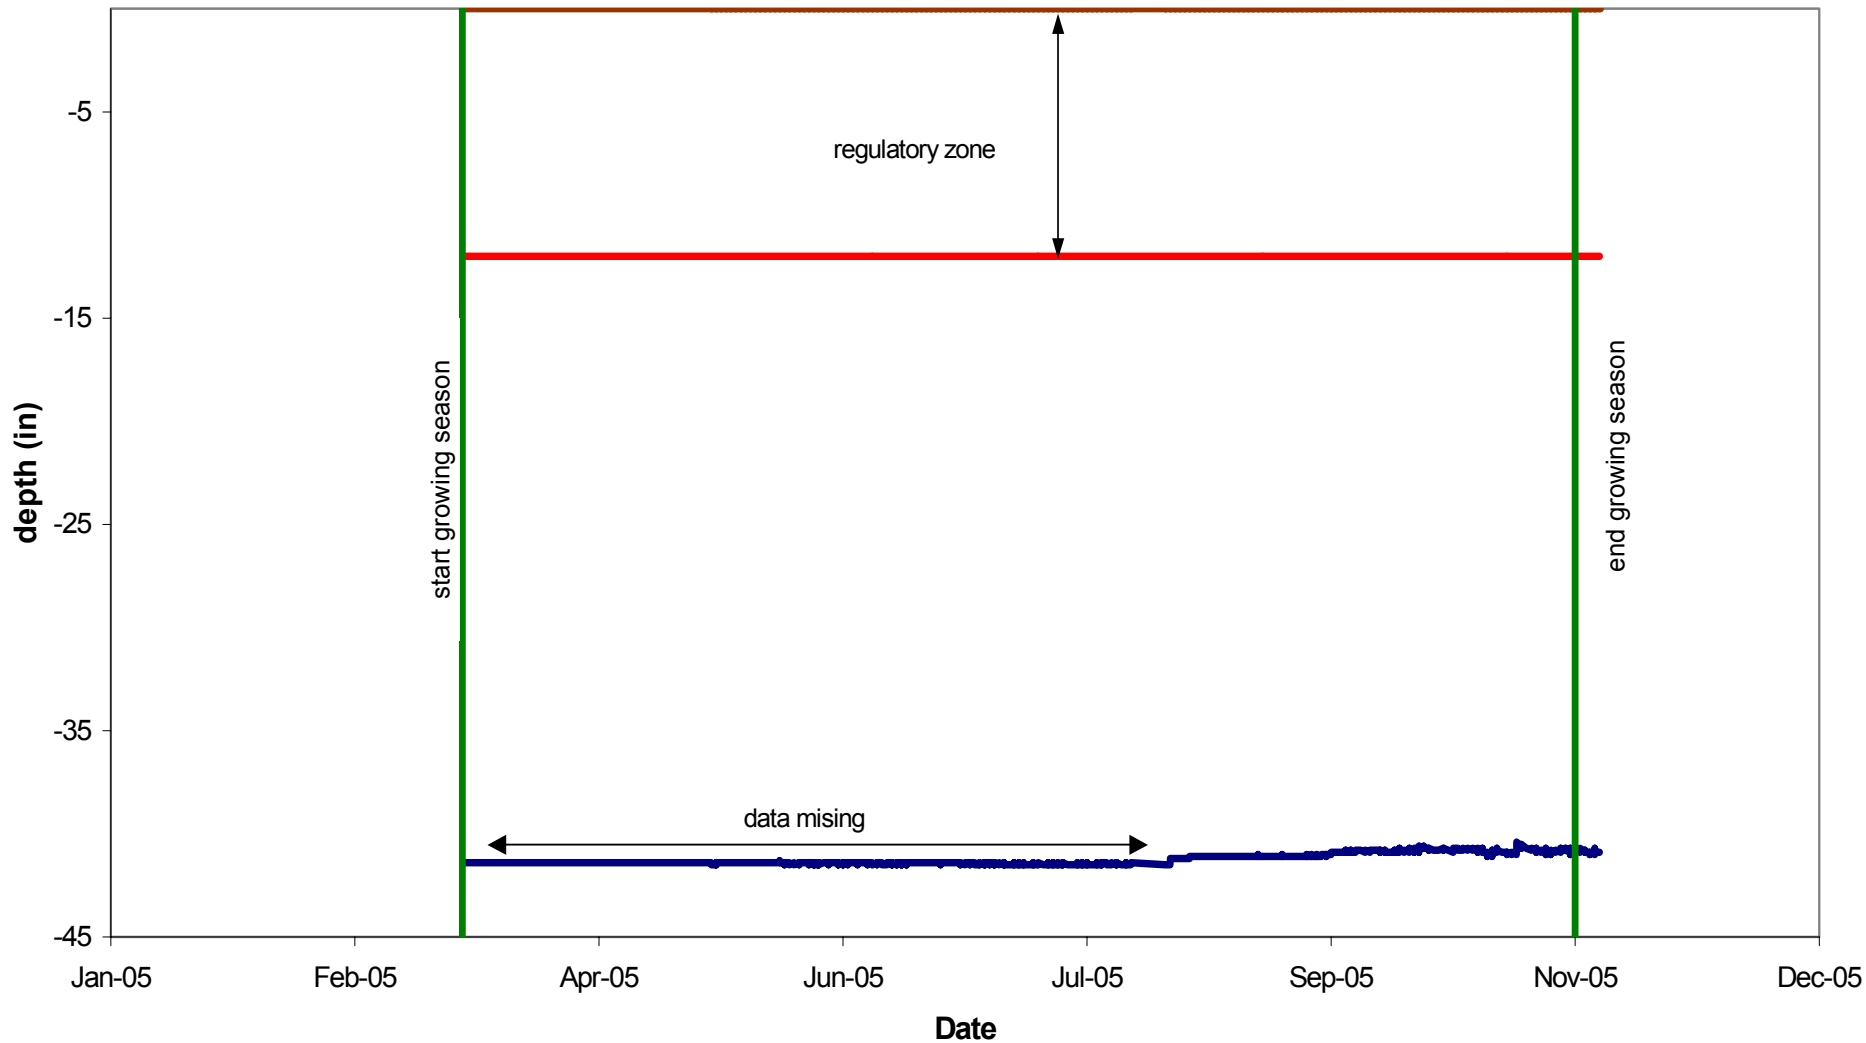
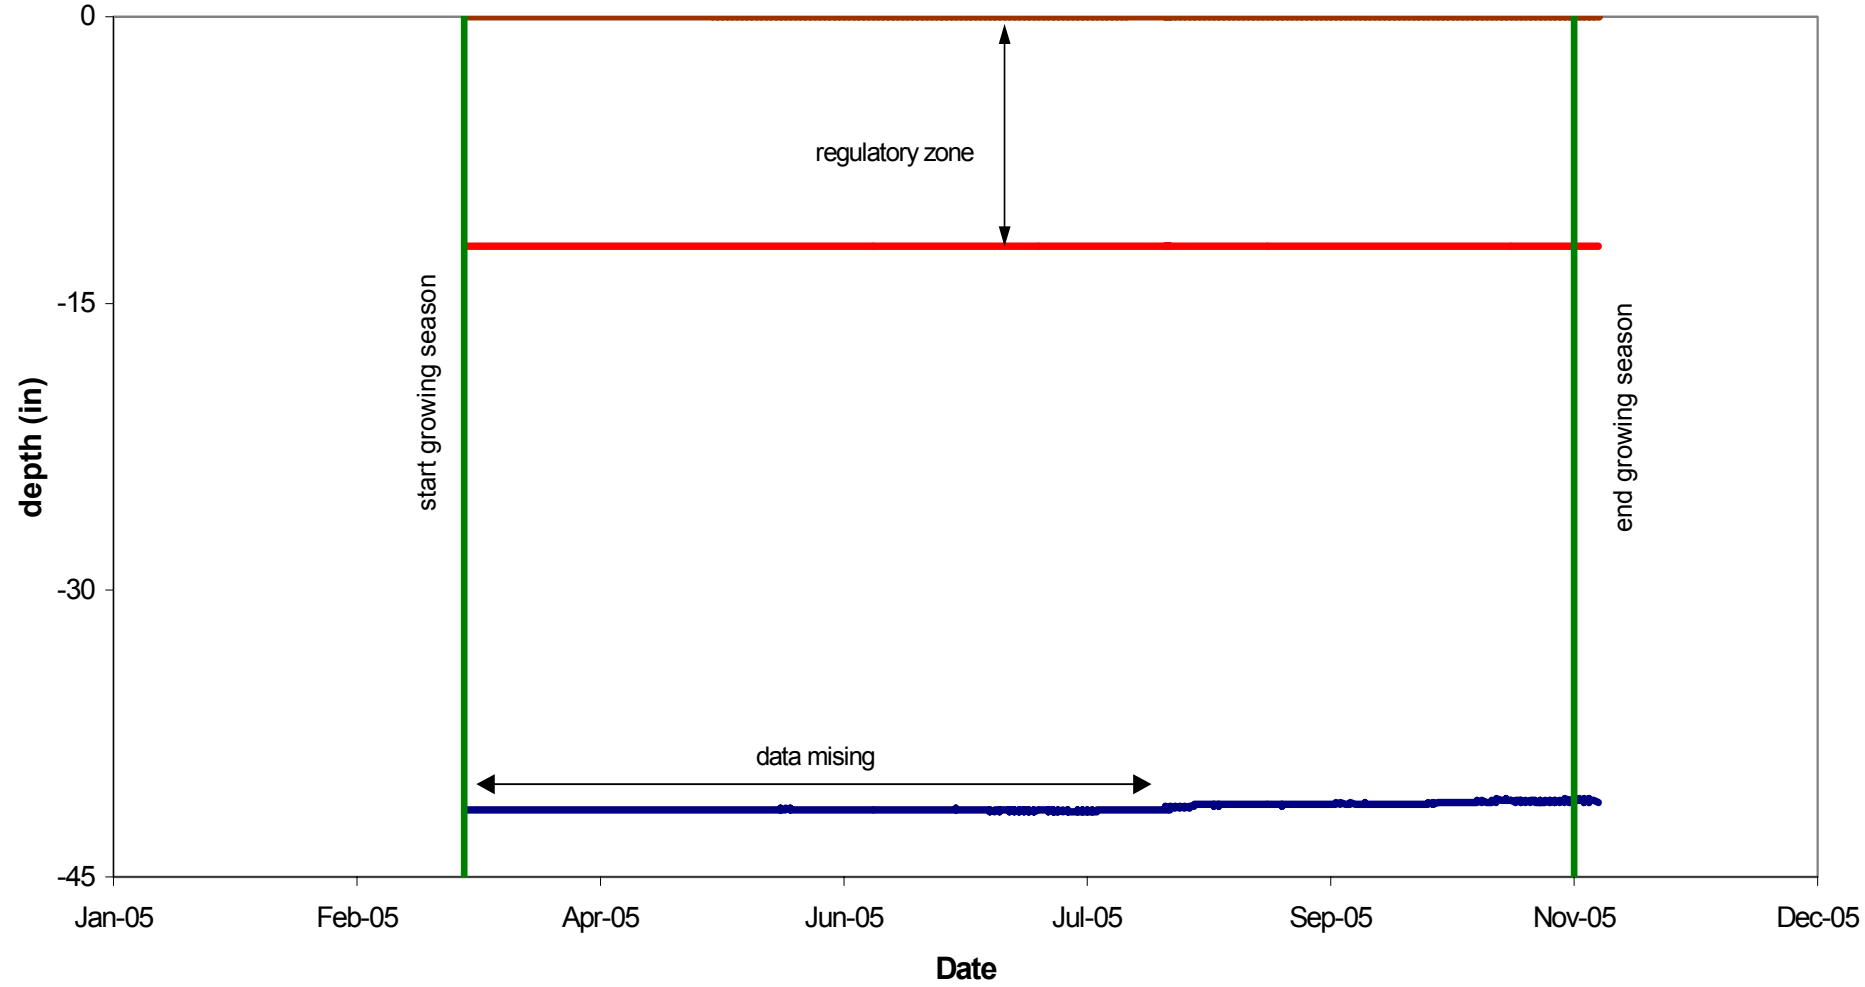
Data collected by a few of the newly installed RDS gages is also presented in Appendix B. The gages were installed in the beginning of August and in the middle of a severe drought in the area. Two of the gages show the site to wet up quite easily, and the base groundwater level to be steadily rising with subsequent rainfalls. However, during this time there were no periods meeting the wetness criteria. The longest period with water table depths within the first 12 inches was 4 days. Data shown from one of these gages exhibited only small changes in water table depths. This may be because the depth was initially below the maximum that can be read by these gages (41 inches).
