MITIGATION PLAN

Final Report for IRT

HUNTSMAN MITIGATION SITE

Wilkes County, NC

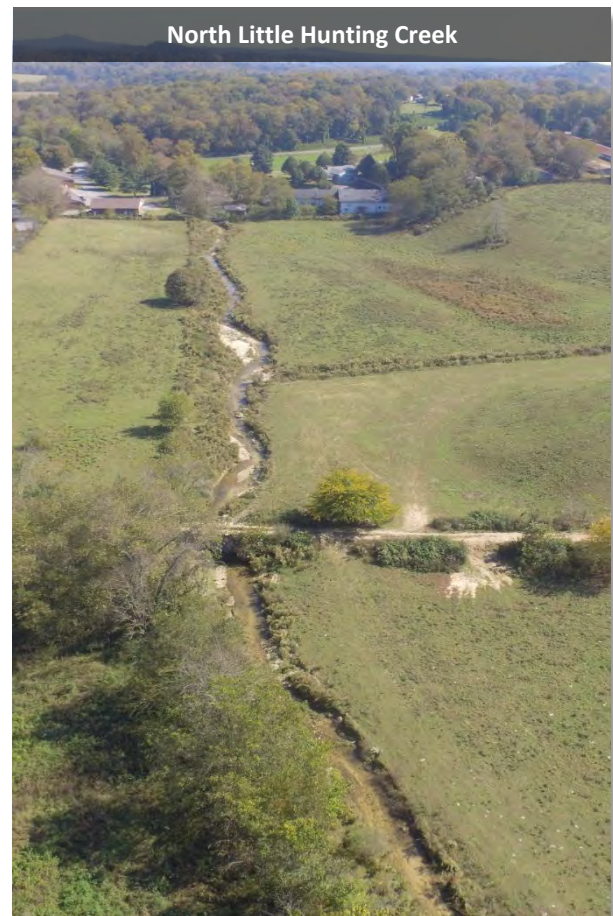
North Little Hunting Creek is classified as a moderately to slightly entrenched Rosgen G4 channel. The stream is straight and incised, but has some floodplain access available during storms.

In the southwest corner of the property, a long, linear stream/wetland feature drains through the pasture to North Little Hunting Creek. Cattle frequently wallow in this feature.

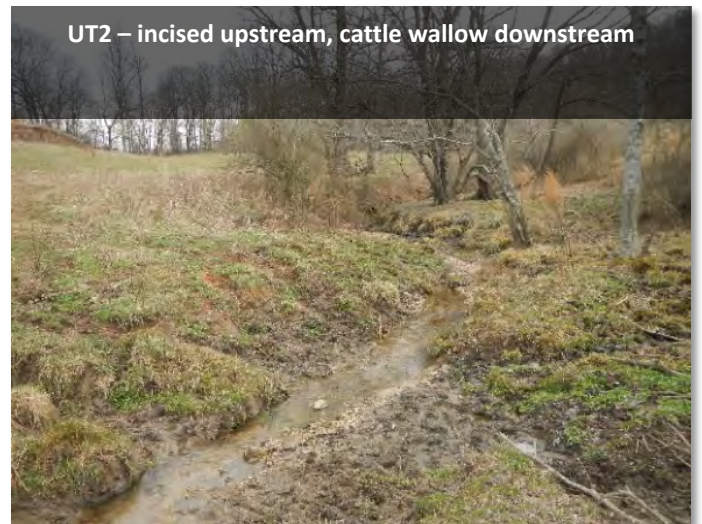
The stream bedform is stable with habitat such as stable cobble/gravel riffles, micropools, leaf packs, and woody debris. Approximately 150 LF upstream of an existing farm road crossing, the stream is confined against the left valley wall and cattle impacts increase. UT2’s valley begins to widen as it approaches the crossing. Just downstream of the crossing, UT2 begins to drop over headcuts and becomes incised and disconnected from the floodplain. UT2 regains connection to the valley downstream but loses bedform due to extreme cattle trampling. The stream becomes anastomosed due to trampling before dropping over a 3-foot headcut at its confluence with Rifle Tributary. The stream continues to be incised with areas of active erosion and drops over several

more headcuts before appearing to stabilize vertically within the incised gully. Here there is some stream bank erosion present, but the main impairment is the channel incision and confinement. As UT2's valley begins to widen and decrease in slope, erosion becomes more predominant. Downstream of UT2's confluence with Barn Branch, the stream is ditched straight out to North Little Hunting Creek. Within this section, UT2 has no bedform diversity and is a long, silted-in run. There is no woody debris present within the stream channel and is completely lacking riparian buffer. Cattle graze directly up to the stream, and the only areas where UT2 regains floodplain connectivity is where the cattle have trampled the banks for access.

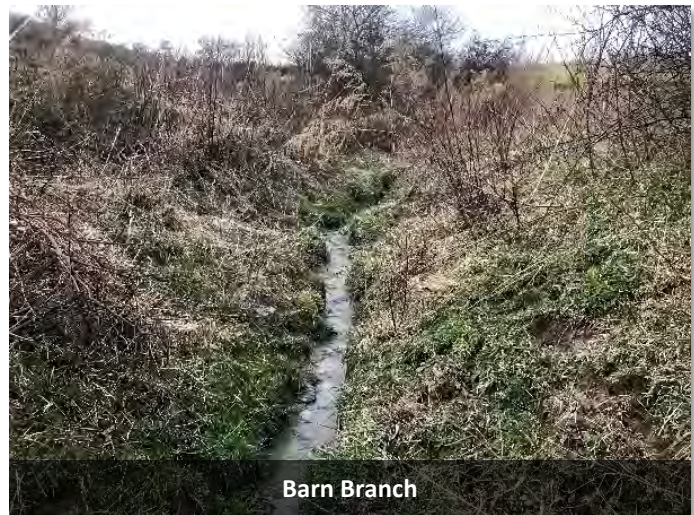
Barn Branch begins at a cattle wallow in a wetland seep. The watershed draining to the stream includes a broad, erodible, sloped pasture area. Barn Branch classifies as an B5a-type channel but is incised throughout its length. The stream is actively eroding in only one area which suggests that the fine sediments embedding the stream substrate are from the upstream pasture erosion. Available habitats include some root mats and riffles with shallow pools.

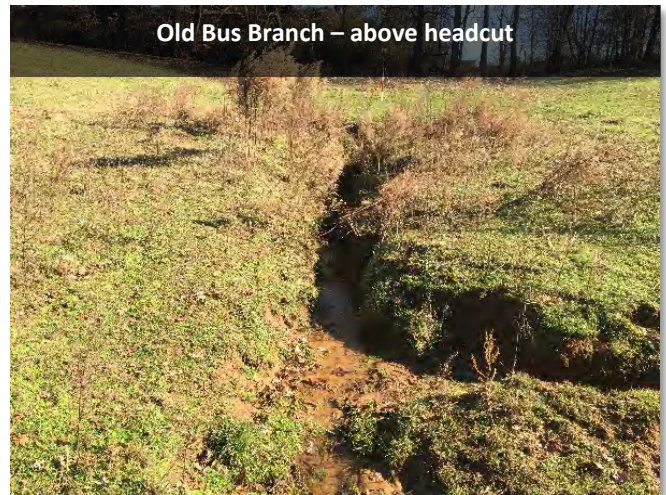
Old Bus Branch originates onsite as a perennial tributary at 10- to 15-foot headcut. Upstream of the headcut, an eroded, ephemeral swale feeds the stream. Multiple trees have fallen into the headcut, including a large tree with a massive root system which has buried the stream and resulted in subsurface flow. Downstream of the large tree, Old Bus Branch continues to be incised and eroded to its confluence with UT2. Instream habitat is limited to small gravel riffles and root mats from the large tree.

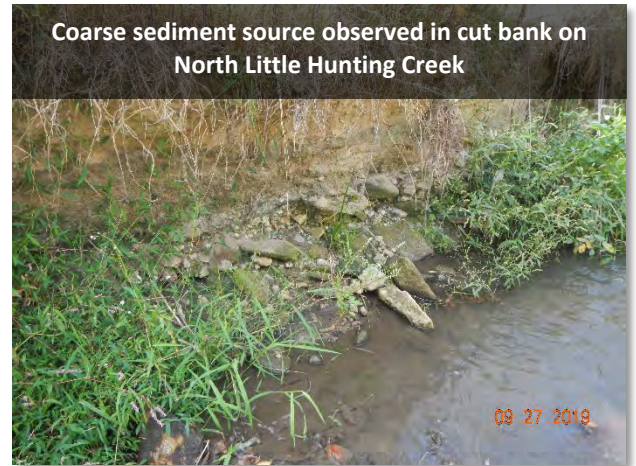
Similar to UT2, North Little Hunting Creek was reviewed near the upstream Site boundary, but full access to the watershed and stream was not possible due to private property restrictions. Above the Site, North Little Hunting Creek's bed consists of alluvially transported cobbles, gravels, and fines. North Little Hunting Creek's watershed is mostly forested except for a few agricultural parcels upstream. Stream banks on the agricultural parcel directly upstream of the Site are fenced from livestock and appear low and stable. Within the Site limits, North Little Hunting Creek's cut banks reveal a buried gravel/cobble layer, and depositional features suggest a source of both fine and coarse sediments from the watershed. It is likely that North Little Hunting Creek has areas of instability higher in the watershed that will supply the Site post-construction.

A well-developed gravel/cobble bar sample and several subpavement samples were collected on North Little Hunting Creek to understand the distribution of sediment transported during a bankfull storm event. A competence analysis performed showed that the design channel is competent to transport the largest materials delivered by the watershed during bankfull storms. Intermittent grade control structures will be incorporated to the design to protect against degradation during larger storm events, and incoming fine sediment will be addressed by stream bank stabilization, connecting the stream to a floodplain, and excavating wide point bars where fine sediment can deposit.

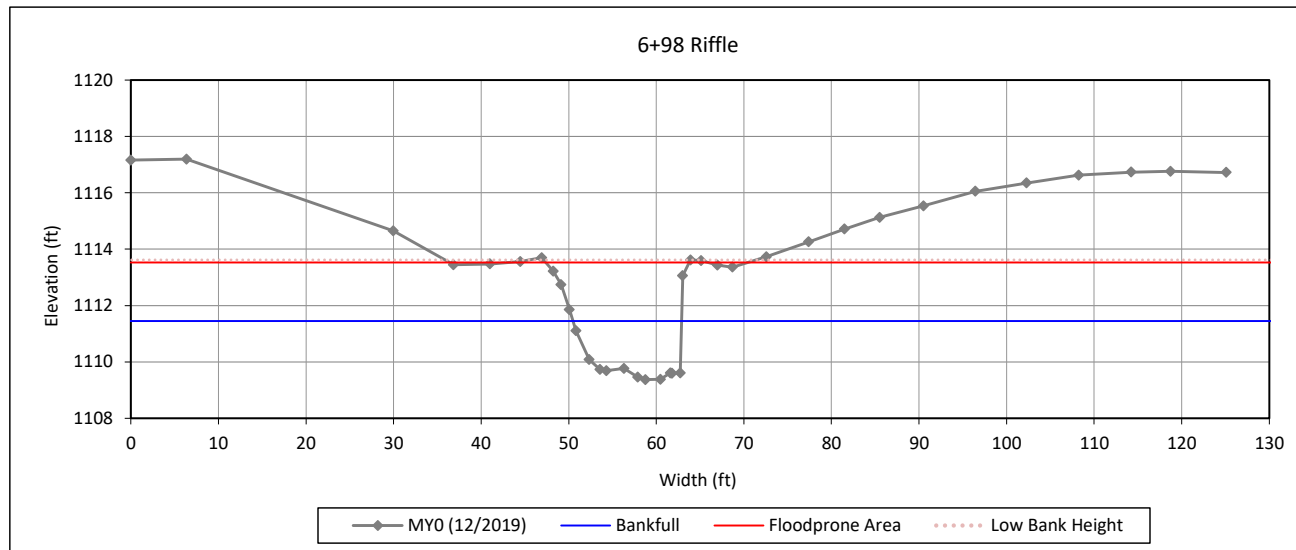
Cross-Section 3 - North Little Hunting Creek

Bankfull Dimensions

20.6	x-section area (ft.sq.)
12.4	width (ft)
1.7	mean depth (ft)
2.1	max depth (ft)
14.7	wetted perimeter (ft)
1.4	hydraulic radius (ft)
7.5	width-depth ratio
17.0	W flood prone area (ft)
1.4	entrenchment ratio
2.0	low bank height ratio

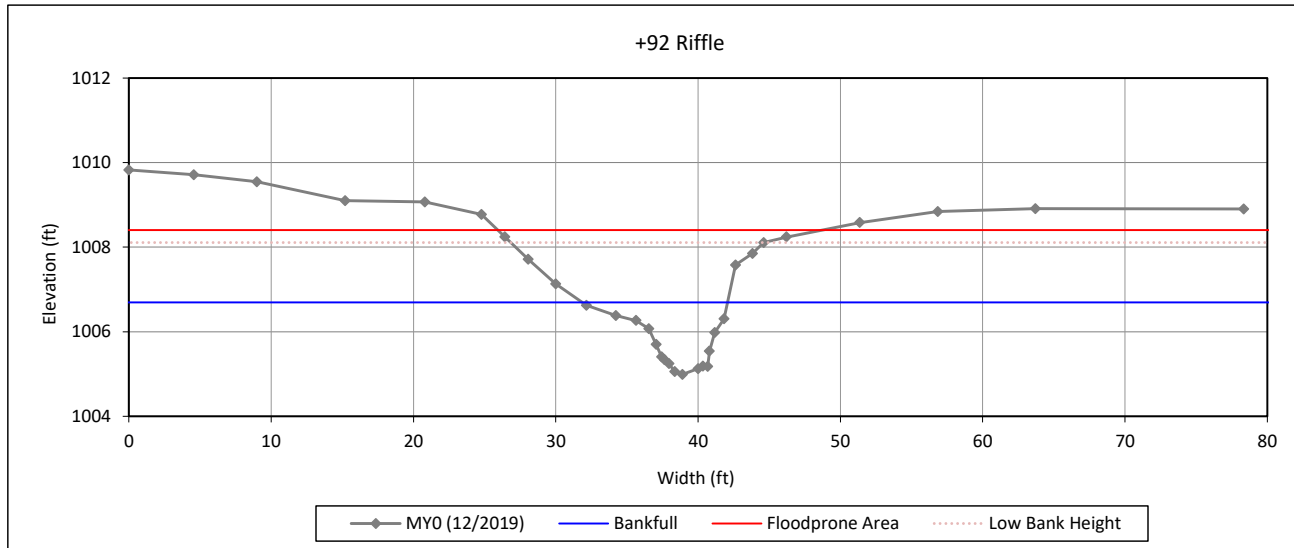
Cross-Section 6 - UT1

Bankfull Dimensions

8.2	x-section area (ft.sq.)
10.2	width (ft)
0.8	mean depth (ft)
1.7	max depth (ft)
11.3	wetted perimeter (ft)
0.7	hydraulic radius (ft)
12.7	width-depth ratio
22.7	W flood prone area (ft)
2.2	entrenchment ratio
1.8	low bank height ratio

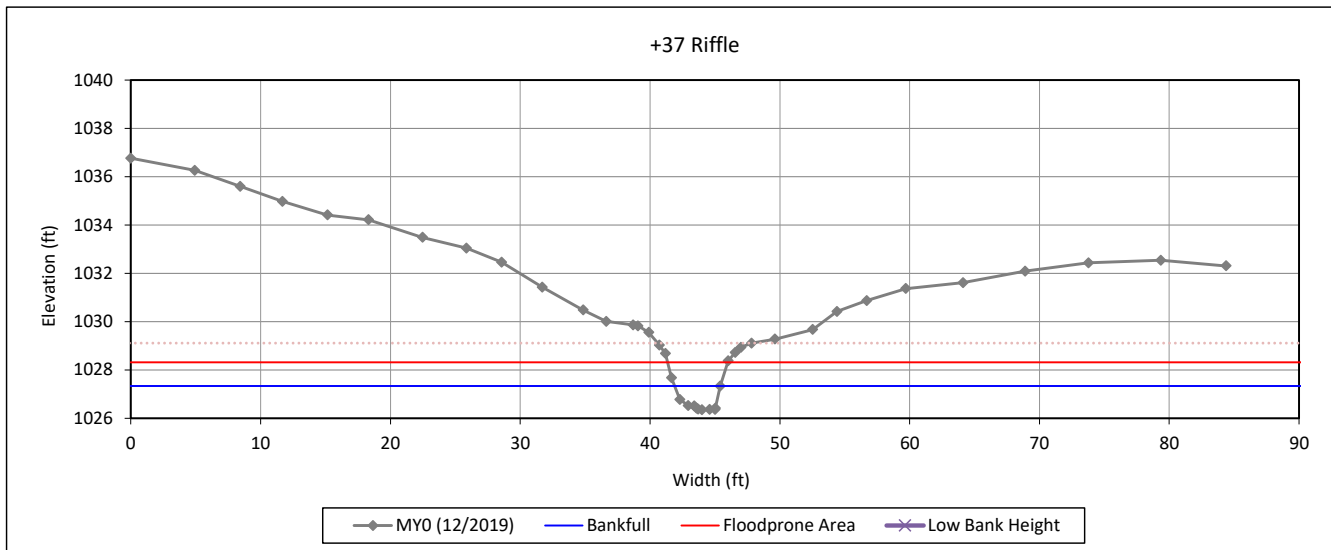
Cross-Section 8 - UT2 R2

Bankfull Dimensions

2.6	x-section area (ft.sq.)
3.5	width (ft)
0.8	mean depth (ft)
1.0	max depth (ft)
4.5	wetted perimeter (ft)
0.6	hydraulic radius (ft)
4.7	width-depth ratio
4.6	W flood prone area (ft)
1.3	entrenchment ratio
2.8	low bank height ratio

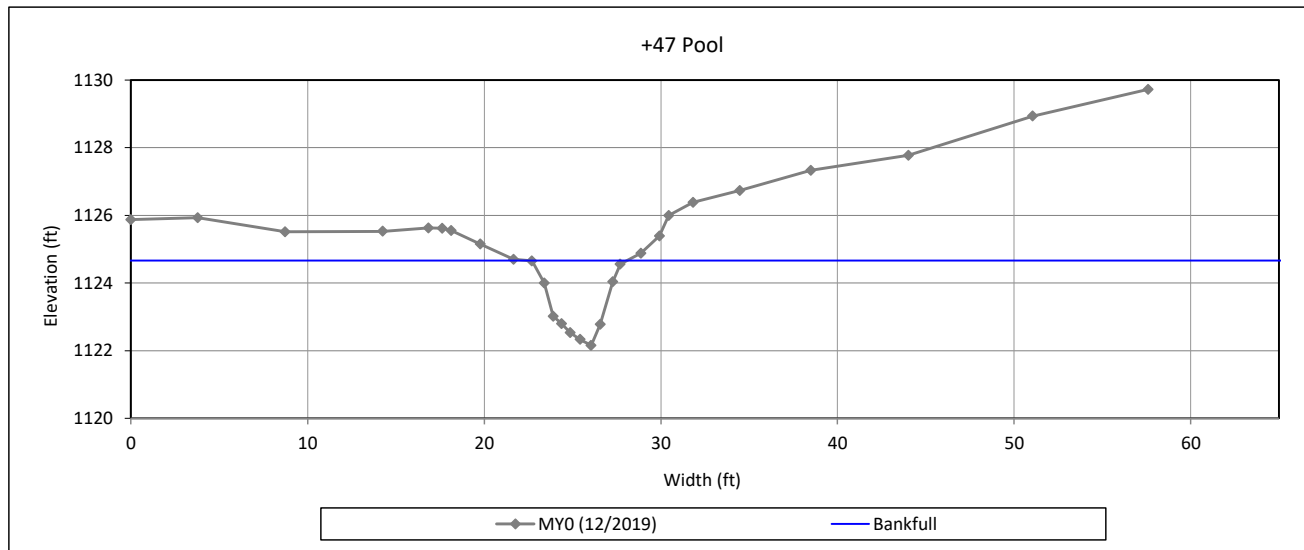
Cross-Section 9 - UT2 R3

Bankfull Dimensions

7.5	x-section area (ft.sq.)
5.0	width (ft)
1.5	mean depth (ft)
2.5	max depth (ft)
7.3	wetted perimeter (ft)
1.0	hydraulic radius (ft)
3.3	width-depth ratio

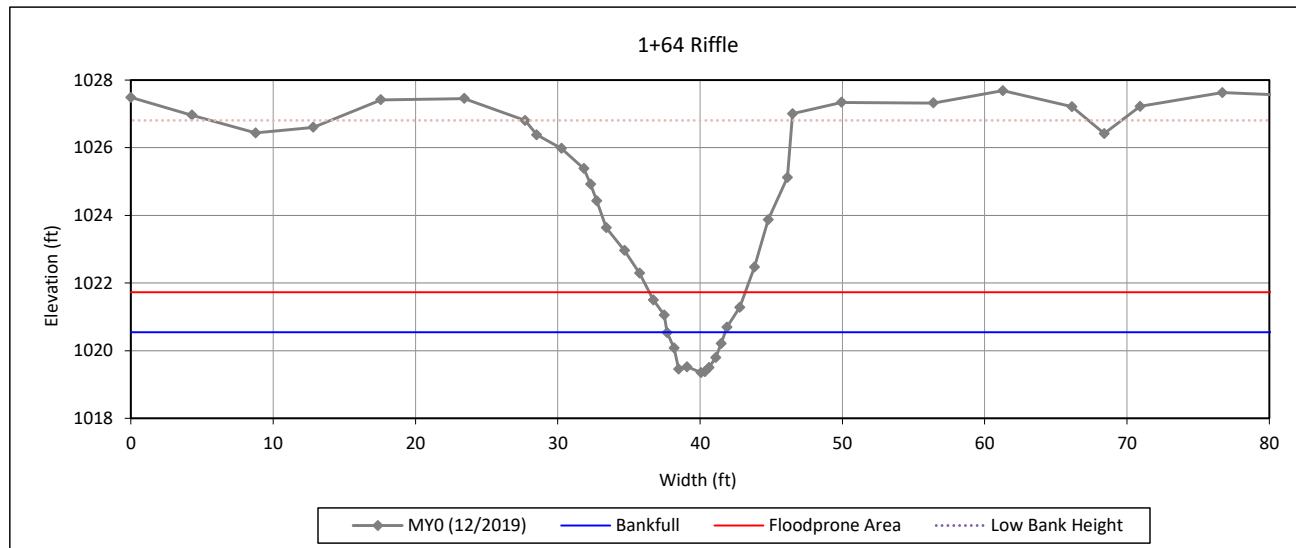
Cross-Section 12 - Old Bus Branch

Bankfull Dimensions

3.4	x-section area (ft.sq.)
4.1	width (ft)
0.8	mean depth (ft)
1.2	max depth (ft)
5.1	wetted perimeter (ft)
0.7	hydraulic radius (ft)
4.9	width-depth ratio
6.8	W flood prone area (ft)
1.7	entrenchment ratio
6.3	low bank height ratio

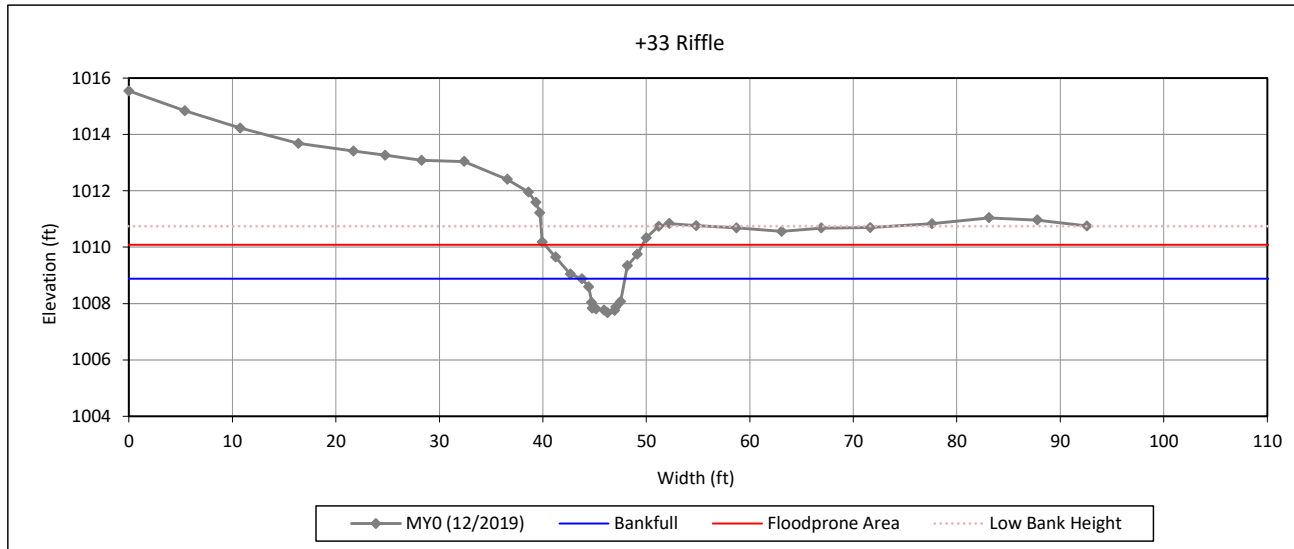
Cross-Section 13 - Barn Branch

Bankfull Dimensions

3.3	x-section area (ft.sq.)
3.8	width (ft)
0.9	mean depth (ft)
1.2	max depth (ft)
4.4	wetted perimeter (ft)
0.7	hydraulic radius (ft)
4.3	width-depth ratio
9.4	W flood prone area (ft)
2.5	entrenchment ratio
2.5	low bank height ratio

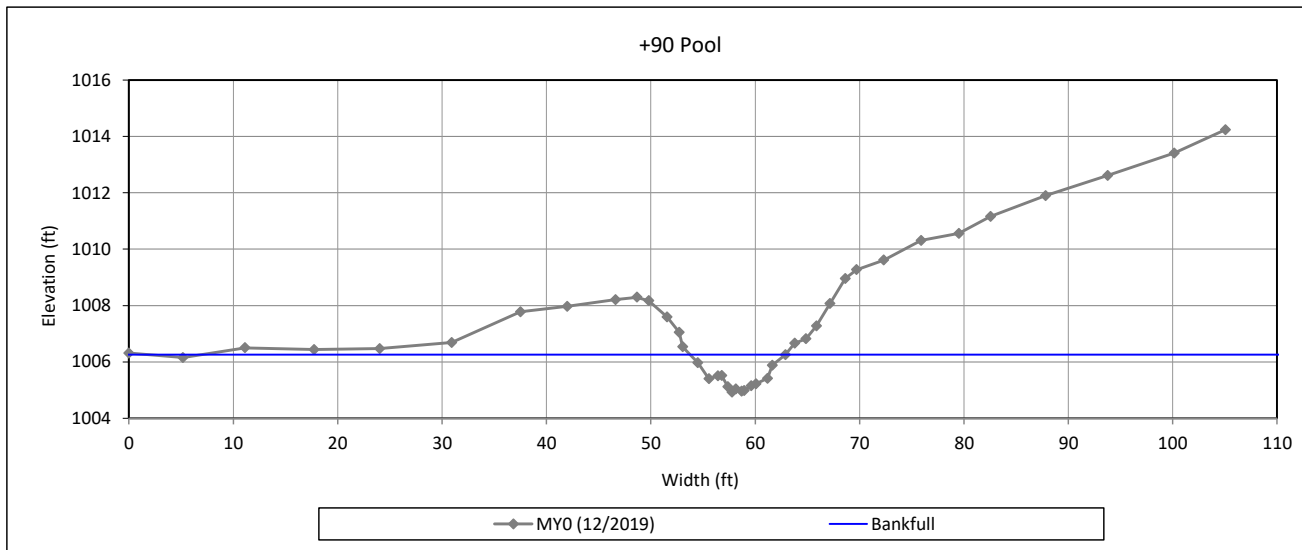
Cross-Section 14 - Barn Branch

Bankfull Dimensions

7.1	x-section area (ft.sq.)
9.1	width (ft)
0.8	mean depth (ft)
1.3	max depth (ft)
9.8	wetted perimeter (ft)
0.7	hydraulic radius (ft)
11.8	width-depth ratio

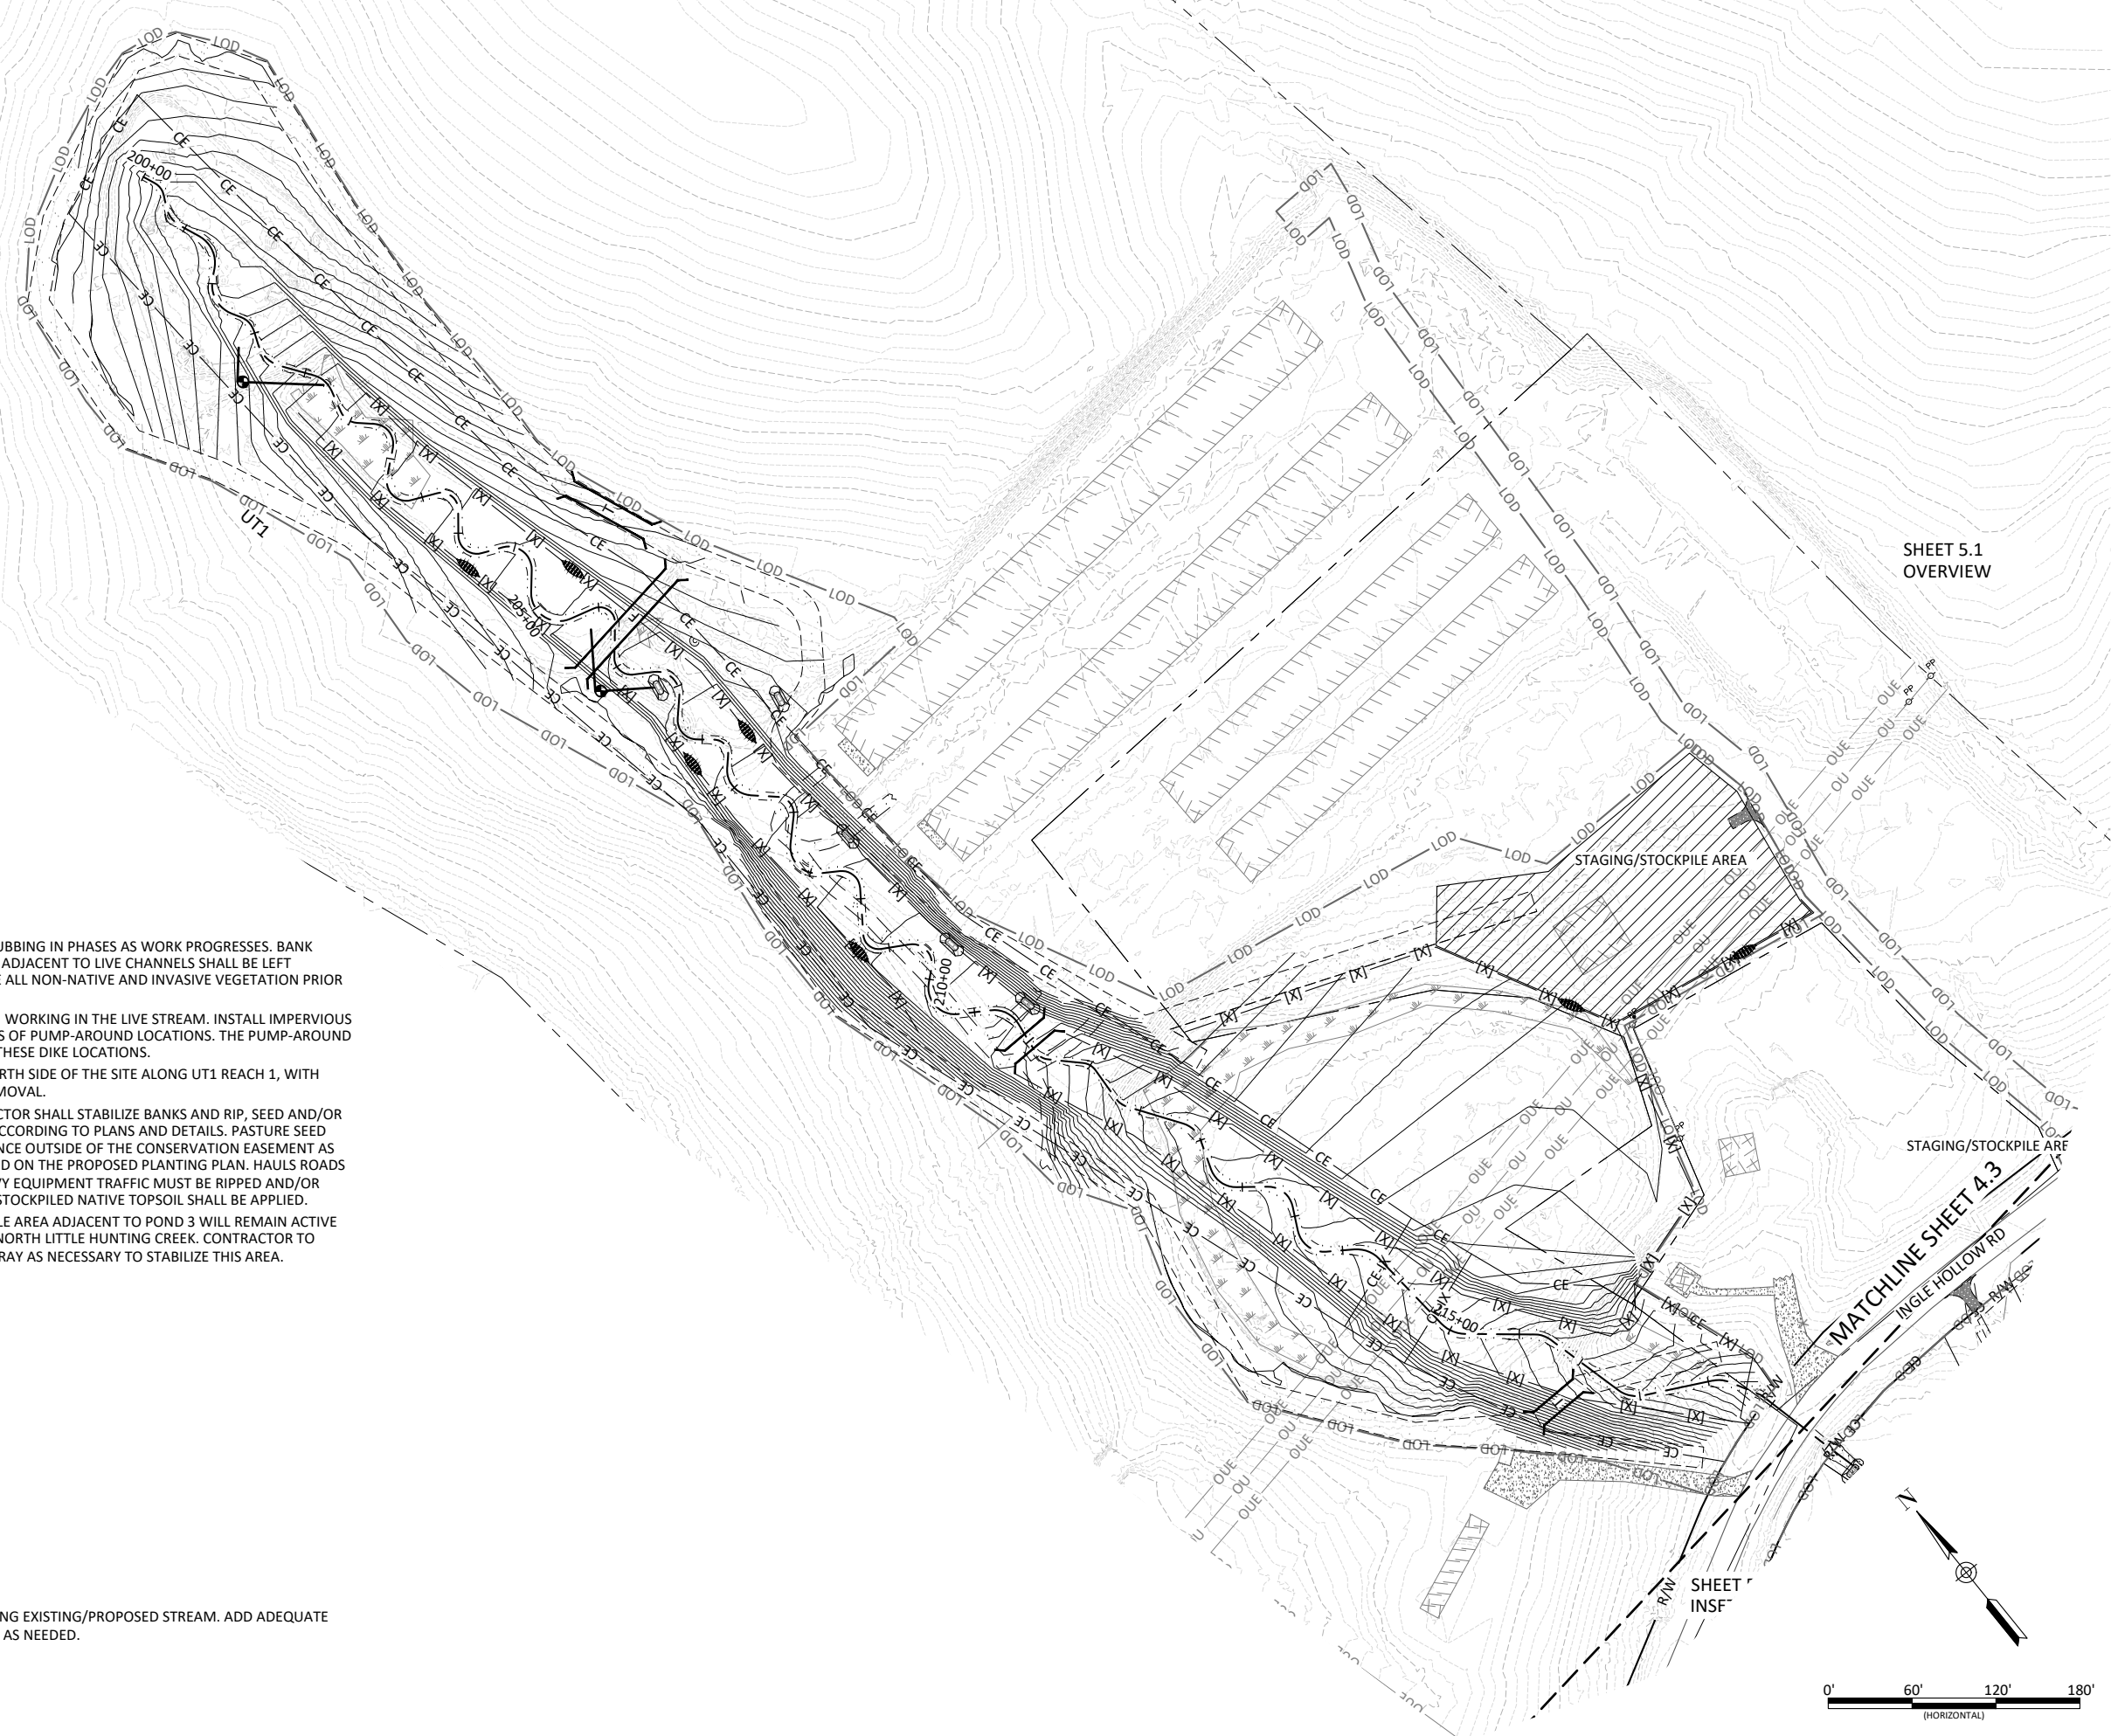
5.1

CONSTRUCTION SEQUENCE:
PHASE 2 - NORTH OF INGLE HOLLOW ROAD

1. PERFORM ANY NECESSARY CLEARING AND GRUBBING IN PHASES AS WORK PROGRESSES. BANK VEGETATION AND VEGETATION IMMEDIATELY ADJACENT TO LIVE CHANNELS SHALL BE LEFT UNDISTURBED AS LONG AS POSSIBLE. REMOVE ALL NON-NATIVE AND INVASIVE VEGETATION PRIOR TO BEGINNING CHANNEL CONSTRUCTION.

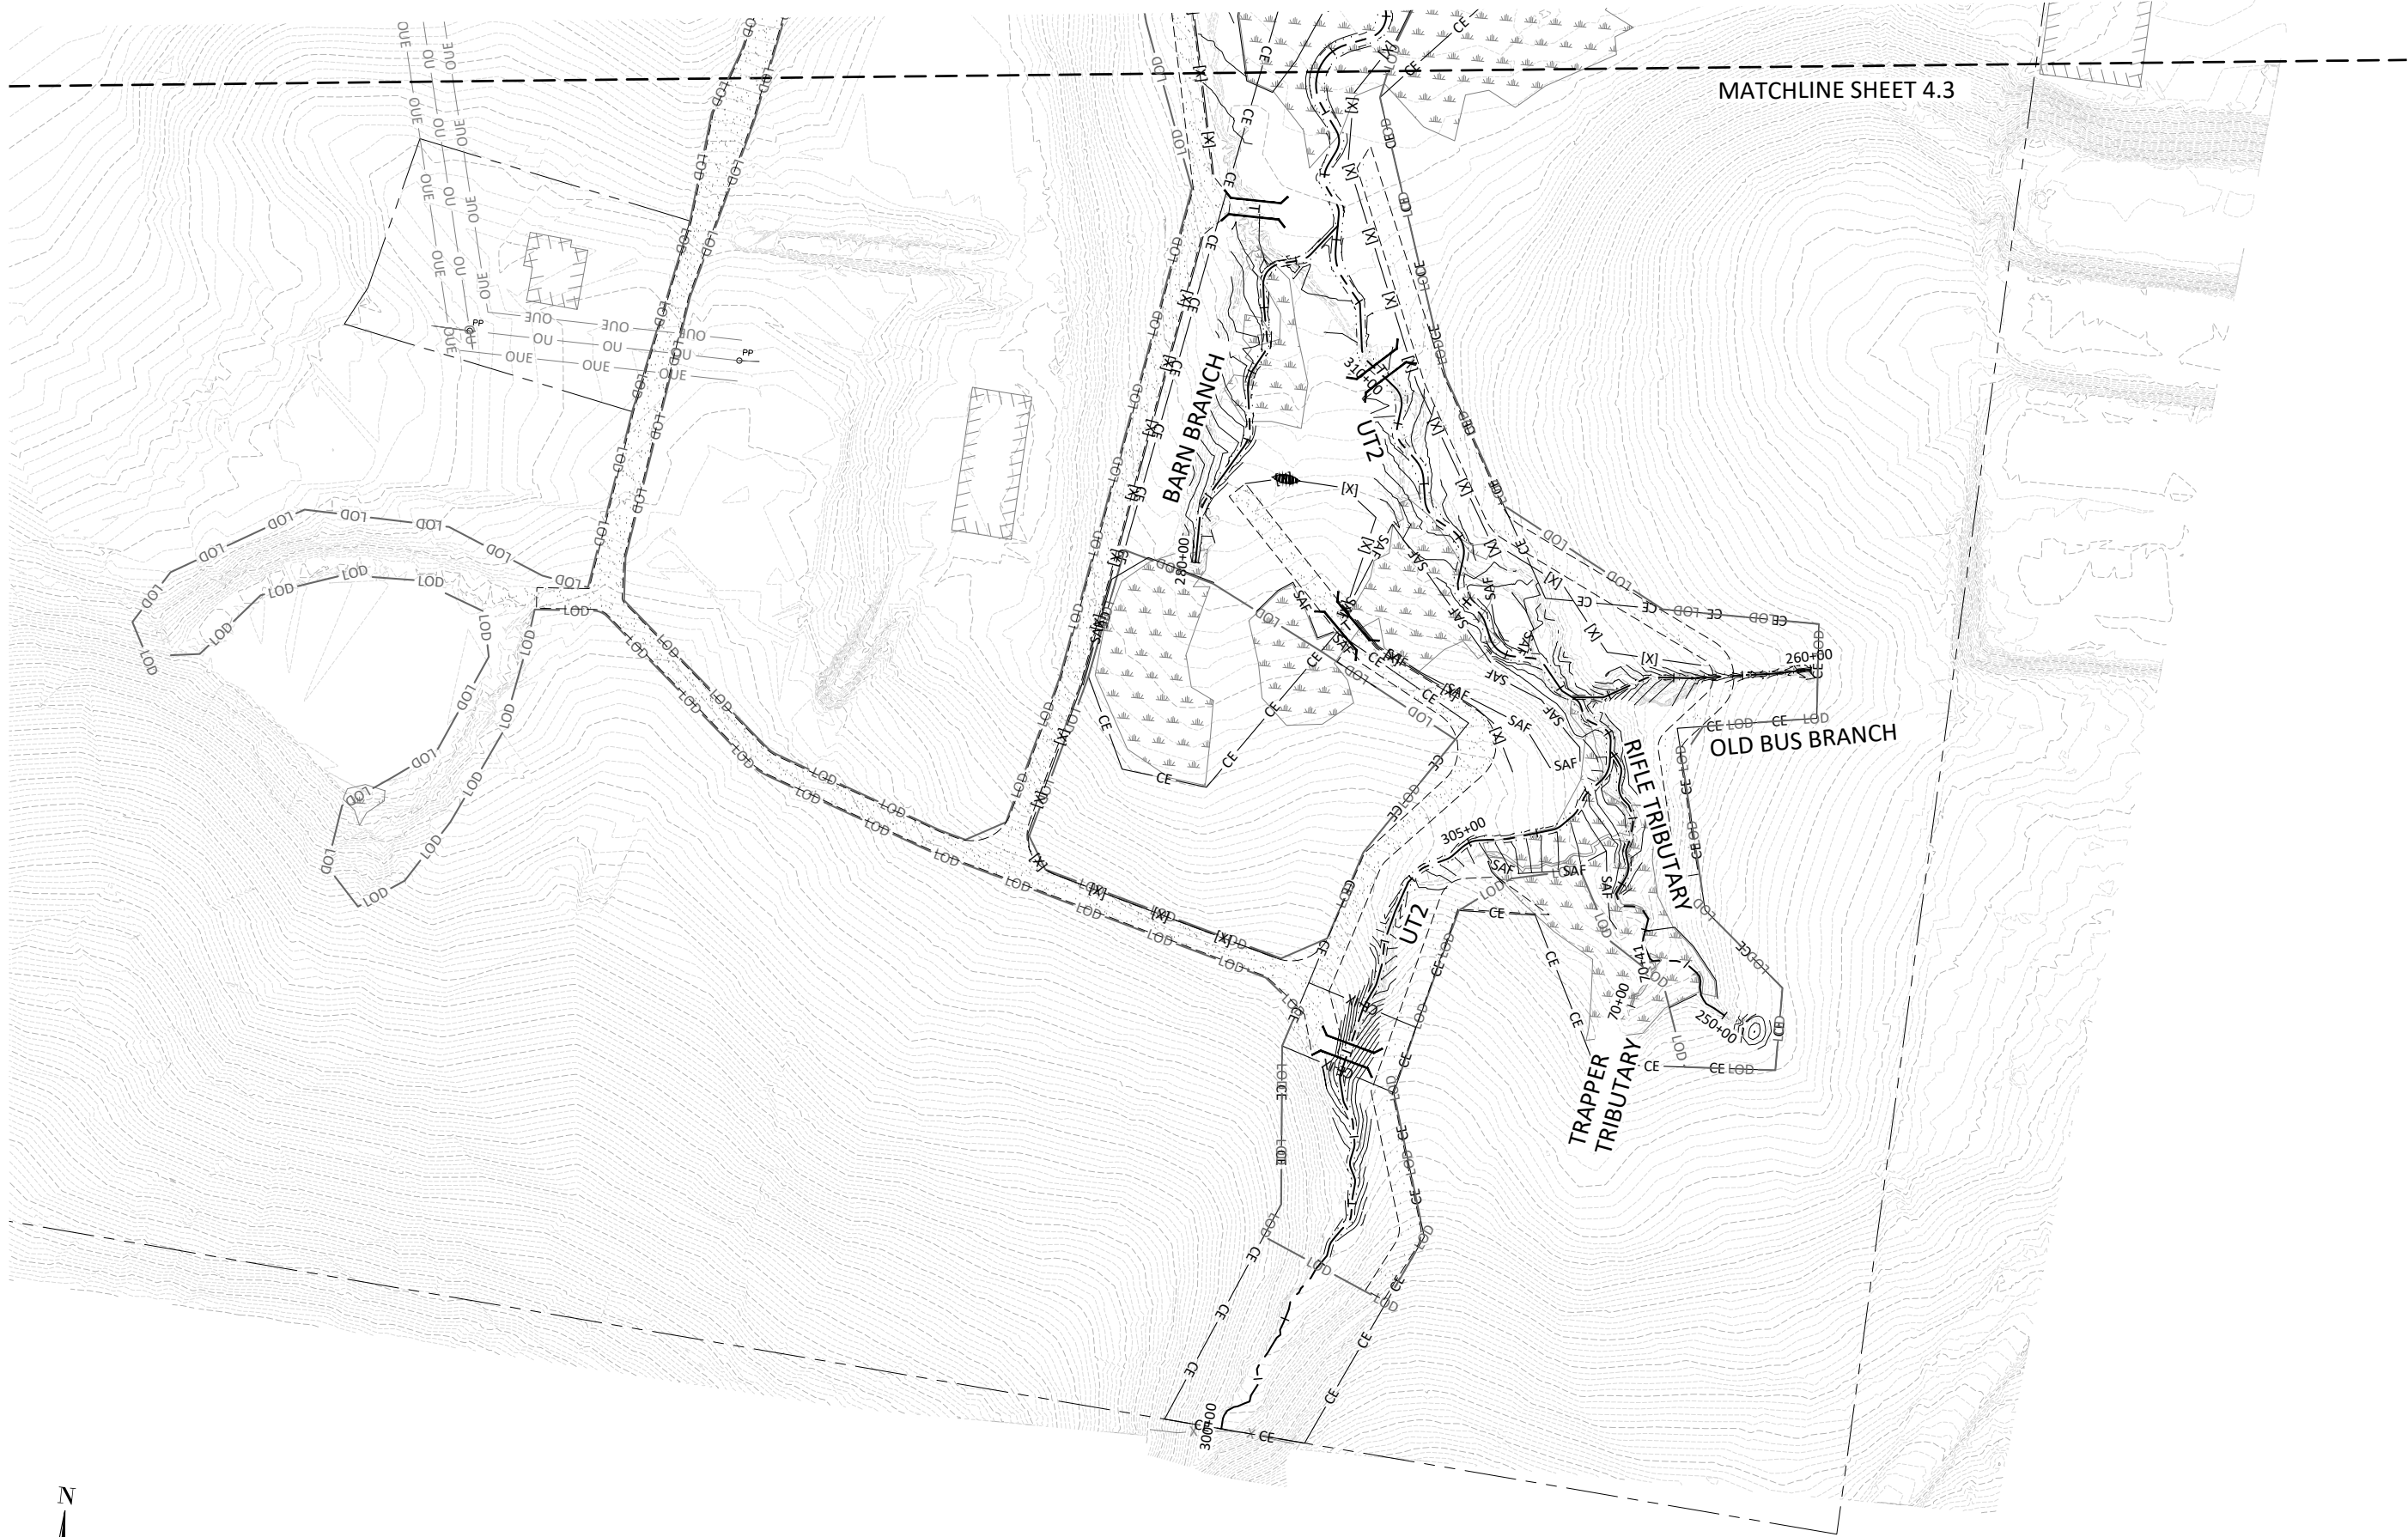
5.3

Huntsman Stream Mitigation Site
 Wilkes County, North Carolina
 PHASE 2 - UT2
 Erosion and Sediment Control Plan
