**FINAL  
ANNUAL MONITORING REPORT  
IRWIN CREEK  
RESTORATION SITE  
MECKLENBURG COUNTY, NORTH CAROLINA  
(EEP Project Number 192)**

Monitoring Year 2 of 5 (2011)

Prepared by:  
Axiom Environmental, Inc.  
218 Snow Avenue  
Raleigh, North Carolina 27603

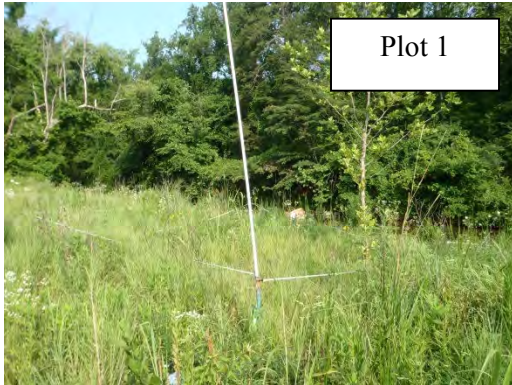
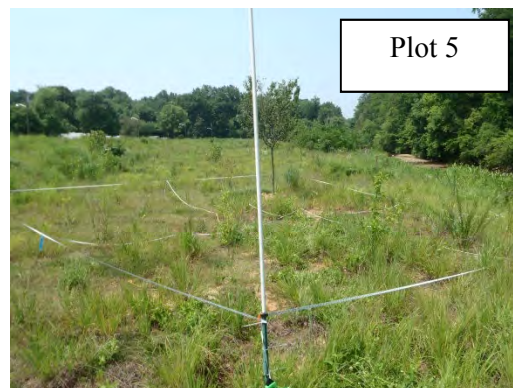
**Vegetation Monitoring Photographs  
Taken June 2011**

The dominant species identified at the Site were planted stems of silky dogwood (*Cornus amomum*), river birch (*Betula nigra*), sycamore (*Platanus occidentalis*), and green ash (*Fraxinus pennsylvanica*). In addition, each individual vegetation plot met success criteria when counting planted stems alone. In general herbaceous vegetation within the Site has been slow to establish, planted ball and burlap trees appear to be in poor health, and many of the planted trees died over the summer of 2010 as the result of dry conditions. These issues encompass the majority of the Site and should continue to be monitored closely in subsequent monitoring years.

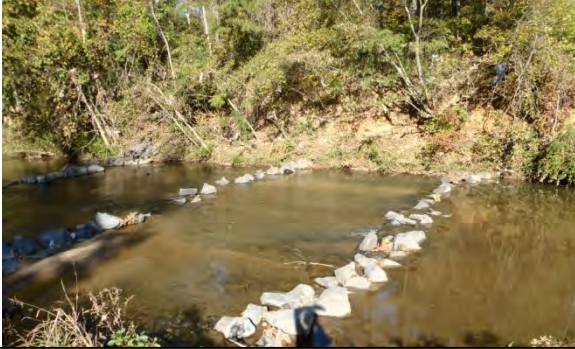
Photo Point 1: Downstream structure left in place to avoid disturbance to wetlands and stream banks in addition to provide potential aquatic habitat and channel grade control

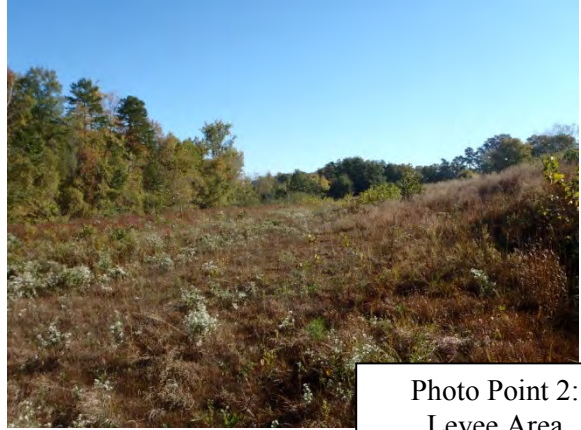
Photo Point 2:  
Levee Area

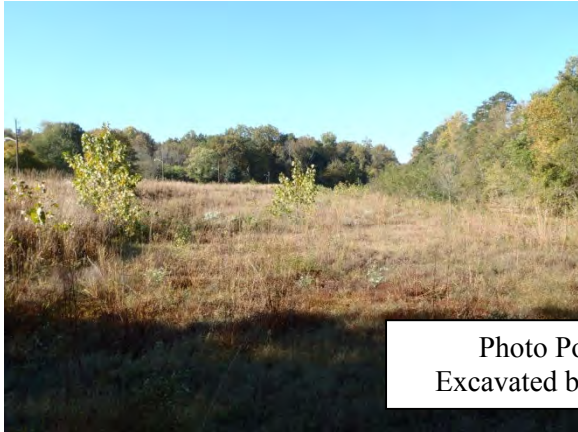
Photo Point 3:  
Excavated bench area

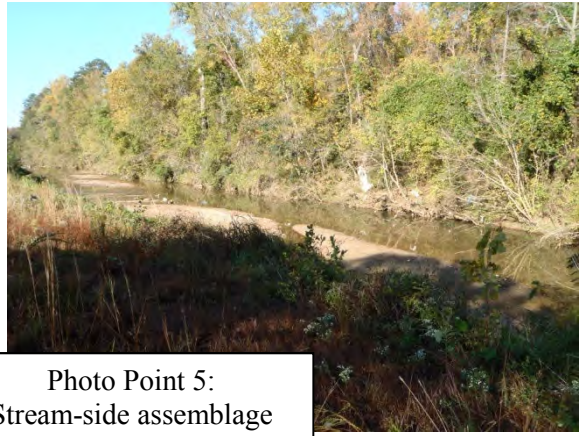
Photo Point 5:  
Stream-side assemblage
