RESTORATION PLAN
JARMANS OAK RESTORATION SITE
ONSLOW COUNTY, NORTH CAROLINA

(Contract #16-D06069-A)
FULL DELIVERY PROJECT
TO PROVIDE STREAM AND WETLAND MITIGATION
IN THE WHITE OAK RIVER BASIN
CATALOGING UNIT 03030001

December 2006

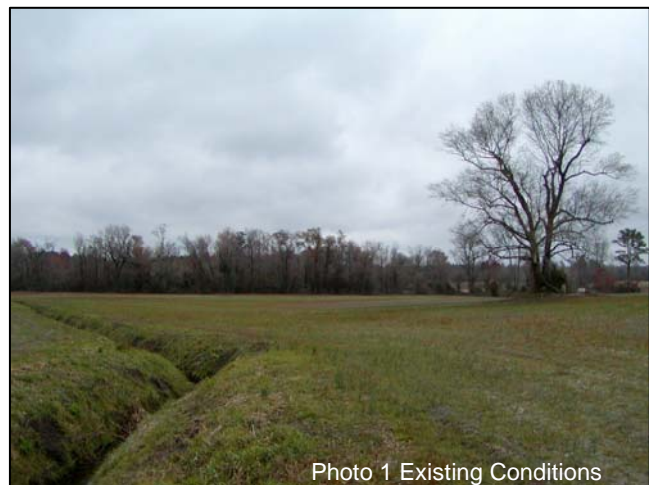
Photo 1 Existing Conditions

Site land use, including agriculture, removal of riparian vegetation, and straightening and dredging of stream channels, has resulted in degraded water quality, unstable channel characteristics (stream entrenchment, erosion, and bank collapse), and decreased wetland function.

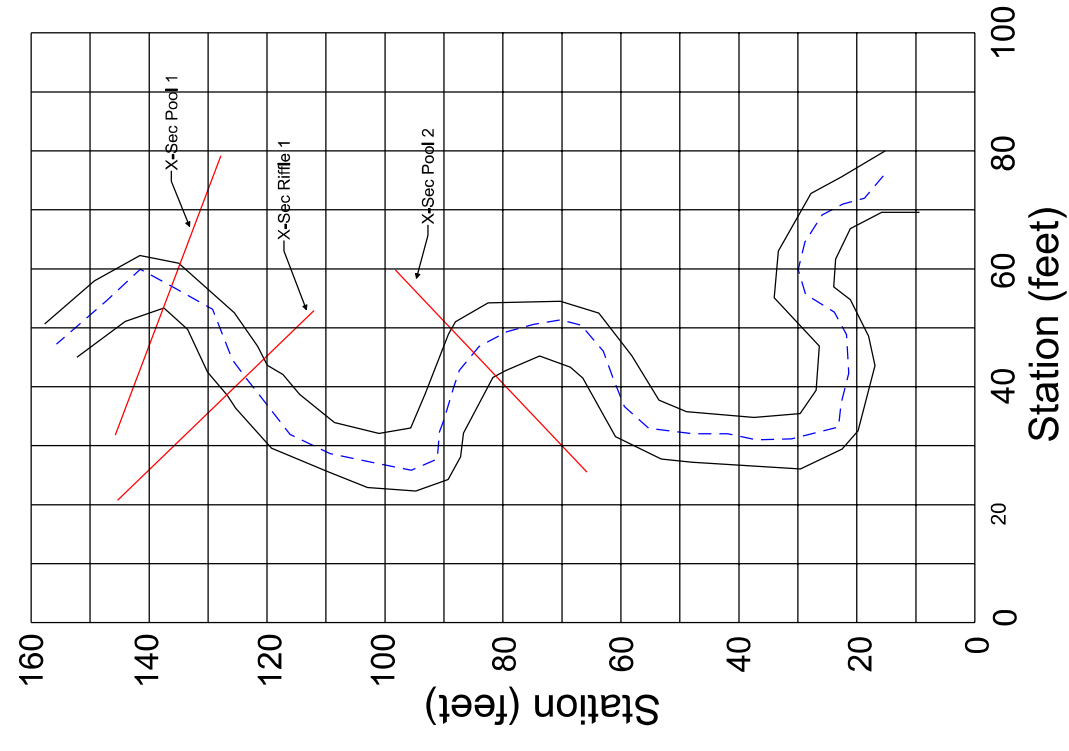
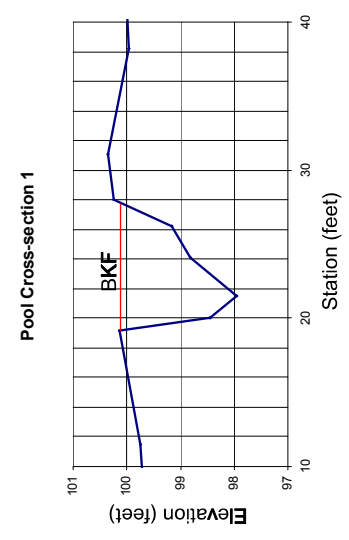
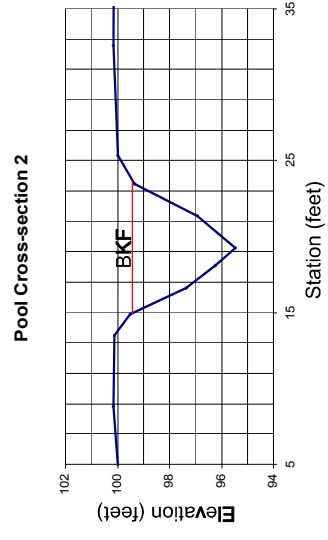
Scale: **NA**
 Date: **NOV 2006**
 Project No.: **06-018**
 FIGURE NO. **11**

Title:
**Reference Dimension,
 Pattern, and Profile**

Cross Section Riffle
 Abkf = 11.6 square feet
 Dave = 1.2 feet
 Wbkf = 9.3 feet
 Dmax = 2.3 feet
 Bank Height = 2.3 feet
 W/D = 7
 FPA = 225
 ENT = 24
 Stream Type = E

Cross Section Pool
 Apool = 11.4 square feet
 Dpool = 2.2 feet
 Wpool = 8.7 feet

Cross Section Pool
 Apool = 19.9 square feet
 Dpool = 4.0 feet
 Wpool = 9.0 feet

A relatively undisturbed reach of Bullard Branch approximately 15 miles northwest of the Site in Duplin County was utilized as the reference reach. This reference reach is characterized by an E-type channel. Distinct bankfull variables were identifiable in the reach and pattern/profile characteristics appear to have not been degraded, allowing for assistance with channel design.

Profile: Based on elevational profile surveys, the reference reach is characterized by a valley slope of 0.0055 (rise/run). Ratios of the reference reach riffle, run, pool, and glide slopes to average water surface slope are 3.2, 0.2, 0.7, and 0.6, respectively. Riffle slopes are steeper than typical for this valley type, and run slopes are flatter than typical for this valley type. Steeper riffle slopes in conjunction with shorter riffle lengths account for the moderate valley slope and allow for more moderate run slopes resulting in a channel which is neither aggrading nor degrading.

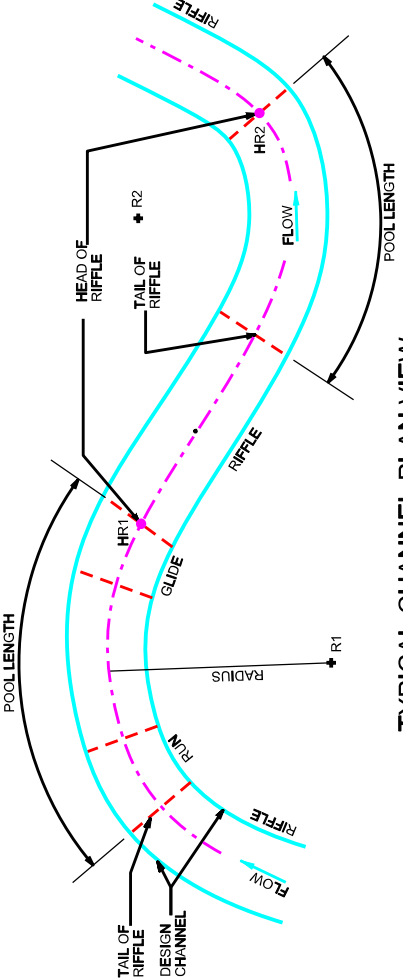
TYPICAL CHANNEL PLAN VIEW

- CHANNEL PLAN VIEW NOTES:
- THE CONTRACTOR SHALL LAYOUT THE CHANNEL ALIGNMENT BY LOCATING THE RADI AND SCRIBING THE CENTER LINE FOR EACH POOL BEND. THE CONNECTING TANGENT SECTIONS SHALL COMPLETE THE LAYOUT OF THE CHANNEL.
 - FIELD ADJUSTMENTS OF THE ALIGNMENT MAY BE REQUIRED TO SAVE TREES OR AVOID OBSTACLES. THE STAKE-OUT SHALL BE APPROVED BY THE CONSTRUCTION MANAGER BEFORE CONSTRUCTION OF THE CHANNEL.

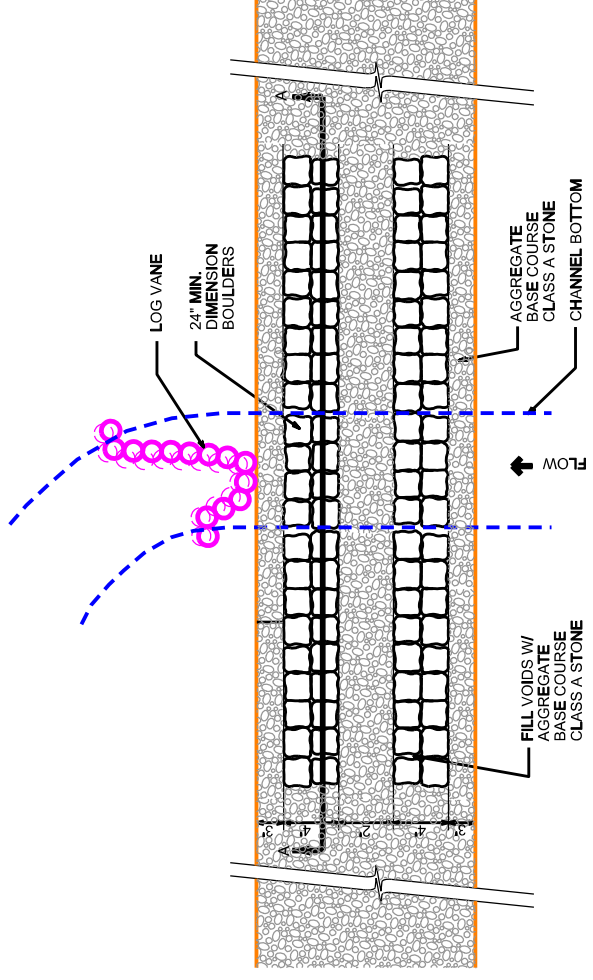
SECTION A-A

- NOTES:
- KEEP FORD CROSS FALL WITHIN 1-2% OF STREAM GRADIENT.
 - FILL VOIDS BETWEEN 24" MINIMUM DIMENSION BOULDERS W/ AGGREGATE BASE COURSE CLASS A TO CREATE DRIVEABLE SURFACE.

PERMANENT CHANNEL FORD DETAIL

PLAN VIEW
 PERMANENT CHANNEL FORD DETAIL
