DRAFT MITIGATION PLAN

The John Deere Stream and Wetland Mitigation Site
Rutherford County, North Carolina
Project No. 96917
Contract No. 6402

Broad River Basin
HUC 03050105

October 2017

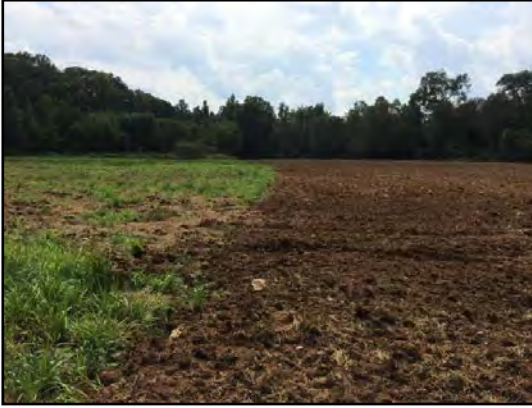
Photo 7. Drained and degraded wetland on east side.

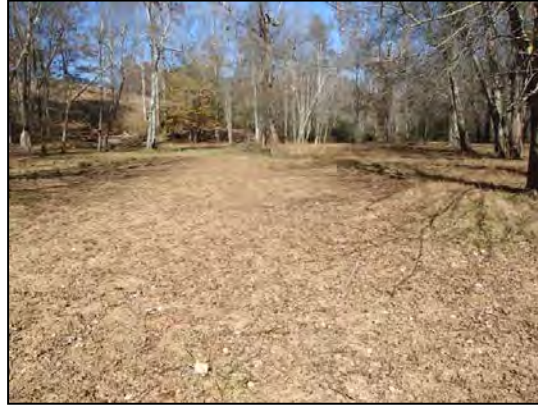
Photo 8. Drained wetland on west side.

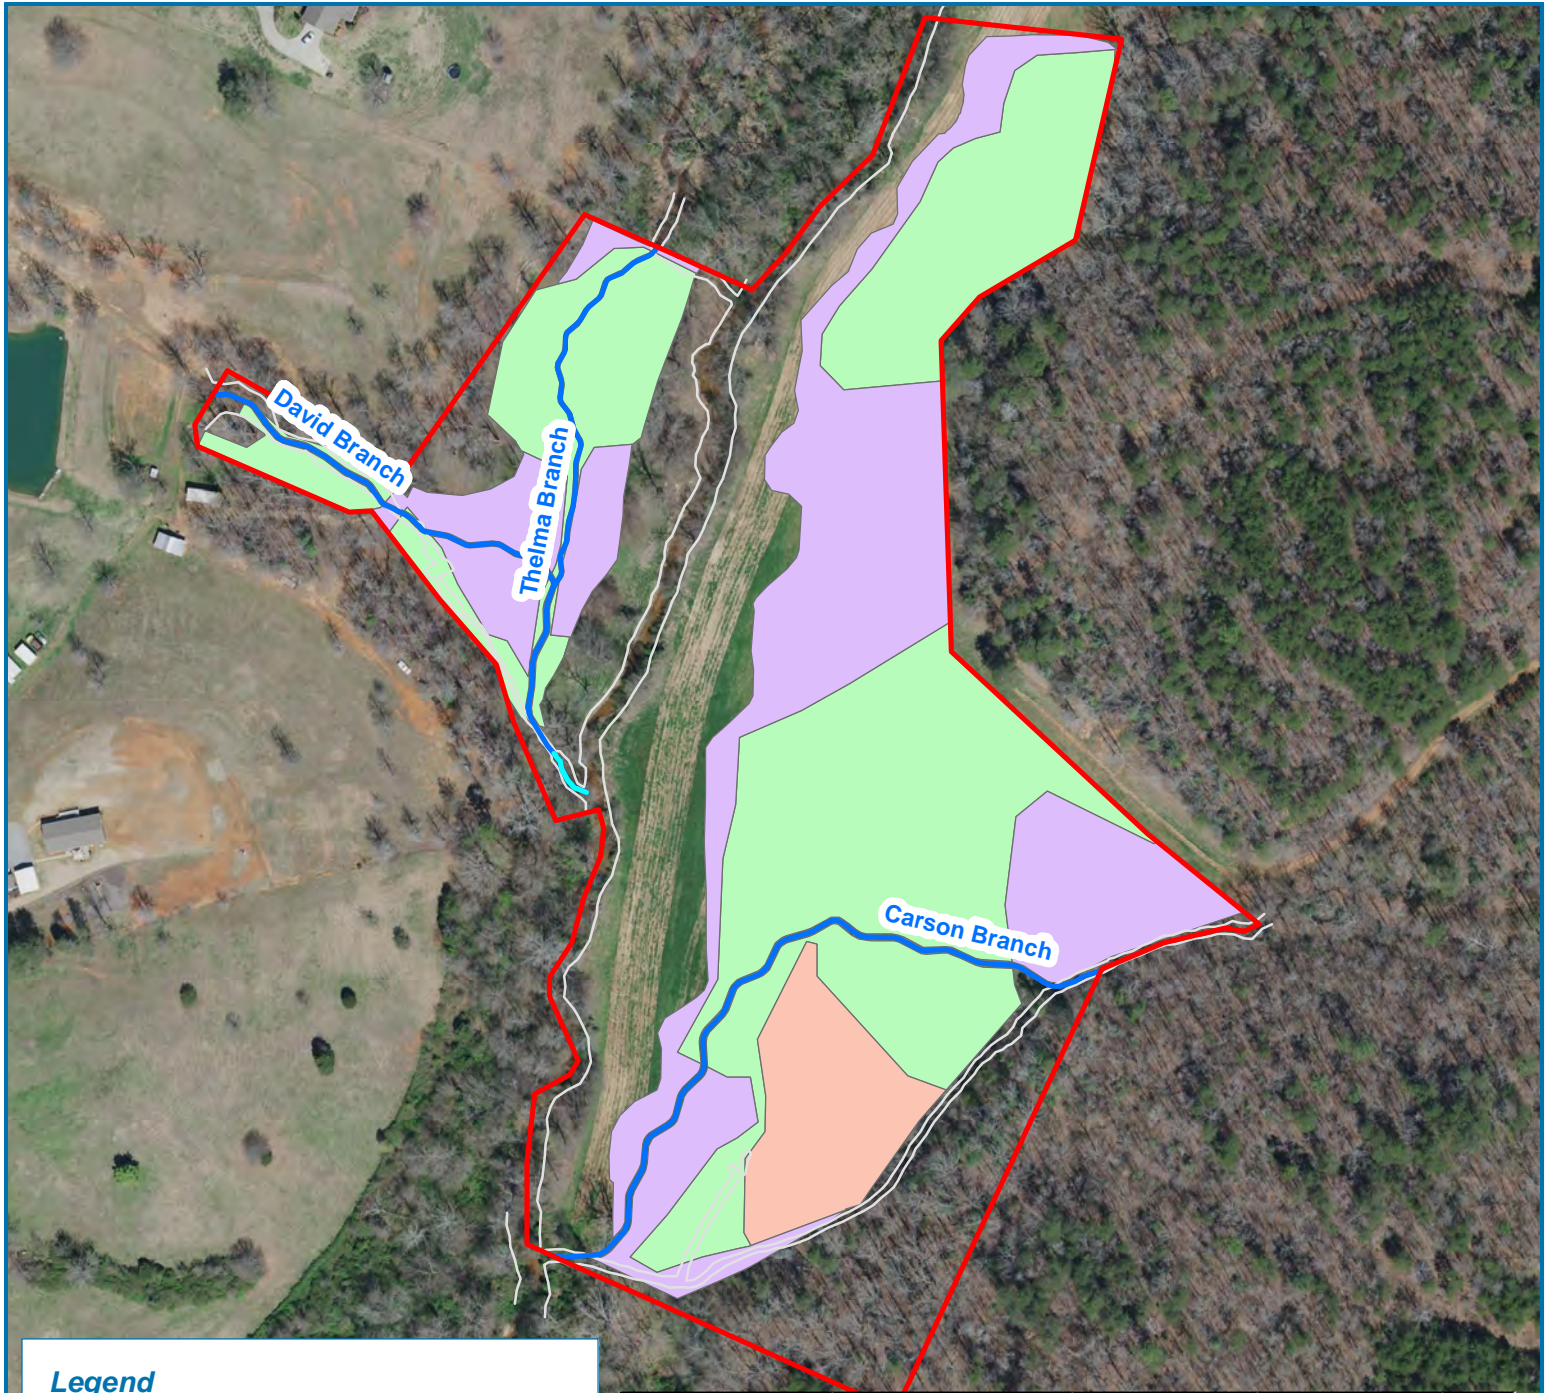
- Proposed Easement (15.37 ac)
- Proposed Streams (1783 LF)
- Existing Top of Bank

Mitigation credits presented in these tables are projections based upon site design (**Figure 9**). Upon completion of site construction, the project components and credits data will be revised to be consistent with the as-built condition.

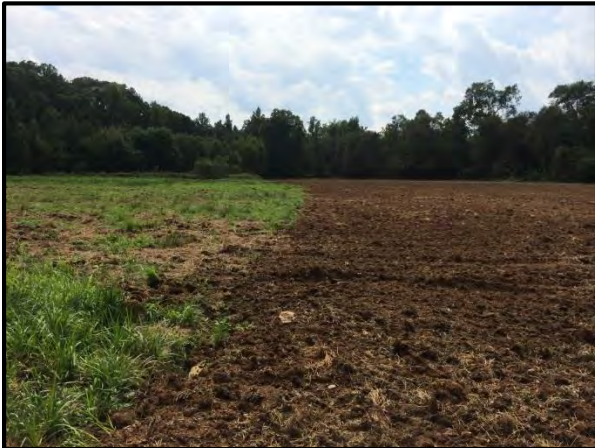
Photo 7. Drained and degraded wetland on east side.

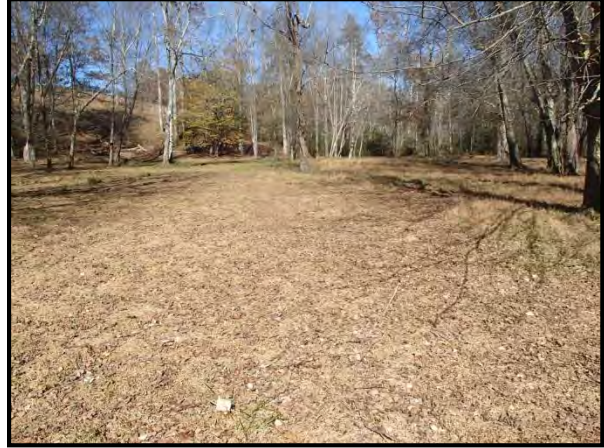
Photo 8. Drained wetland on west side.
