**UT to Little Hunting Creek (Johnson Site)
Stream Restoration Monitoring Report**

**EEP Project # 197
EEP Contract # D09078s
Monitoring Year 05**

Data Collection: September 2014

Submitted: December 2014

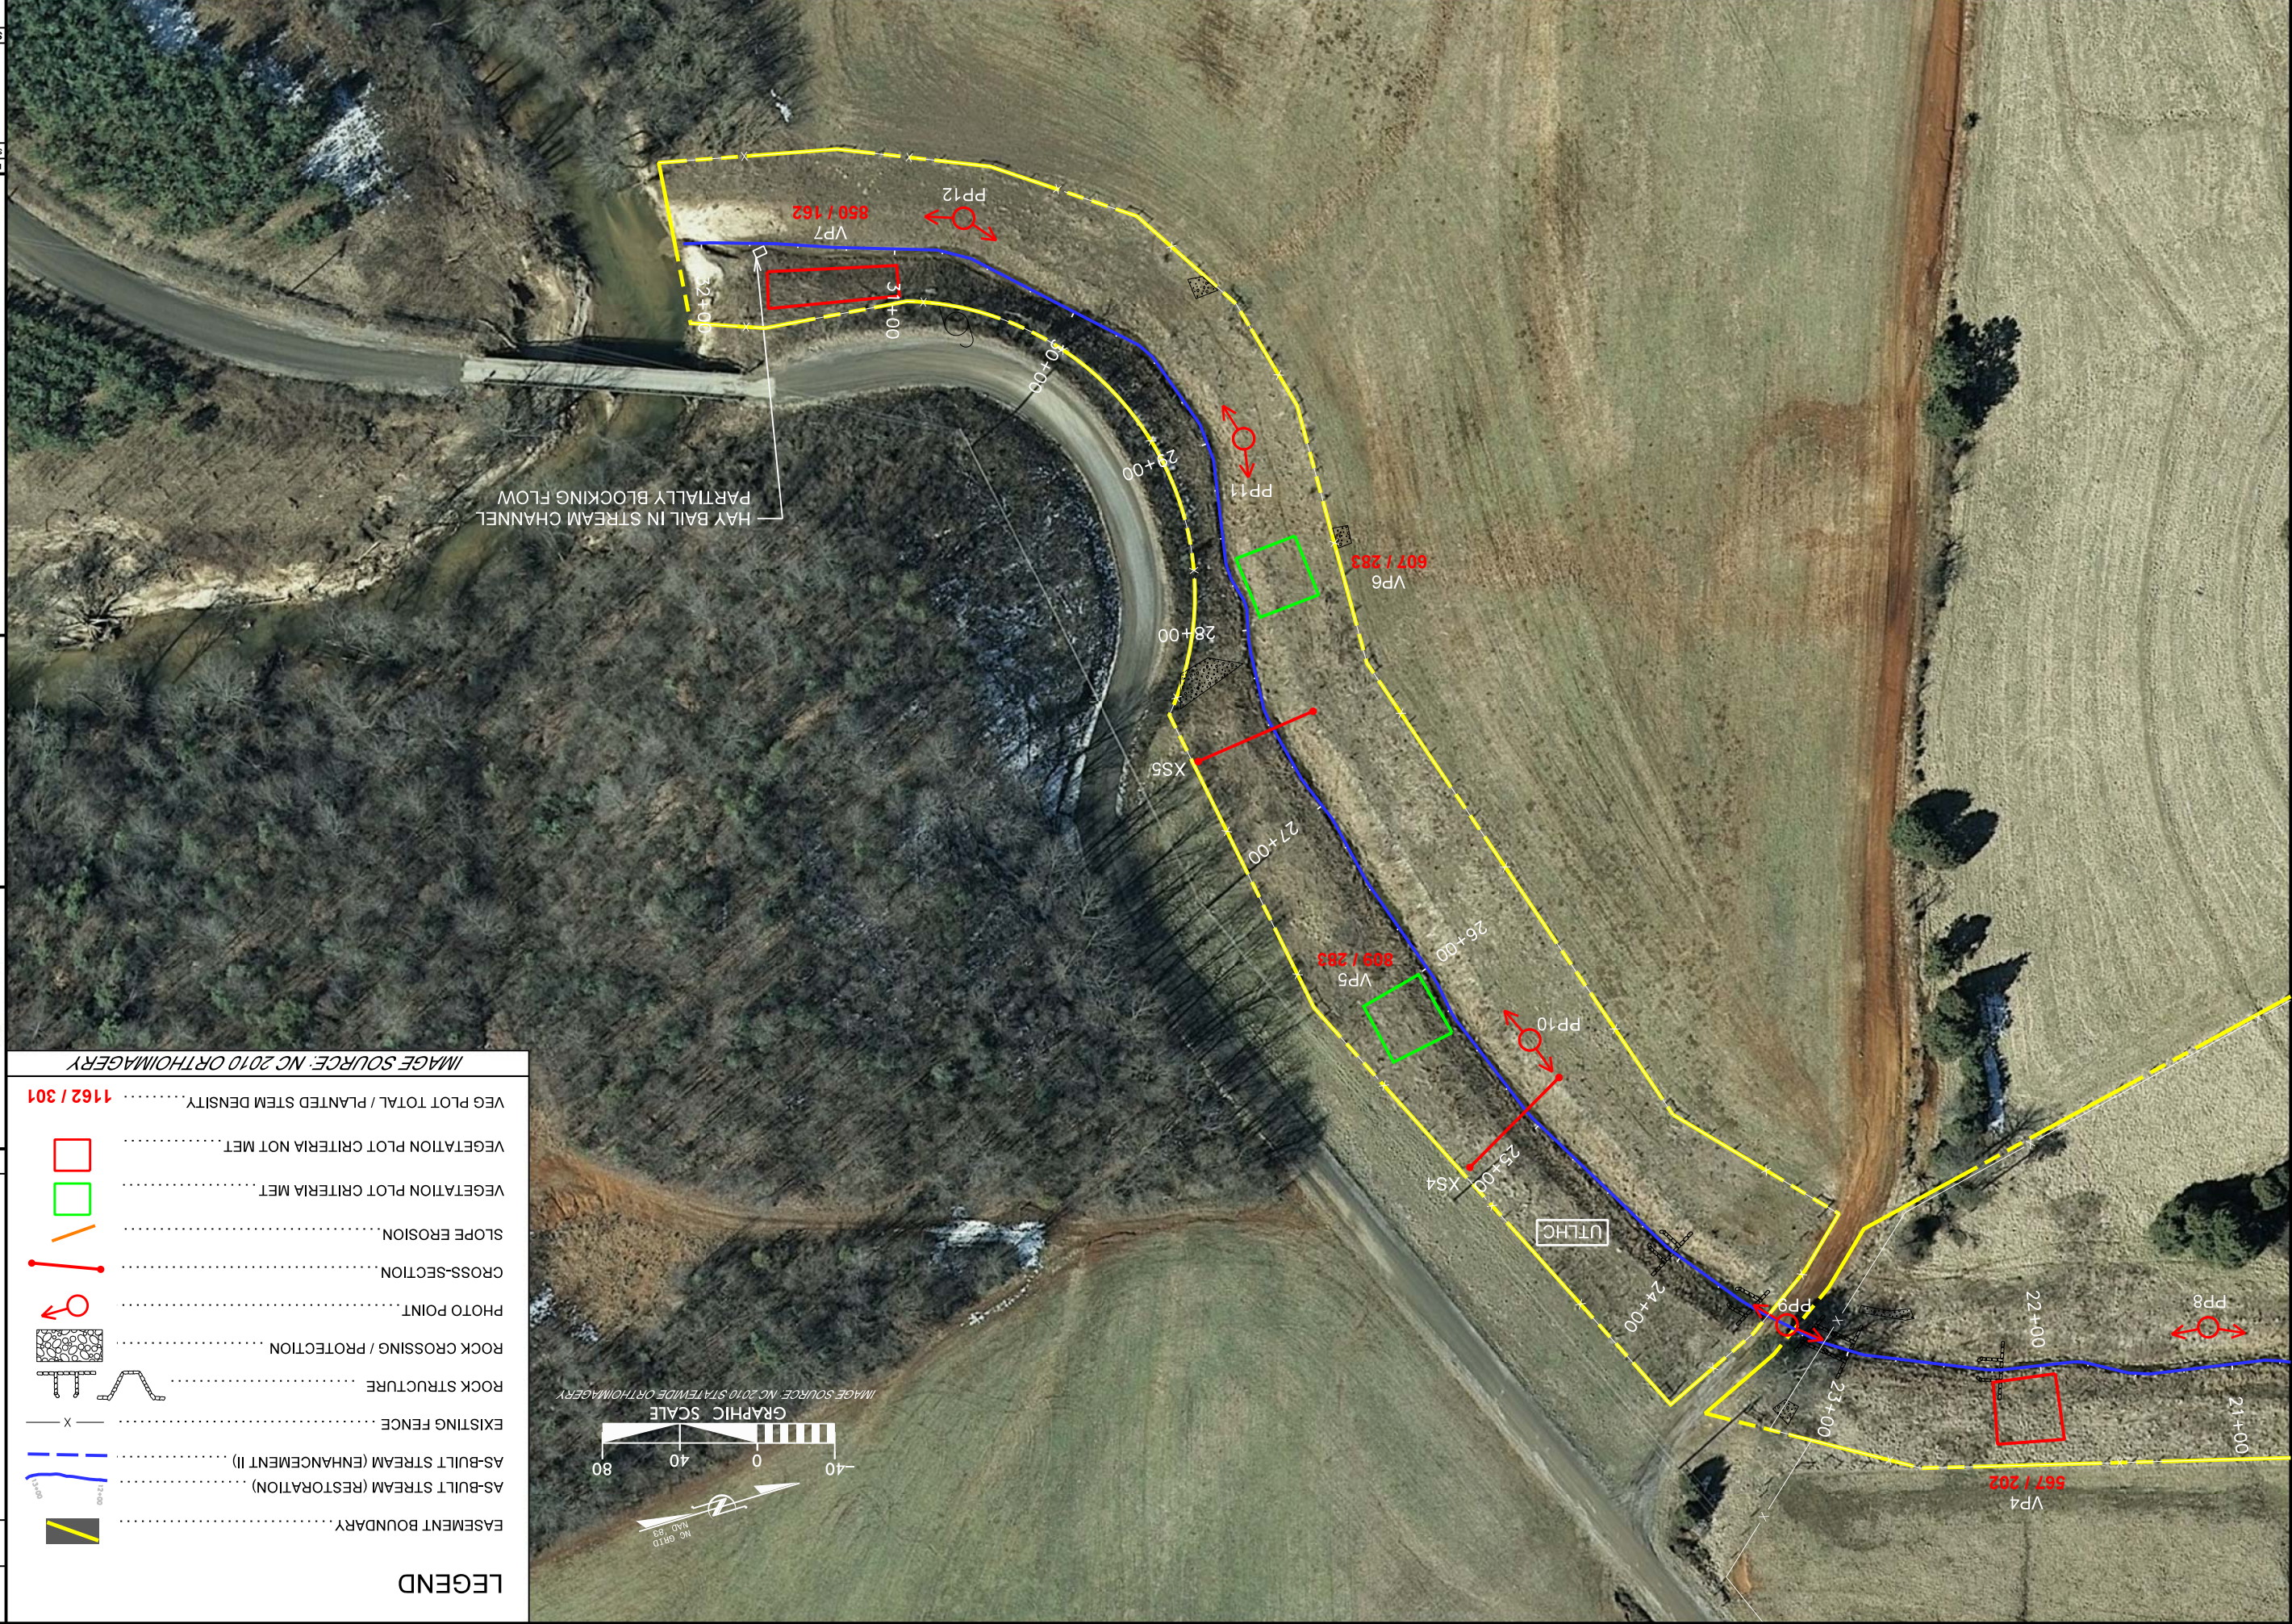
DATE: NOV 2014
SCALE: SEE GRAPHIC
CURRENT
CONDITION
PLAN VIEW
SHEET 2 OF 2

HAY BAIL IN STREAM CHANNEL
PARTIALLY BLOCKING FLOW

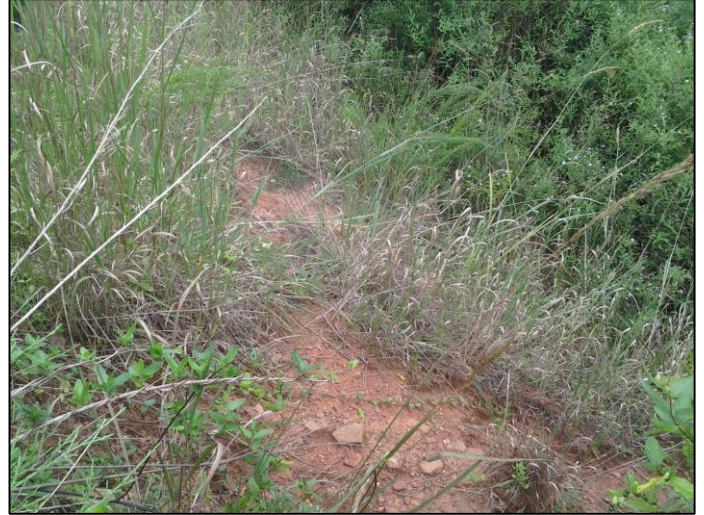
Station 19+00 Right bank – MY-05 September 2014

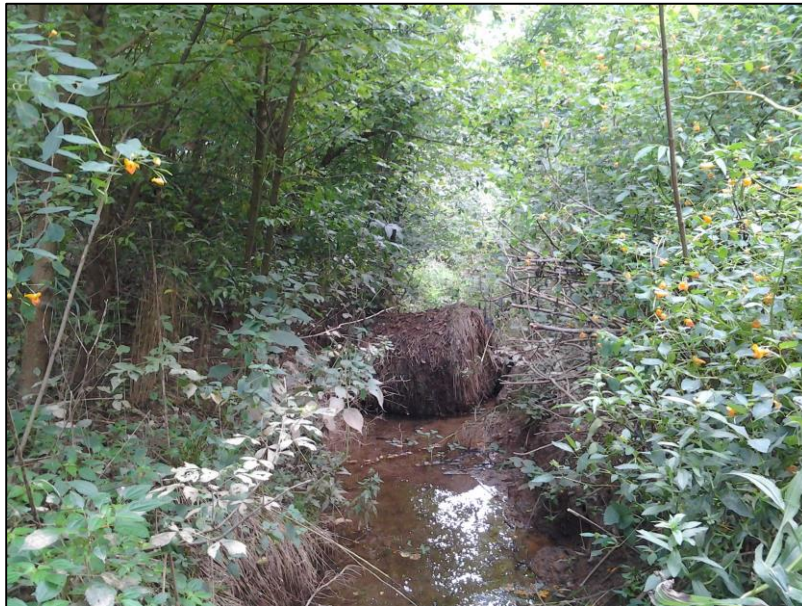
Station 31+25 Hay bale in stream – MY-05 September 2014

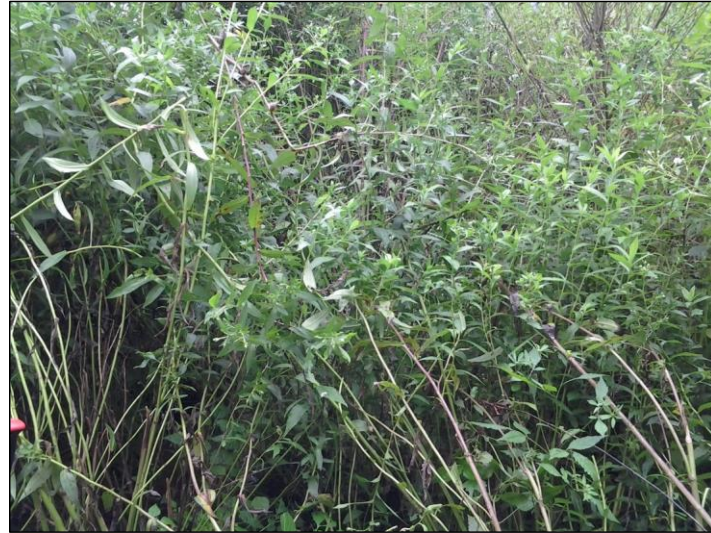
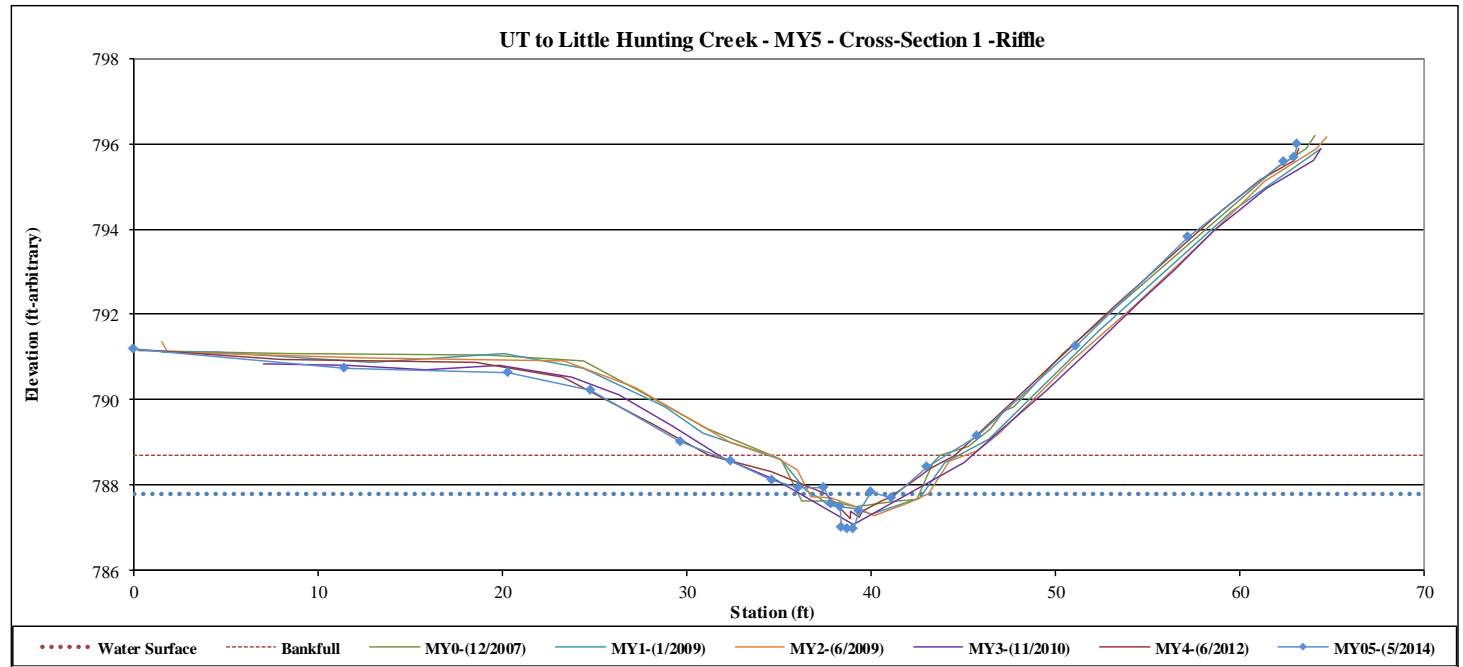
Project Name	UT to Hunting Creek
EEP Project Number	197
Cross-Section ID	XS-1, Riffle, 3+92
Survey Date	5/2014

SUMMARY DATA	
Bankfull Elevation (ft)	788.70
Bankfull Cross-Sectional Area (ft ²)	8.60
Bankfull Width (ft)	12.50
Flood Prone Area Elevation (ft)	790.43
Flood Prone Width (ft)	63.10
Bankfull Mean Depth (ft)	0.70
Bankfull Max Depth (ft)	1.70
W/D Ratio	18.20
Entrenchment Ratio	5.00
Bank Height Ratio	0.49

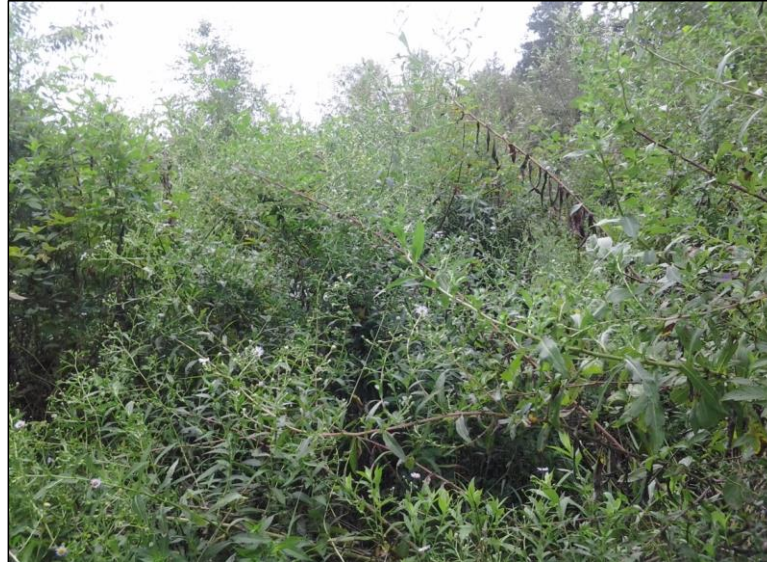
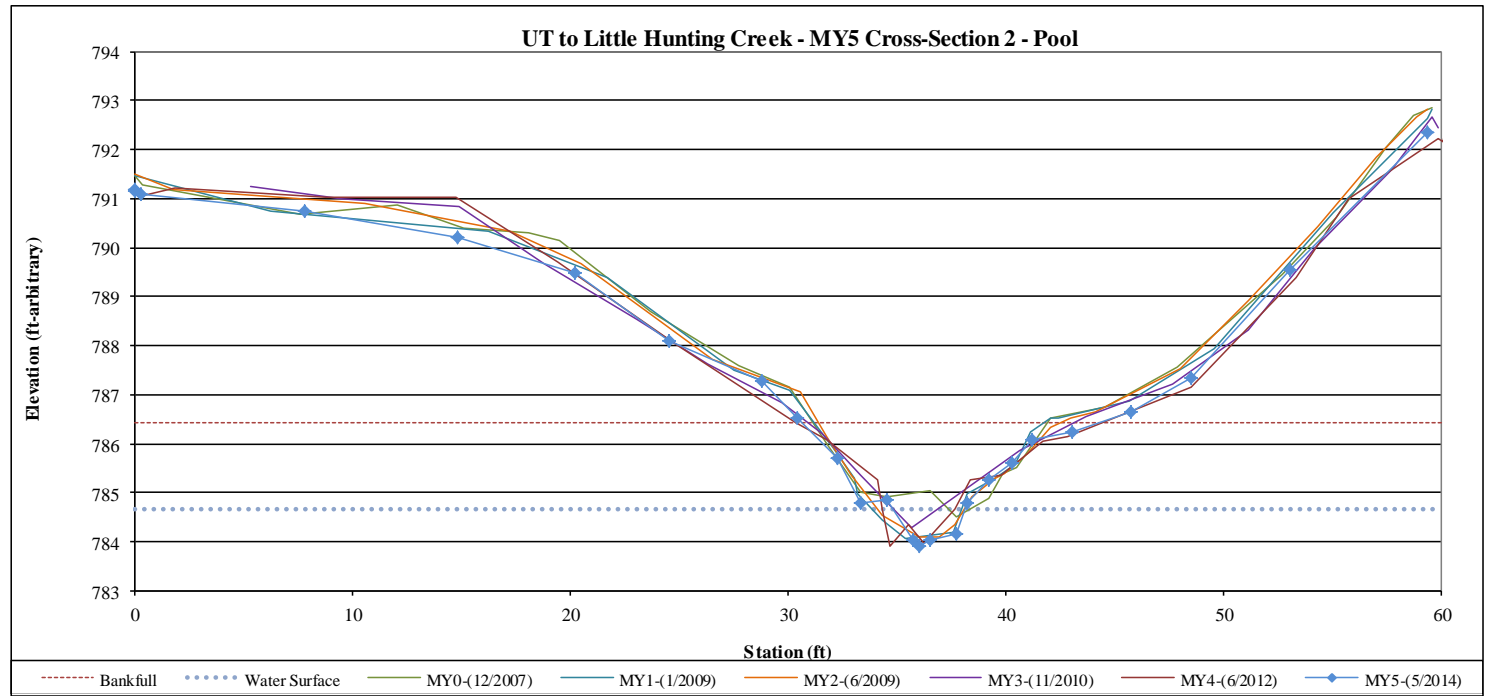
Project Name	UT to Little Hunting Creek
EEP Project Number	197
Cross-Section ID	XS-2, Pool, 5+25
Survey Date	5/2014

SUMMARY DATA	
Bankfull Elevation (ft)	786.42
Bankfull Cross-Sectional Area (ft ²)	14.40
Bankfull Width (ft)	10.80
Flood Prone Area Elevation (ft)	-
Flood Prone Width (ft)	-
Bankfull Mean Depth (ft)	1.30
Bankfull Max Depth (ft)	2.50
W/D Ratio	-
Entrenchment Ratio	-
Bank Height Ratio	-

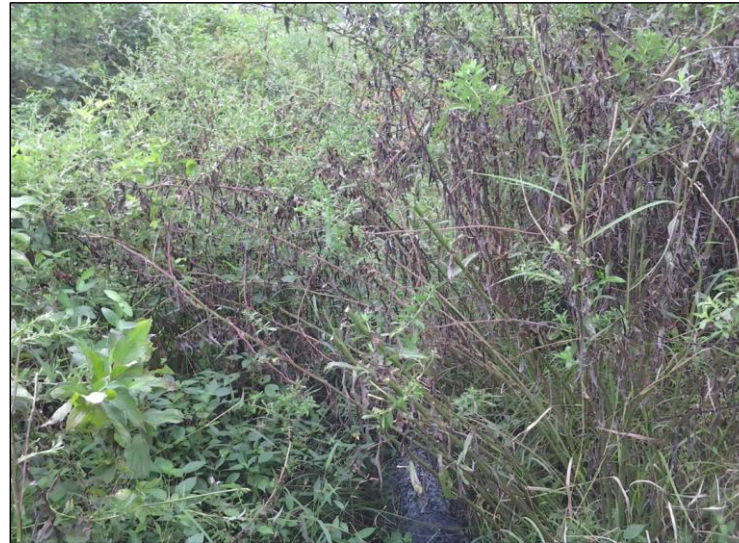
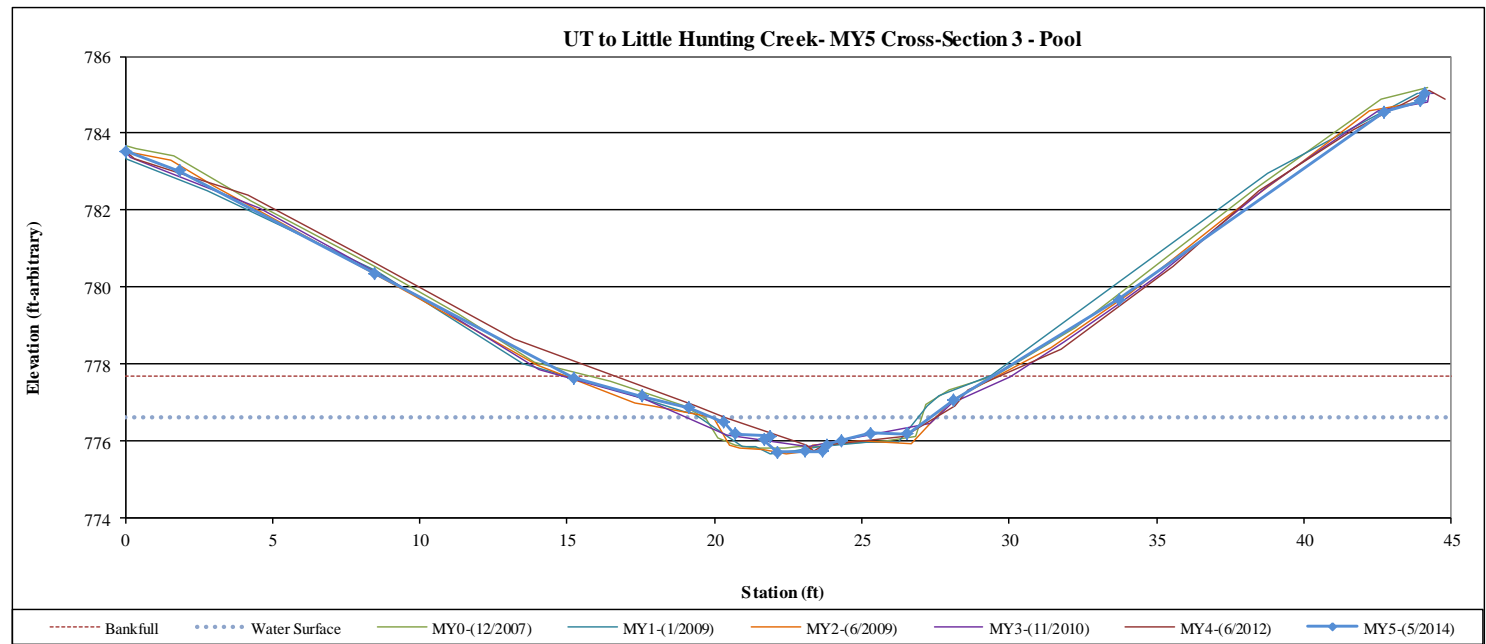
Project Name	UT to Little Hunting Creek
EEP Project Number	197
Cross-Section ID	XS-3, Pool, 9+41
Survey Date	5/2014

SUMMARY DATA	
Bankfull Elevation (ft)	777.69
Bankfull Cross-Sectional Area (ft ²)	15.40
Bankfull Width (ft)	14.30
Flood Prone Area Elevation (ft)	-
Flood Prone Width (ft)	-
Bankfull Mean Depth (ft)	1.10
Bankfull Max Depth (ft)	2.00
W/D Ratio	-
Entrenchment Ratio	-
Bank Height Ratio	-

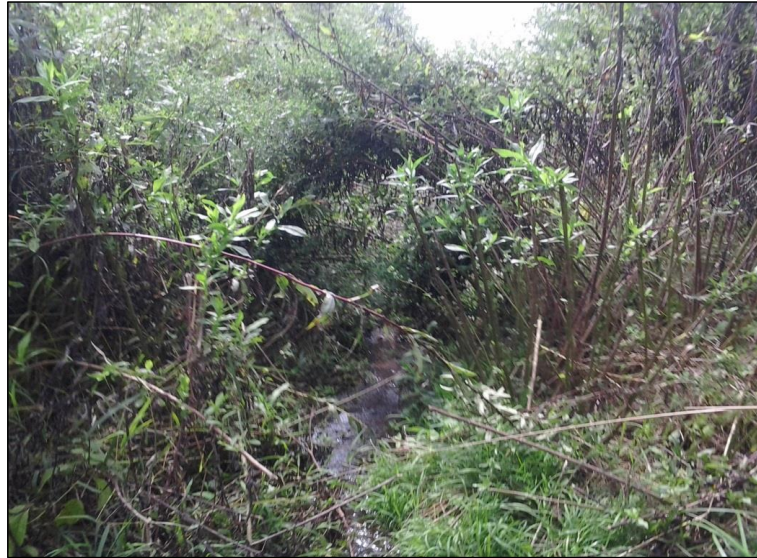
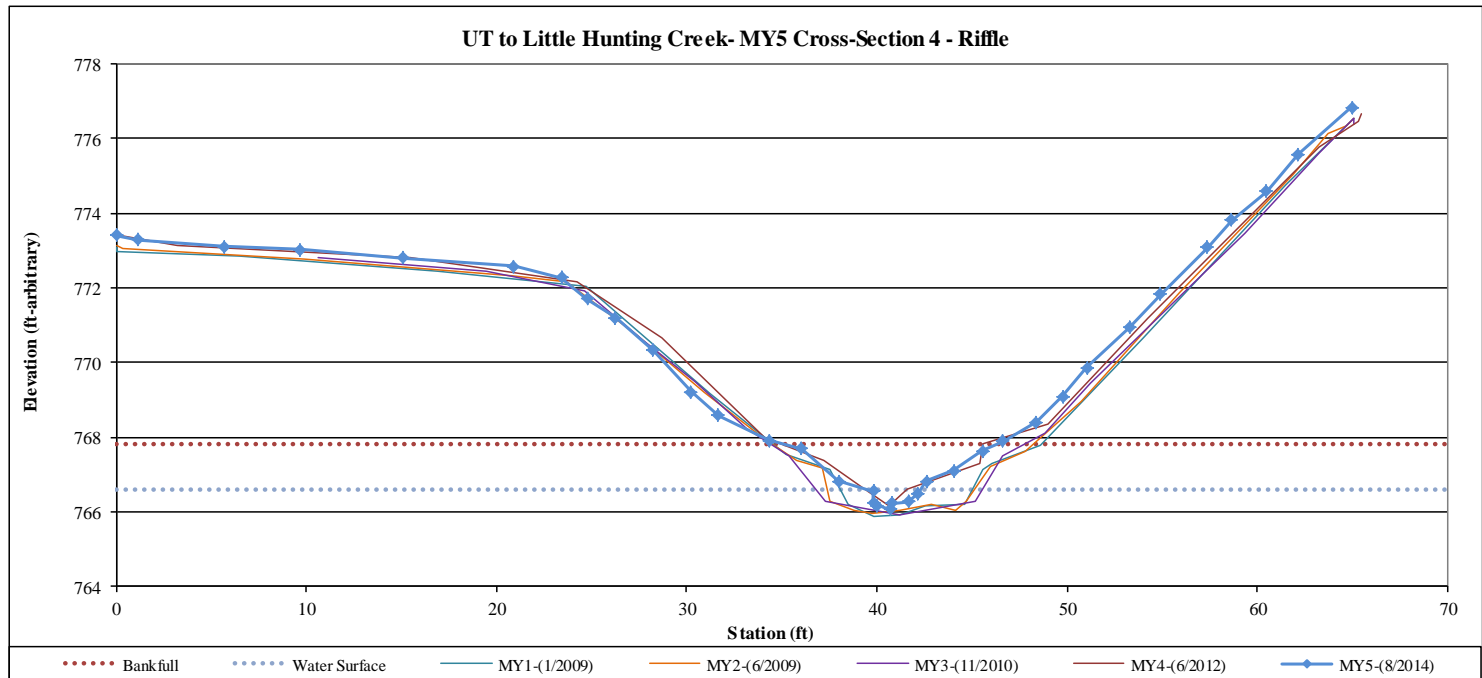
Project Name	UT to Little Hunting Creek
EEP Project Number	197
Cross-Section ID	XS-4, Riffle, 14+72
Survey Date	8/2014

SUMMARY DATA	
Bankfull Elevation (ft)	767.81
Bankfull Cross-Sectional Area (ft ²)	8.70
Bankfull Width (ft)	9.00
Flood Prone Area Elevation (ft)	769.60
Flood Prone Width (ft)	20.90
Bankfull Mean Depth (ft)	1.00
Bankfull Max Depth (ft)	1.70
W/D Ratio	9.30
Entrenchment Ratio	2.30
Bank Height Ratio	0.40

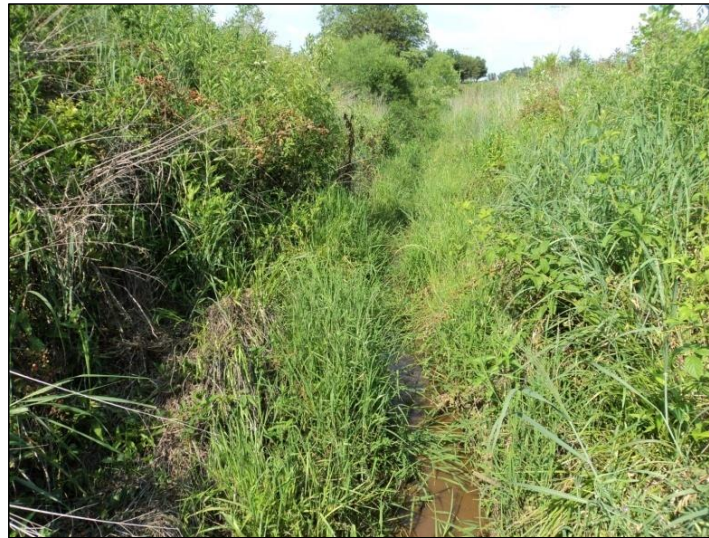
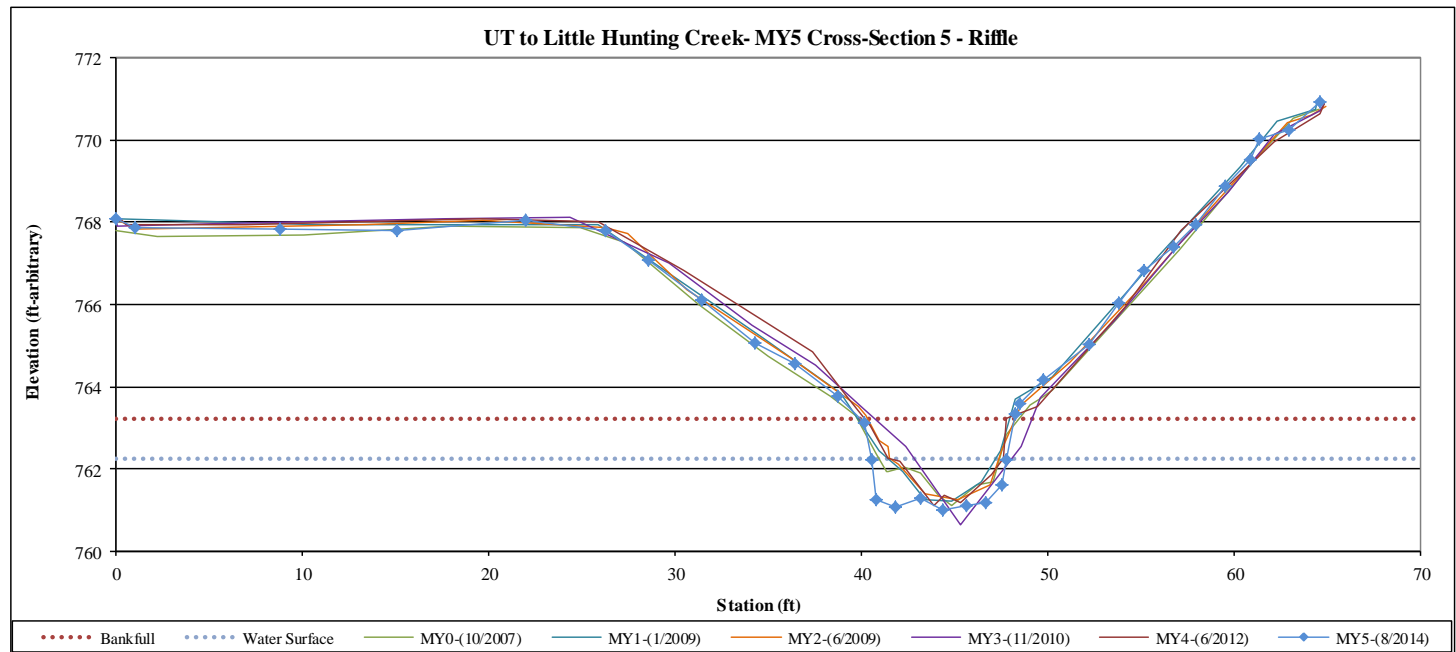
Project Name	UT to Little Hunting Creek
EEP Project Number	197
Cross-Section ID	XS-5, Riffle, 17+10
Survey Date	8/2014

SUMMARY DATA	
Bankfull Elevation (ft)	763.22
Bankfull Cross-Sectional Area (ft ²)	14.90
Bankfull Width (ft)	8.20
Flood Prone Area Elevation (ft)	765.40
Flood Prone Width (ft)	19.60
Bankfull Mean Depth (ft)	1.80
Bankfull Max Depth (ft)	2.20
W/D Ratio	4.50
Entrenchment Ratio	2.10
Bank Height Ratio	1.00

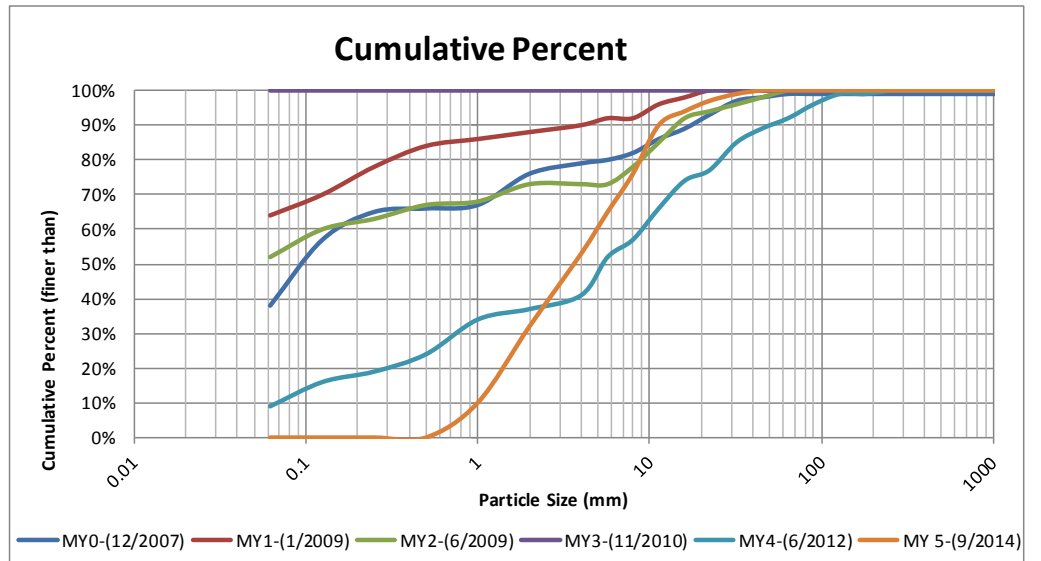
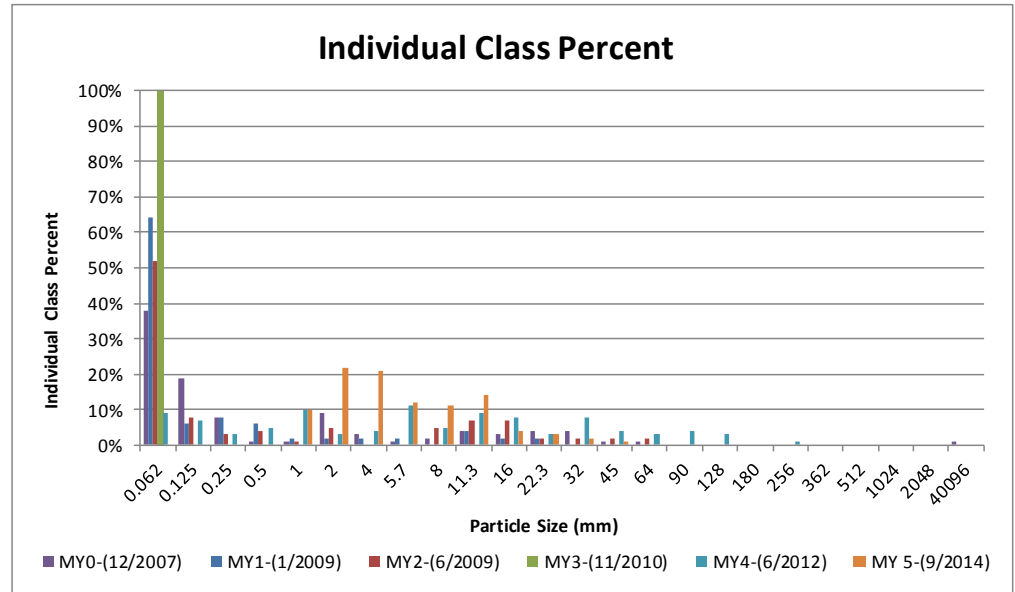
Project Name: UT to Little Hunting Creek (Johnson Site)					
Cross-Section: 1					
Feature: Riffle					
MY5-(9/2014)					
Description	Material	Size (mm)	Total #	Item %	Cum %
Silt/Clay	silt/clay	0.062	0	0%	0%
Sand	very fine sand	0.125	0	0%	0%
	fine sand	0.250	0	0%	0%
	medium sand	0.50	0	0%	0%
	coarse sand	1.00	10	10%	10%
	very coarse sand	2.0	22	22%	32%
Gravel	very fine gravel	4.0	21	21%	53%
	fine gravel	5.7	12	12%	65%
	fine gravel	8.0	11	11%	76%
	medium gravel	11.3	14	14%	90%
	medium gravel	16.0	4	4%	94%
	course gravel	22.3	3	3%	97%
	course gravel	32.0	2	2%	99%
	very coarse gravel	45	1	1%	100%
	very coarse gravel	64	0	0%	100%
Cobble	small cobble	90	0	0%	100%
	medium cobble	128	0	0%	100%
	large cobble	180	0	0%	100%
	very large cobble	256	0	0%	100%
Boulder	small boulder	362	0	0%	100%
	small boulder	512	0	0%	100%
	medium boulder	1024	0	0%	100%
	large boulder	2048	0	0%	100%
Bedrock	bedrock	40096	0	0%	100%
TOTAL % of whole count			100	100%	100%

Summary Data	
D50	3.6
D84	9.6
D95	18.00

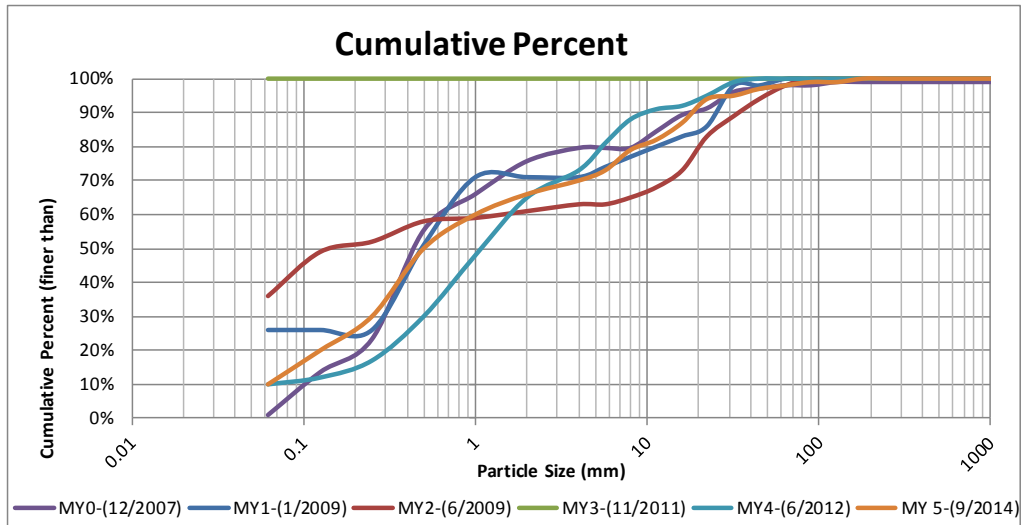
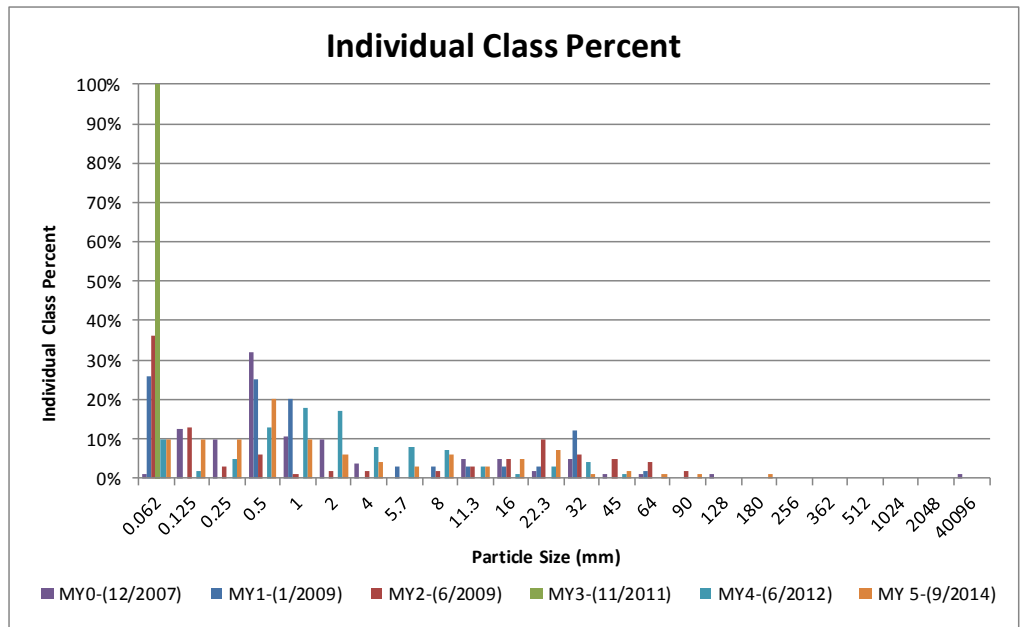
Project Name: UT to Little Hunting Creek (Johnson Site)					
Cross-Section: 2					
Feature: Pool					
MY5-(9/2014)					
Description	Material	Size (mm)	Total #	Item %	Cum %
Silt/Clay	silt/clay	0.062	10	10%	10%
Sand	very fine sand	0.125	10	10%	20%
	fine sand	0.250	10	10%	30%
	medium sand	0.50	20	20%	50%
	coarse sand	1.00	10	10%	60%
	very coarse sand	2.0	6	6%	66%
Gravel	very fine gravel	4.0	4	4%	70%
	fine gravel	5.7	3	3%	73%
	fine gravel	8.0	6	6%	79%
	medium gravel	11.3	3	3%	82%
	medium gravel	16.0	5	5%	87%
	course gravel	22.3	7	7%	94%
	course gravel	32.0	1	1%	95%
	very coarse gravel	45	2	2%	97%
	very coarse gravel	64	1	1%	98%
Cobble	small cobble	90	1	1%	99%
	medium cobble	128	0	0%	99%
	large cobble	180	1	1%	100%
	very large cobble	256	0	0%	100%
Boulder	small boulder	362	0	0%	100%
	small boulder	512	0	0%	100%
	medium boulder	1024	0	0%	100%
	large boulder	2048	0	0%	100%
Bedrock	bedrock	40096	0	0%	100%
TOTAL % of whole count			100	100%	100%

Summary Data	
D50	0.35
D84	9.1
D95	22

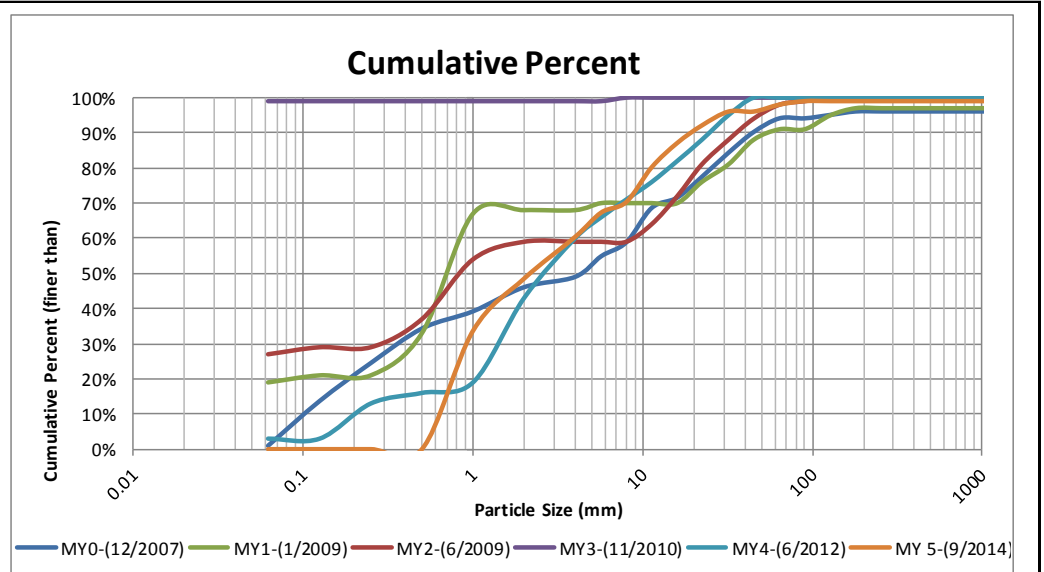
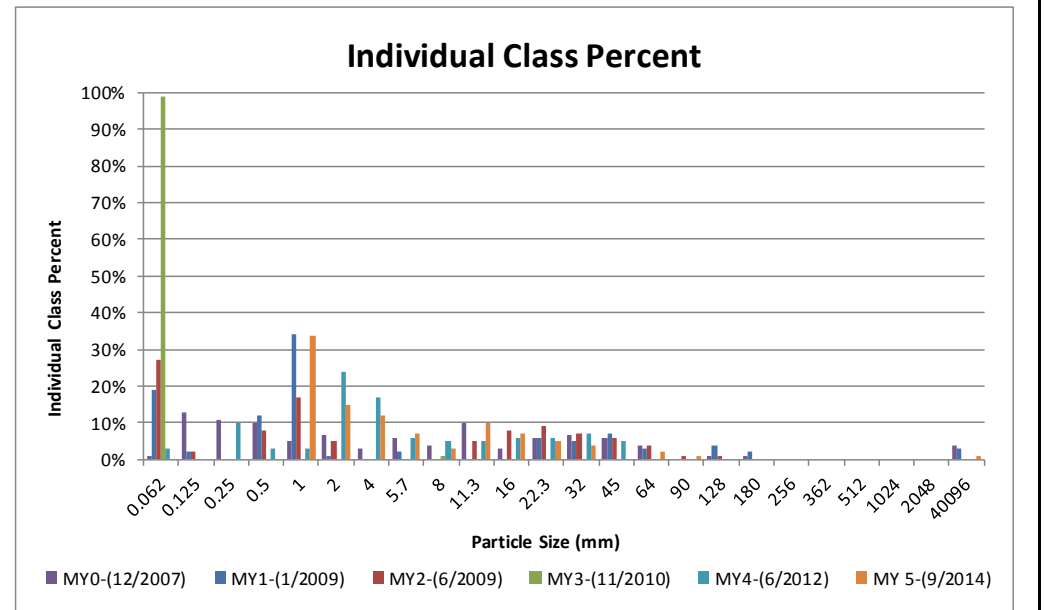
Project Name: UT to Little Hunting Creek (Johnson Site)					
Cross-Section: 3					
Feature: Pool					
MY5-(9/2014)					
Description	Material	Size (mm)	Total #	Item %	Cum %
Silt/Clay	silt/clay	0.062	0	0%	0%
Sand	very fine sand	0.125	0	0%	0%
	fine sand	0.250	0	0%	0%
	medium sand	0.50	0	0%	0%
	coarse sand	1.00	34	34%	34%
	very coarse sand	2.0	15	15%	49%
Gravel	very fine gravel	4.0	12	12%	60%
	fine gravel	5.7	7	7%	67%
	fine gravel	8.0	3	3%	70%
	medium gravel	11.3	10	10%	80%
	medium gravel	16.0	7	7%	87%
	course gravel	22.3	5	5%	92%
	course gravel	32.0	4	4%	96%
	very coarse gravel	45	0	0%	96%
	very coarse gravel	64	2	2%	98%
Cobble	small cobble	90	1	1%	99%
	medium cobble	128	0	0%	99%
	large cobble	180	0	0%	99%
	very large cobble	256	0	0%	99%
Boulder	small boulder	362	0	0%	99%
	small boulder	512	0	0%	99%
	medium boulder	1024	0	0%	99%
	large boulder	2048	0	0%	99%
Bedrock	bedrock	40096	1	1%	100%
TOTAL % of whole count			101	100%	100%

Summary Data	
D50	2.1
D84	13
D95	27

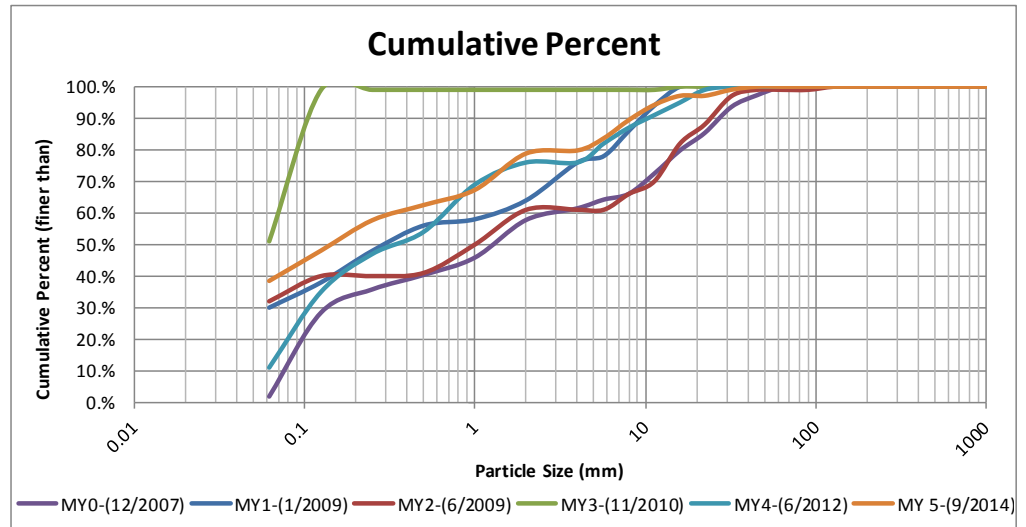
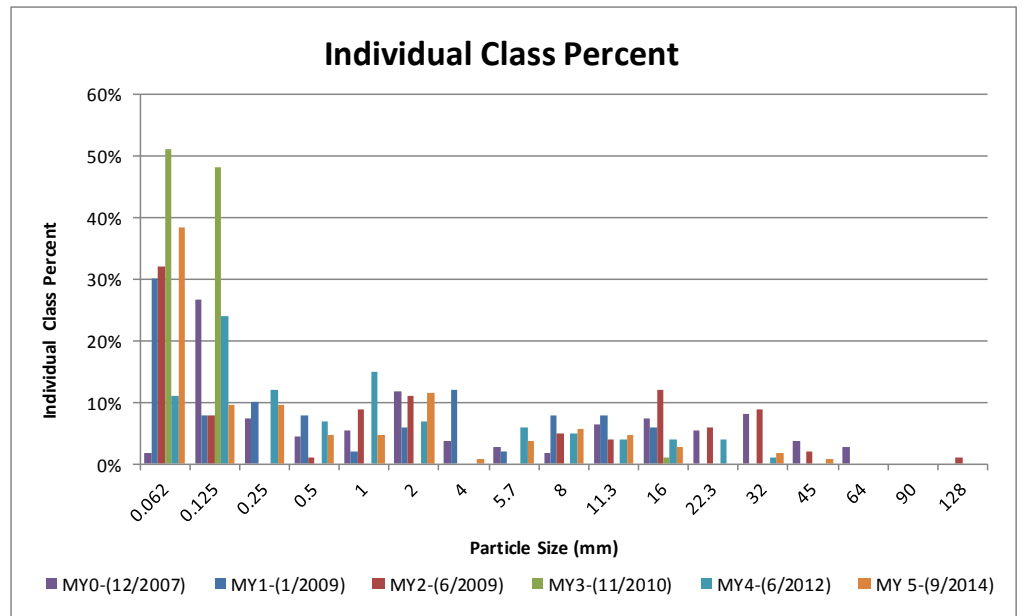
Project Name: UT to Little Hunting Creek (Johnson Site)					
Cross-Section: 4					
Feature: Riffle					
MY5-(9/2014)					
Description	Material	Size (mm)	Total #	Item %	Cum %
Silt/Clay	silt/clay	0.062	40	38%	38%
Sand	very fine sand	0.125	10	10%	48%
	fine sand	0.250	10	10%	58%
	medium sand	0.50	5	5%	63%
	coarse sand	1.00	5	5%	67%
	very coarse sand	2.0	12	12%	79%
Gravel	very fine gravel	4.0	1	1%	80%
	fine gravel	5.7	4	4%	84%
	fine gravel	8.0	6	6%	89%
	medium gravel	11.3	5	5%	94%
	medium gravel	16.0	3	3%	97%
	course gravel	22.3	0	0%	97%
	course gravel	32.0	2	2%	99%
	very coarse gravel	45	1	1%	100%
	very coarse gravel	64	0	0%	100%
Cobble	small cobble	90	0	0%	100%
	medium cobble	128	0	0%	100%
	large cobble	180	0	0%	100%
	very large cobble	256	0	0%	100%
Boulder	small boulder	362	0	0%	100%
	small boulder	512	0	0%	100%
	medium boulder	1024	0	0%	100%
	large boulder	2048	0	0%	100%
Bedrock	bedrock	40096	0	0%	100%
TOTAL % of whole count			104	100%	100%

Summary Data	
D50	0.14
D84	6.1
D95	12.0

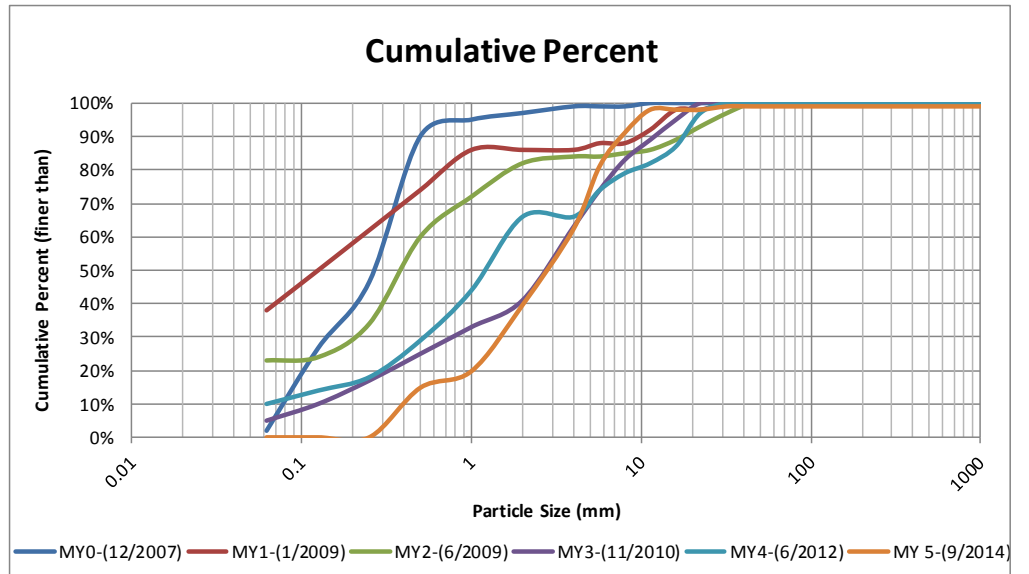
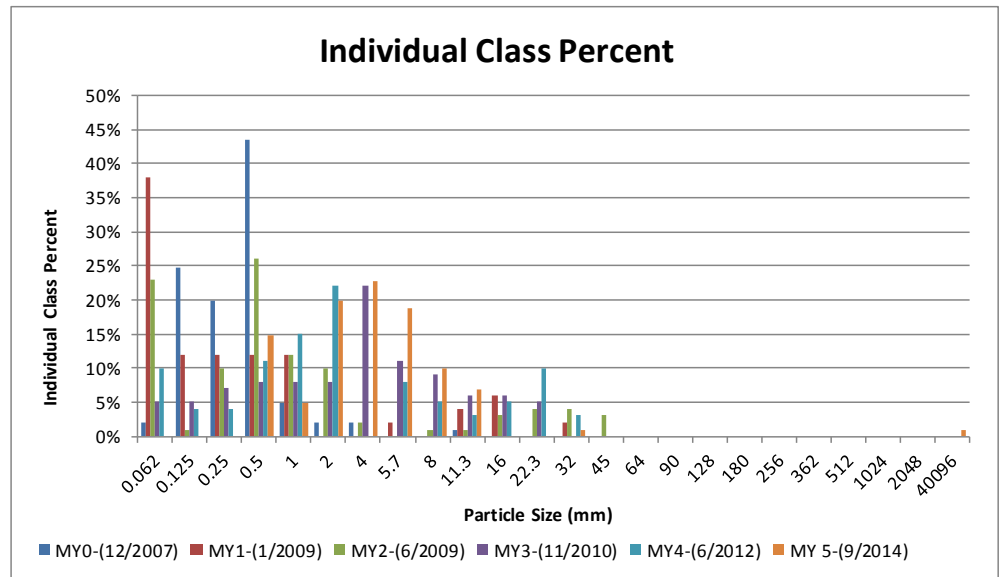
Project Name: UT to Little Hunting Creek (Johnson Site)					
Cross-Section: 5					
Feature: Riffle					
MY5-(9/2014)					
Description	Material	Size (mm)	Total #	Item %	Cum %
Silt/Clay	silt/clay	0.062	0	0%	0%
Sand	very fine sand	0.125	0	0%	0%
	fine sand	0.250	0	0%	0%
	medium sand	0.50	15	15%	15%
	coarse sand	1.00	5	5%	20%
	very coarse sand	2.0	20	20%	40%
Gravel	very fine gravel	4.0	23	23%	62%
	fine gravel	5.7	19	19%	81%
	fine gravel	8.0	10	10%	91%
	medium gravel	11.3	7	7%	98%
	medium gravel	16.0	0	0%	98%
	course gravel	22.3	0	0%	98%
	course gravel	32.0	1	1%	99%
	very coarse gravel	45	0	0%	99%
	very coarse gravel	64	0	0%	99%
Cobble	small cobble	90	0	0%	99%
	medium cobble	128	0	0%	99%
	large cobble	180	0	0%	99%
	very large cobble	256	0	0%	99%
Boulder	small boulder	362	0	0%	99%
	small boulder	512	0	0%	99%
	medium boulder	1024	0	0%	99%
	large boulder	2048	0	0%	99%
Bedrock	bedrock	40096	1	1%	100%
TOTAL % of whole count			101	100%	100%

Summary Data	
D50	2.7
D84	6.4
D95	9.20
